# FACILITY CONDITION ASSESSMENT AND LEVEL I ENERGY AUDIT

## FACILITY CONDITION ASSESSMENT AND LEVEL I ENERGY AUDIT of LAKEVIEW CEMETERY BUILDING

455 North Avenue  
Burlington, Vermont 05401

**EMG Project #:** 110226.14R-014.294  
**Date of Report:** November 11, 2014  
**On site Date:** August 26, 2014 and August 29, 2014

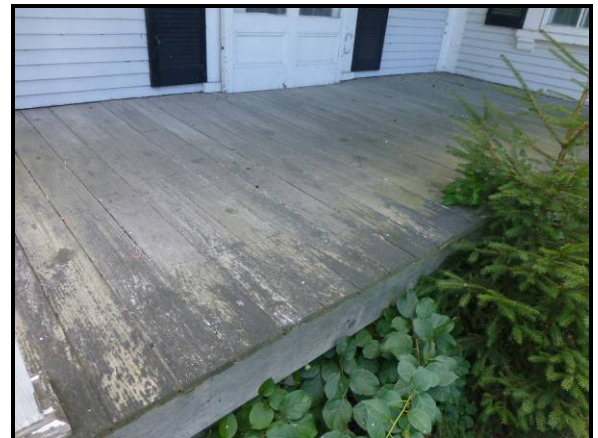
- The front porch is in fair to poor condition. The stairs and ramps are deteriorated in localized areas and will require replacement during the assessment period. The cost of this work is included in the Replacement Reserves Report.

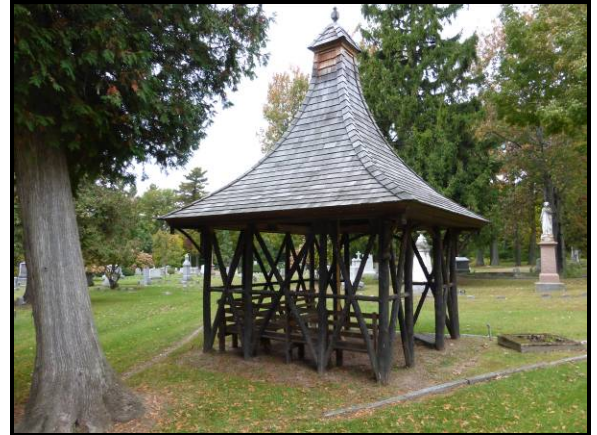
- The gazebo is in good condition and will require routine maintenance during the assessment period.
- There are two fountains in the cemetery that are no longer functioning. The masonry bases are crumbling and deteriorated. The cast iron fountains have been disassembled and are lying in the maintenance area. The fountains will require repair and refurbishing to restore them to their original state. The cost of this work is included in the Replacement Reserves Report.

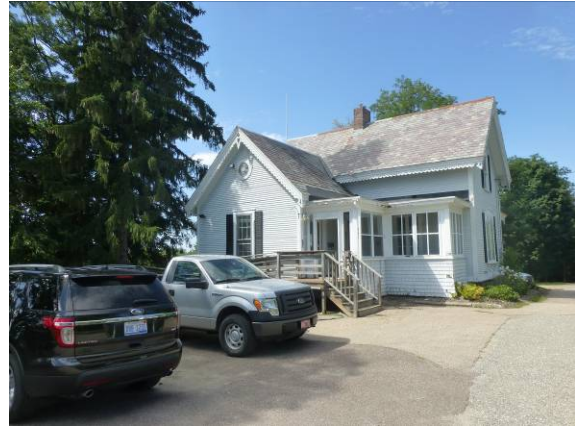
Photo #2: South elevation of cemetery building

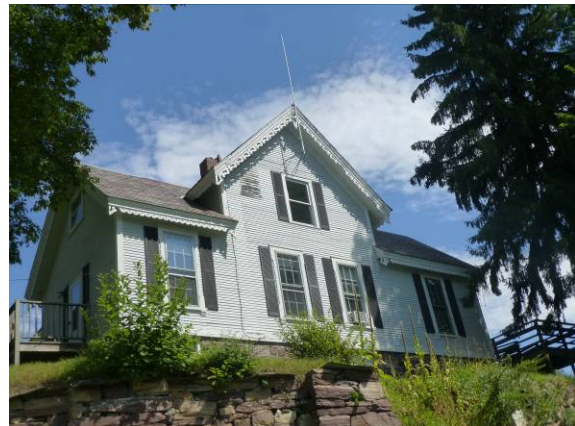
Photo #4: West elevation of cemetery building

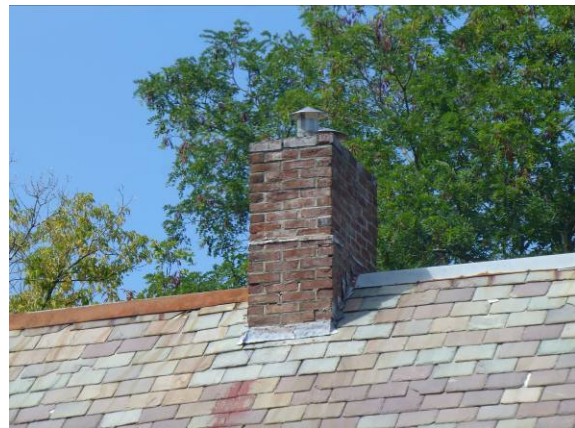
Photo #6: Cemetery building chimney

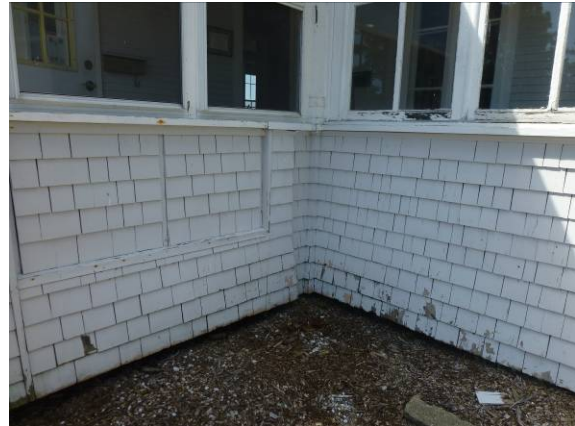
Photo #8: Cemetery building siding detail

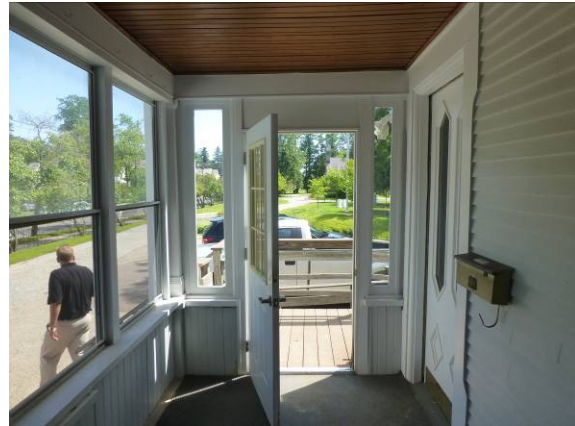
Photo #14: Main entrance
