## **Burlington Conservation Board**

## Conservation Board Meeting Minutes

## FY20 Burlington Slope Inspections

**CITY OF BURLINGTON, VERMONT  
SLOPE STABILITY INSPECTION**

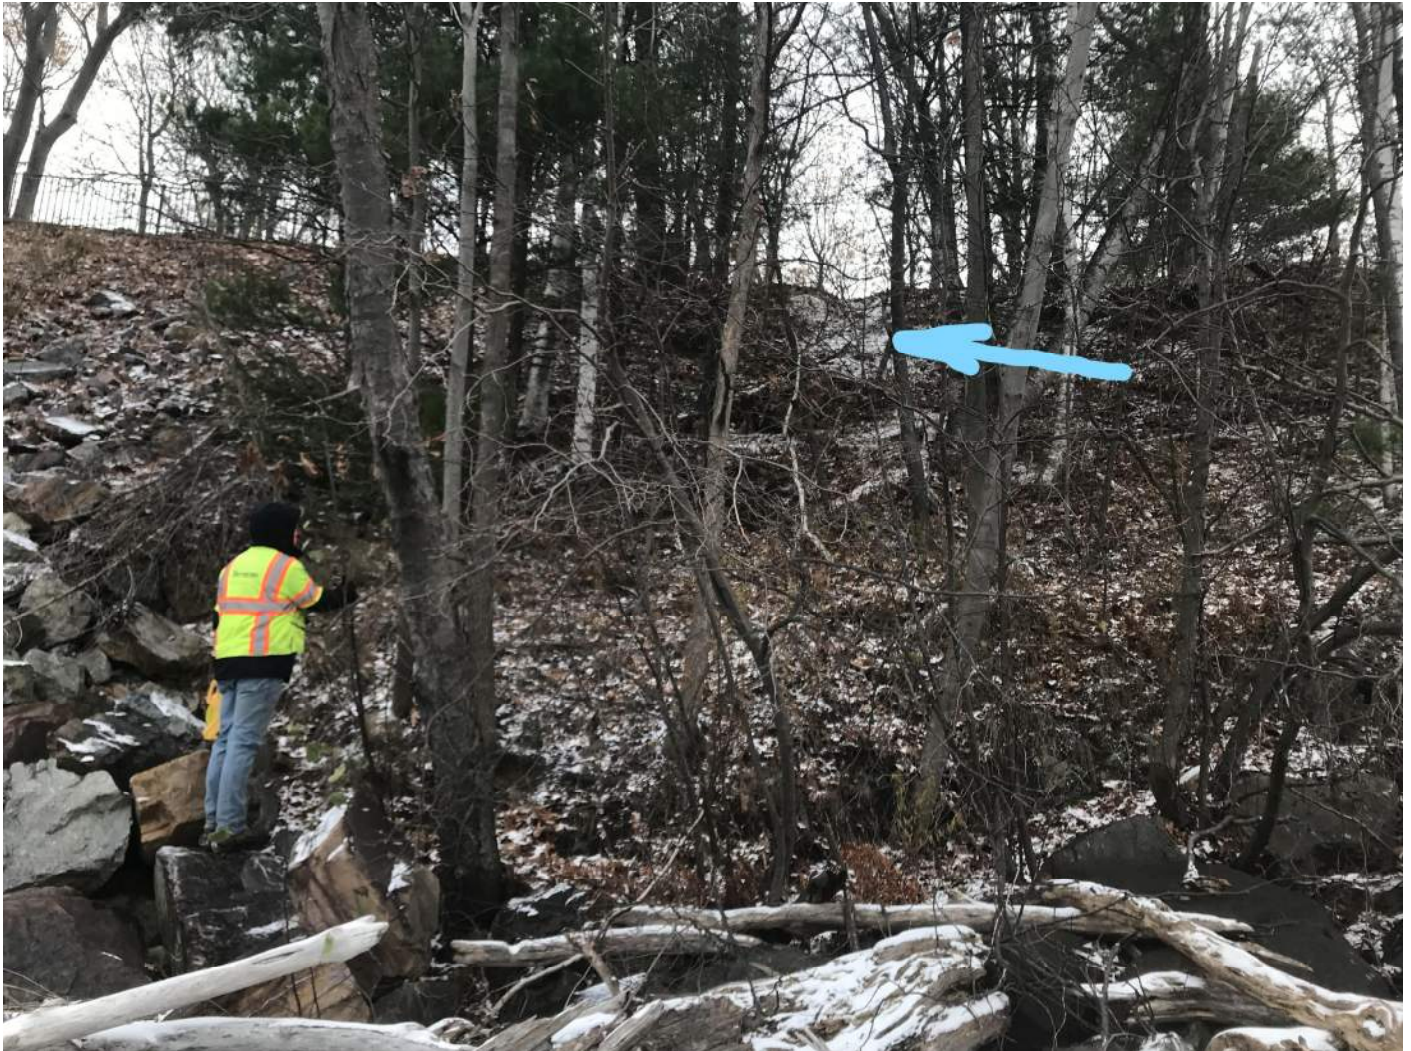
**Photograph 7:** View to southeast; incipient gullying at top of natural slope caused by surface water run-off

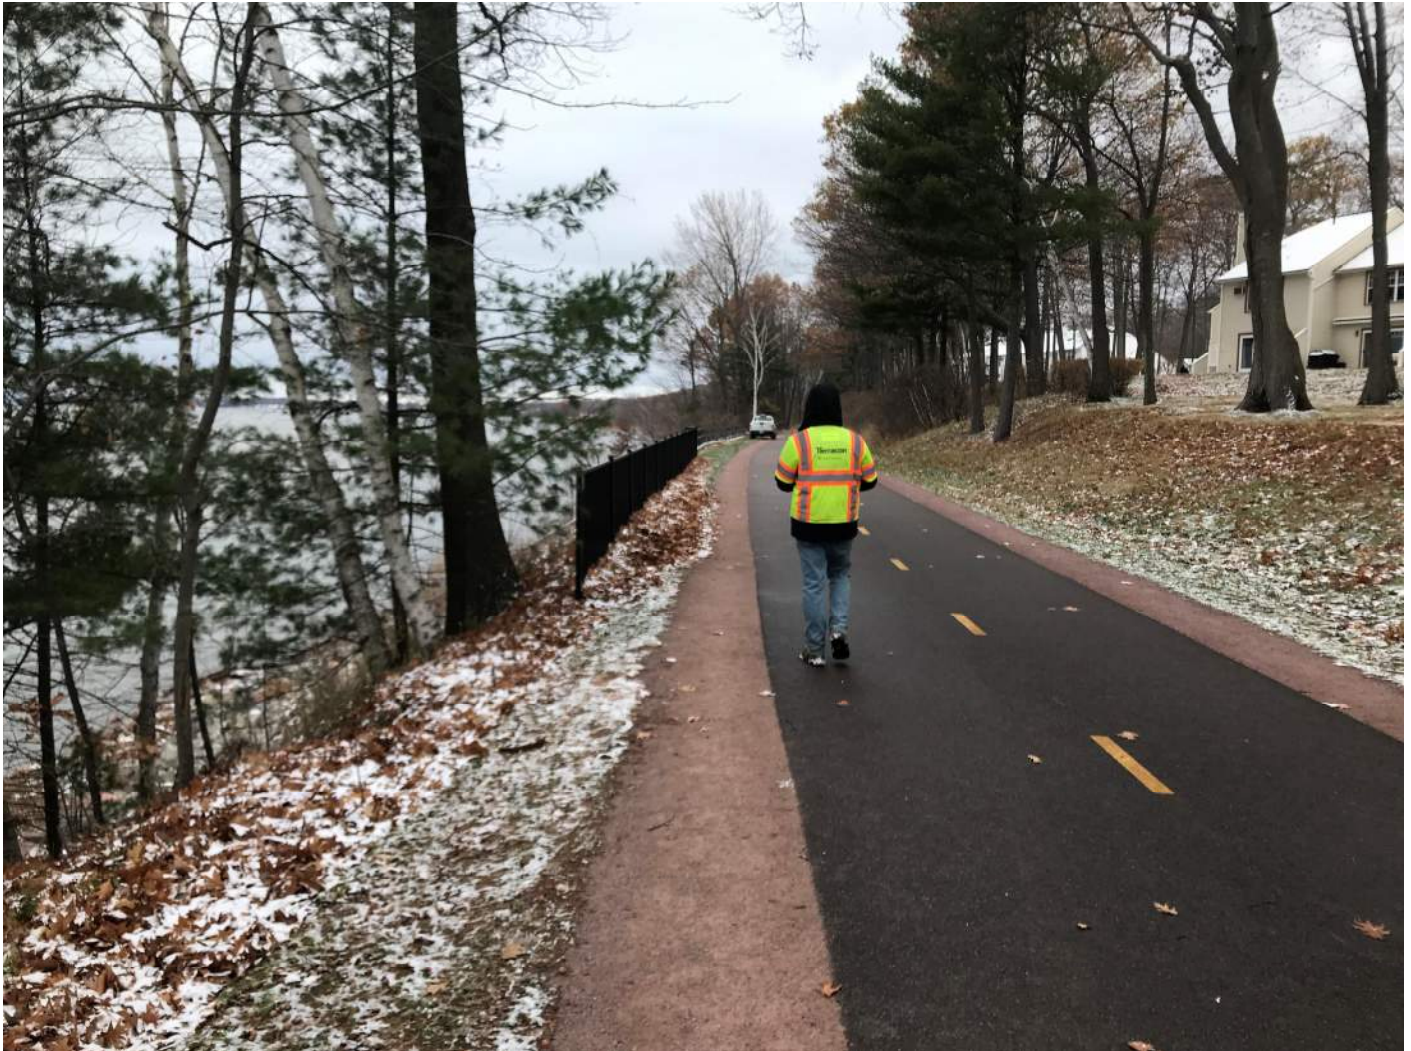
**Photograph 9:** View to north of bike path at the top of remediated slope; no stress-relief cracking or incipient slumping observed

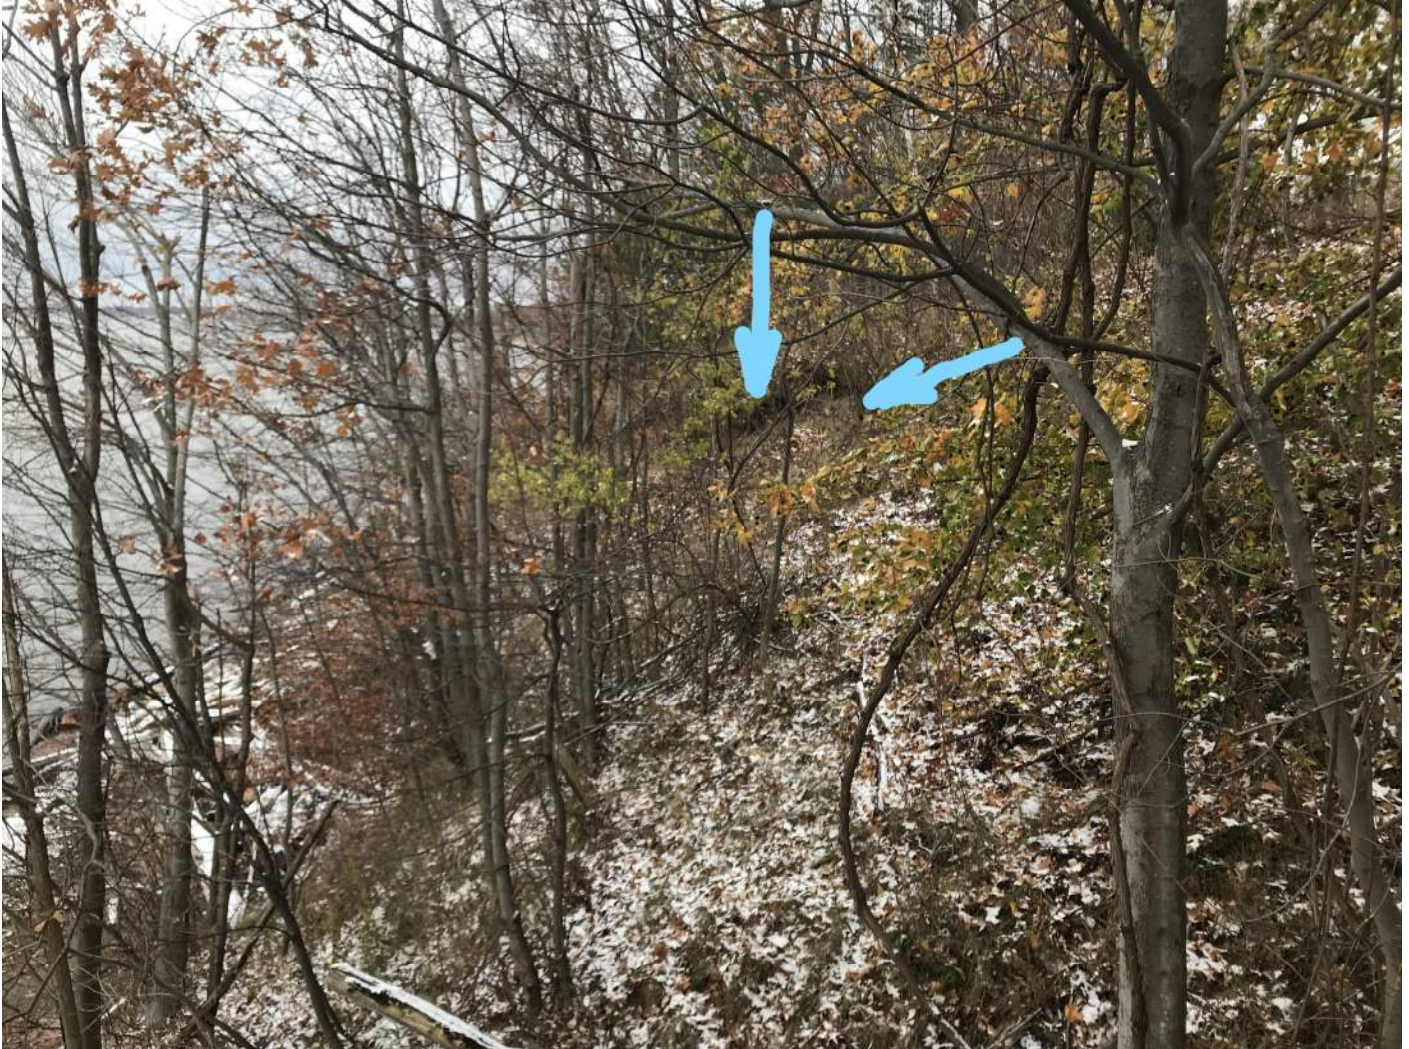
**Photograph 10:** View to north showing rotational landslide scarp (indicated by arrows) and scarp head in foreground; natural slope on northern flank of remediated slope; indicates historical event(s)

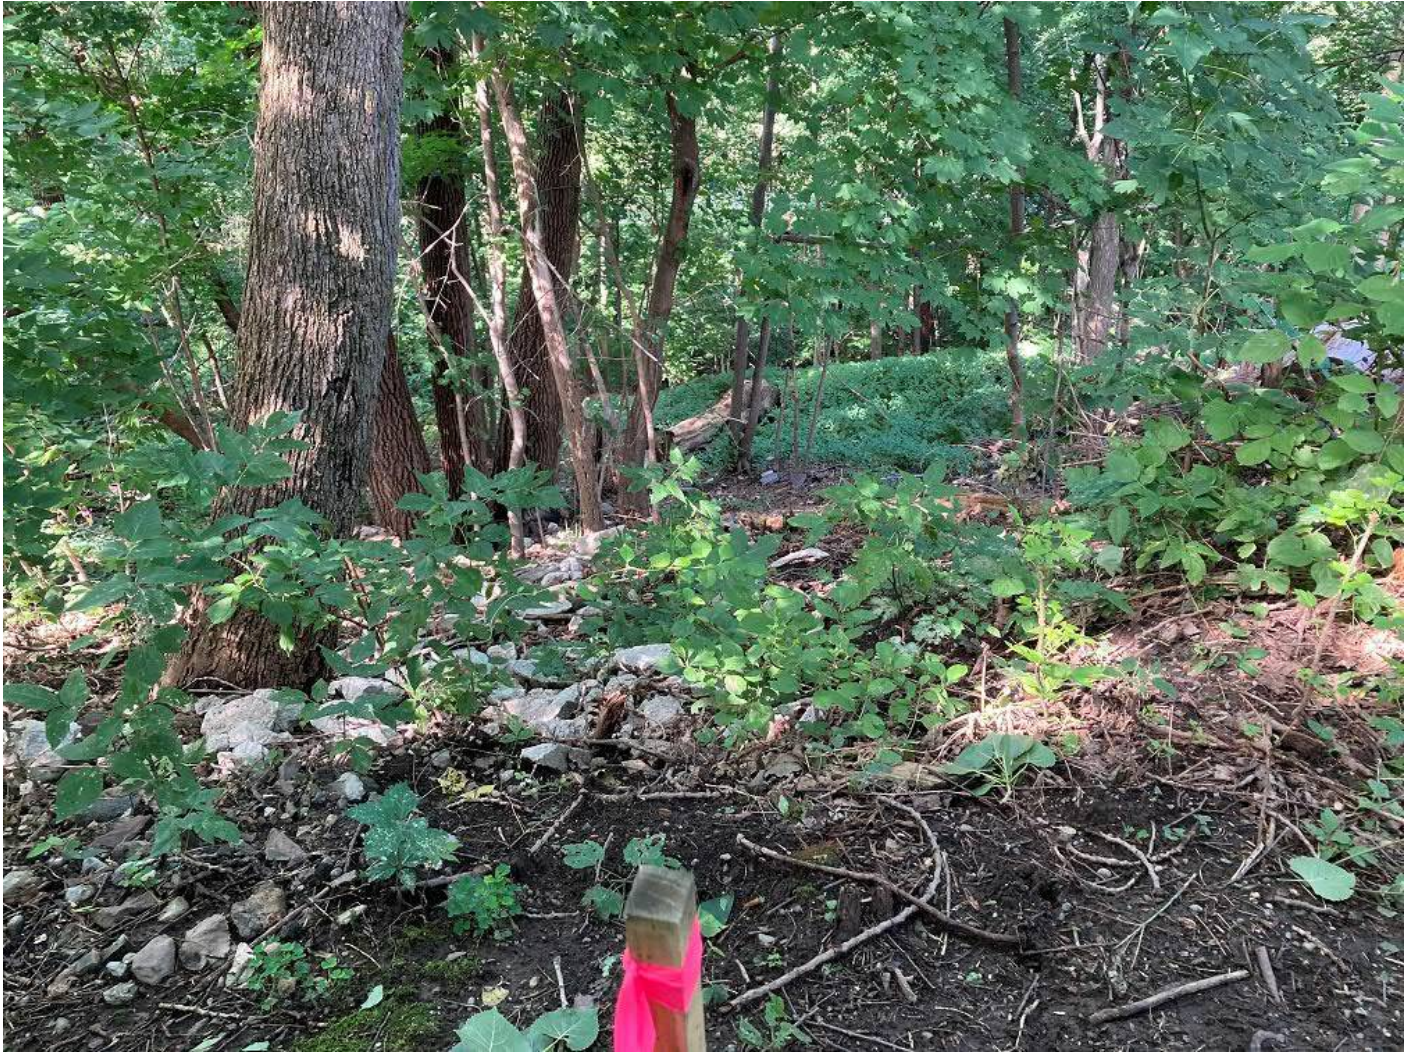
**Photograph 4:** View to north from behind Burlington Collision building showing overgrown downslope historical slump/slide debris center right

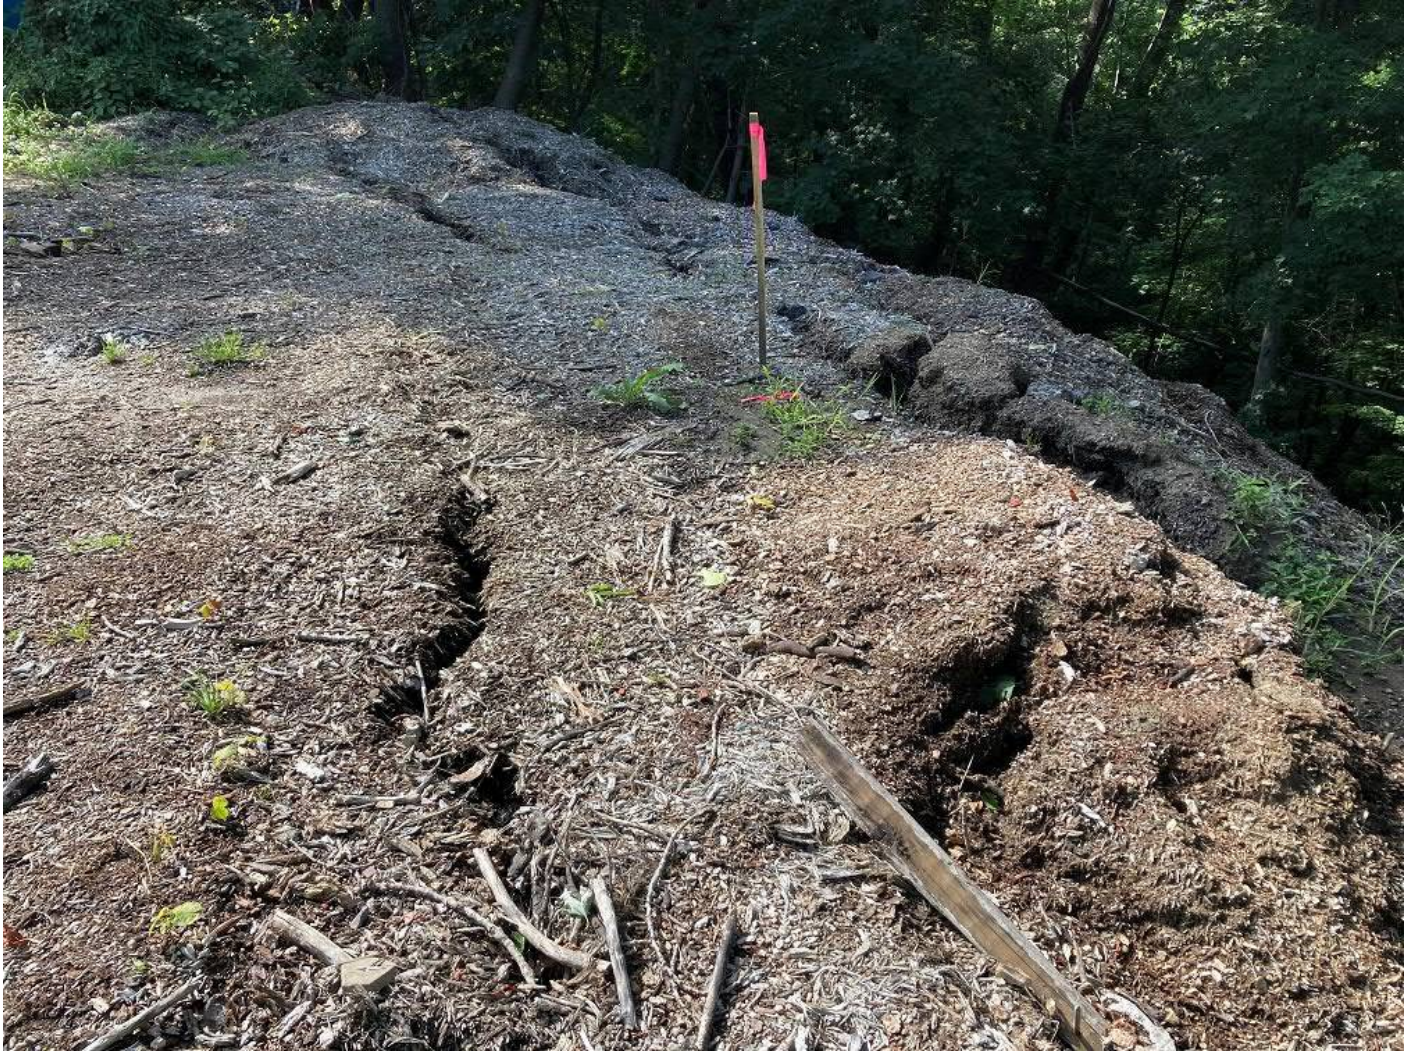
**Photograph 5:** View to west northwest, east of Burlington Collision building, showing crown cracks and beginning of future slump/slide, at top of former failed slope

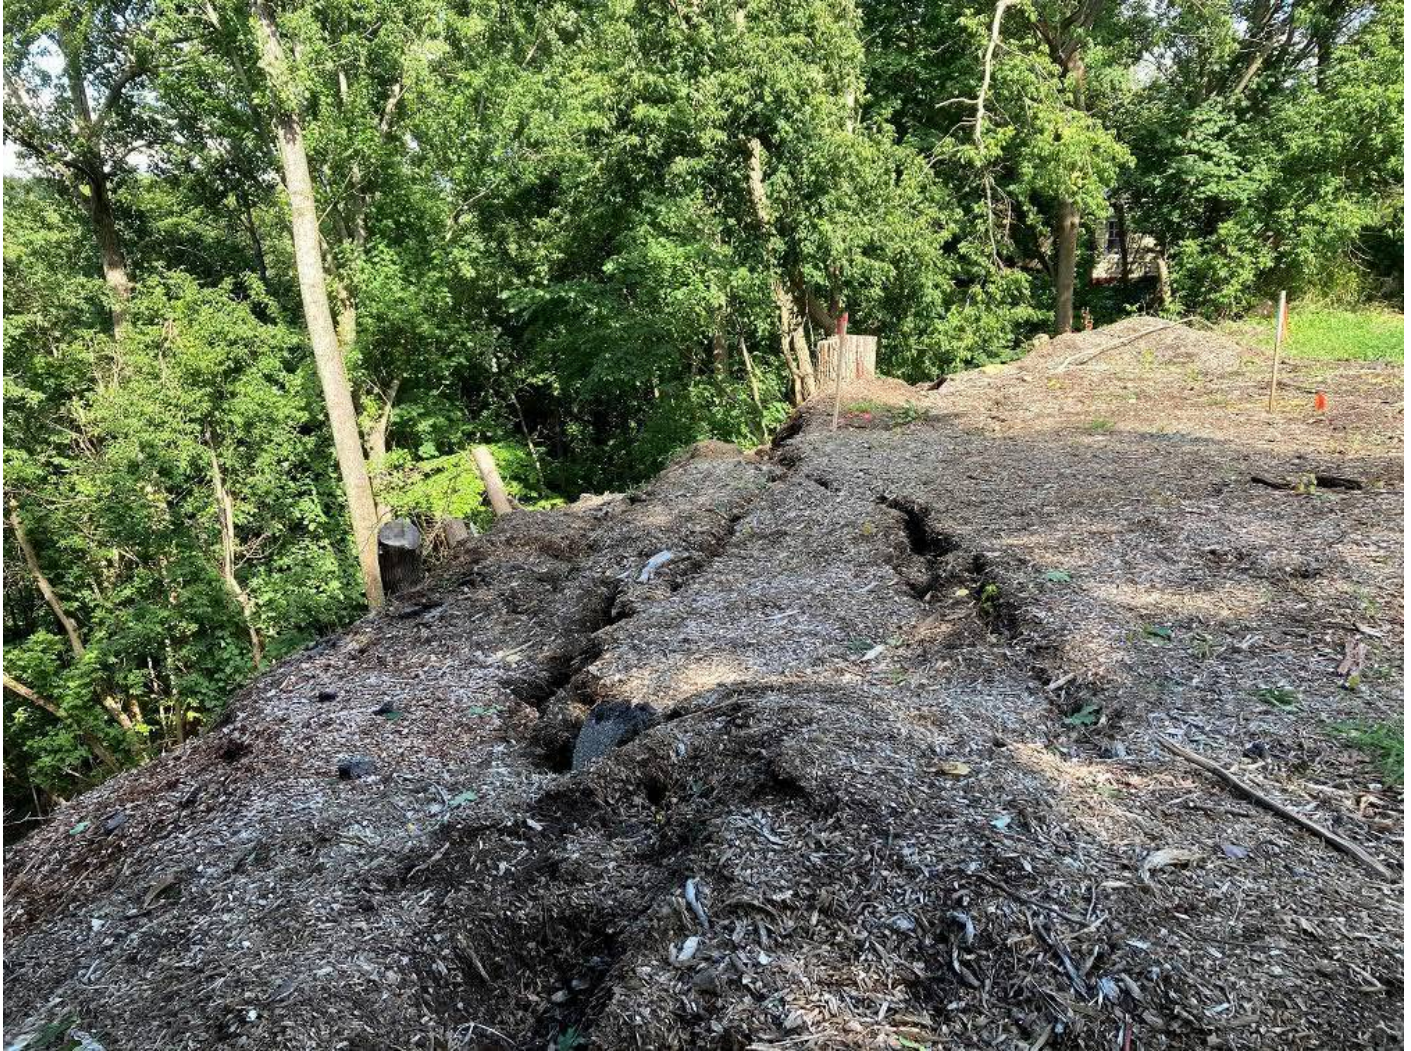
**Photograph 6:** View to northeast, additional view of crown cracks at top of slope, east of Burlington Collision building

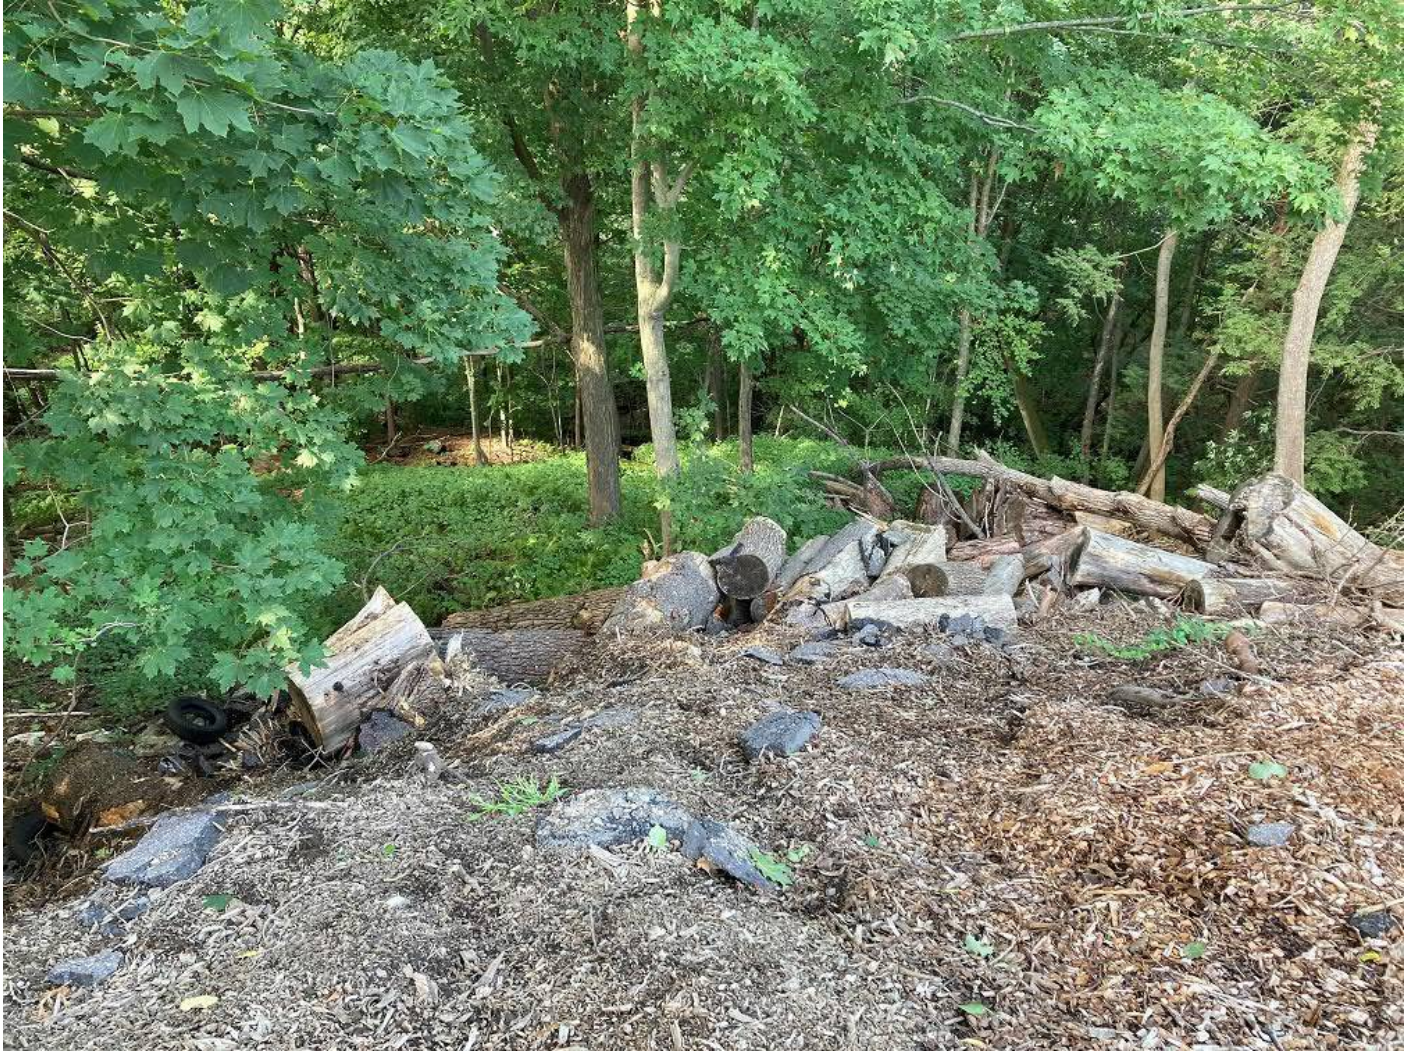
**Photograph 7:** View to north downslope from crown cracks at top of slope east of Burlington Collision building; logs appear to be placed to stabilize slide; overgrown historic slump/slide debris apparent beyond logs;

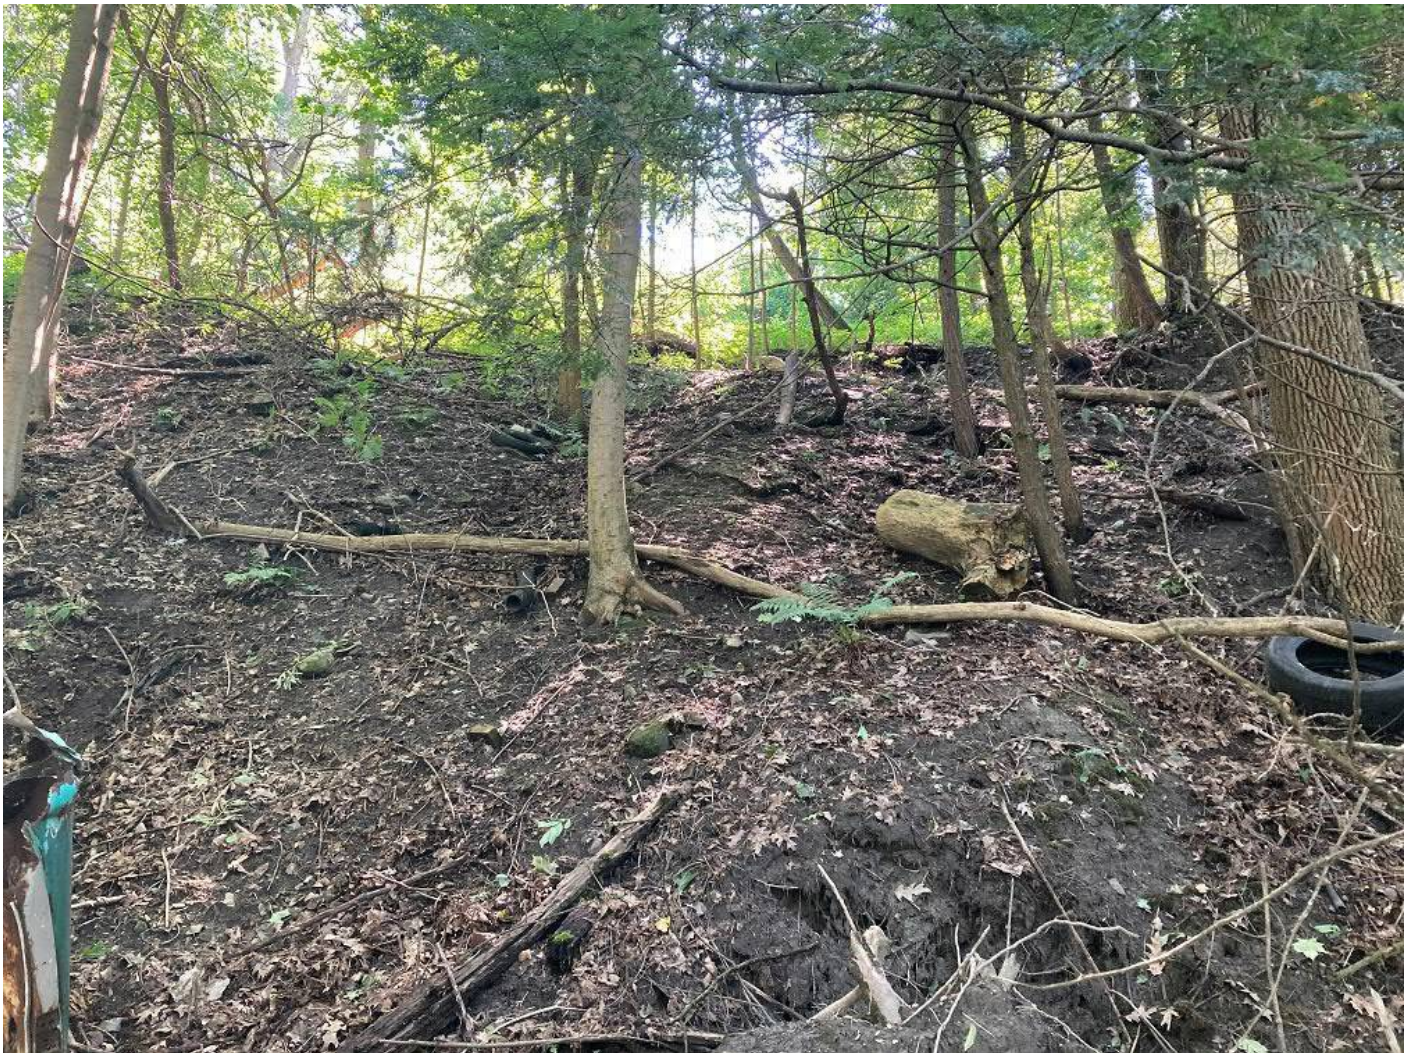
**Photograph 8:** View to south-southwest towards Burlington Collision showing exposed, unvegetated, historic slump/slide debris; exposed soil mass subject to continual erosion during precipitation.

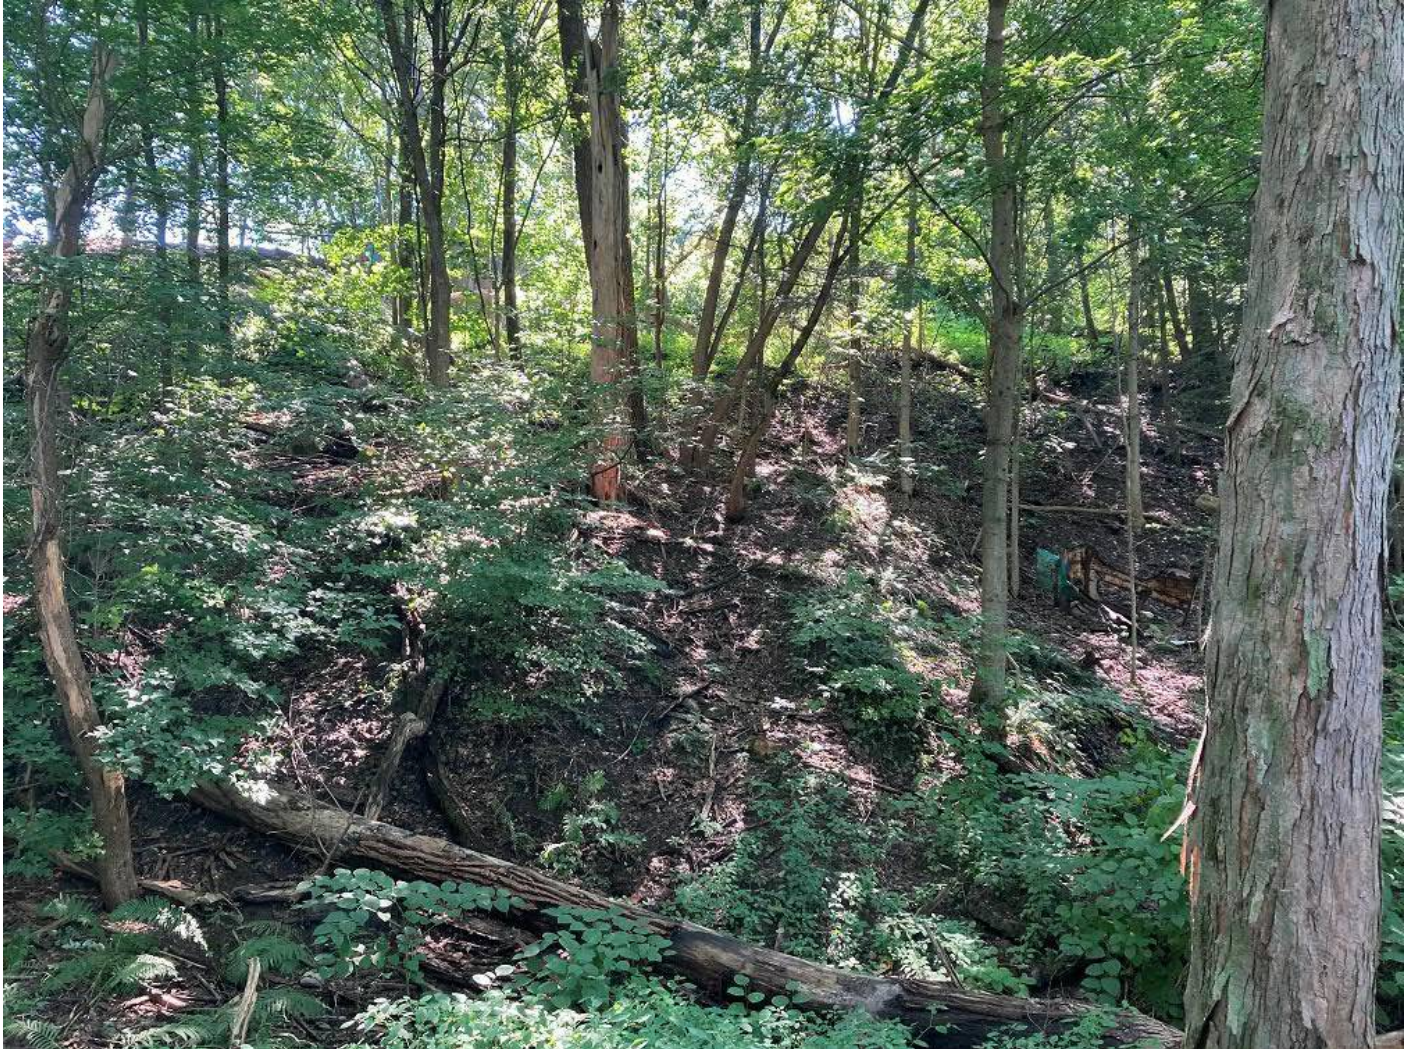
**Photograph 10:** View to south of historic debris slump downslope from Burlington Collision; location of crown cracks at top of slope east of building at upper left; note leaning trees at center of photo and exposed soil surface subject to continual erosion during precipitation events

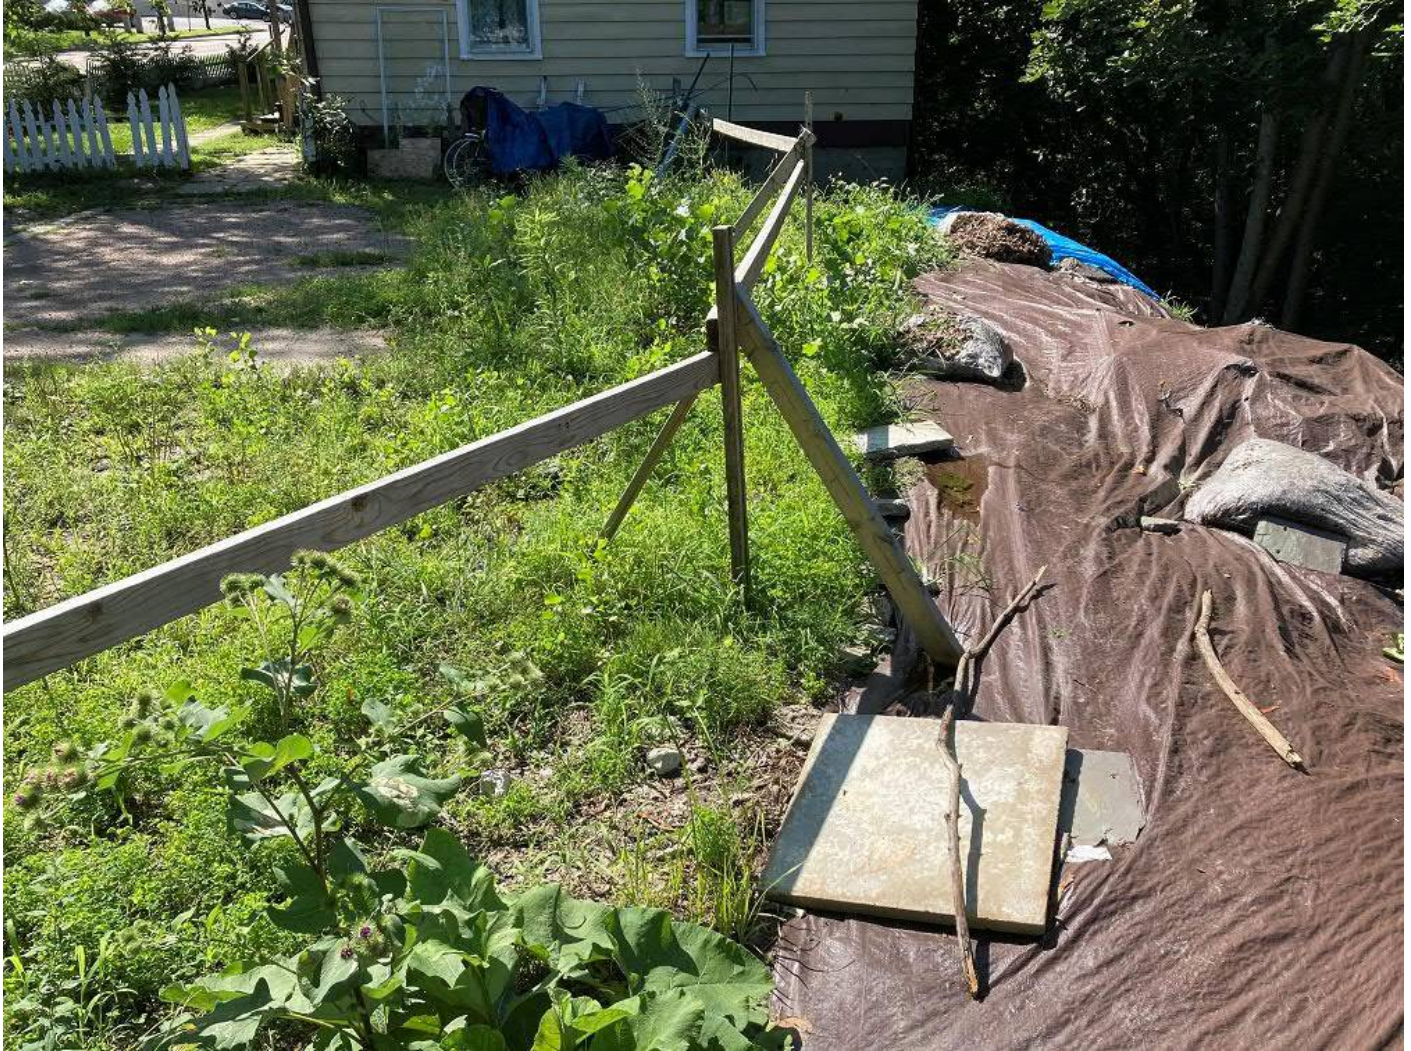
**Photograph 16:** View to west toward residence showing remediation at top of slope (placement of fabric and rip-rap); no distinct surface cracking or slumping in grassy area south of rip-rap

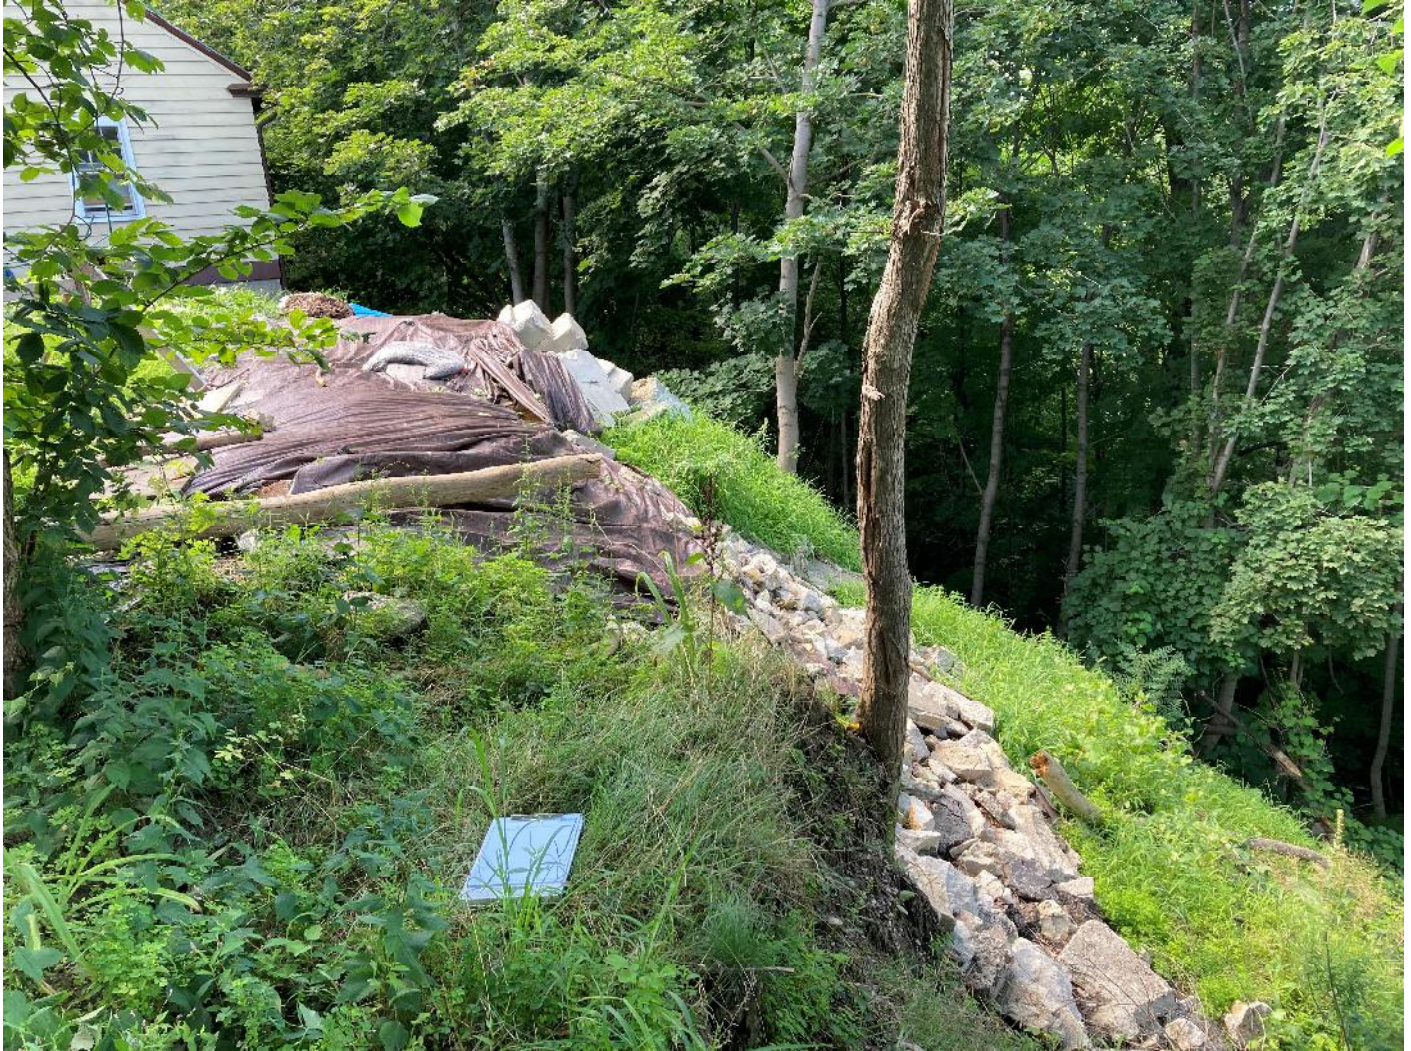
**Photograph 17:** View to west northwest, additional view of rip-rap armor at top of slope east of residence

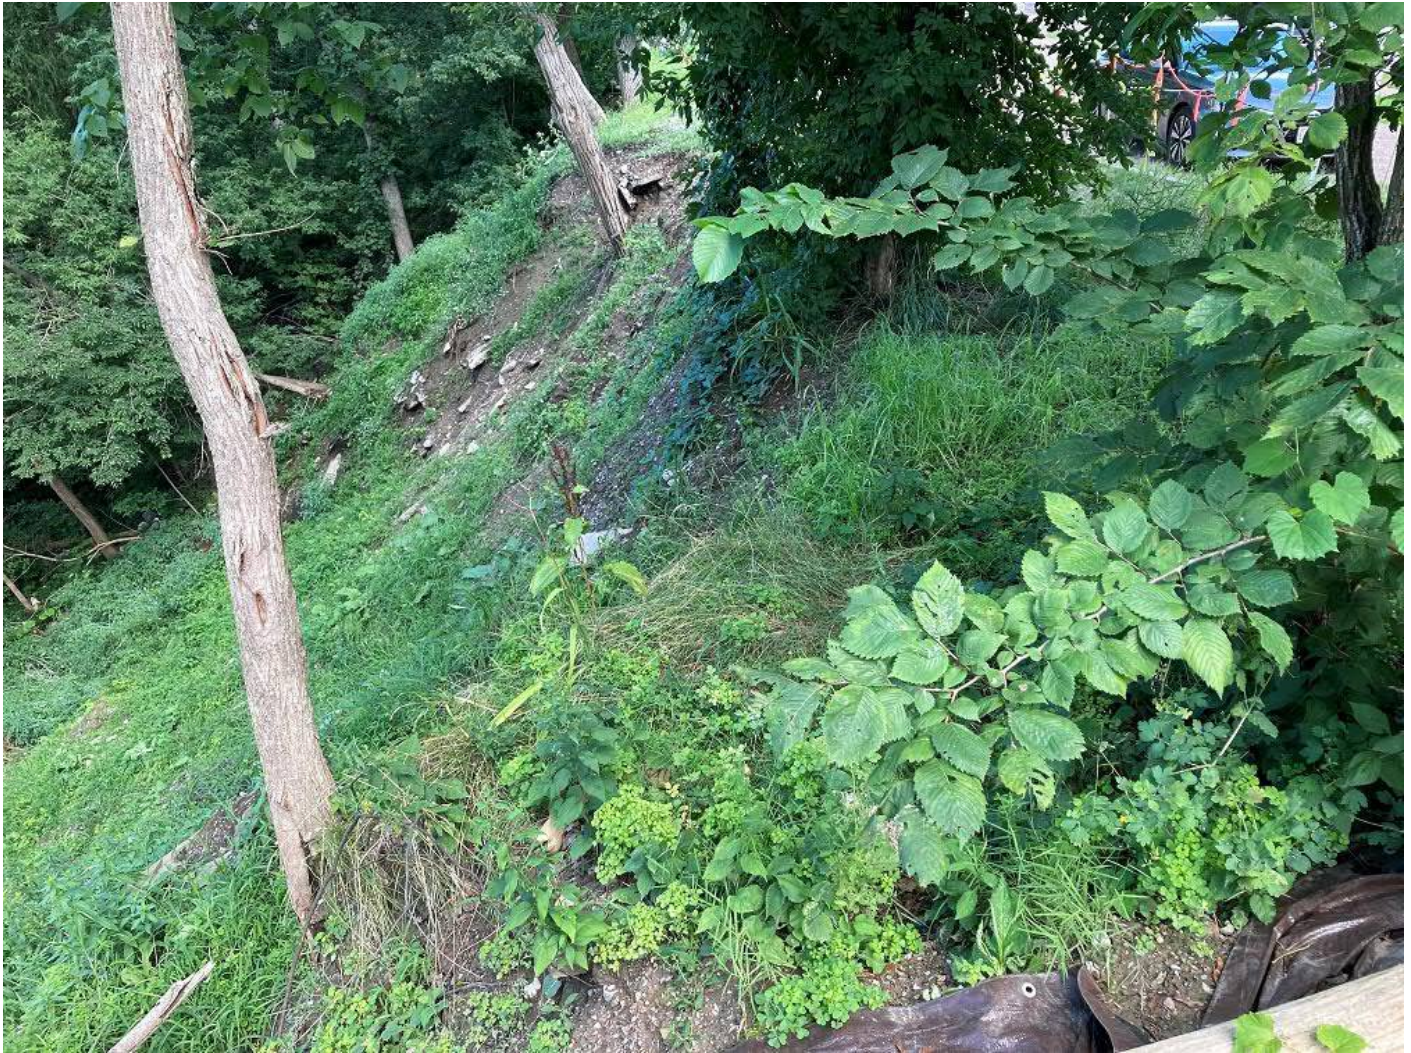
**Photograph 20:** View to east of soil slide east of residence, looking towards property at 365 Riverside Avenue; note leaning tree top center (see inspection report for 365 Riverside Avenue for additional photographs); exposed surfaces subject to localized failure and erosion during precipitation events

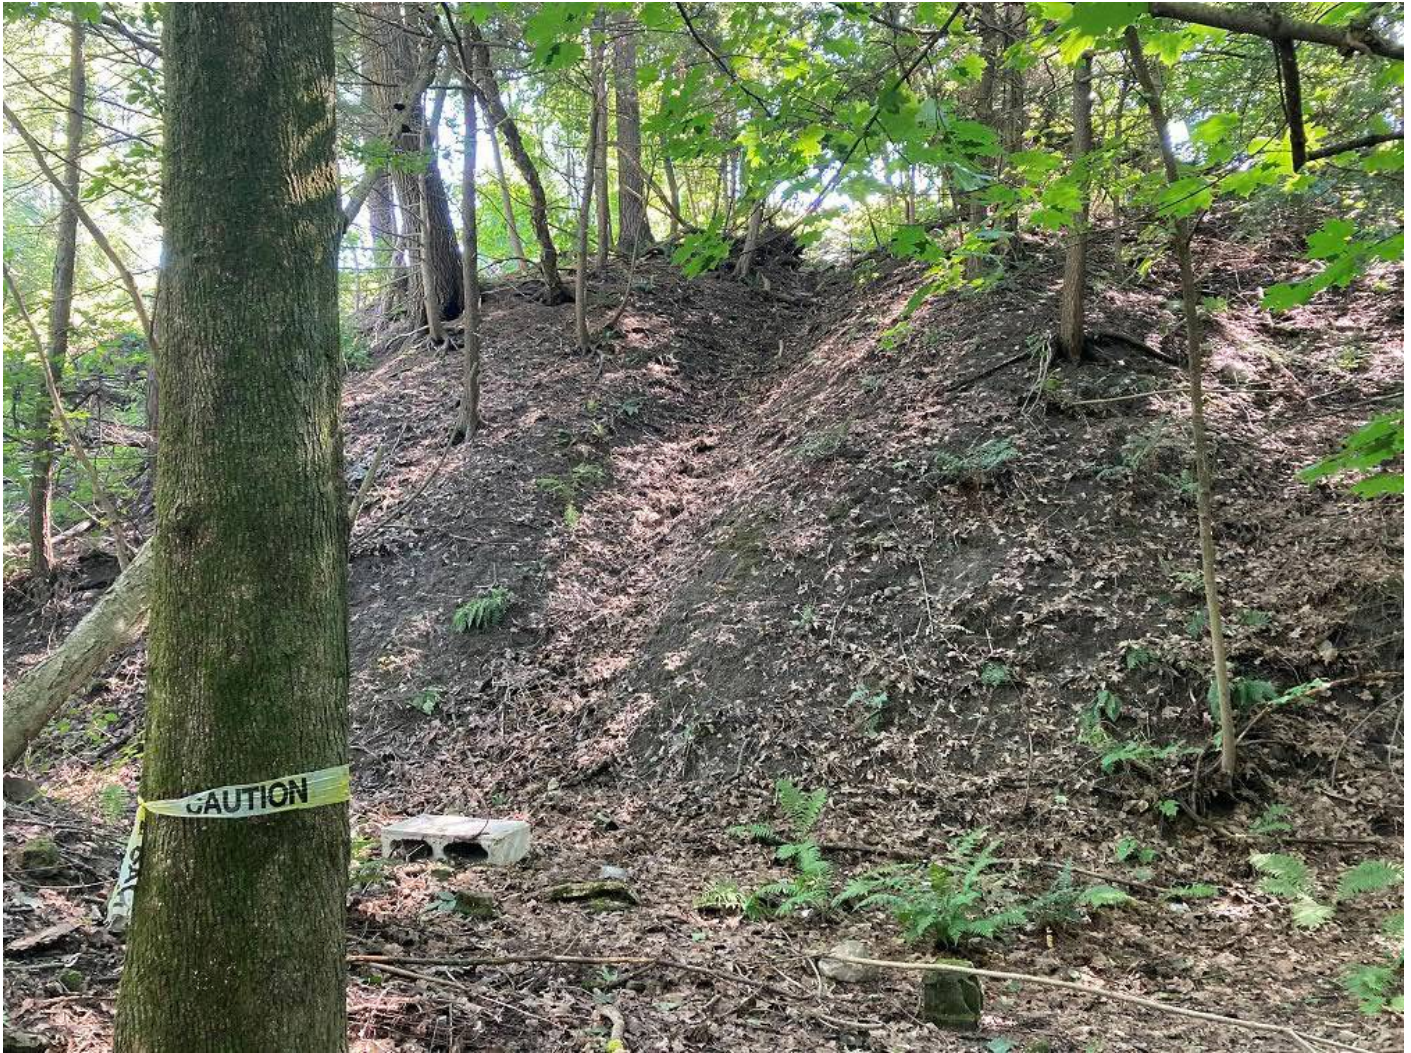
**Photograph 21:** View to south of exposed historic soil slump debris downslope from residence at 389 Riverside Avenue; exposed soil subject to continual erosion during precipitation events; note gully formation from surface runoff at center and right of photograph

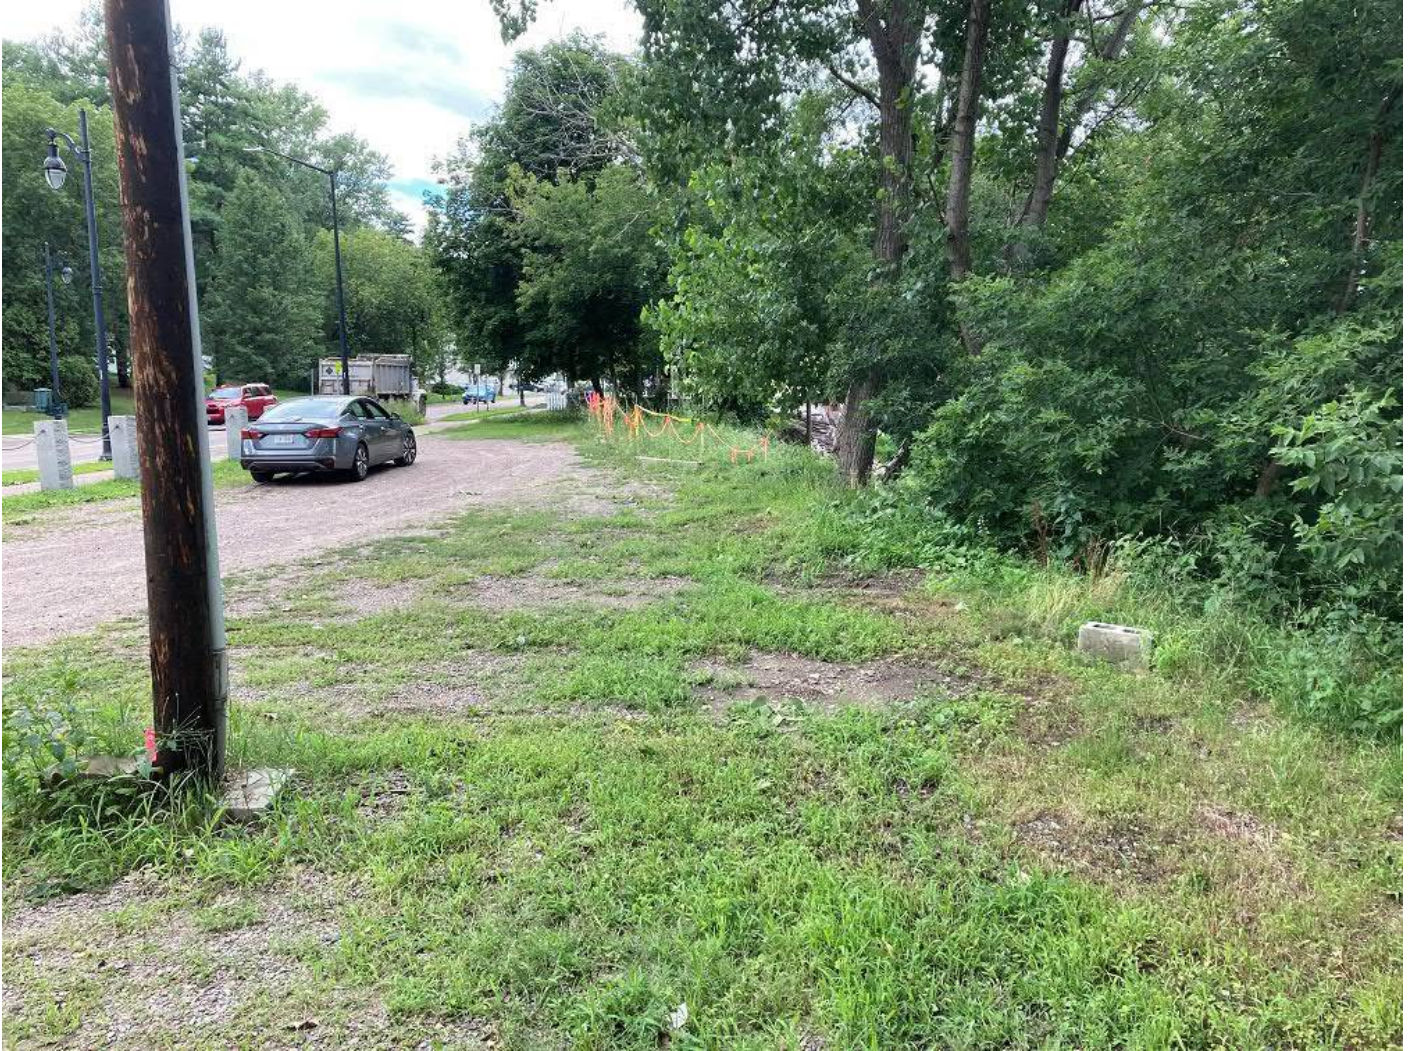
**Photograph 23:** View to west of top of slope between 365 Riverside Avenue (Hall's Hitches) and 389 Riverside Avenue (private residence – top center) showing stable platform at top of slope to left; incipient slumping possible at bottom-right and center-right of photograph; failed slope to right of stakes and flagging; exposed soil scarp obscured by vegetation at center-right of photograph.

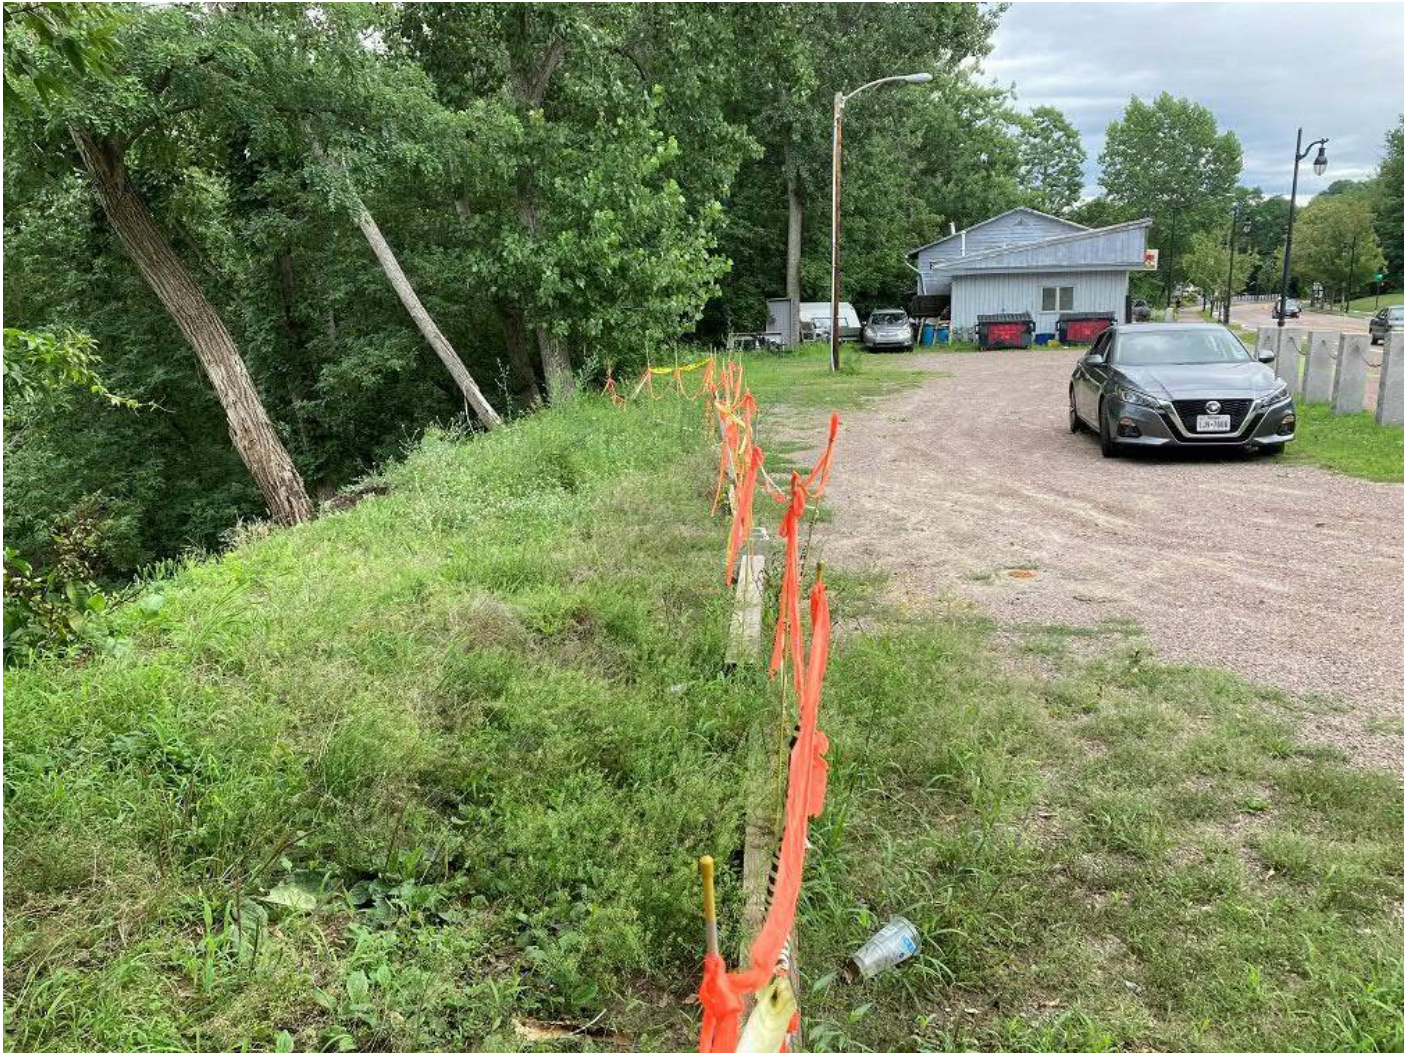
**Photograph 24:** View to east towards Hall's Hitches and Welding showing stable platform to right of flagging (i.e. no evidence of surface slumping or cracking) and top of failed slope at extreme left; note lean of trees top left; note monitoring well center right
