## **Burlington Conservation Board**

## Conservation Board Meeting Minutes

## FY20 Burlington Slope Inspections

**CITY OF BURLINGTON, VERMONT  
SLOPE STABILITY INSPECTION**

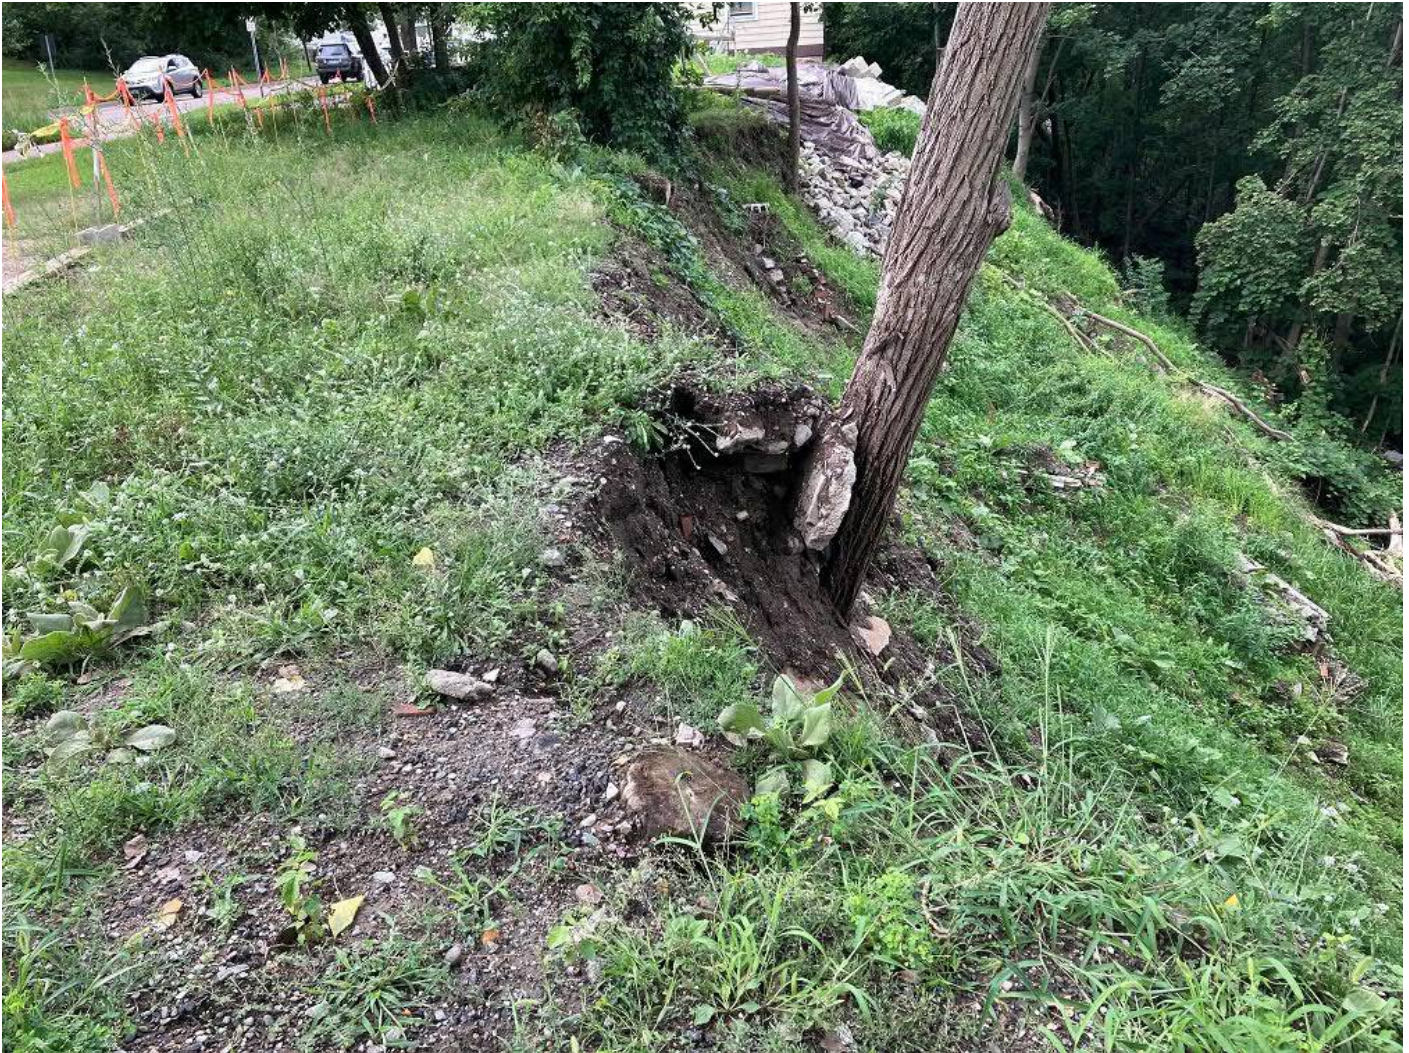
**Photograph 25:** View to west toward residence at 389 Riverside Avenue showing failure scarp at top of slope and overgrown slide/slump debris to center-right

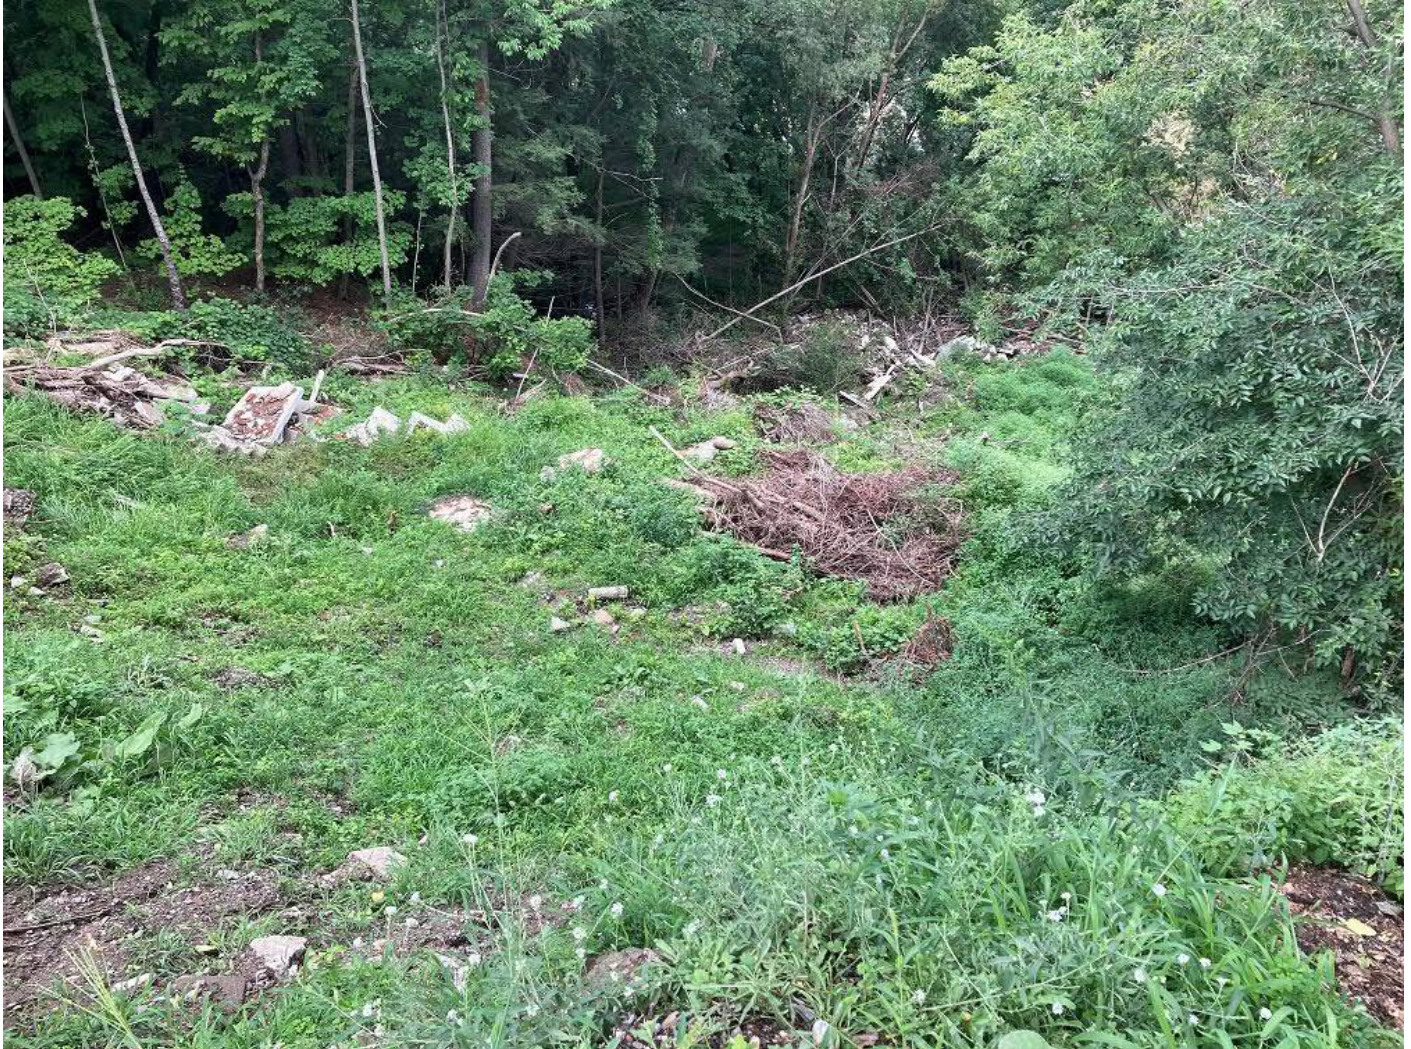
**Photograph 26:** View to north of overgrown historical slide/slump debris from top of failure scarp between 365 and 389 Riverside Avenue

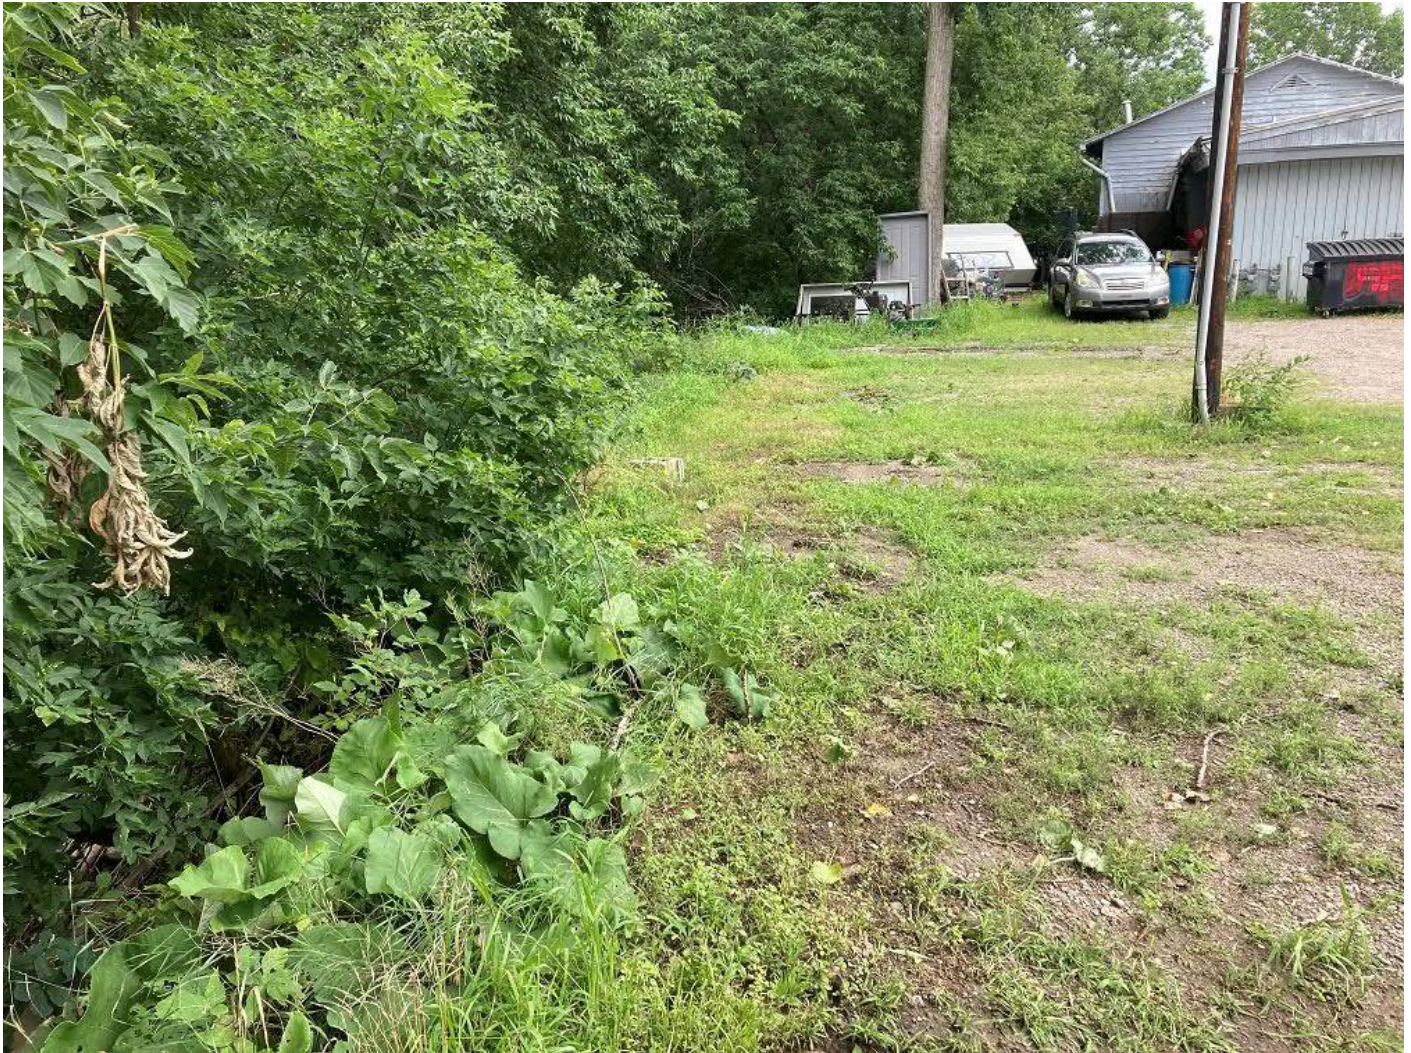
**Photograph 27:** View to east towards Hall's Hitches building, east of failed slope, showing stable surface platform (i.e. no distinct slumping or crown cracking); possible beginning traces of surface slumping top center of photograph; soil scarp obscured and covered by vegetation at left of photograph

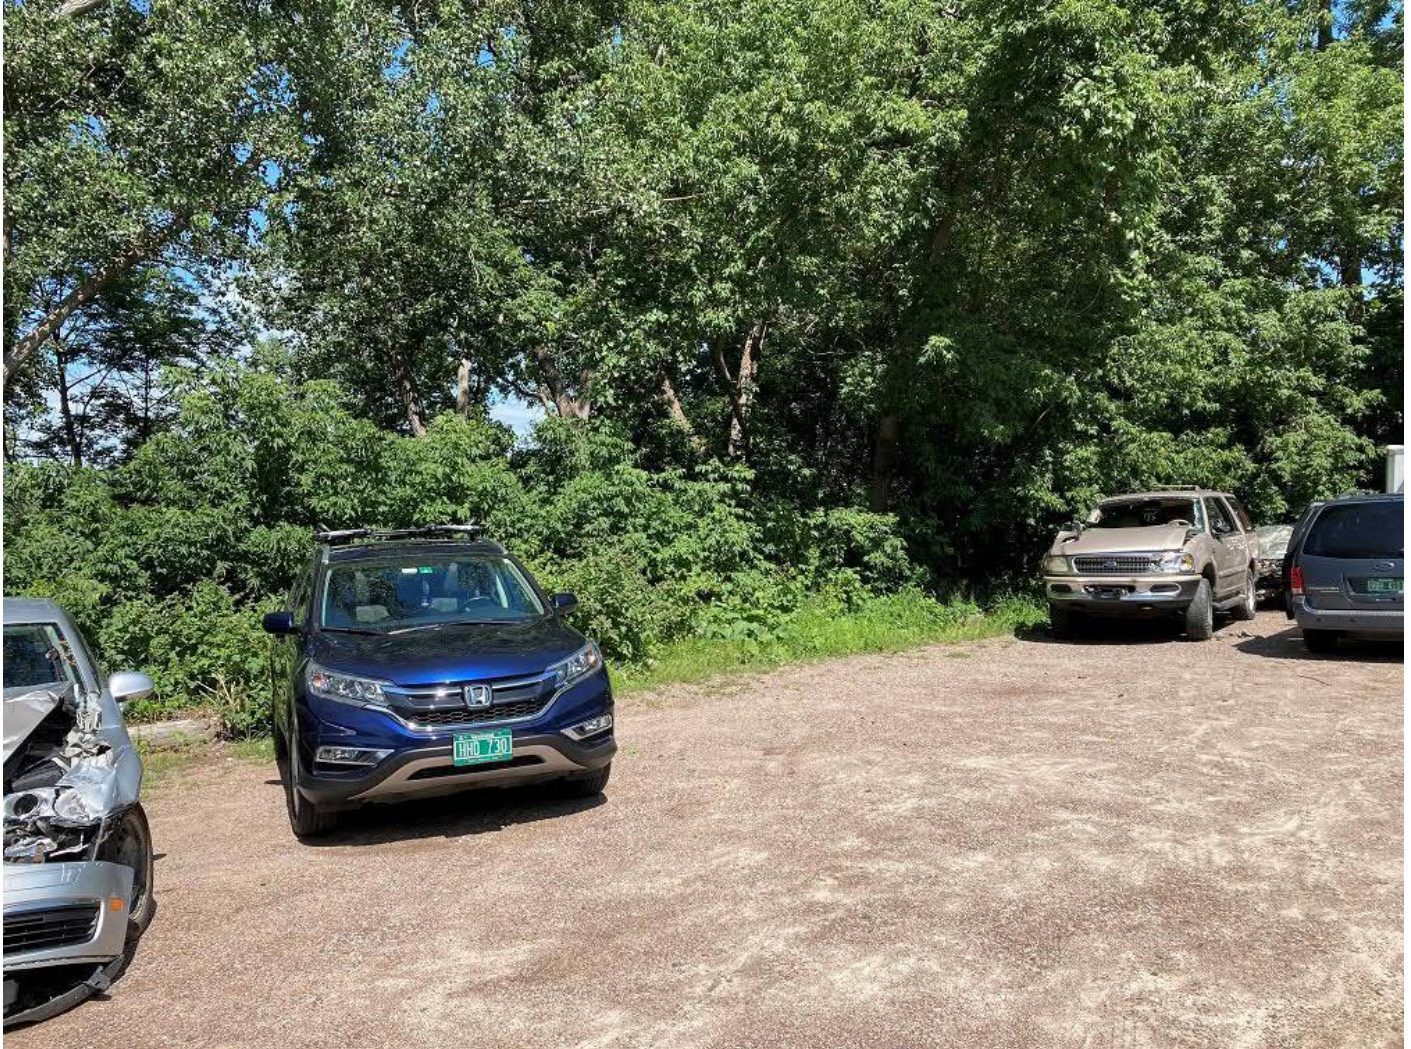
**Photograph 28:** View to northeast of top of slope at eastern portion of Hall's Hitches and Welding property showing stable platform at top of slope; note dense vegetation at top of slope which extends downslope

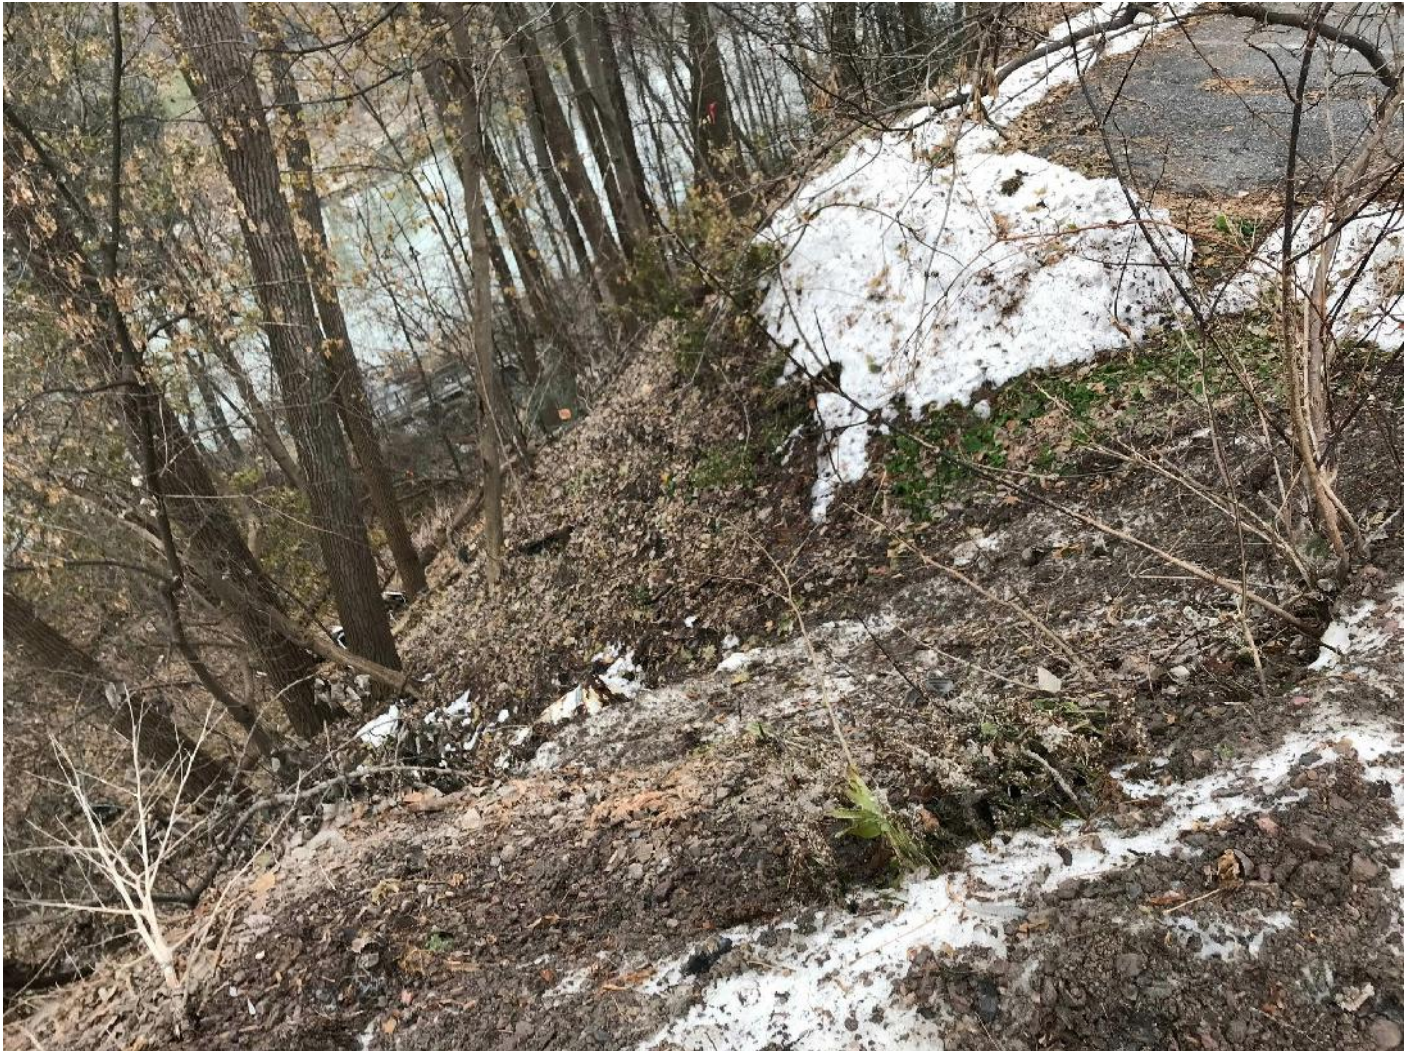
**Photograph 31:** View to northwest, downslope, taken by Hoyle Tanner Associates during the December 2019 inspection showing the boundary between 365 and 317 Riverside Avenue (Bluebird BBQ); note gully formation from surface runoff at center of photograph and possible crown cracking at bottom right; western parking area for Bluebird BBQ at top right

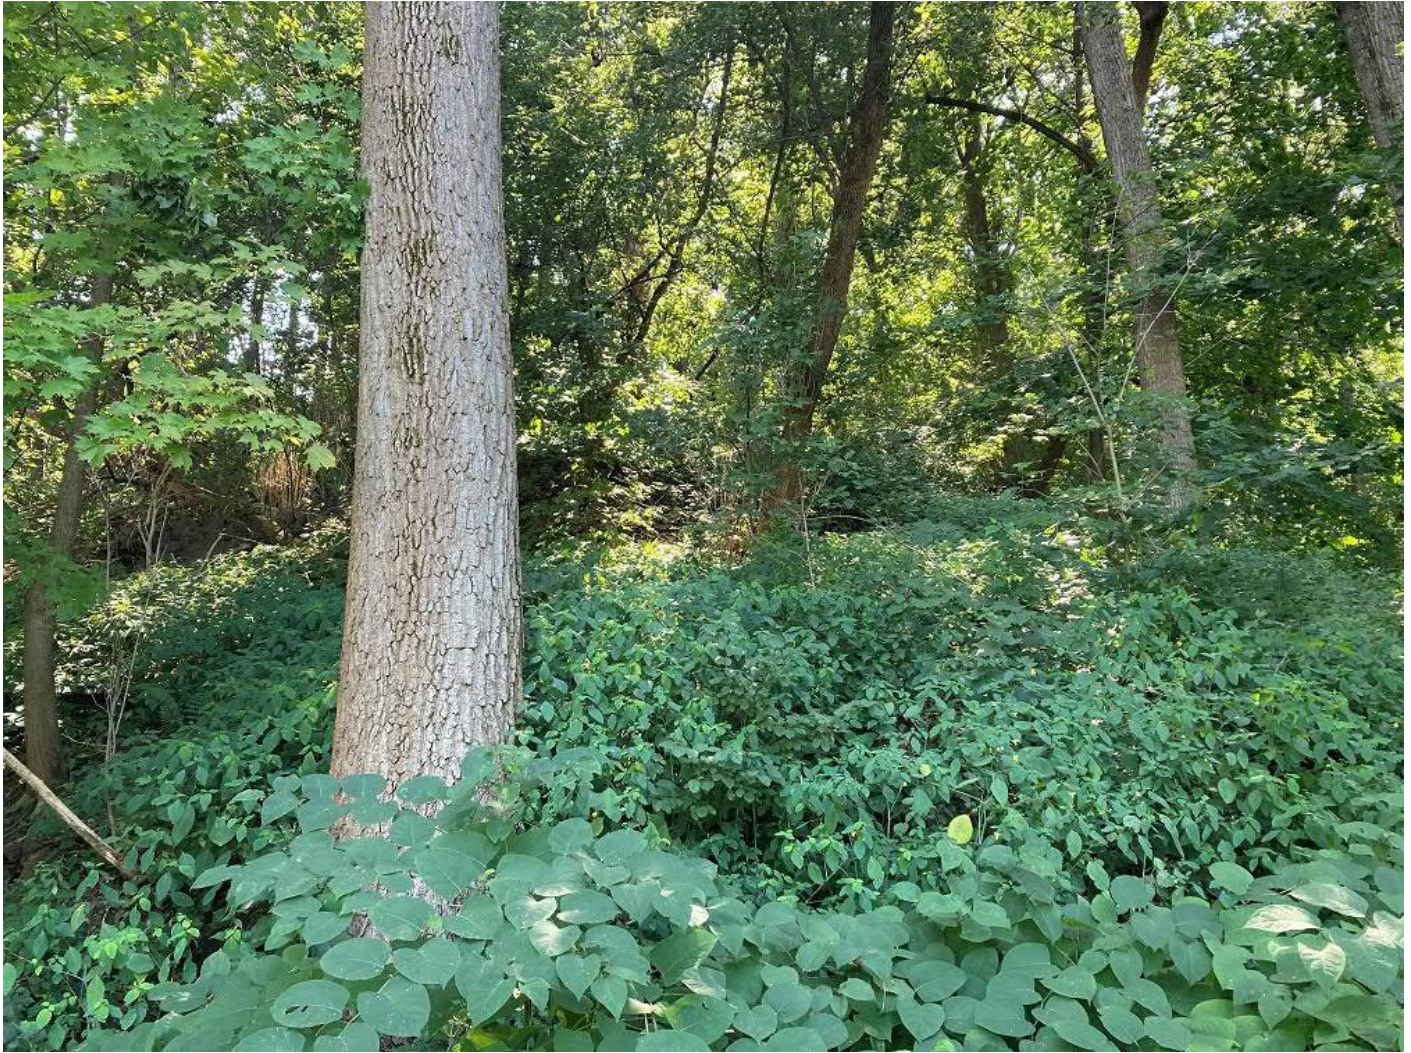
**Photograph 32:** View to south looking upslope to 365 Riverside Avenue, Hall's Hitches and Welding, showing density of vegetation on historic slide/slump debris; soil scarp in historic debris mass present at center and center-left of photograph

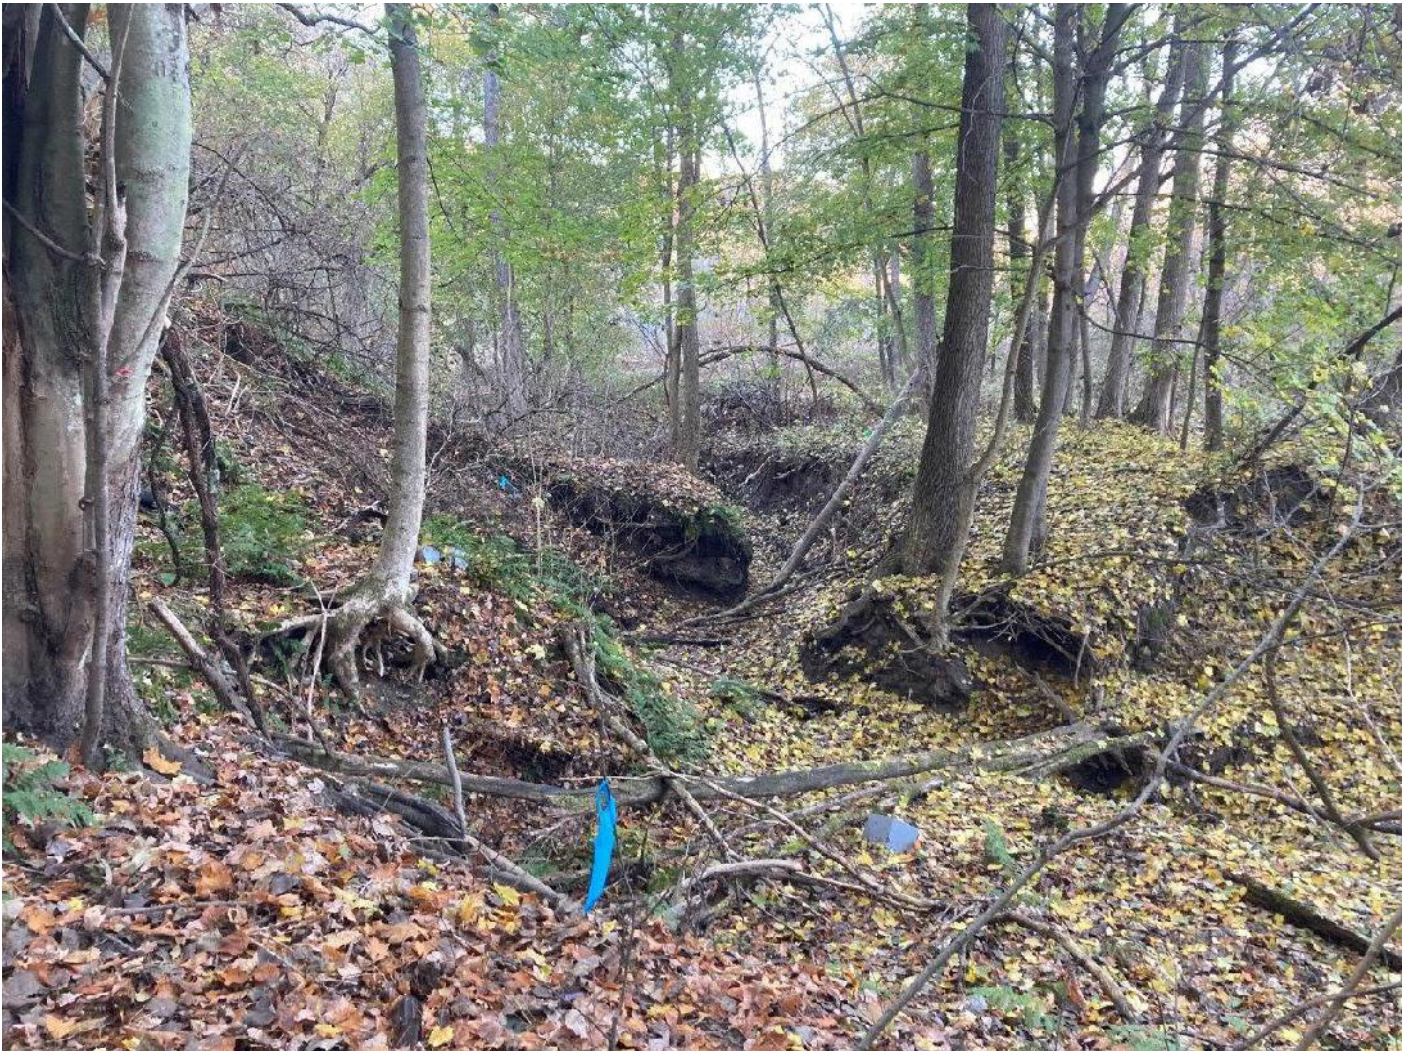
**Photograph 21:** View to west of erosion channel at the toe of the slope west of Culvert 3; failed lower portion of slope at left-center of photograph a result of erosion undercutting into the toe of the slope.

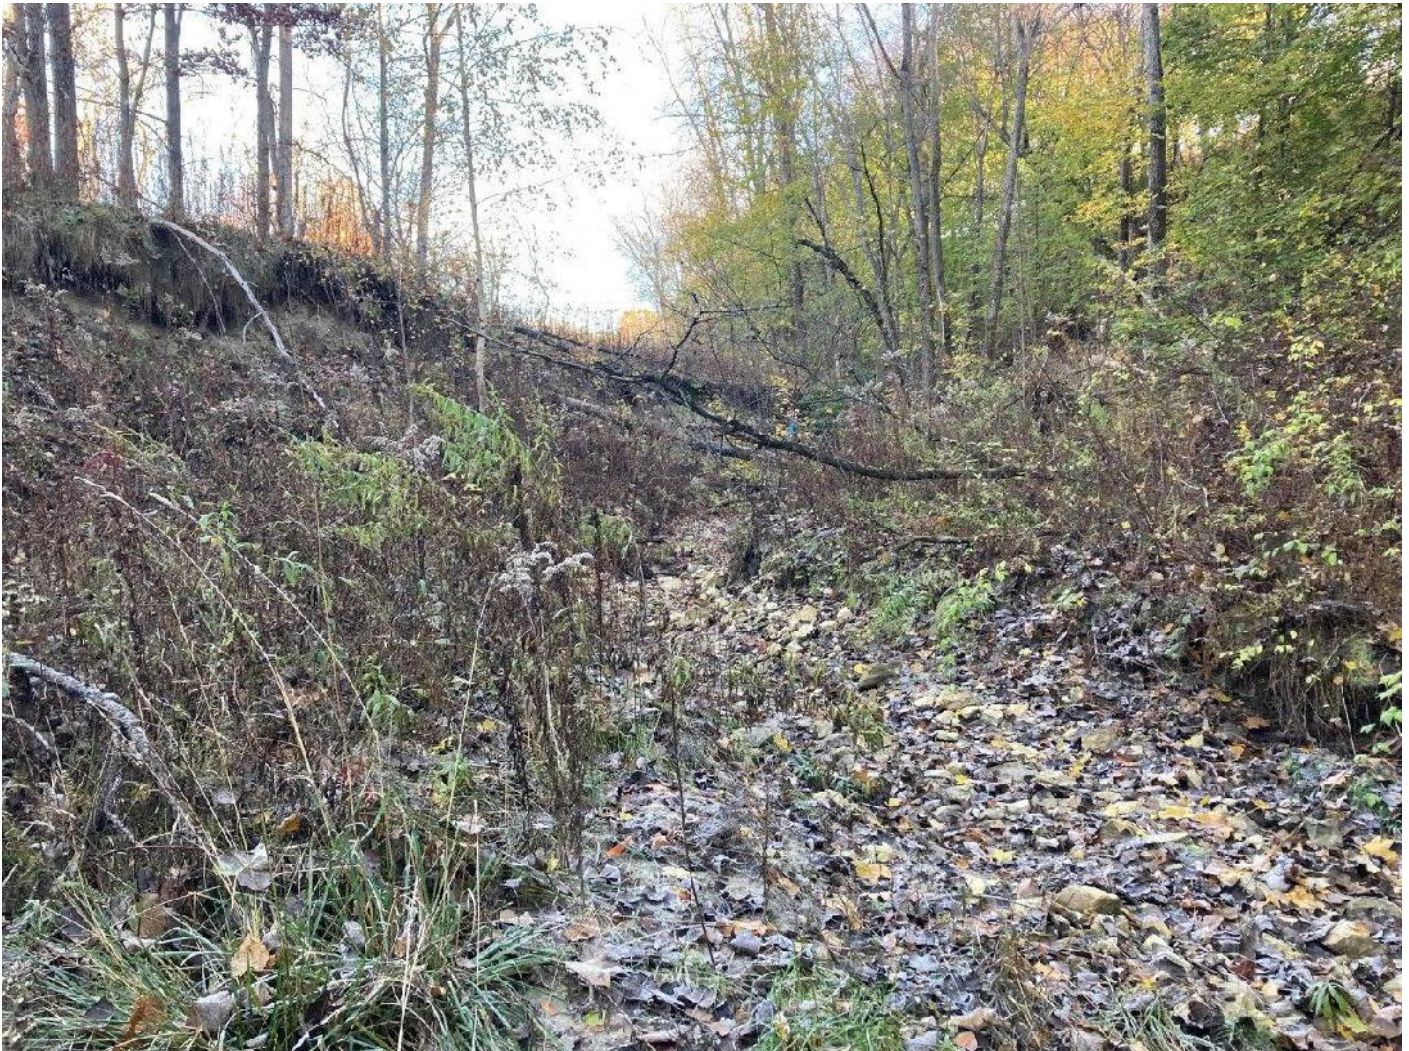
**Photograph 22:** View to east from position of Photograph 21 showing large erosional gully north of toe of Manhattan Drive slope.

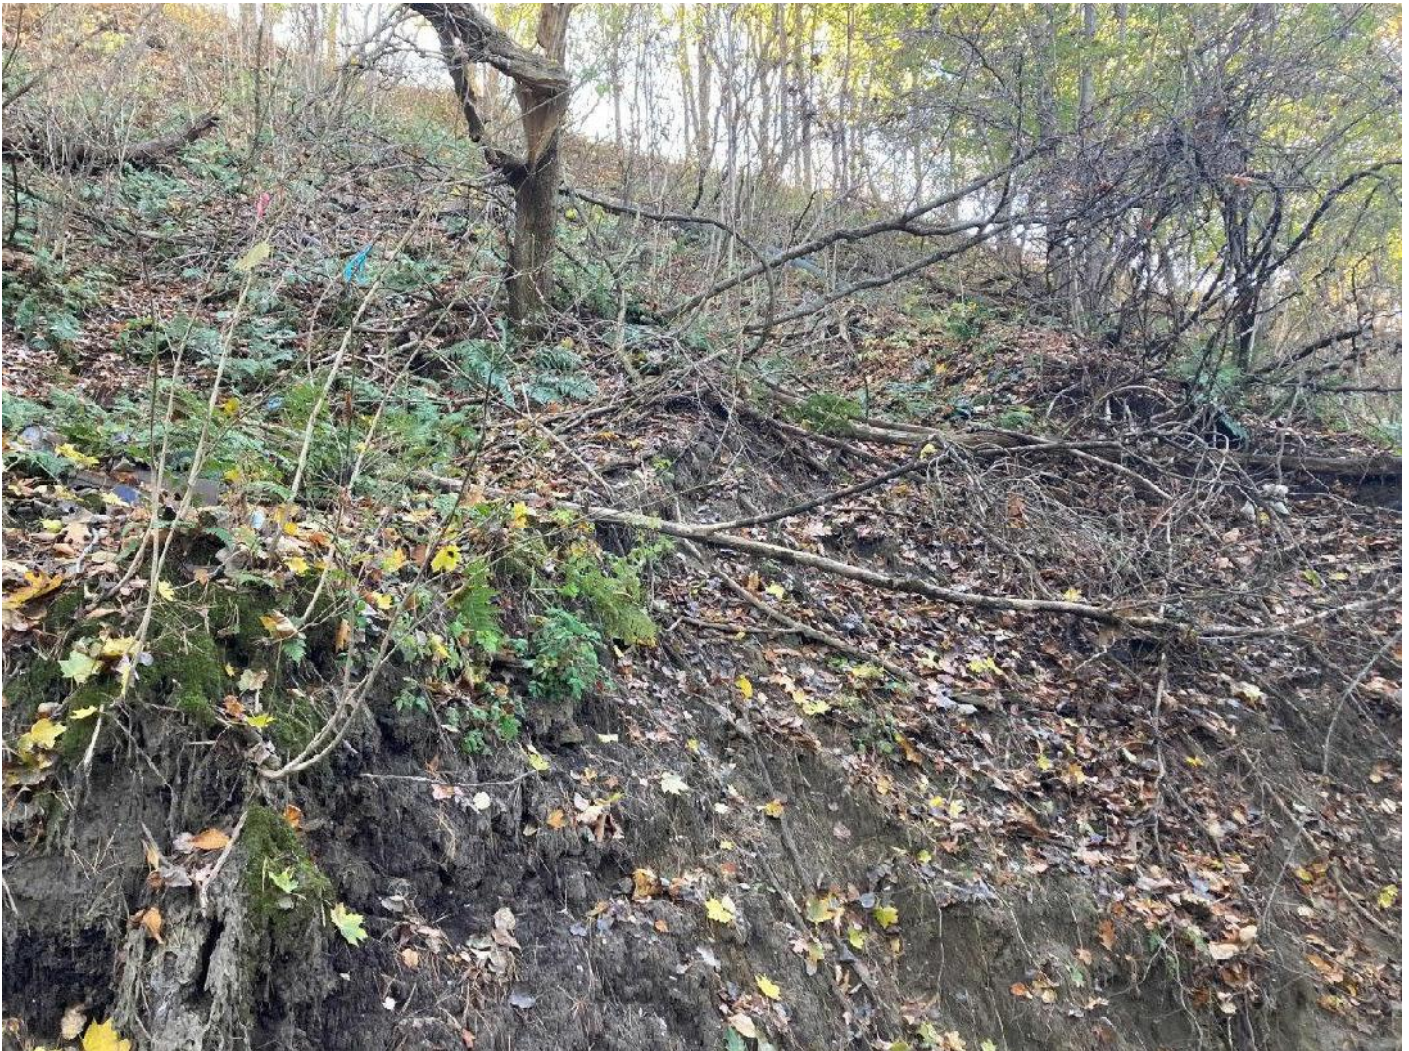
**Photograph 23:** View to southwest from toe of slope showing discharge pipe from Manhattan Drive at top-center (designated herein as Culvert 4) and failure/erosional surface in foreground at toe of slope; failure a result of historical heavy surface flow cutting into toe of slope;

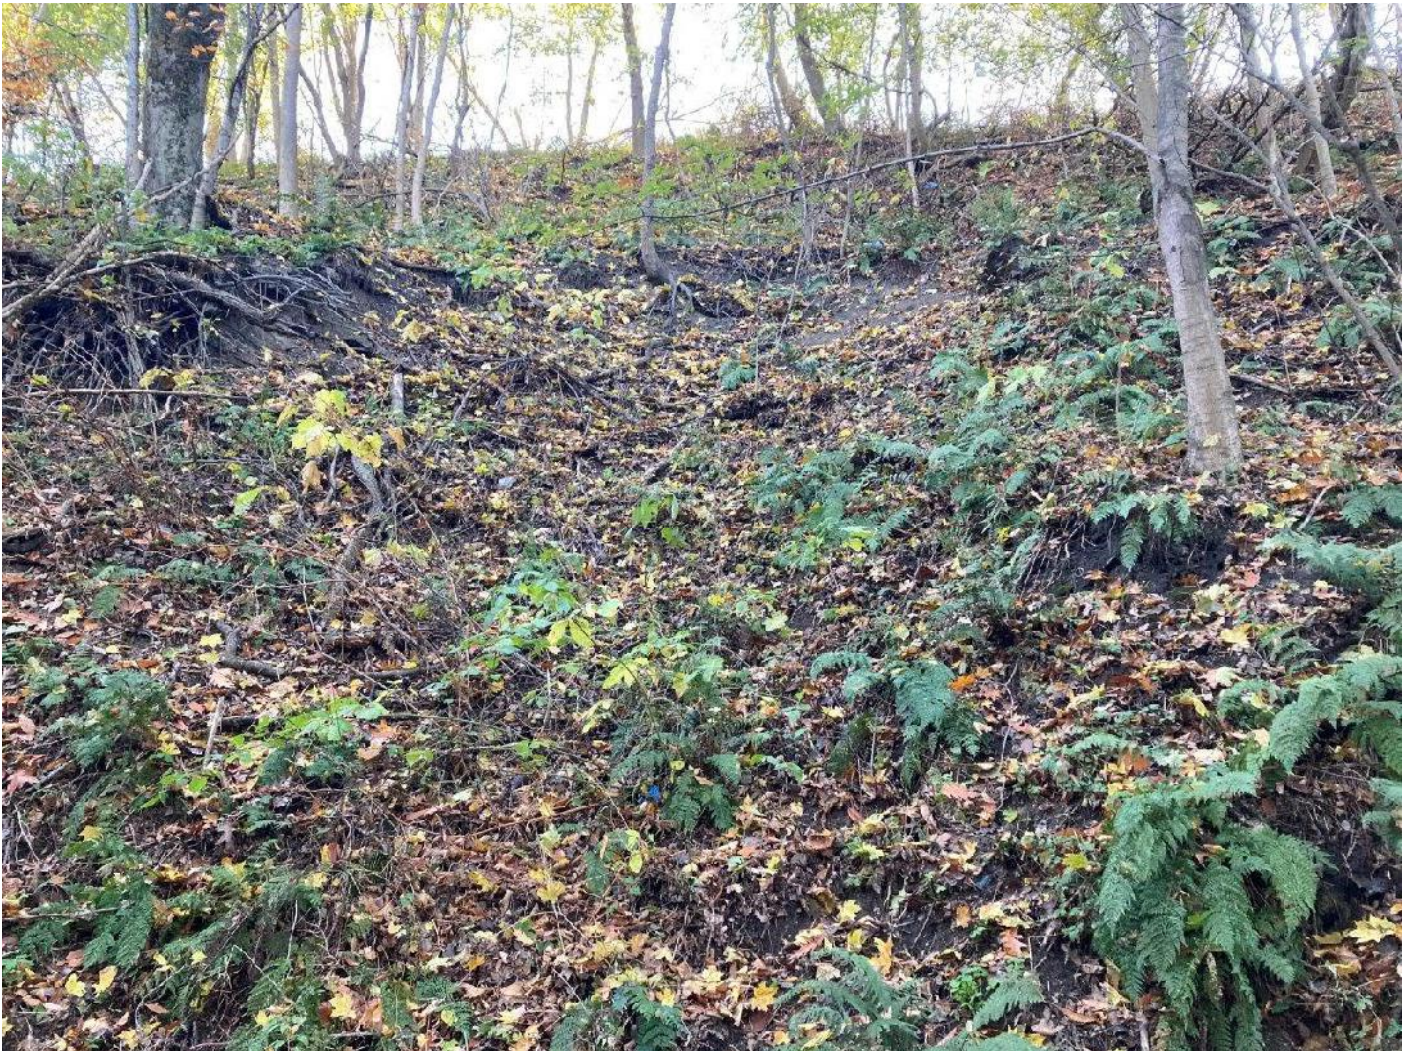
**Photograph 24:** View to south from near toe of slope to Manhattan Drive showing failure surface at base of slope; failure most likely a result of erosion into base of slope during historical flow in erosion channel at toe of slope (see Photograph 25).

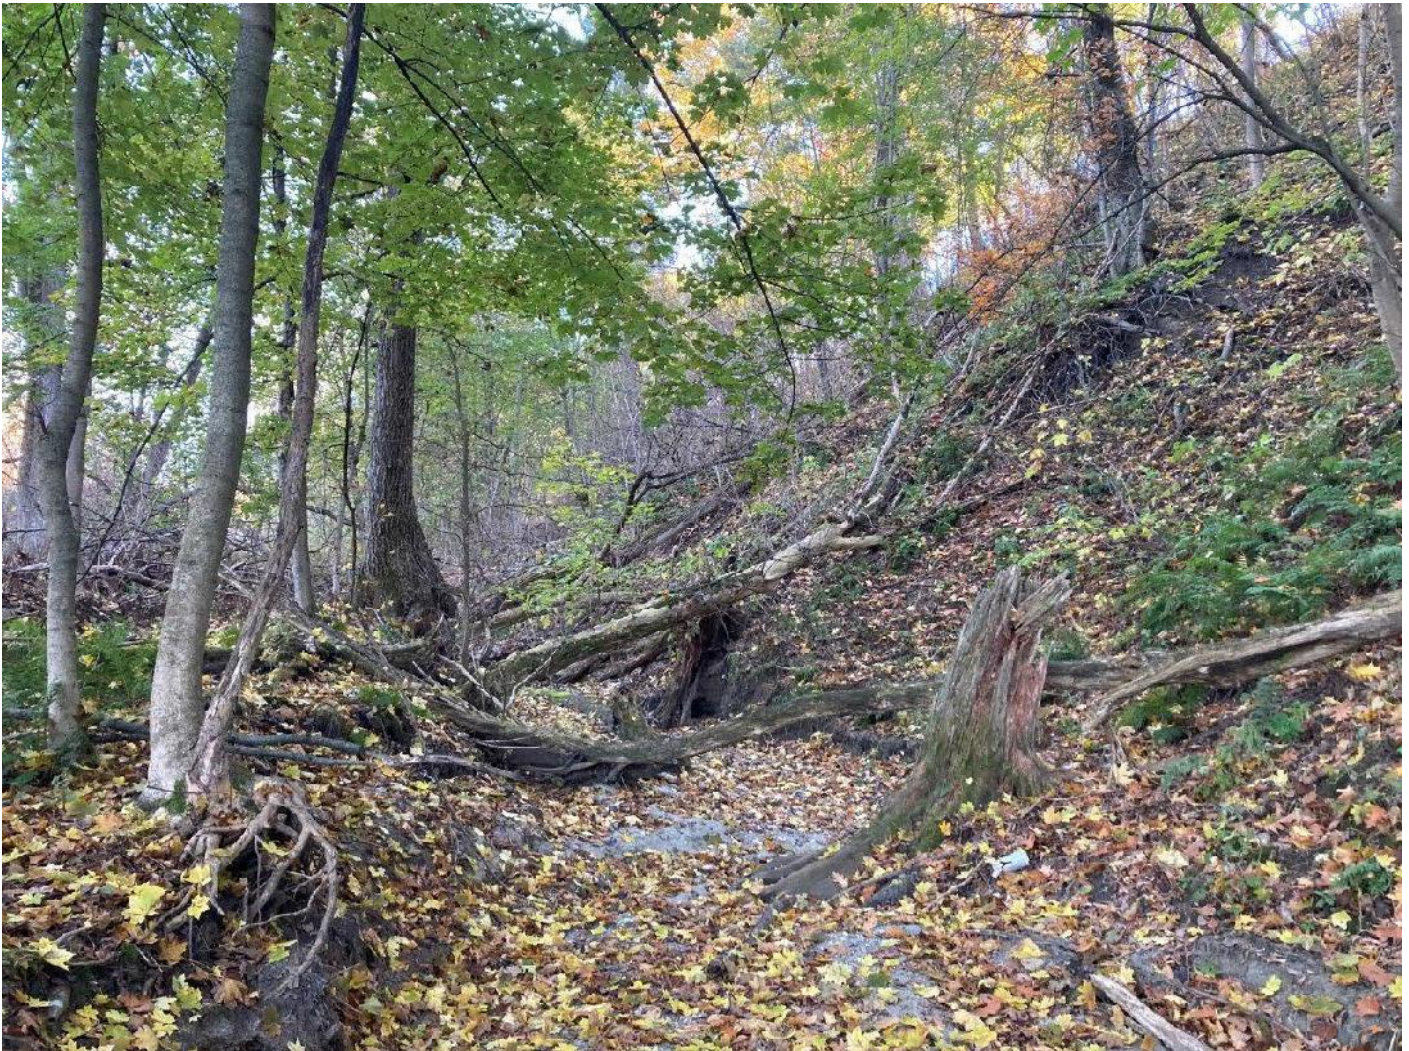
**Photograph 25:** View to east showing erosion channel and failed lower portion of slope west of Culvert 4 pipe.

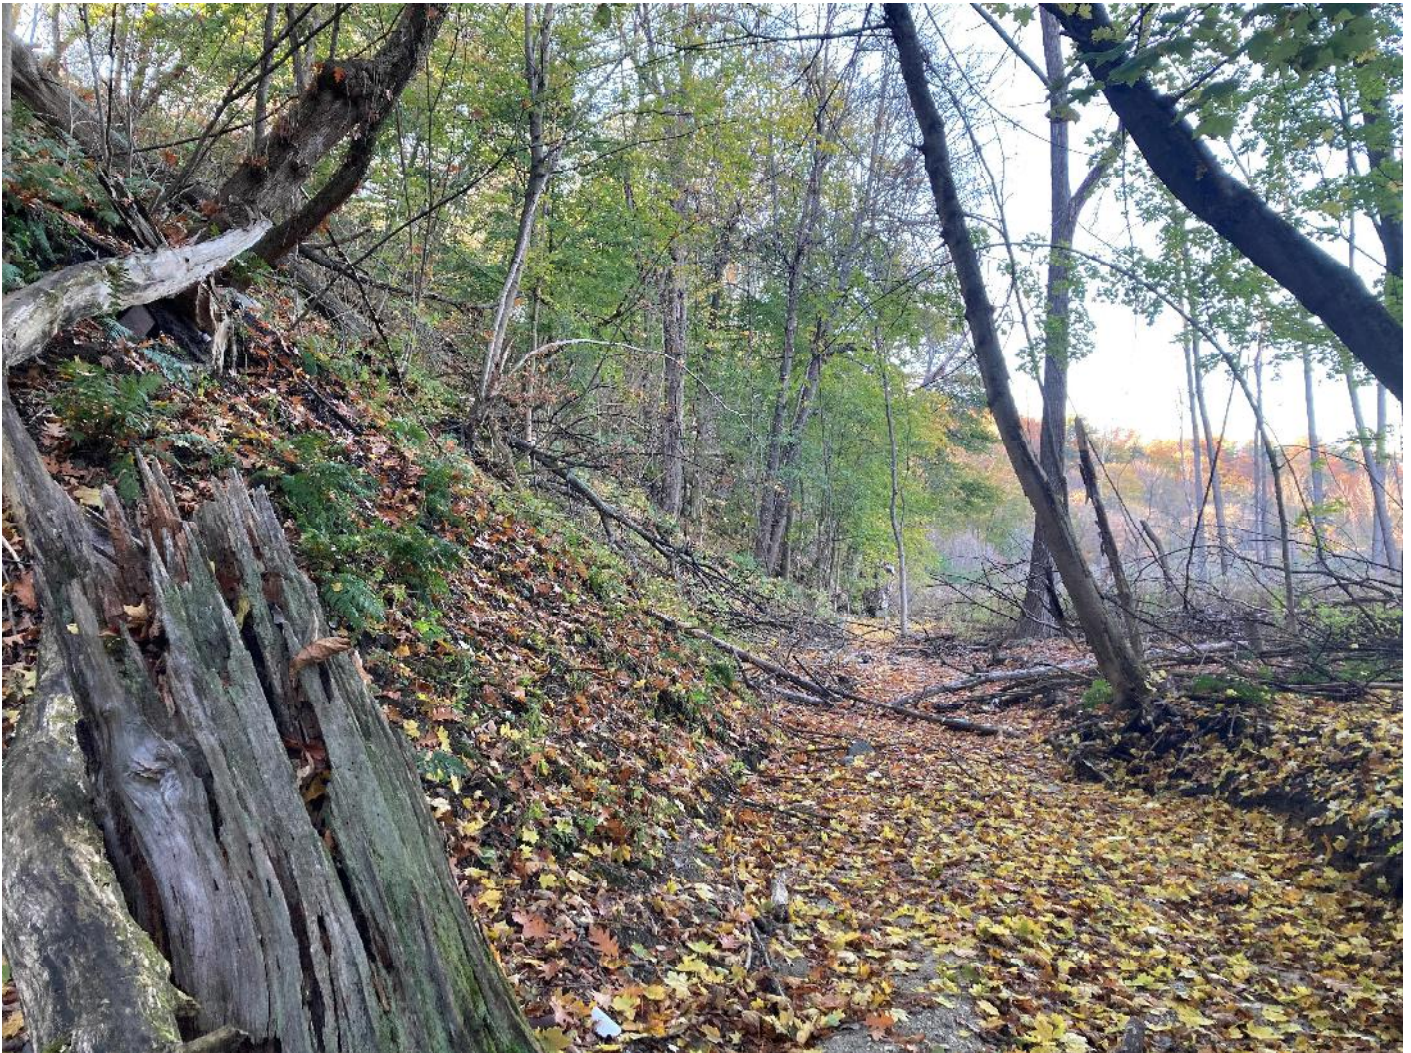
**Photograph 26:** View west-northwest showing discharge channel at base of slope; channel is directed towards wetlands at right-center of photograph; future high-flow events will continue to erode into toe of slope as shown in foreground.

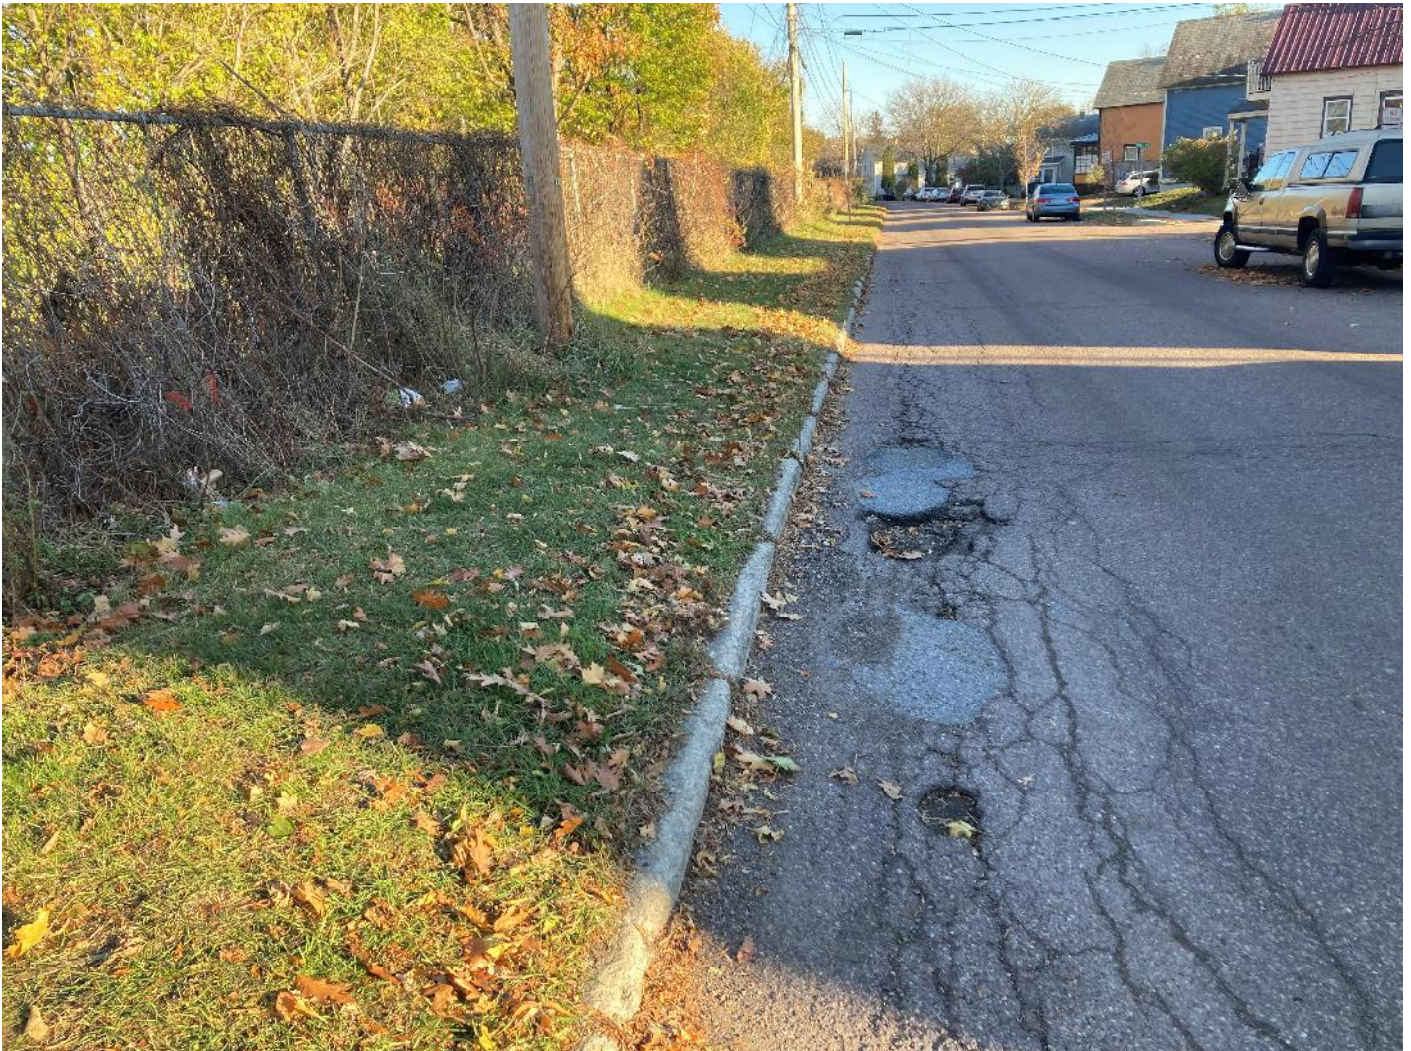
**Photograph 28:** View to east along Manhattan Drive from Convent Square at top of slope; no distinct ground disturbance observed; stressed asphalt cracking may be a result of slope creep?

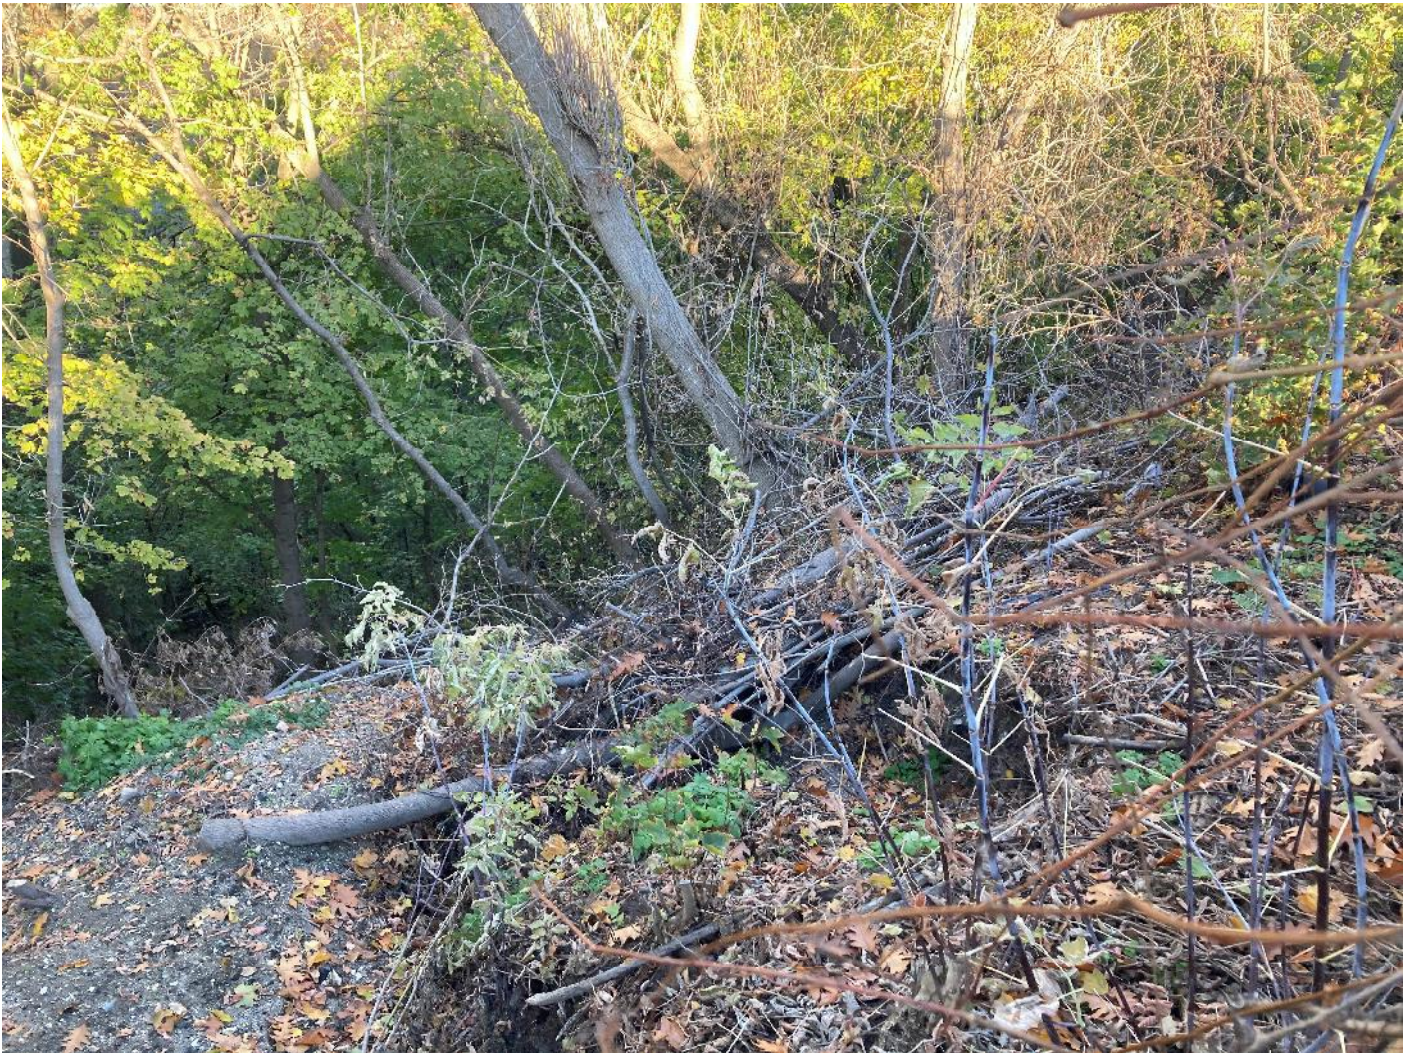
**Photograph 29:** View to north from top of slope on Manhattan Drive showing minor surface failure; note lean of trees at center of photo and exposed soil at bottom right.

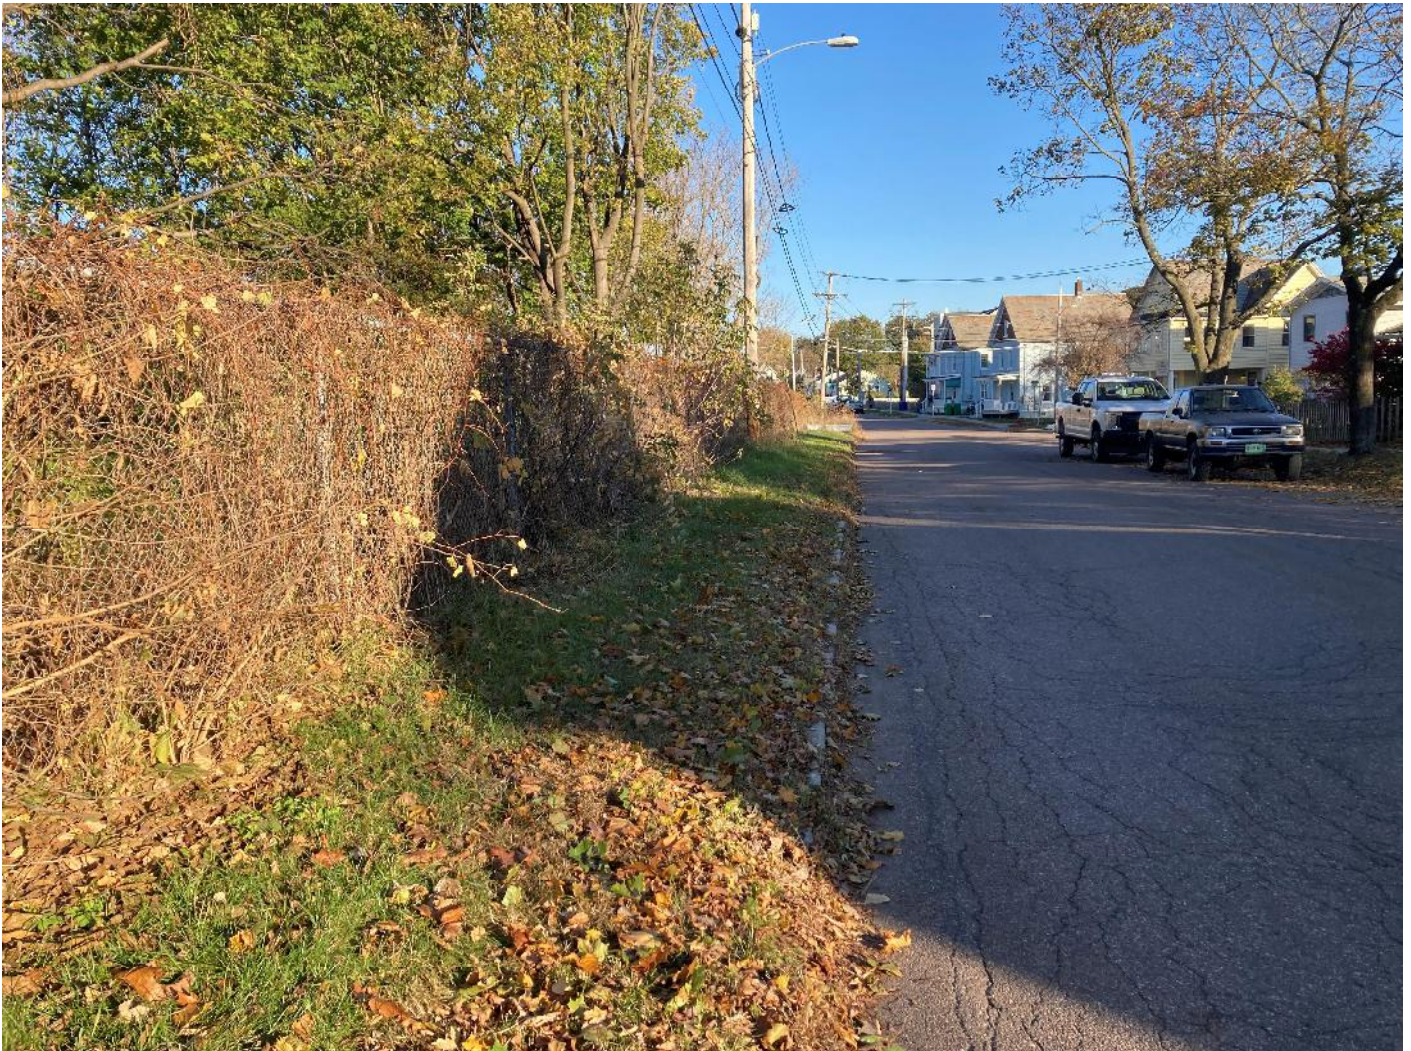
**Photograph 30:** View to east along Manhattan Drive at the top of the slope; no distinct scarps or disturbed ground observed; note stressed pavement cracking.
