## **Burlington Conservation Board**

## Conservation Board Meeting Minutes

## FY20 Burlington Slope Inspections

**CITY OF BURLINGTON, VERMONT  
SLOPE STABILITY INSPECTION**

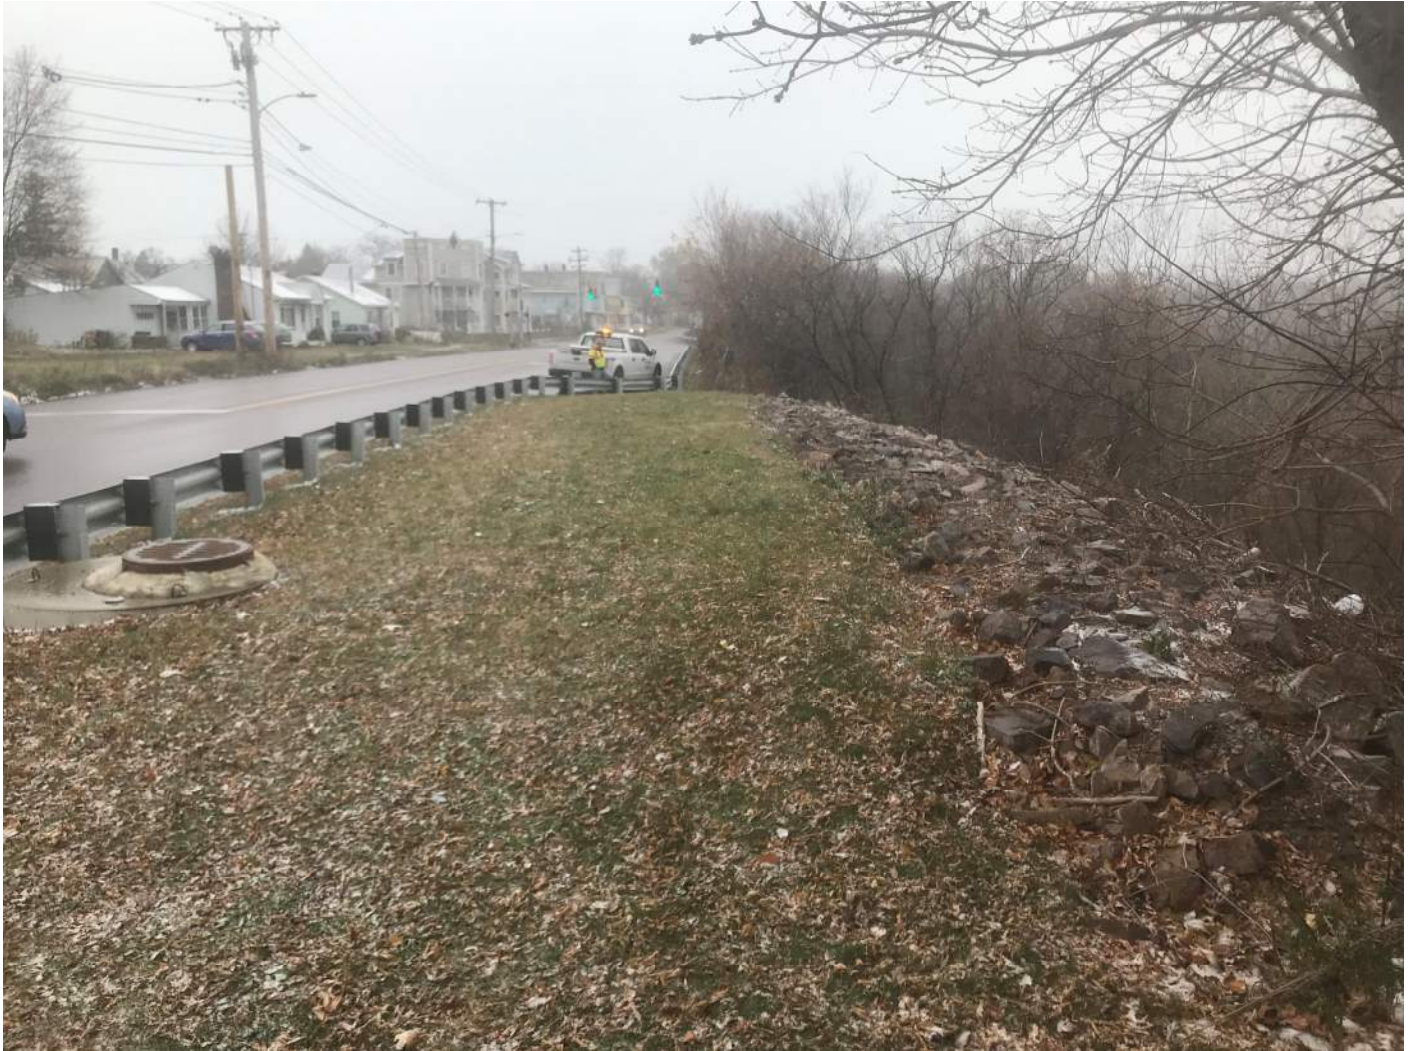
**Photograph 9:** View to west along Manhattan Drive showing the top of the remediated slope and absence of transverse cracks and slumps indicative of movement

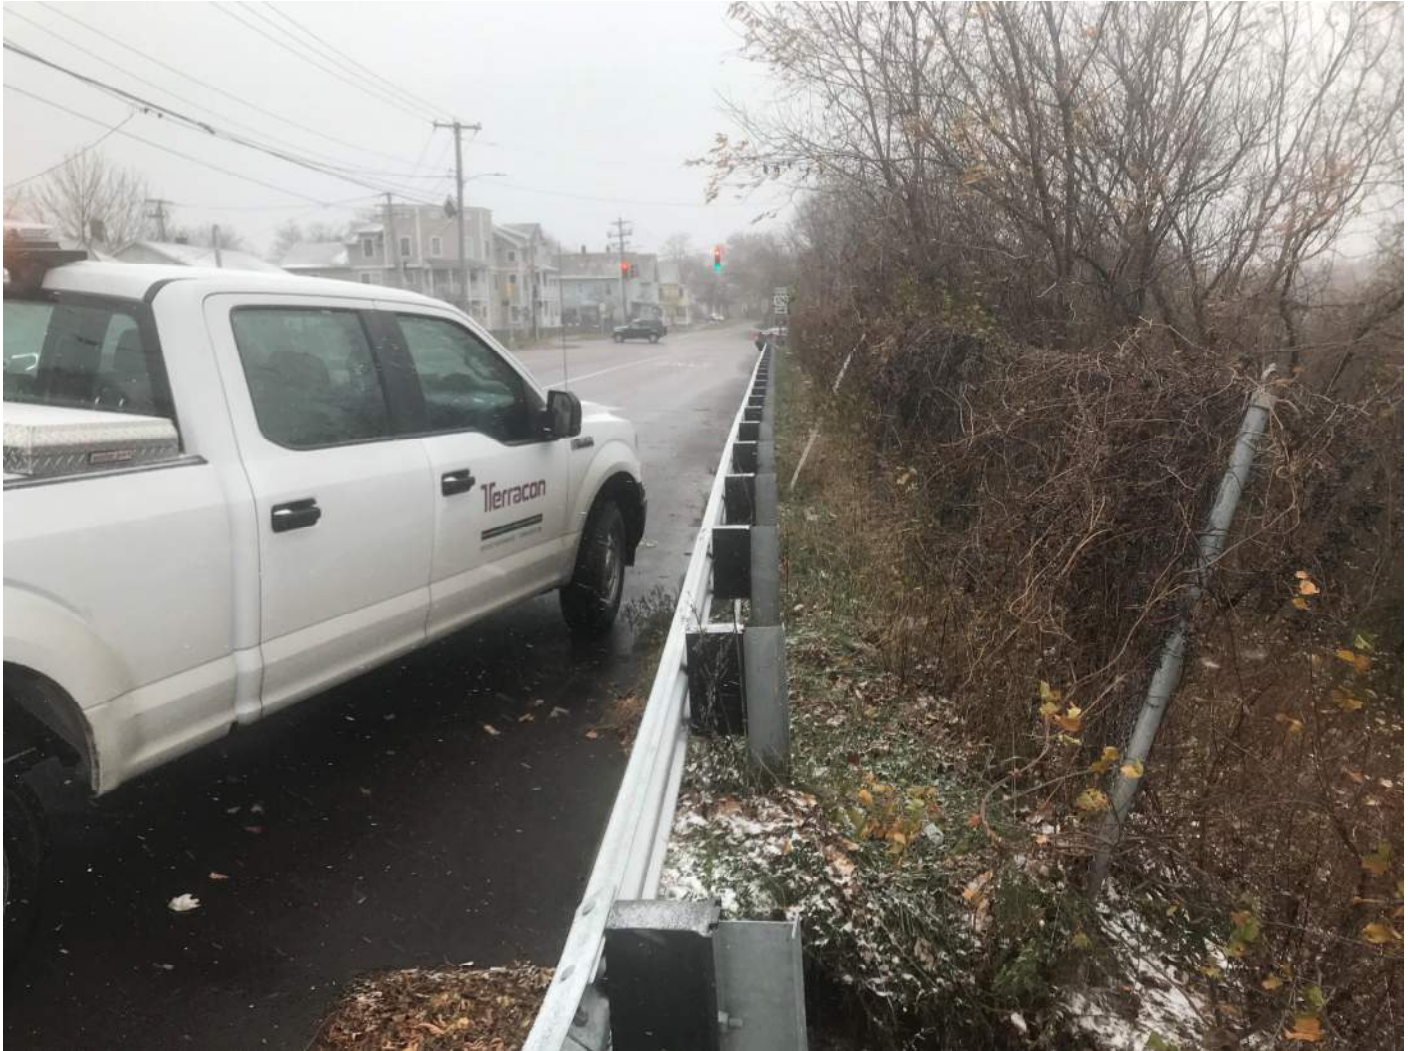
**Photograph 10:** View to west along Manhattan Drive showing the top of the natural slope on western flank of remediated slope; no transverse stress cracking in pavement and guard rail shows no sign of movement; fence section may have been damaged during remediation of slope

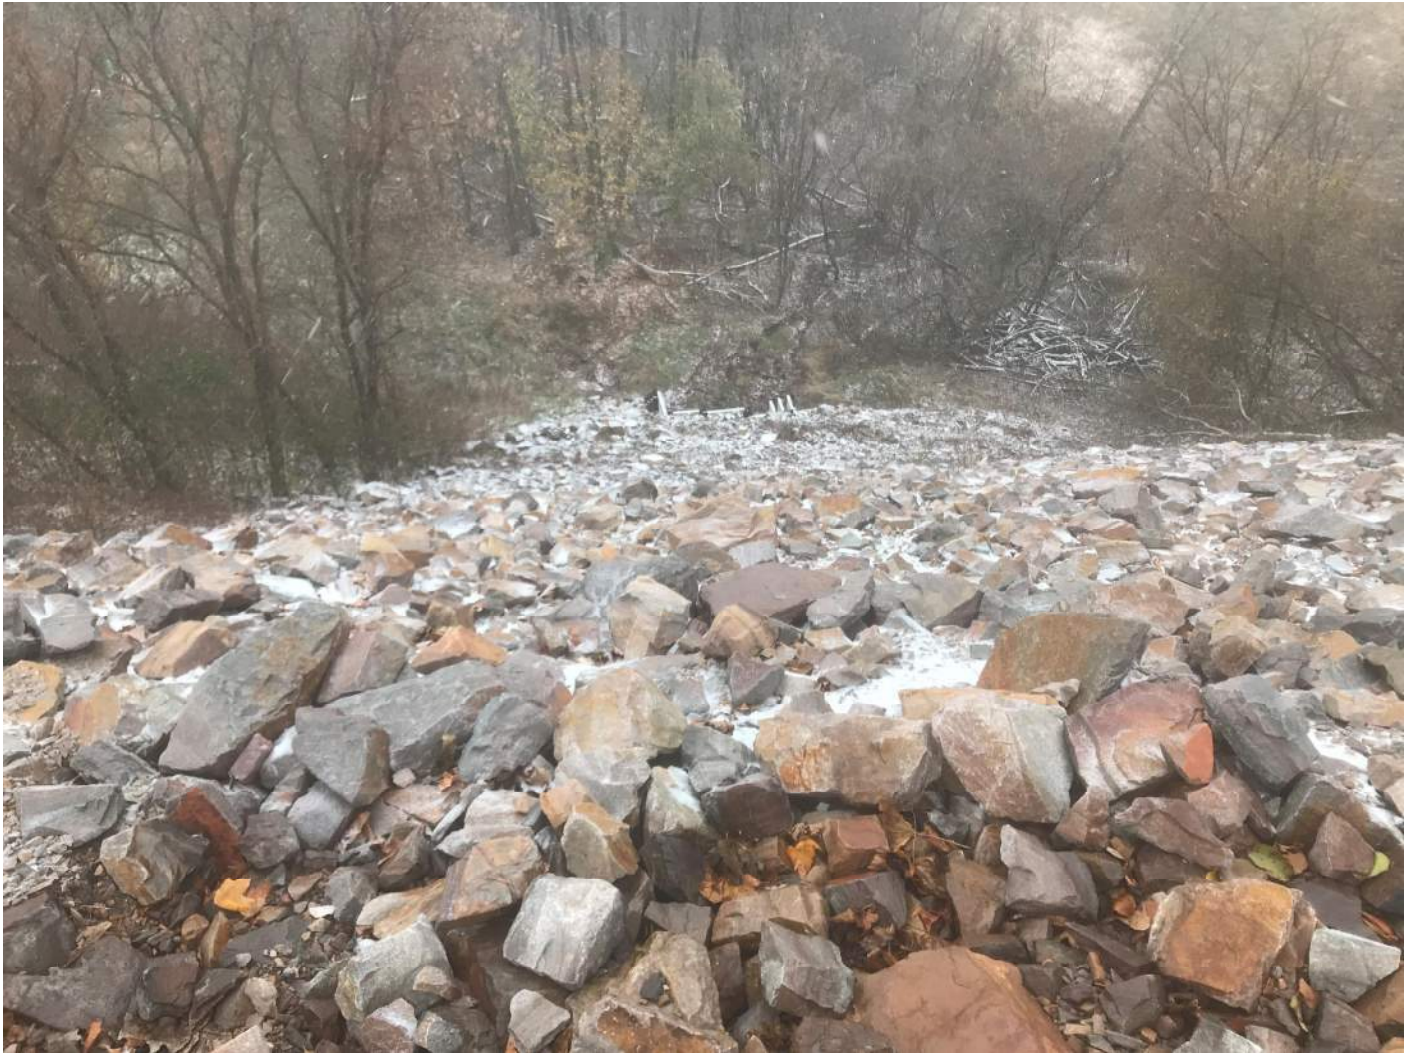
**Photograph 11:** View to north showing stability, nature and size of rip-rap armor on remediated slope

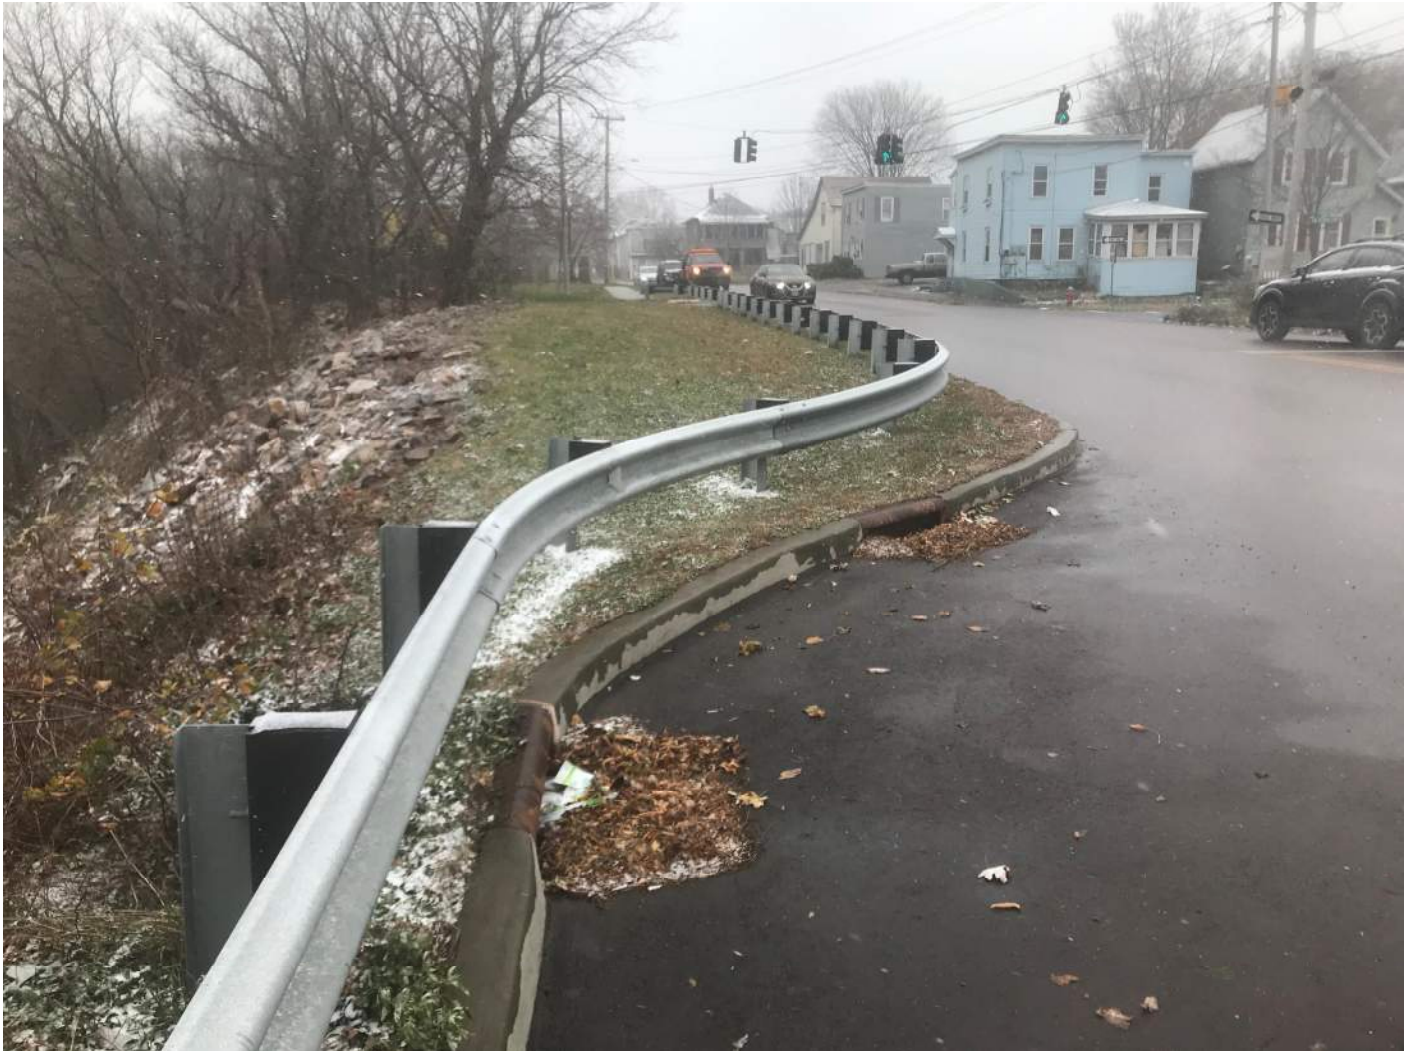
**Photograph 12:** View to east along Manhattan Drive showing top of remediated slope; pavement and grassy areas show no signs of distress or transverse cracking indicative of movement; guard rail appears stable and shows no sign of movement

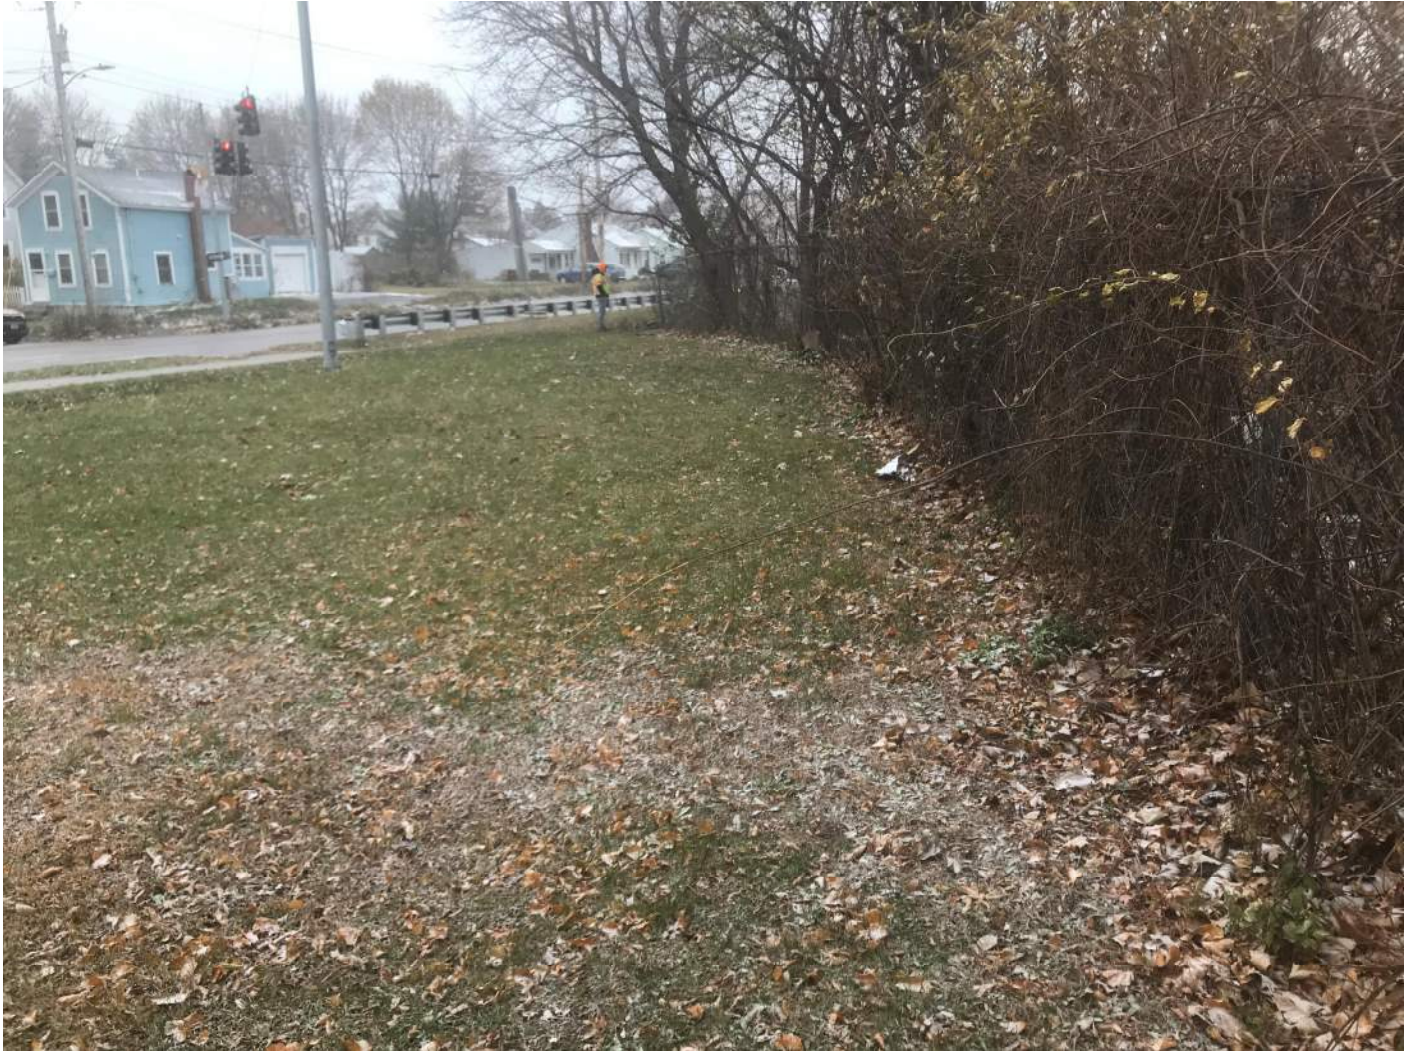
**Photograph 13:** View to southwest of top of natural slope on eastern flank of remediated slope; no distinct signs of stress or indications of slumping or movement are evident

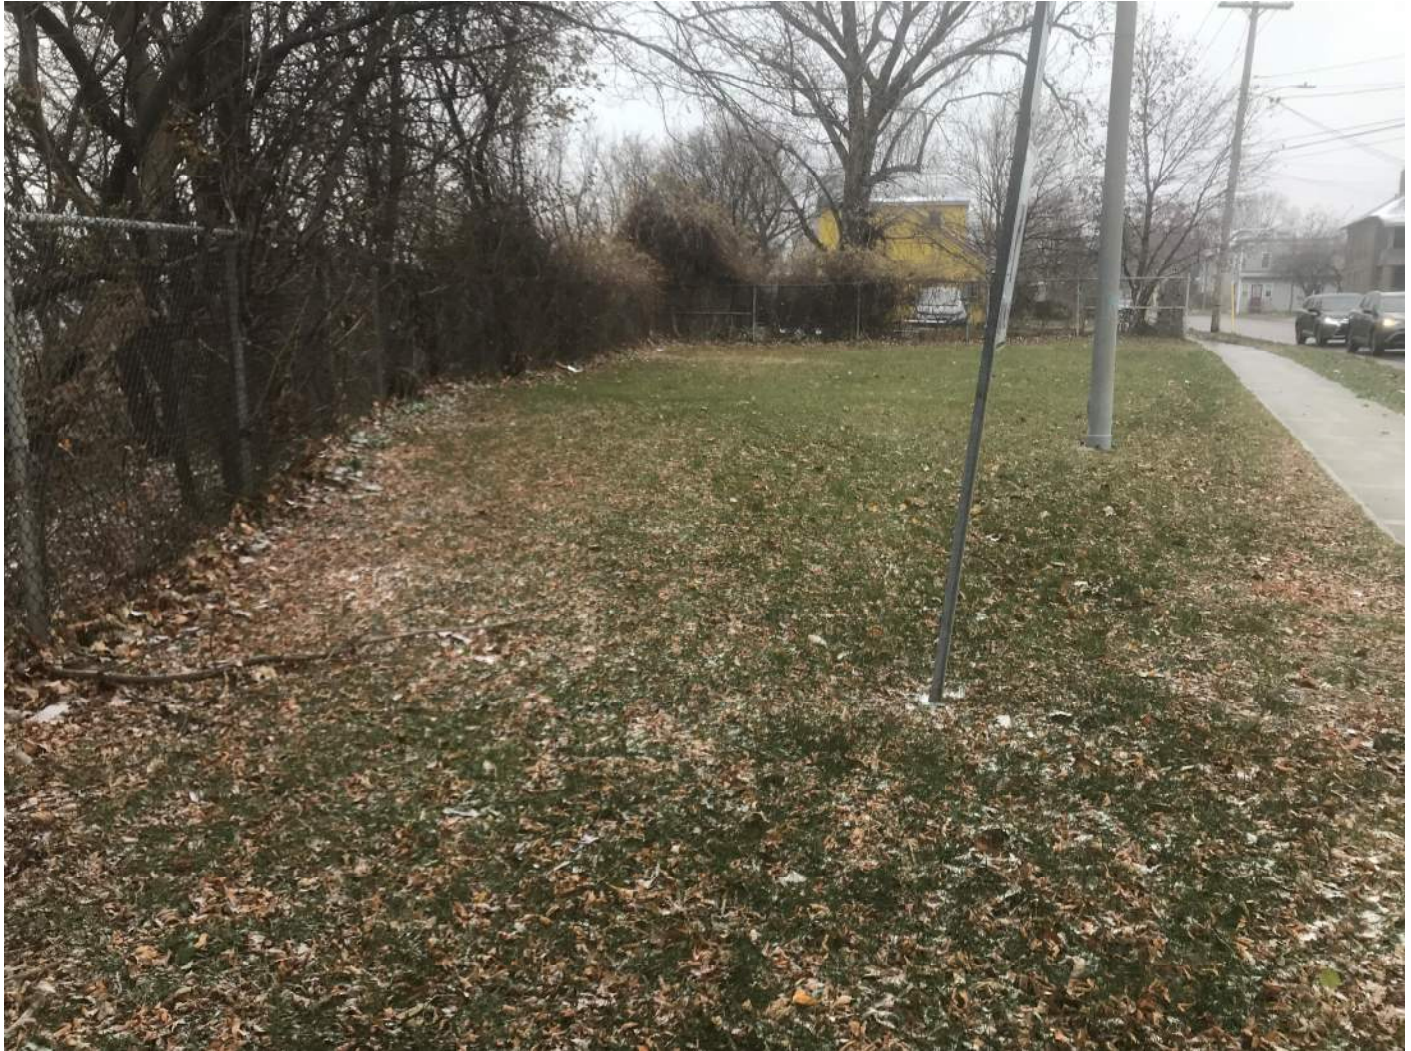
**Photograph 14:** View to east showing top of natural slope on eastern flank of remediated slope; no distinct signs of stress cracking, slumping or movement evident

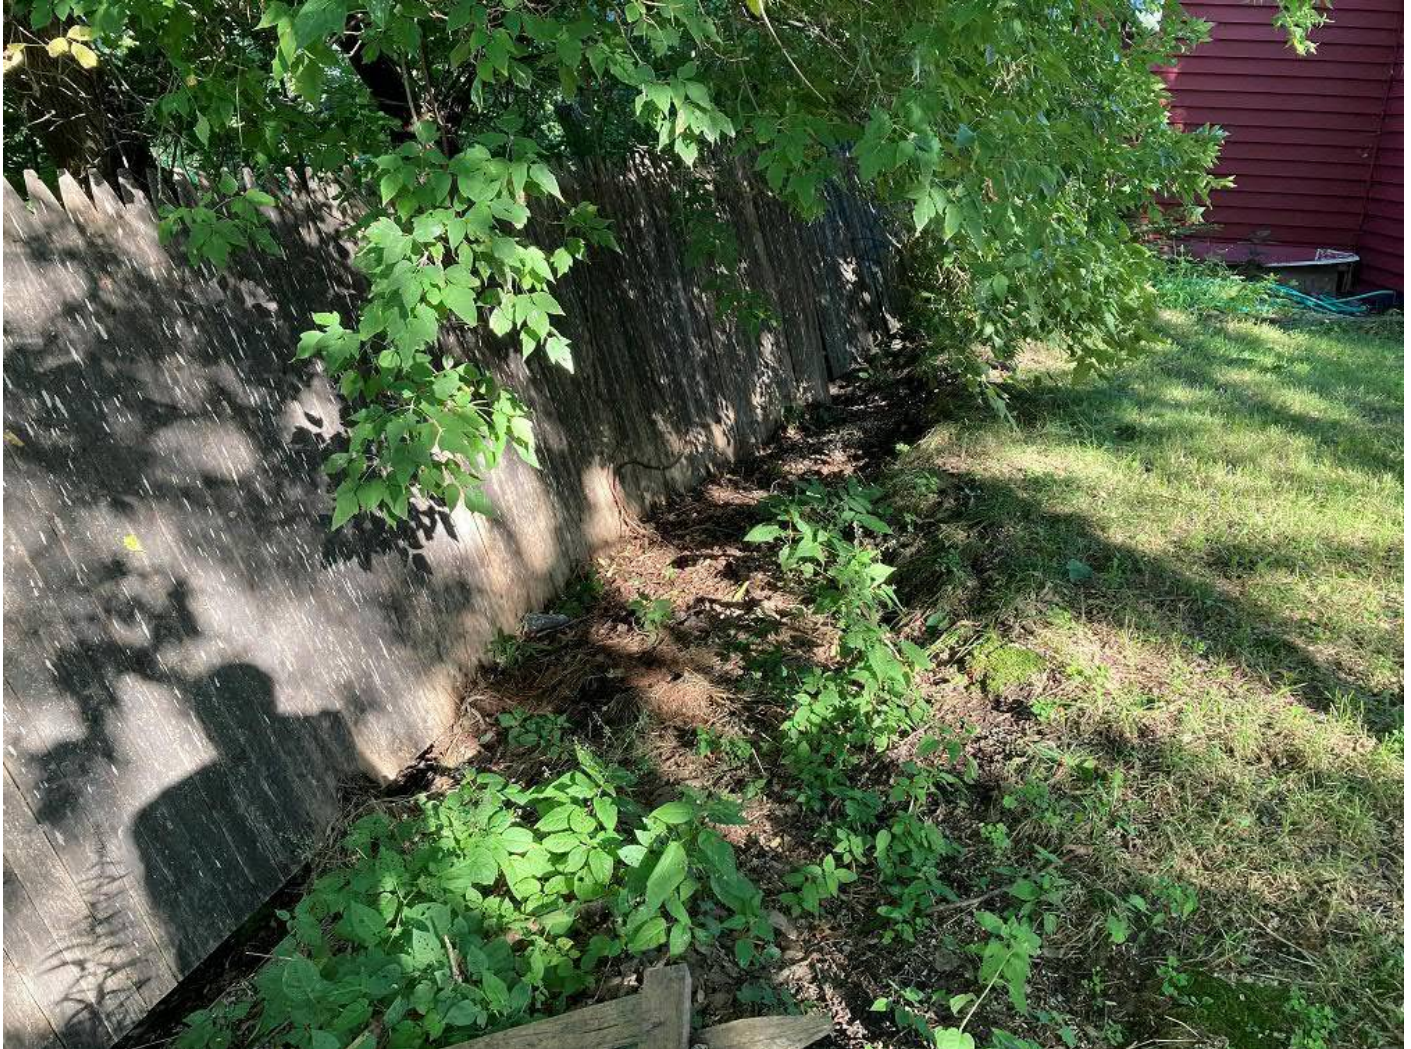
**Photograph 1:** View to east of scarp formation at top of slope west of Kismayo Kitchen building; note failure of wooden fence

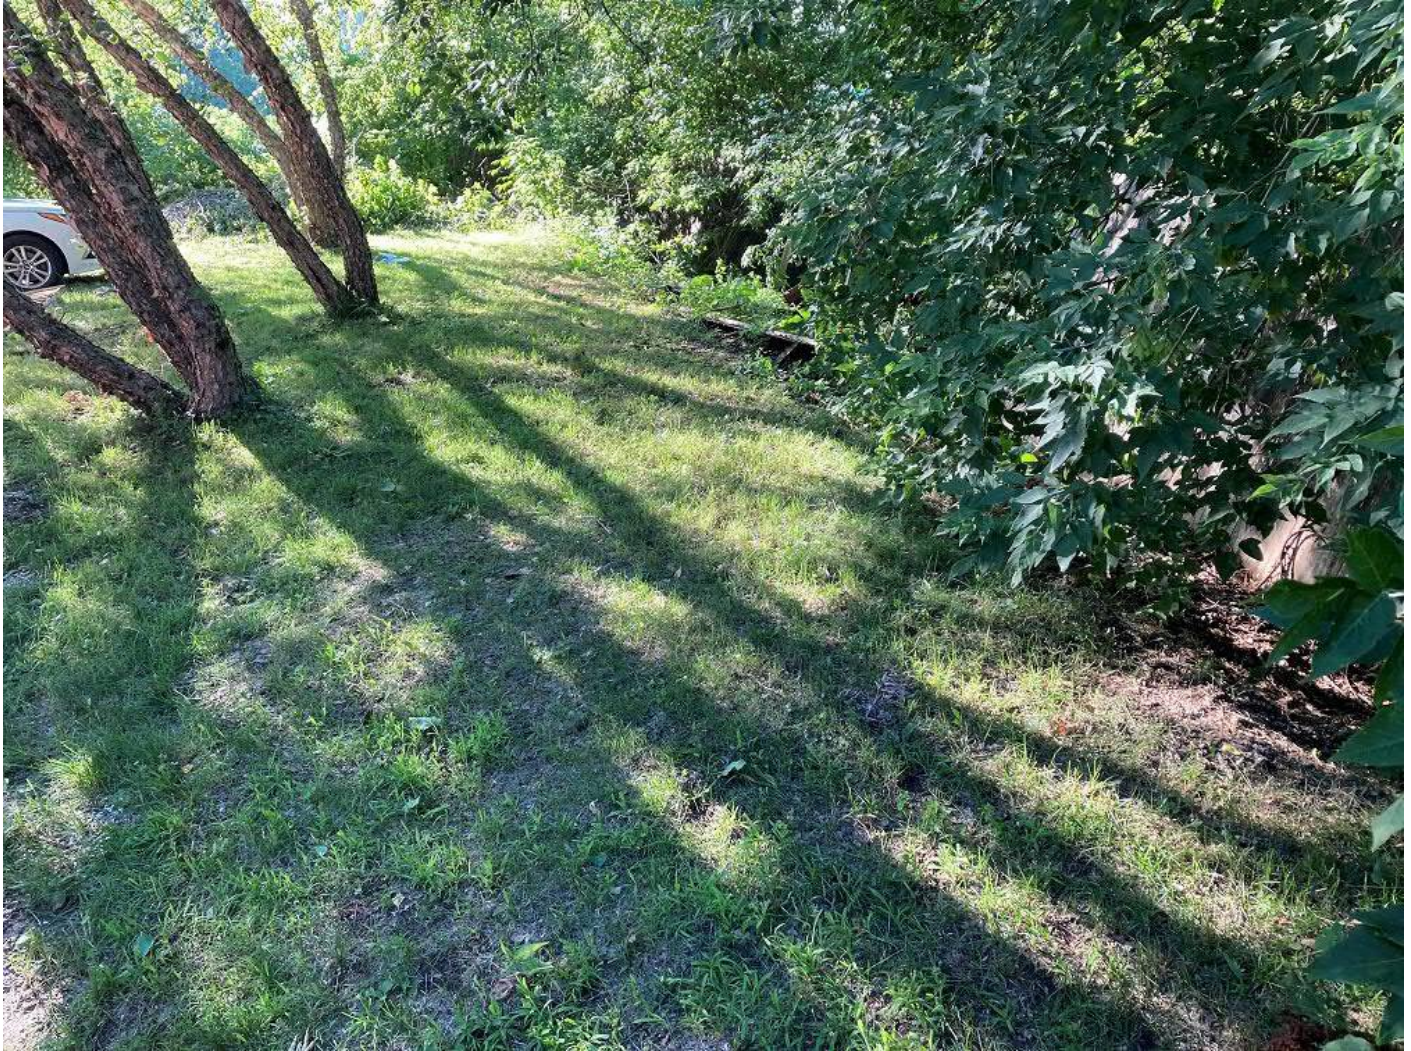
**Photograph 2:** View to west of Kismayo Kitchen building showing beginning of scarp formation at top of slope and irregular ground indicative of incipient slumping; note direction of lean of trees at upper left

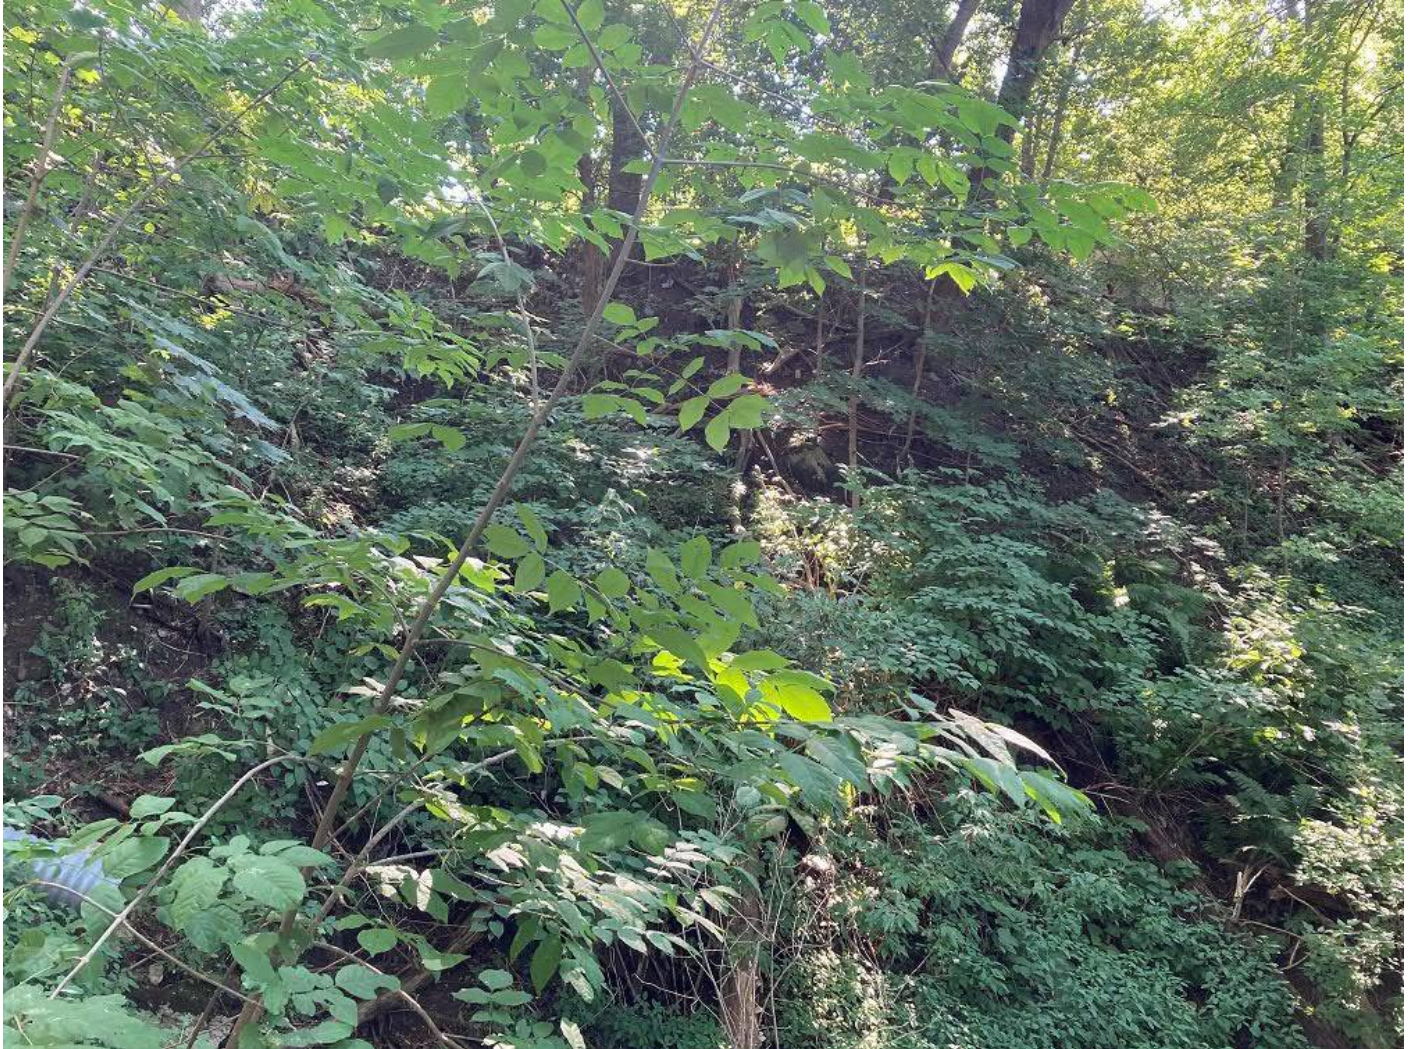
**Photograph 6:** View to southwest of exposed face of historical failure scarp; Kismayo Kitchen building can be seen at top right; note density of summer vegetation; exposed soil will continue to erode during precipitation events and top of slope will be subject to future localized failures; not discharge pipe at lower left of photograph.

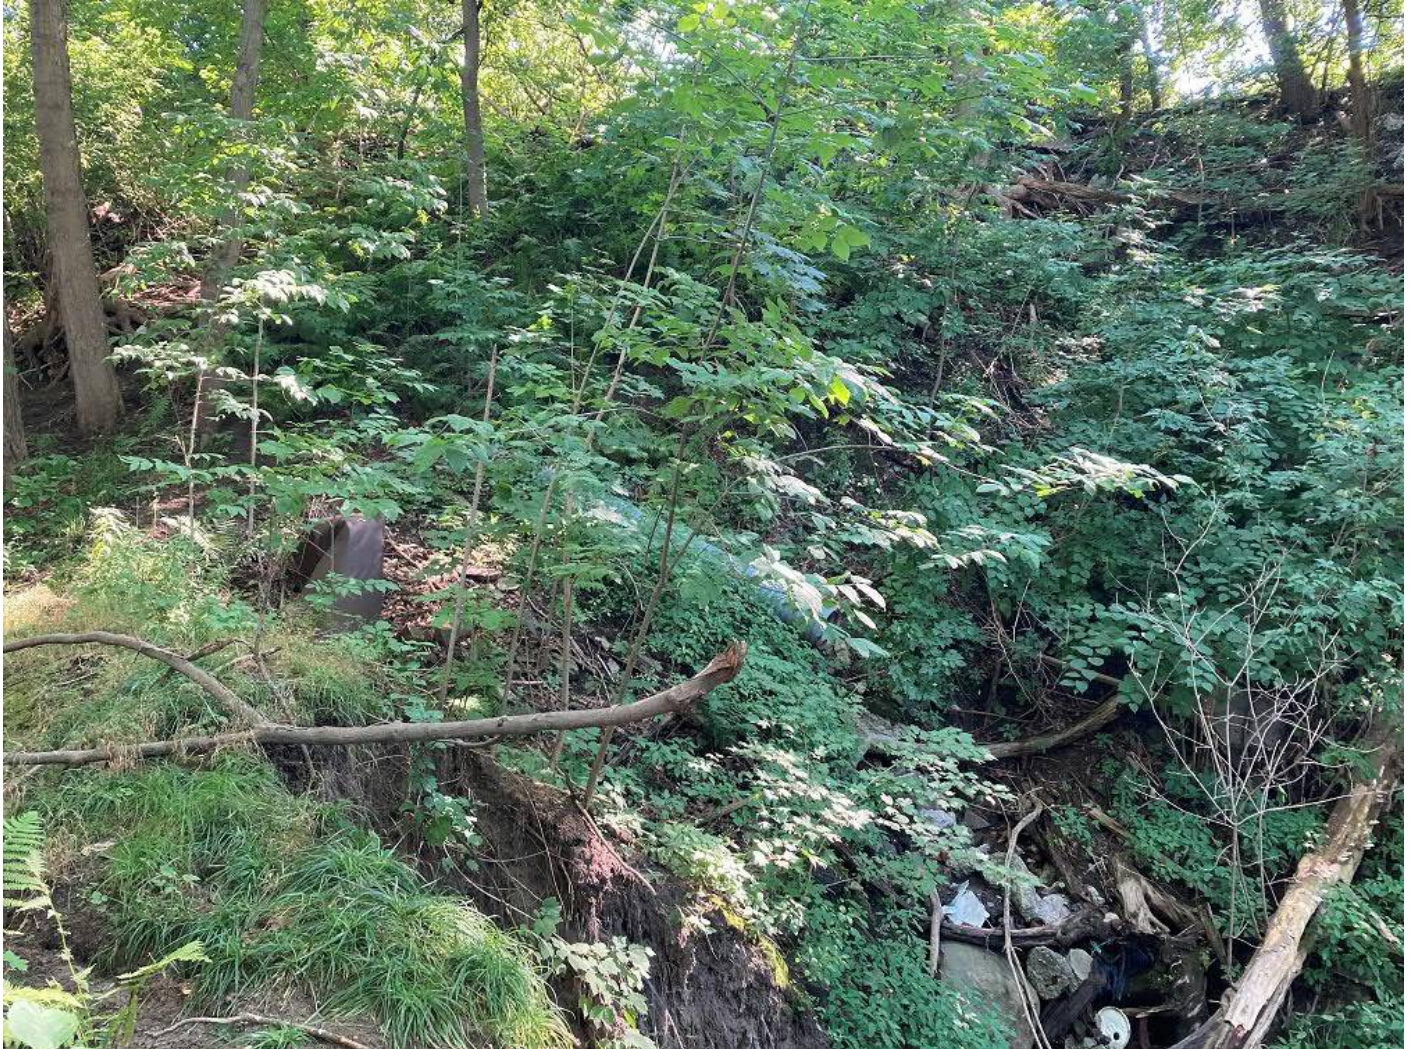
**Photograph 7:** View to southeast of stormwater discharge pipe (center of photograph) and gully formation from discharge; note debris in gully and exposed soil scarp at top of slope (top right of photograph) east of Kismayo Kitchen building

- **Needs Further Assessment** – Significant erosion at pipe outlet (reference Drainage Issue D2). Recommend City address by stabilizing apron and channel with rock slope armoring. Verify with Stormwater Department pipe flows and size armoring accordingly.

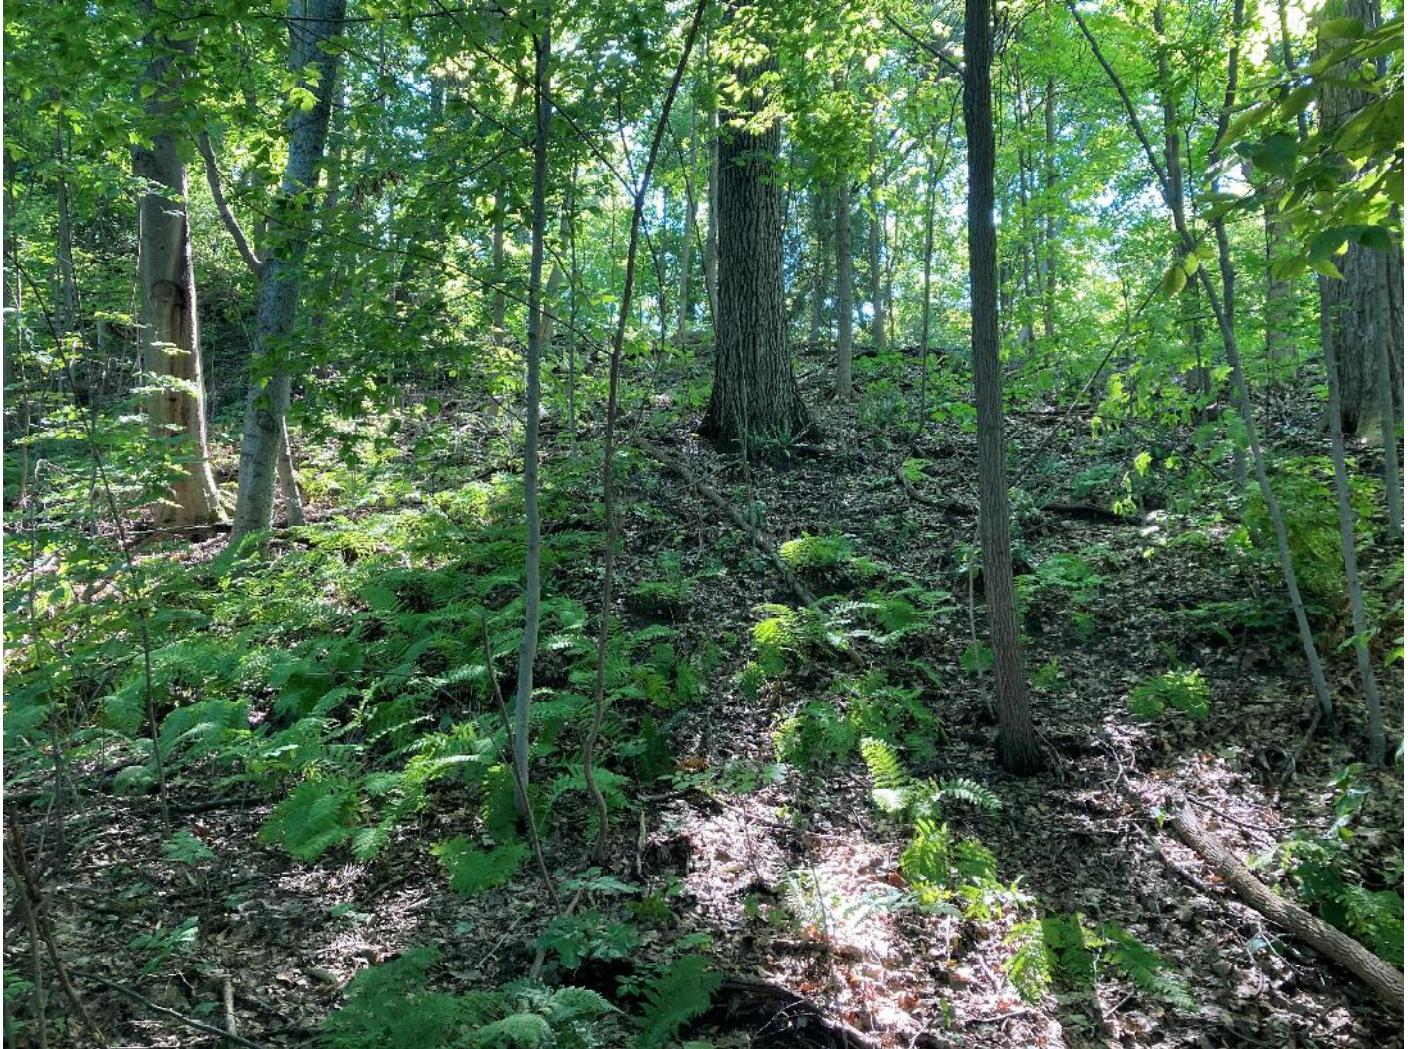
**Photograph 10:** View to south upslope showing probable historic slump/slide mass generated during historic failure events; note no distinct leaning of trees

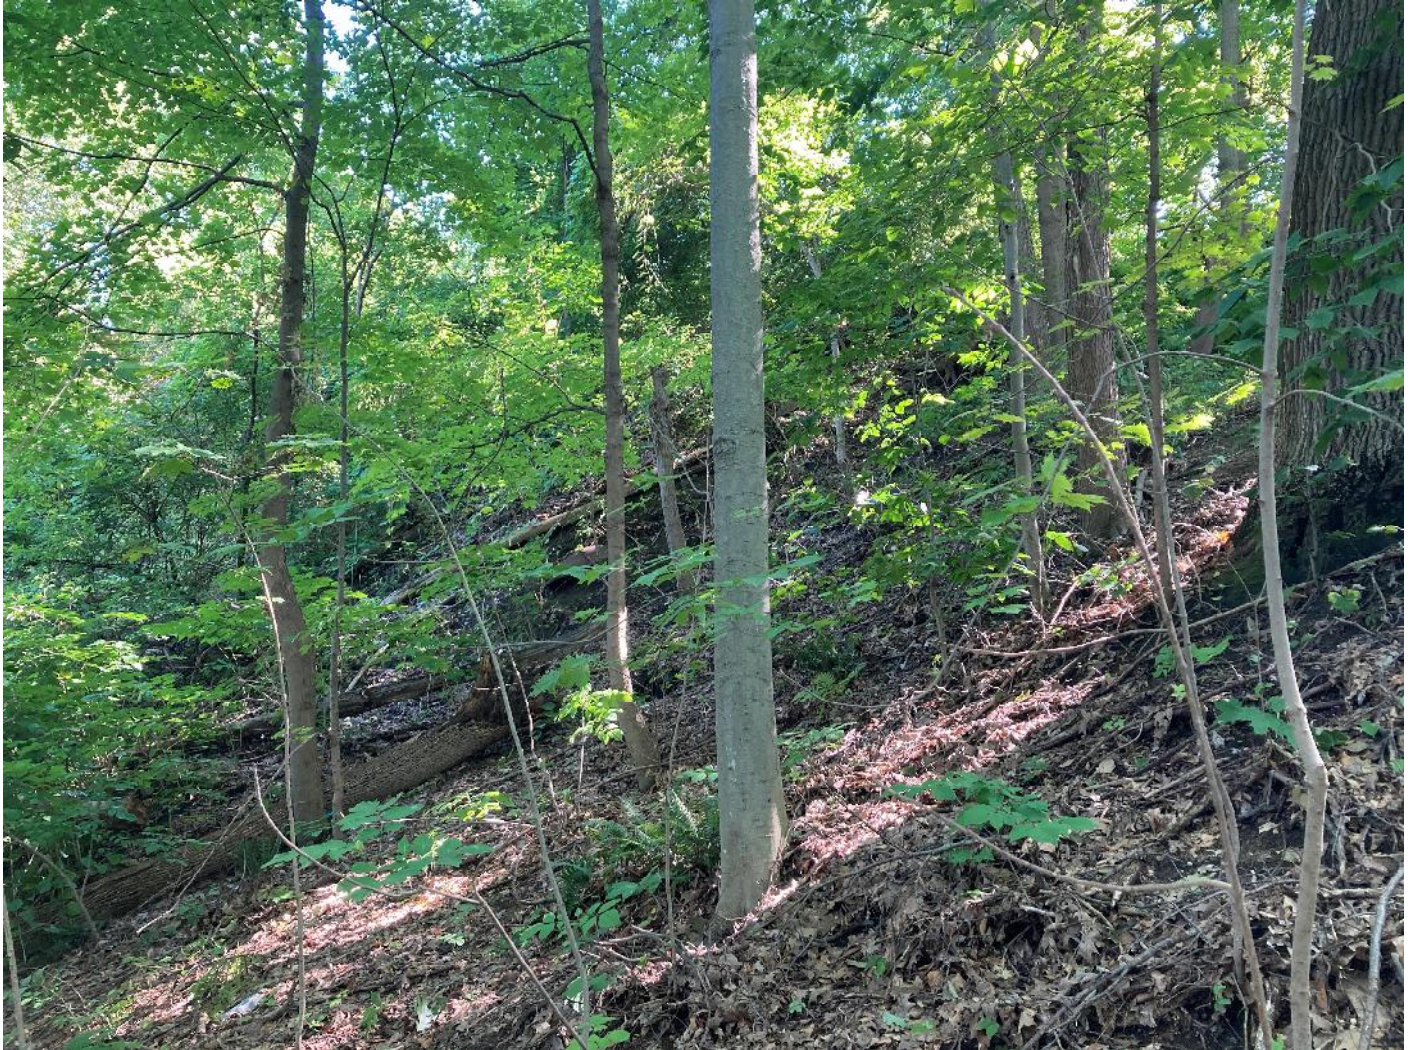
**Photograph 11:** View to east-southeast of historic soil slump/slide mass downslope from area between 471 Riverside Avenue (GBG Indian Kitchen) and 505 Riverside Avenue (Kismayo Kitchen); areas of exposed soil will continue to erode during precipitation events

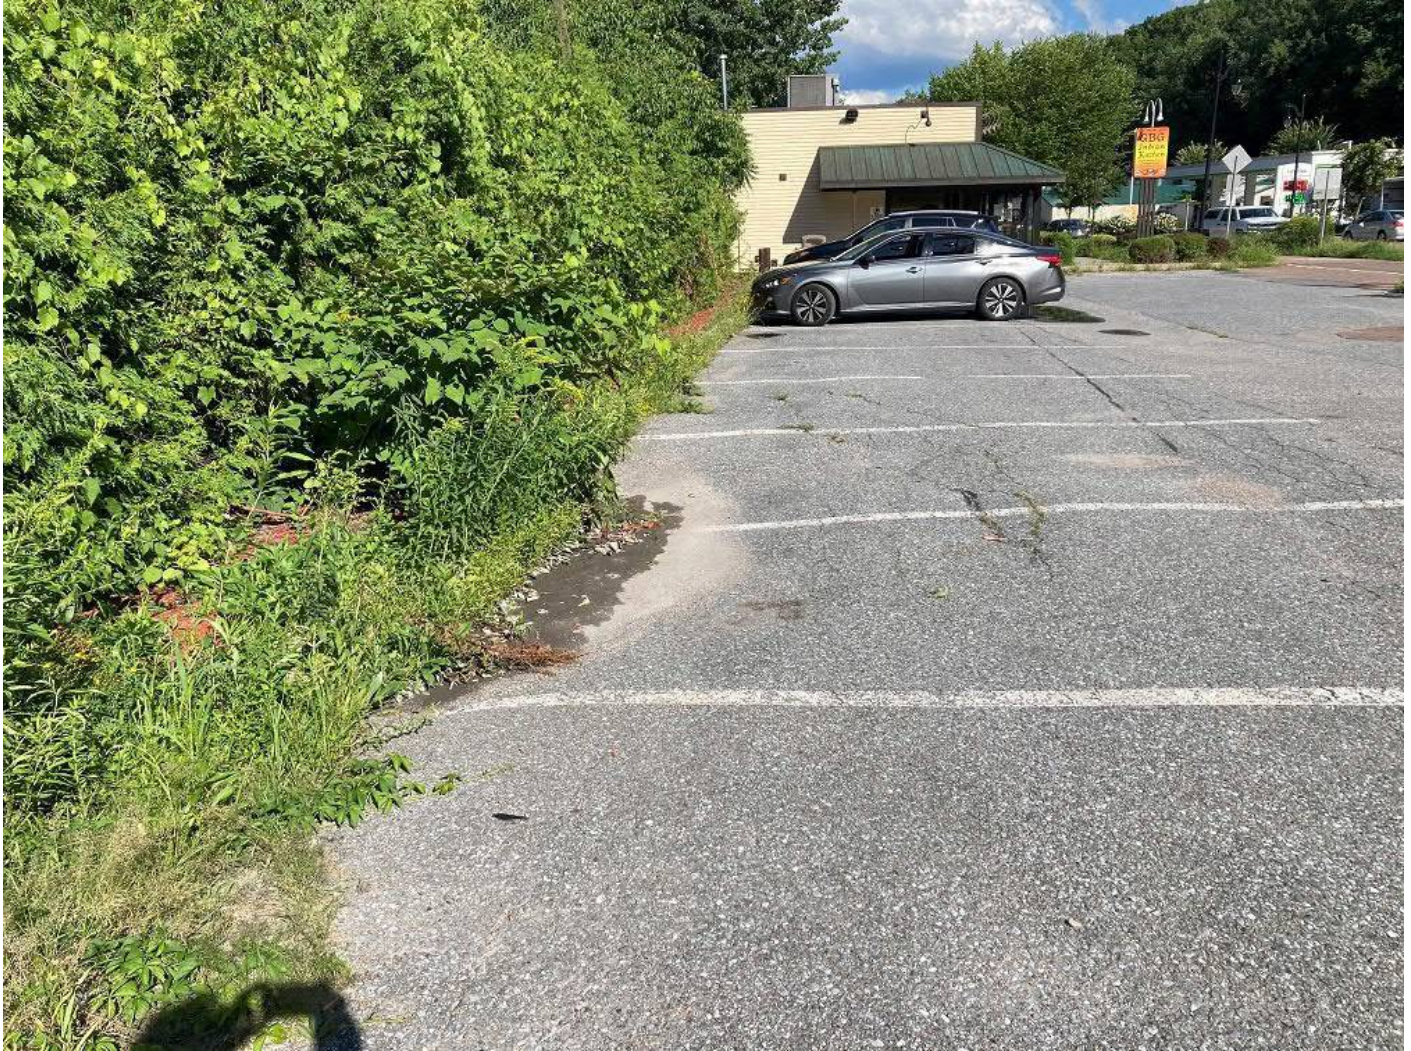
**Photograph 14:** View to east towards GBG Indian Kitchen showing localized incipient earth slumping in parking area at center of photograph; note area of recent ponded water; exposed historical failure scarp is present beyond trees to left.

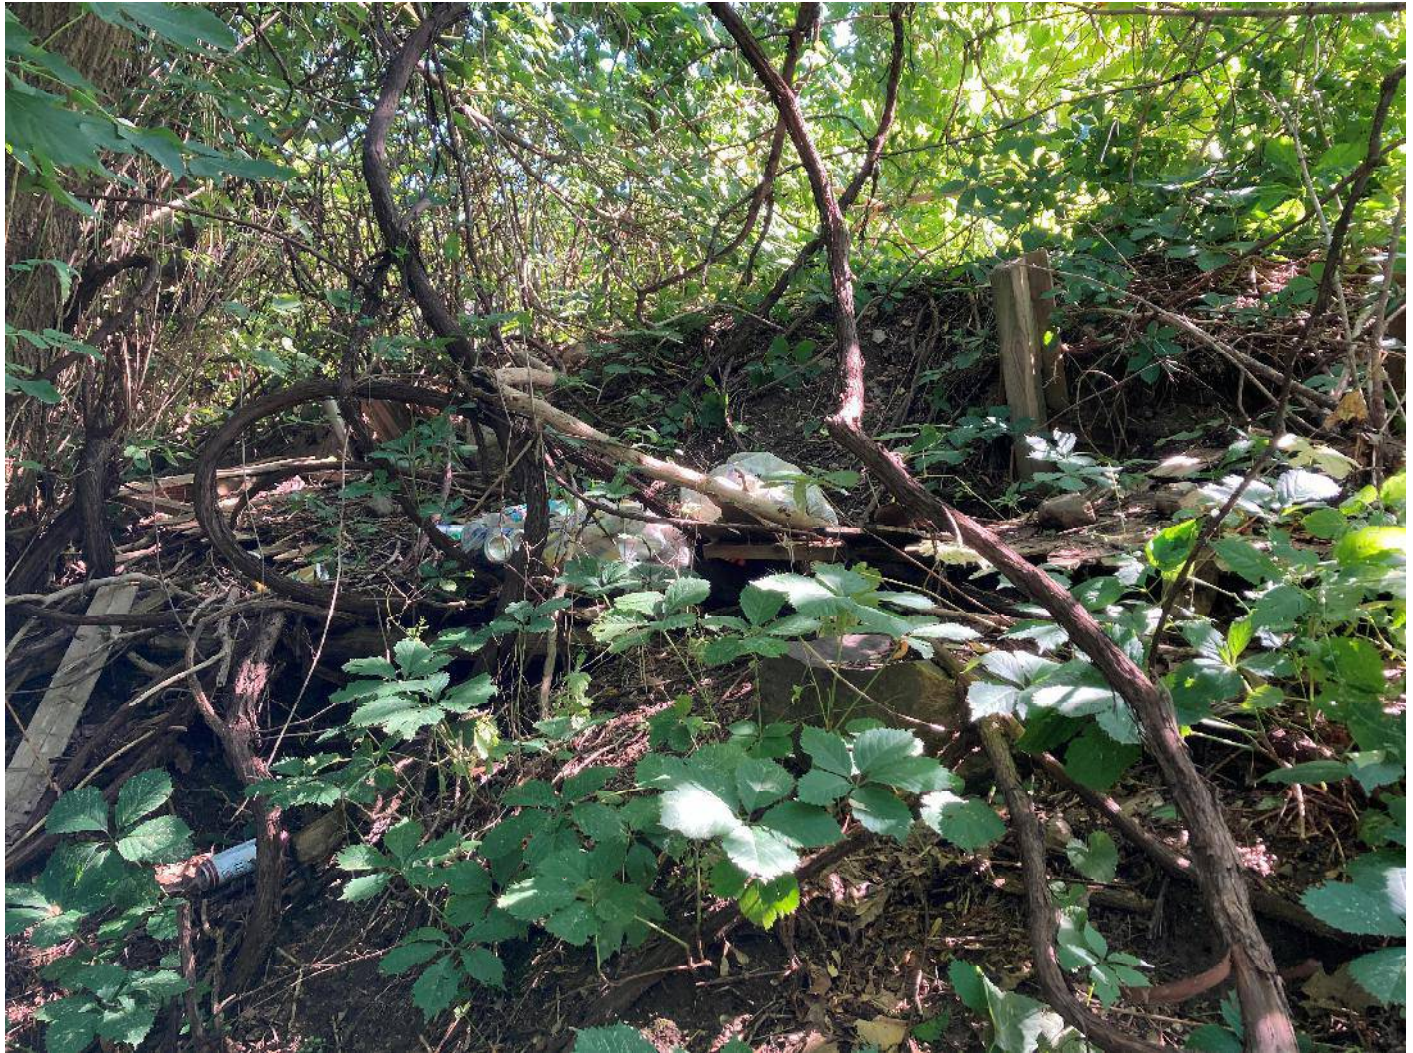
**Photograph 15:** View to southeast of exposed soil scarp adjacent to northern boundary of western parking lot for GBG Indian Kitchen; note density of vegetation

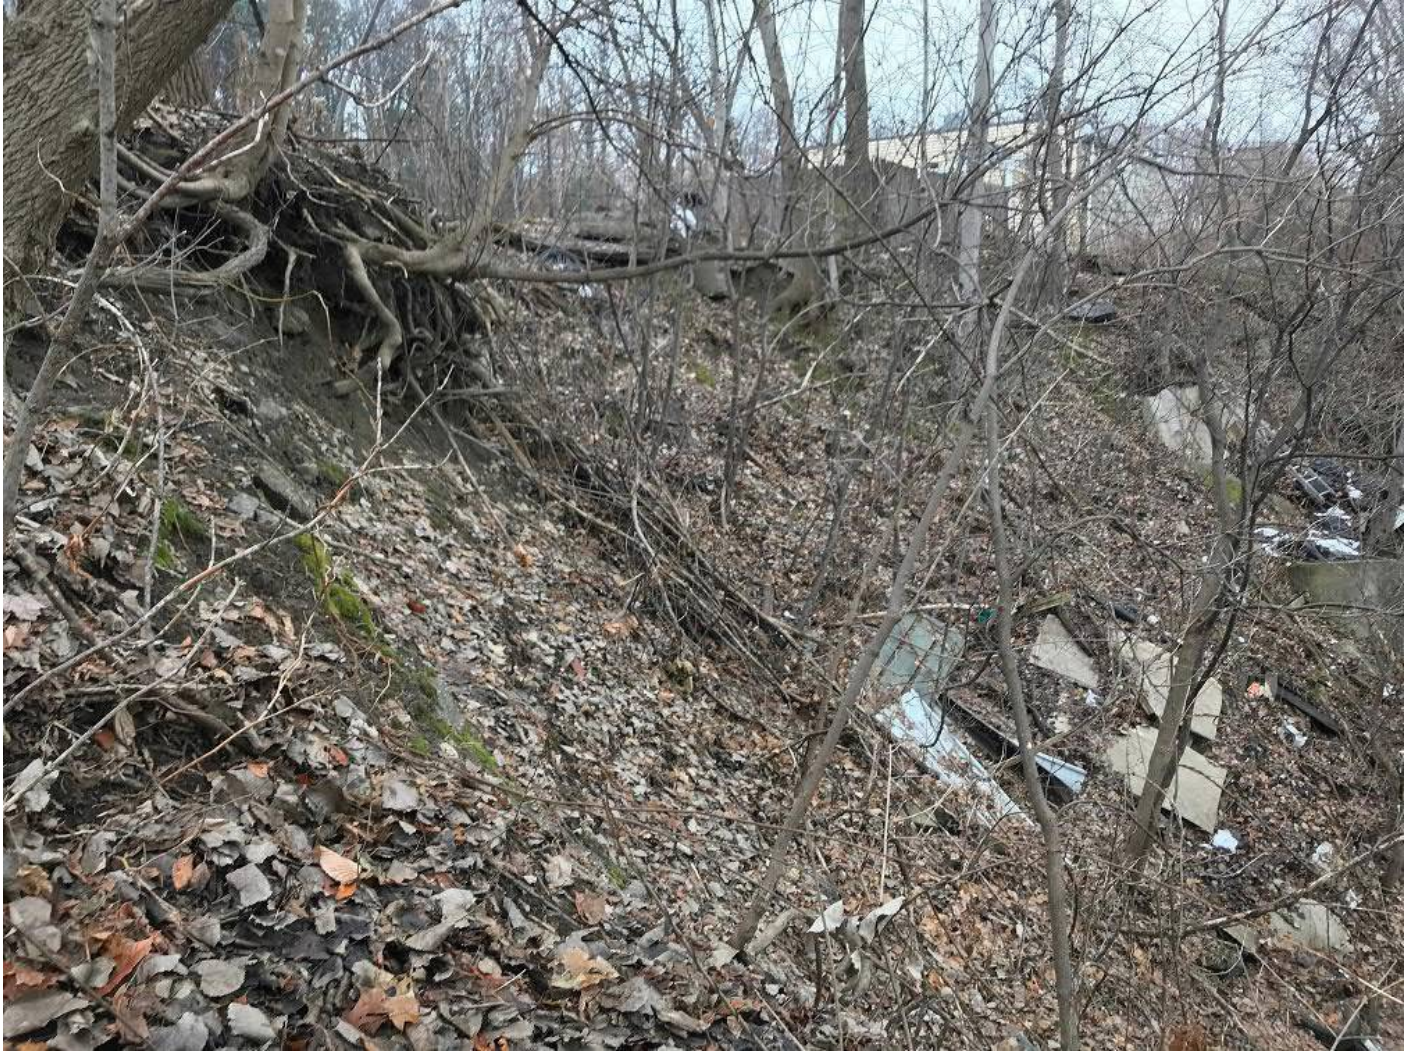
**Photograph 17:** View to southwest showing GBG Indian Kitchen (top right), and failure scarp top left; photograph taken in December 2019 during inspection by Hoyle-Tanner Associates; note change in density of vegetation; exposed slope subject to surface erosion during precipitation events
