## **Burlington Conservation Board**

## Conservation Board Meeting Minutes

## FY20 Burlington Slope Inspections

**CITY OF BURLINGTON, VERMONT  
SLOPE STABILITY INSPECTION**

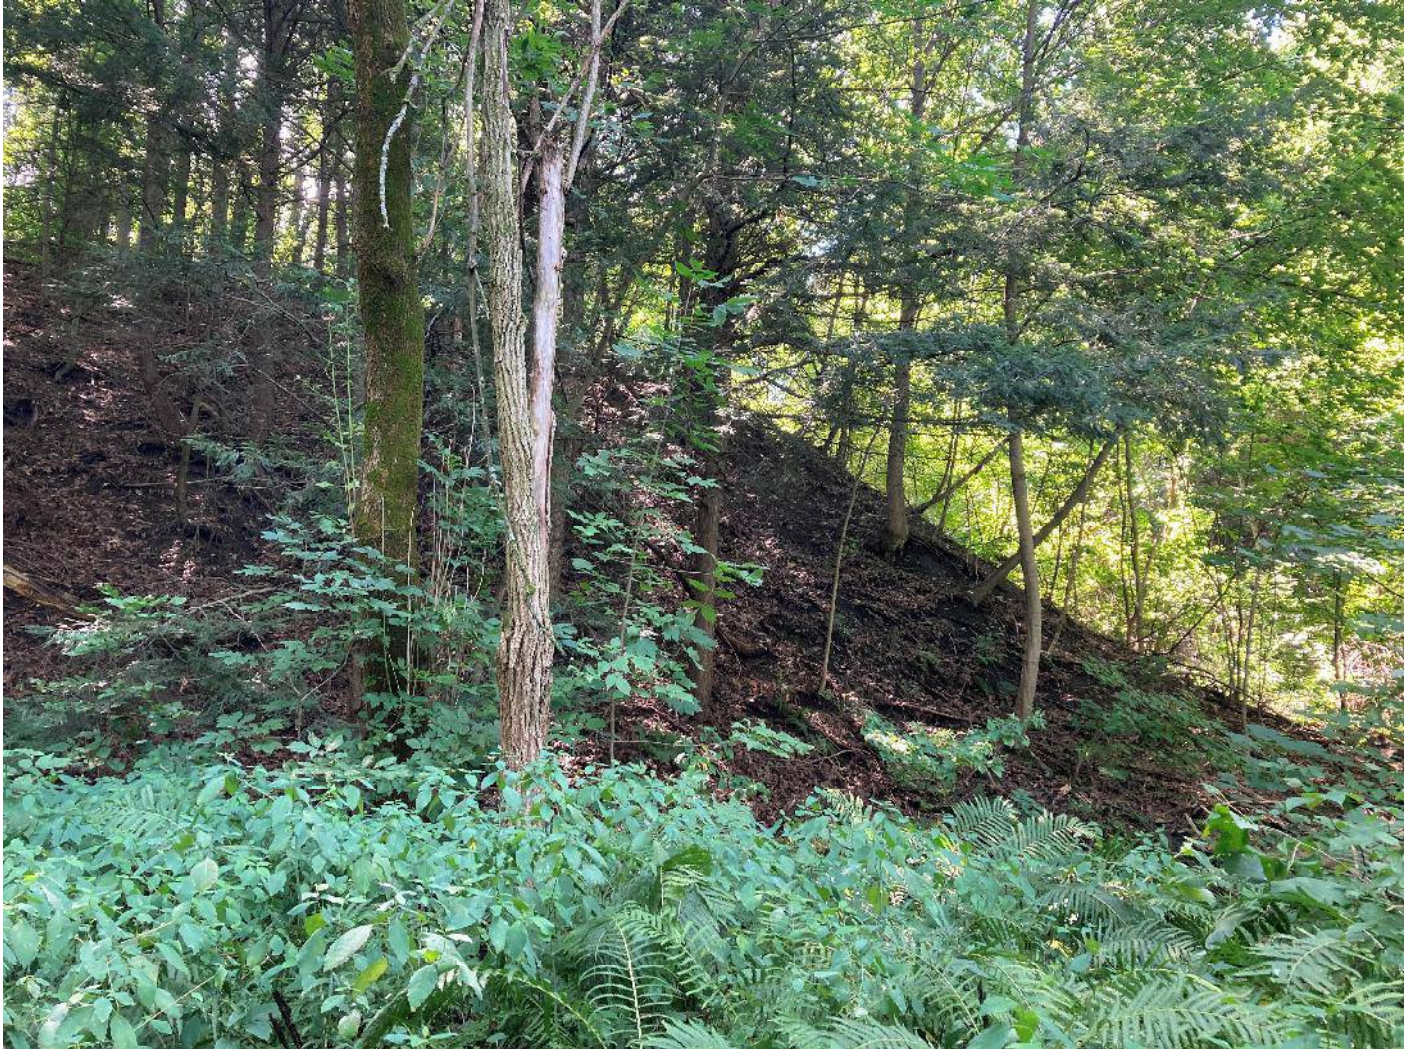
**Photograph 18:** View to west downslope from GBG Indian Kitchen (just south of River Walk Trail) showing soil slump debris from inferred historic failure event; exposed soil surfaces subject to continual surface erosion from precipitation events;

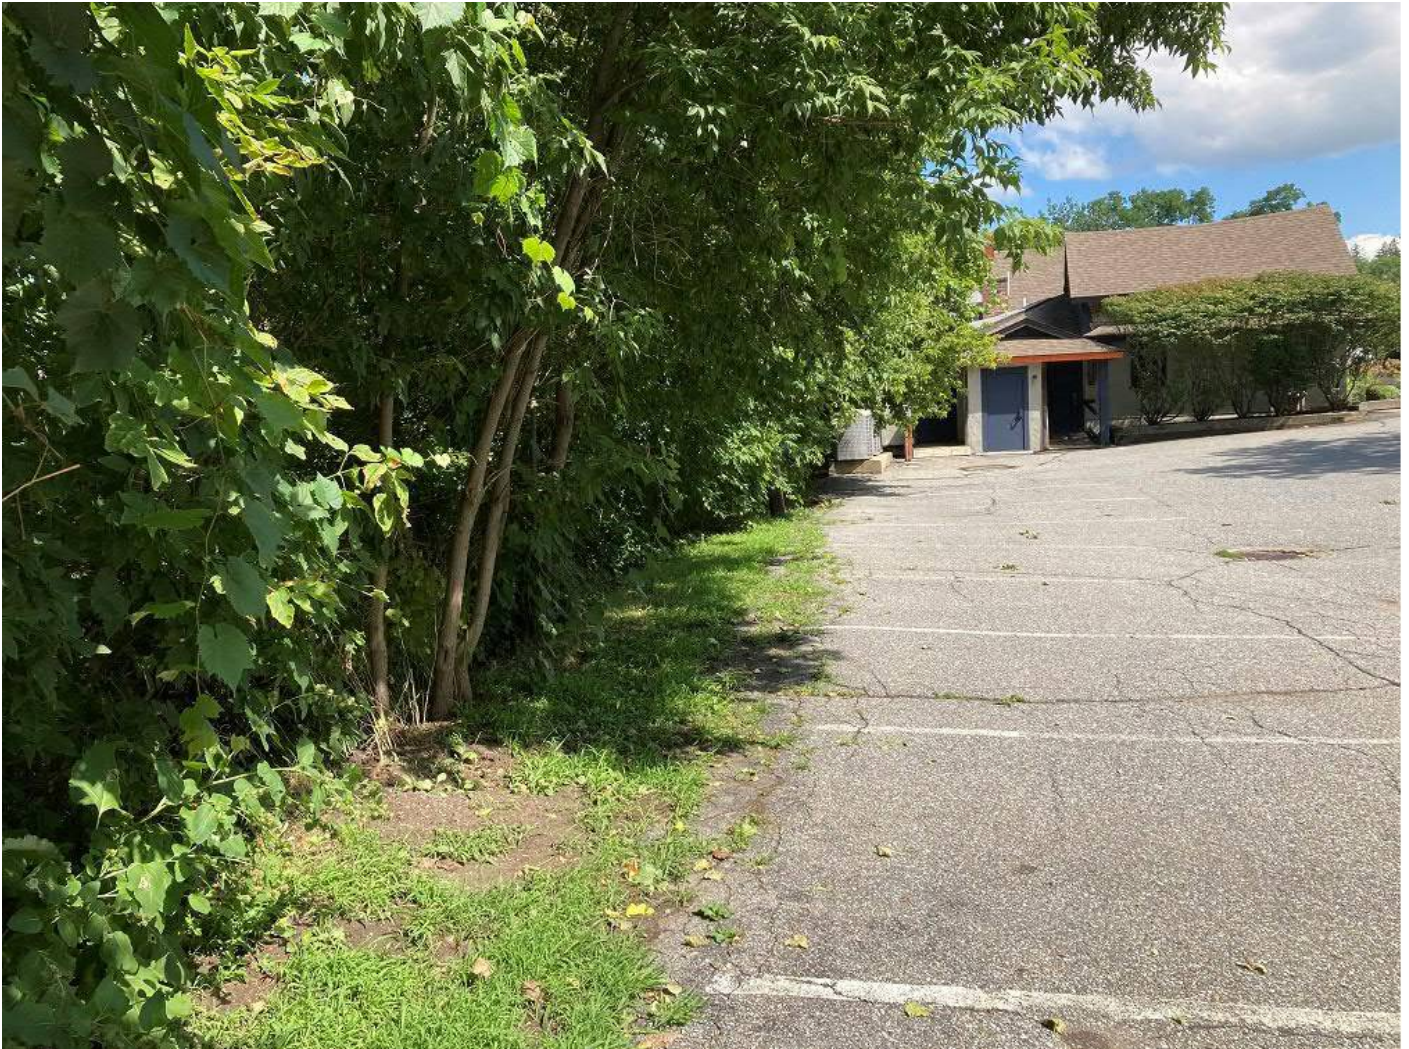
**Photograph 1:** View to east, toward Bluebird BBQ building from boundary between 317 and 365 Riverside Avenue properties, showing top of slope and absence of distinct surface expression of slump formation or crown cracking; stressed pavement cracks are a possible indicator of ongoing creep; note catch basin at right center of photograph; washout and gully formation from excess surface flow can be seen at bottom left of photograph

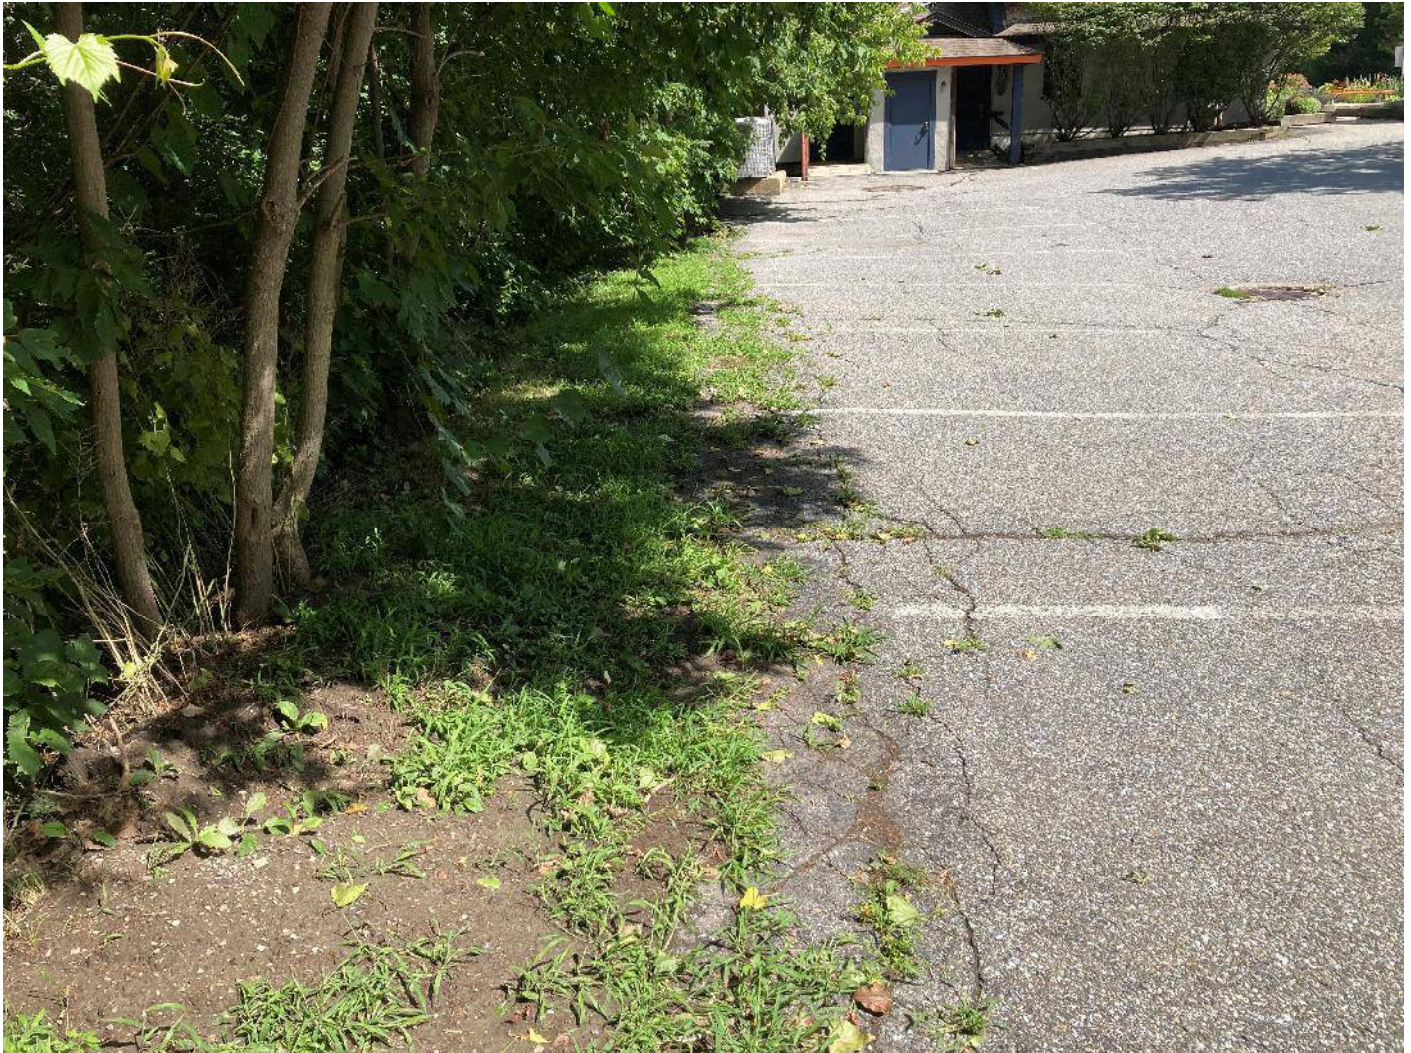
**Photograph 2:** View to east towards Bluebird BBQ building showing stress-release cracking in pavement at top of slope in west parking; cracking in pavement is a possible indicator of ongoing creep; gully washout from surface flow can be seen at bottom left of photograph

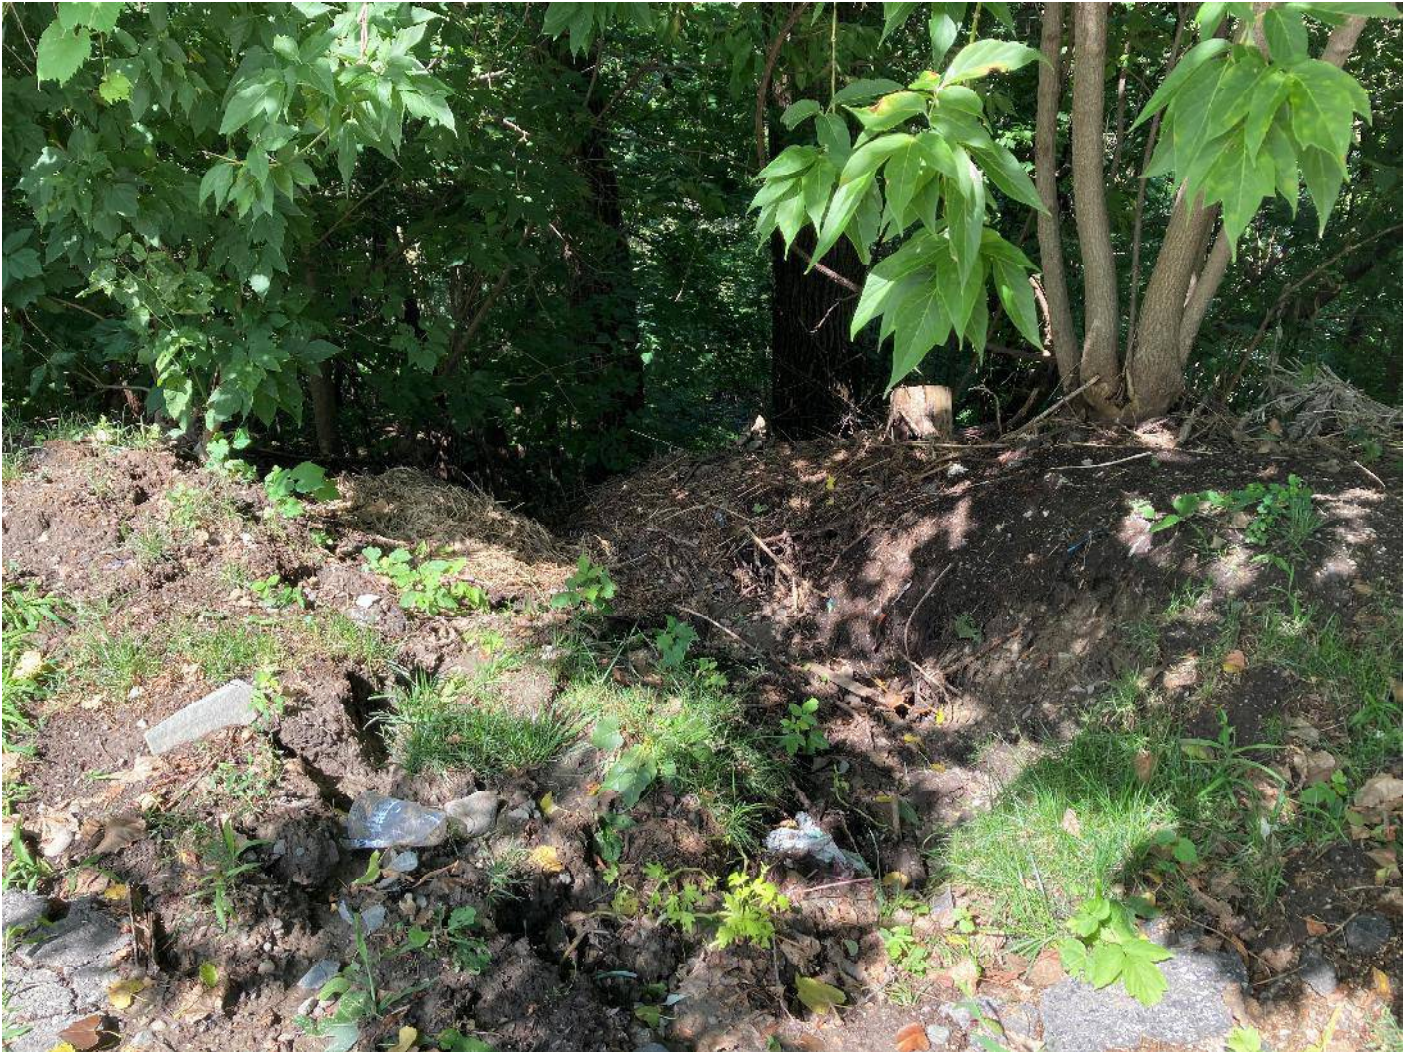
**Photograph 3:** View to north showing close-up of gully formation (Photo 2) from excess surface runoff at top of slope

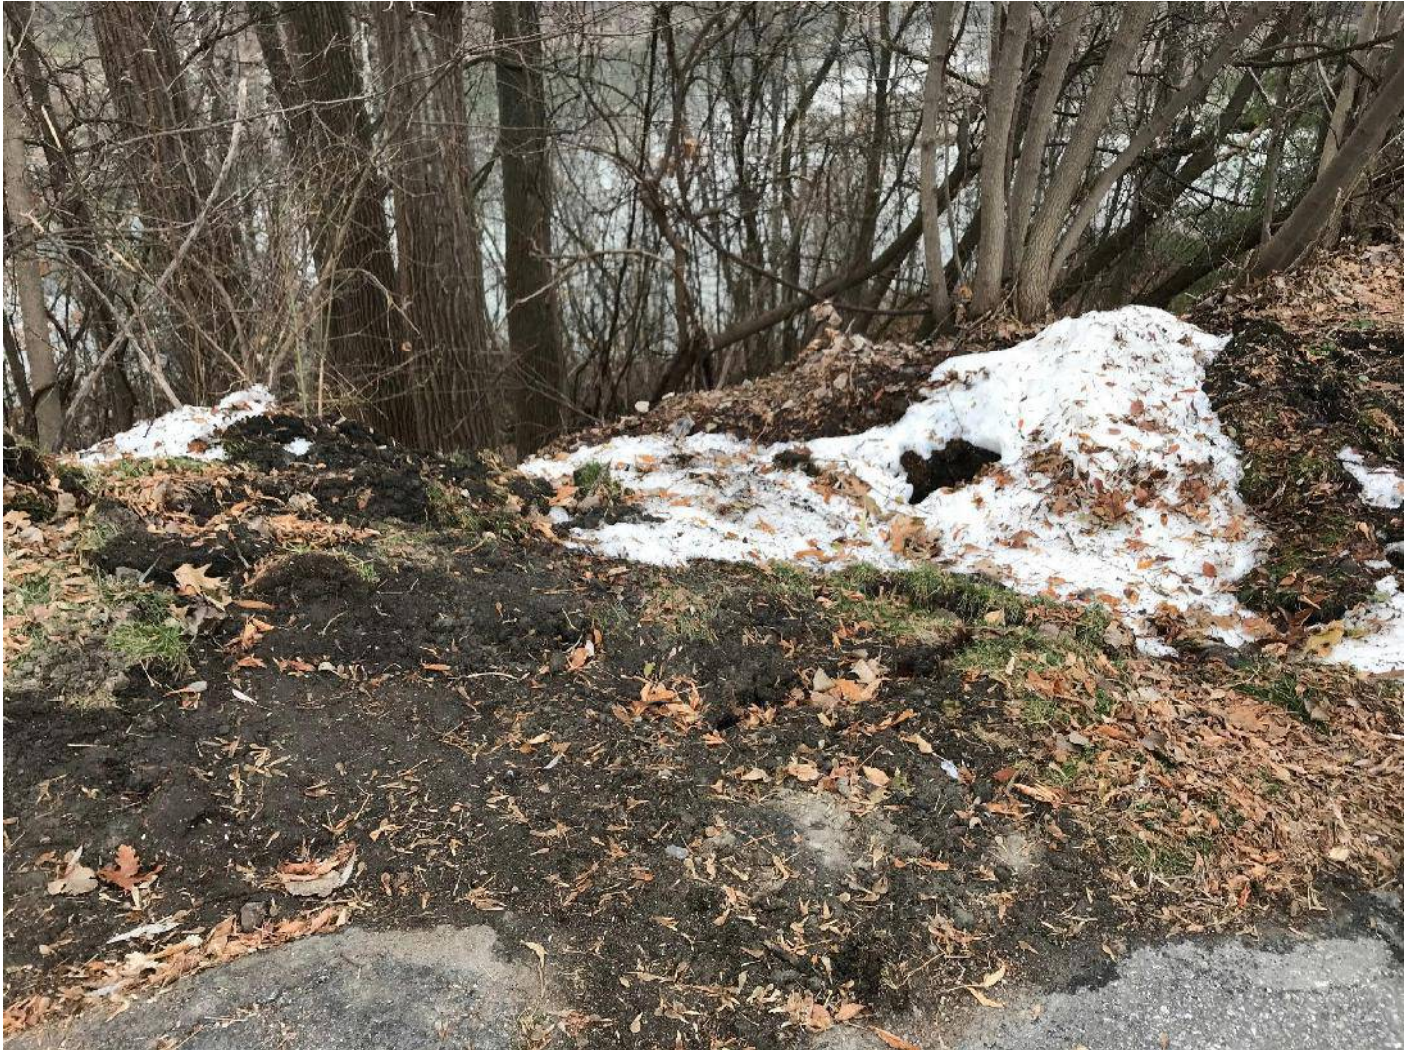
**Photograph 4:** View to northwest taken by Hoyle Tanner Associates during December 2019 inspection showing gully formation and surface cracking at top of slope at west parking lot of Bluebird BBQ

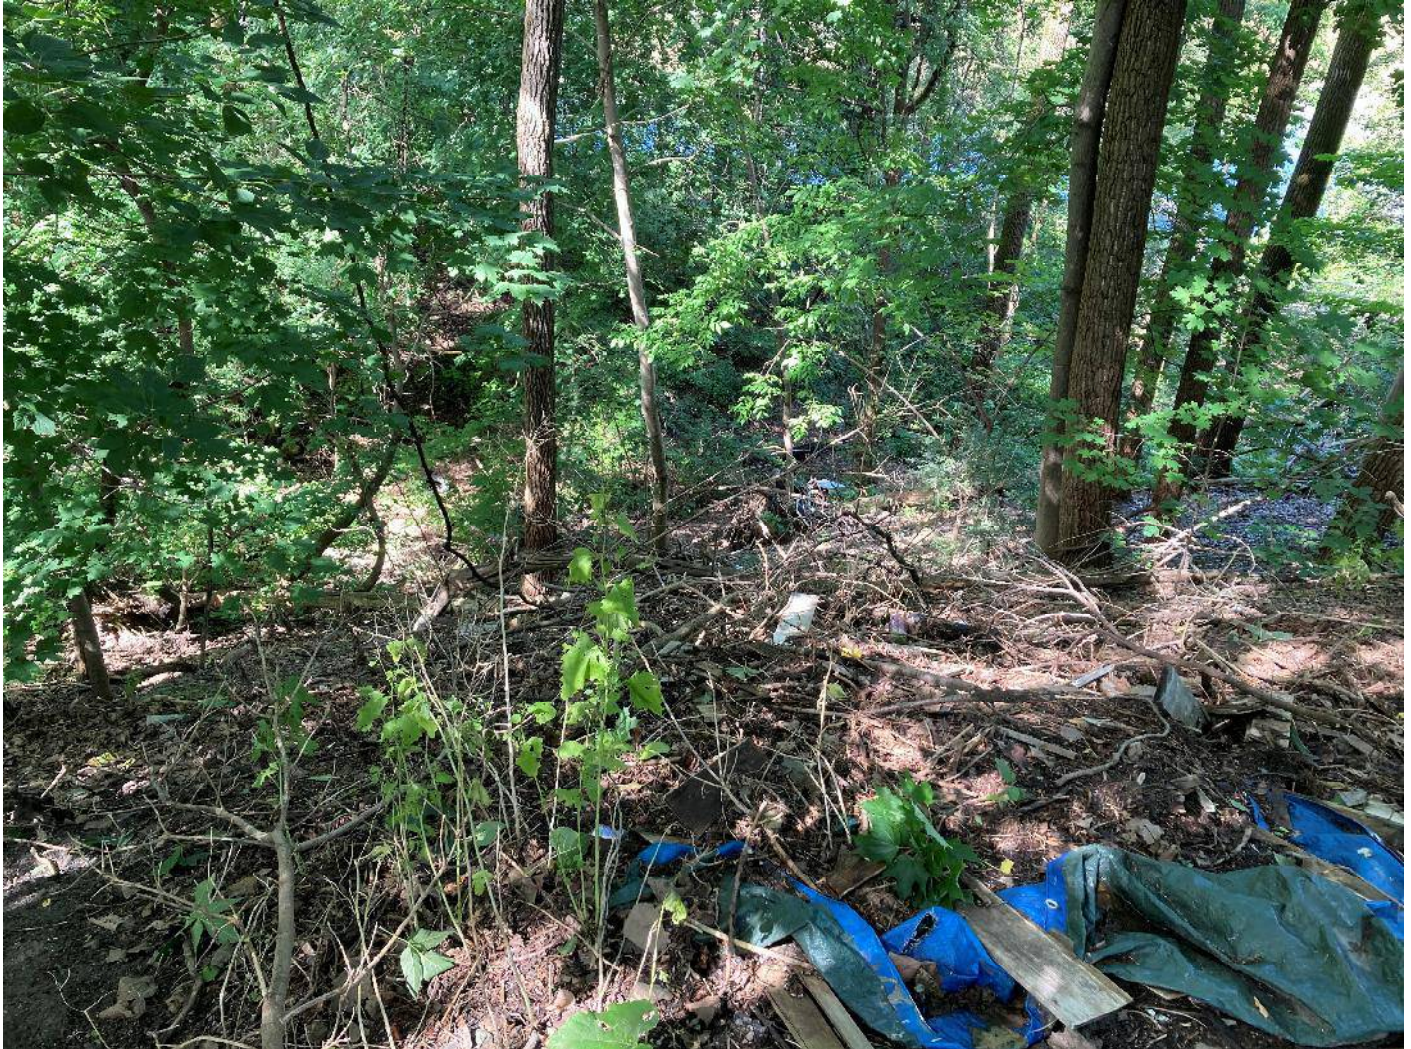
**Photograph 5:** View downslope from western parking lot of Bluebird BBQ

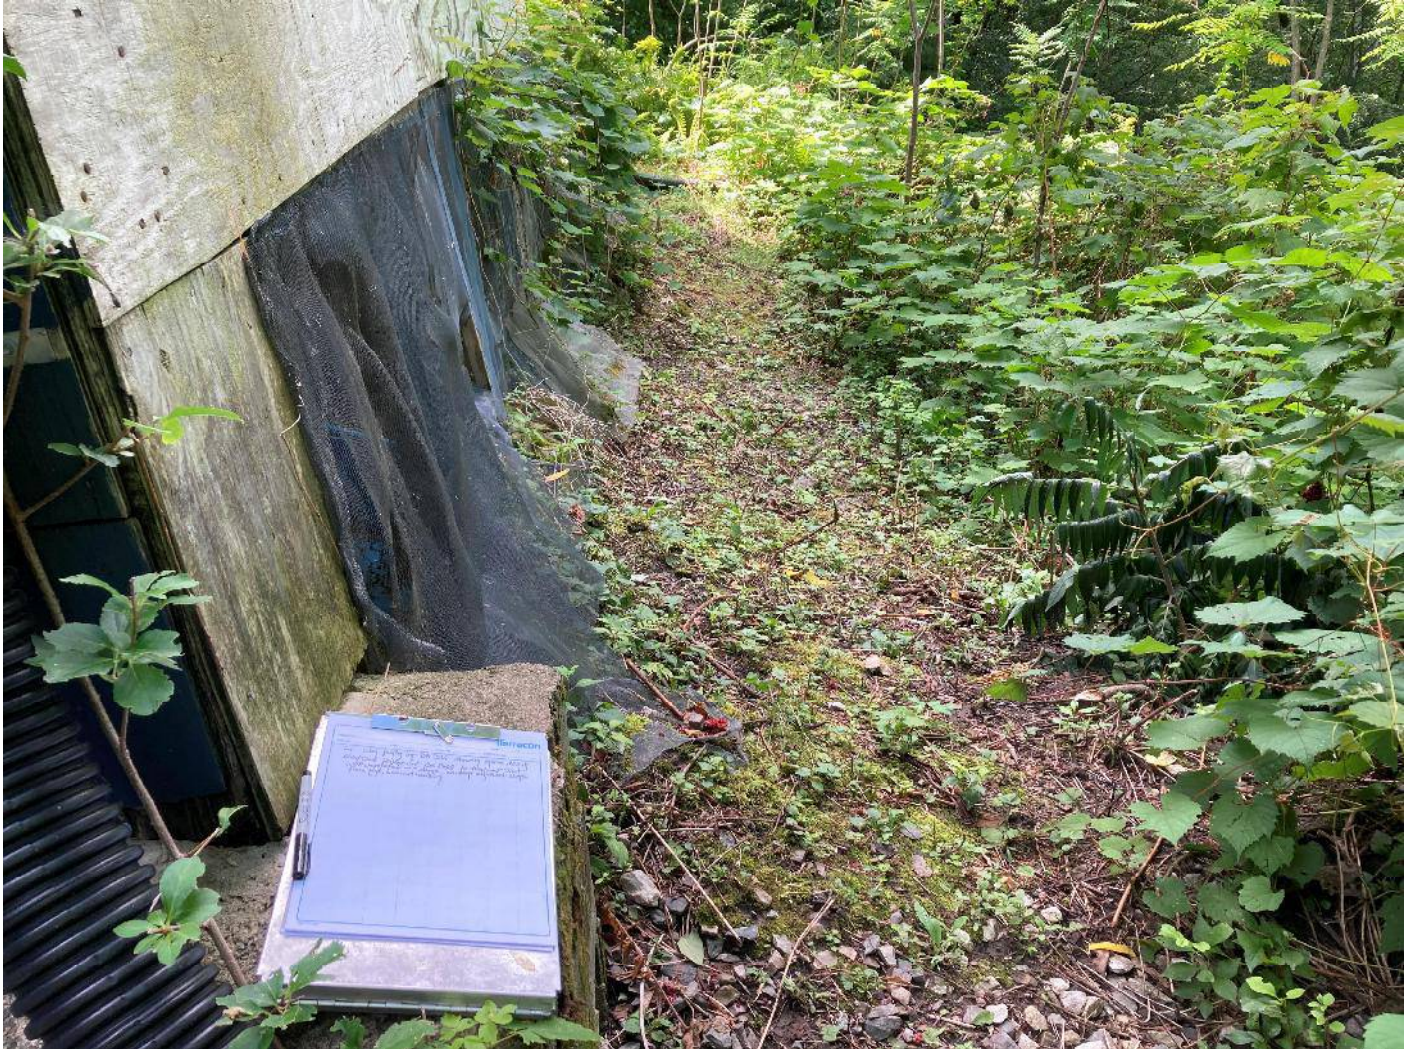
**Photograph 6:** View to west behind Bluebird BBQ building; note curvature at top of slope but no distinct slump or crack formation at surface; soil scarp obscured by vegetation at right of photograph

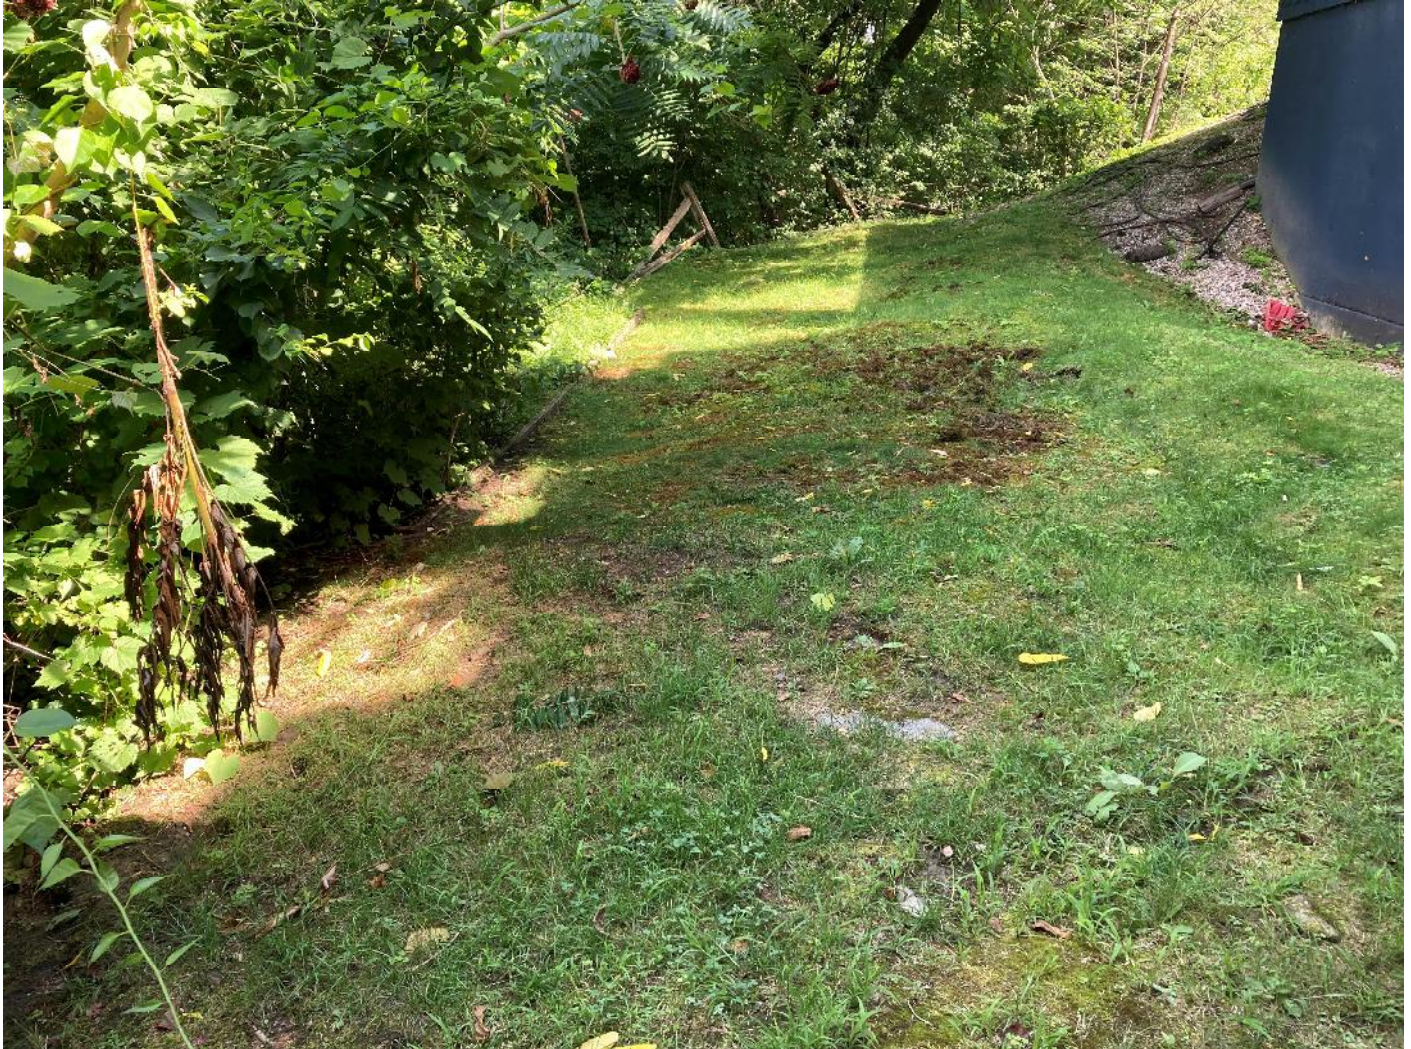
**Photograph 7:** View to east behind Bluebird BBQ building showing well vegetated stable platform with no evidence of surface cracking or slumping; however, note failed fence at top center of photograph

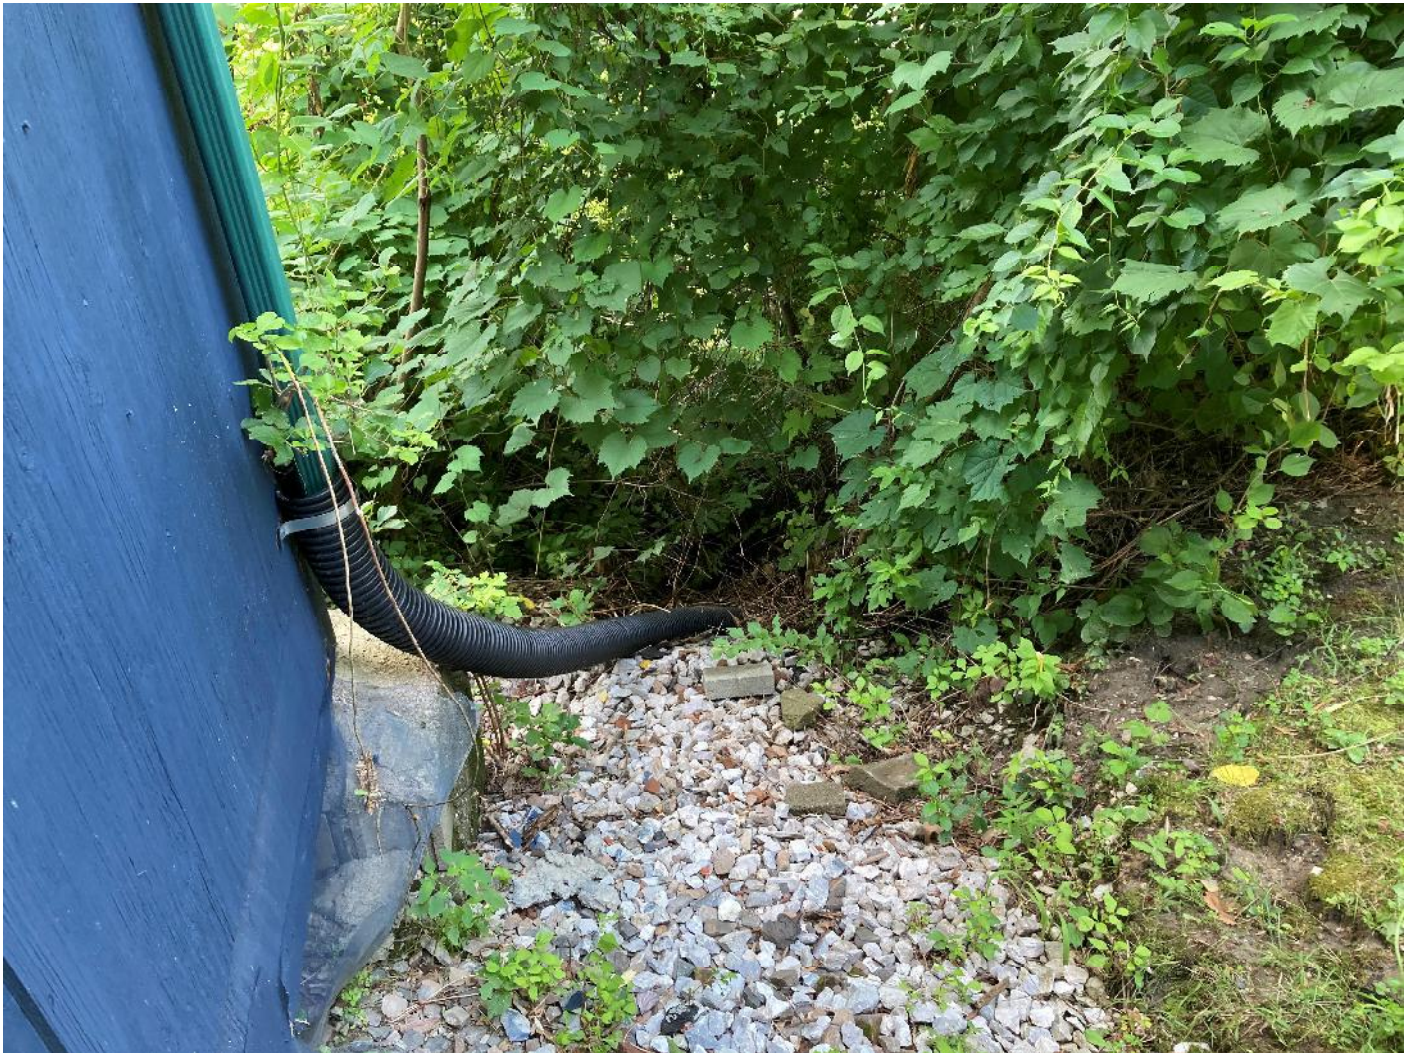
**Photograph 8:** View to north downslope showing stormwater discharge hose from Bluebird BBQ building; discharge of water downslope has caused surface soil erosion (see Photo 14)

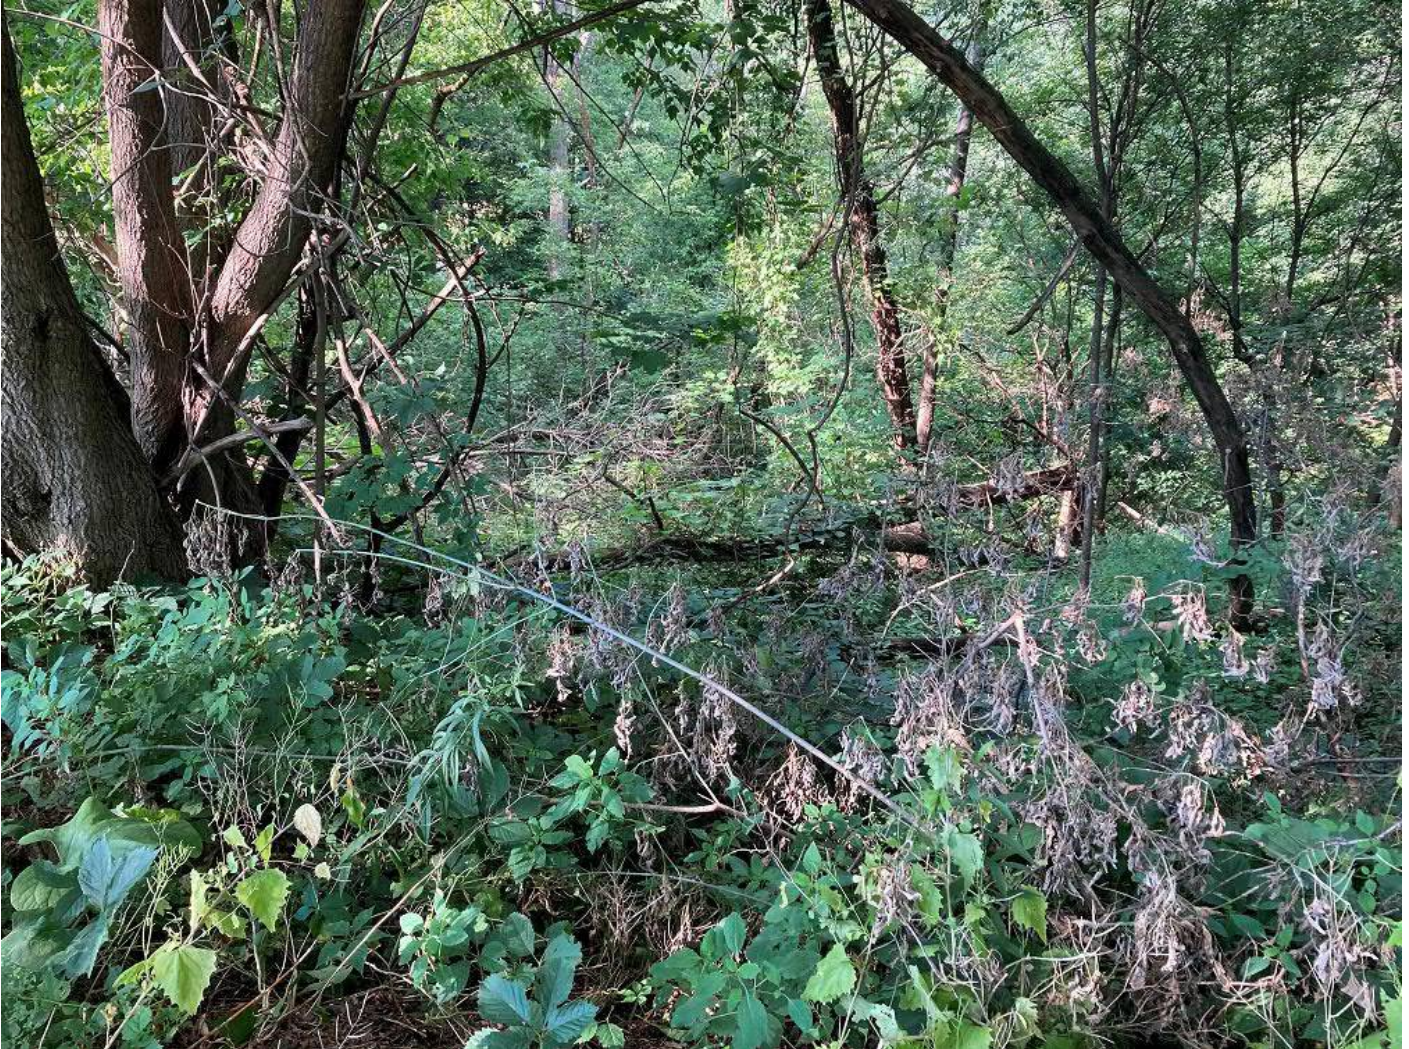
**Photograph 24:** View to north from top of slope at Michael's Auto Sales giving an indication of the density of summer vegetation in this area
