# BURLINGTON WATER RESOURCES

## WATER SERVICE LINE INVENTORY PROJECT

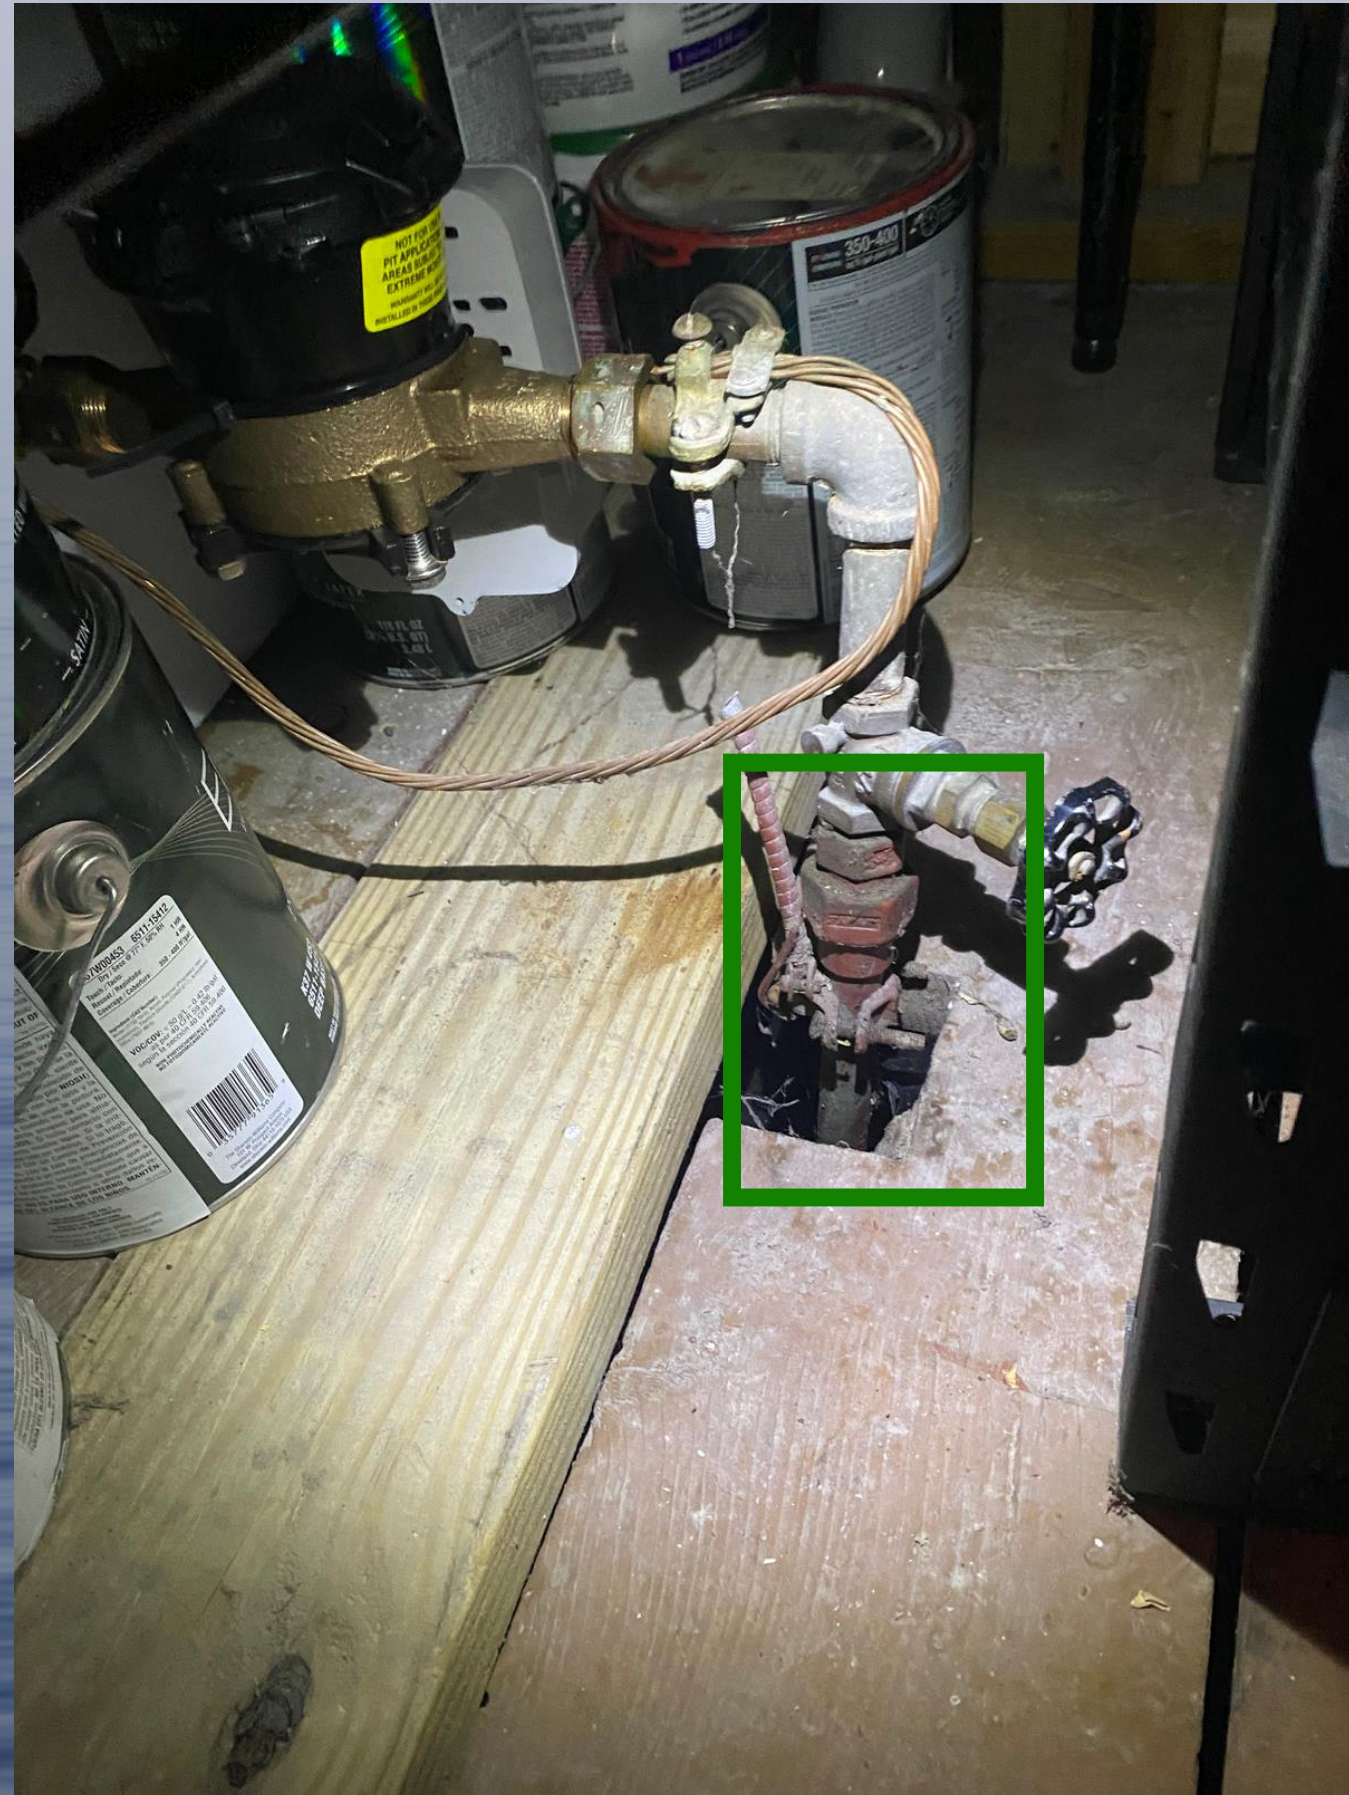
- Well lit
- Clearly shows service entering from floor from side angle
- Water meter visible
- Photo framed closely around the service and meter

This is an ideal survey photo submission
