## Burlington Design Advisory Board

# Design Advisory Board

**Tuesday, August 13, 2024, 3:00 PM**

**Proposed construction of addition to Feeding Champlain Valley facility. (Project Manager, Mary O'Neil)**

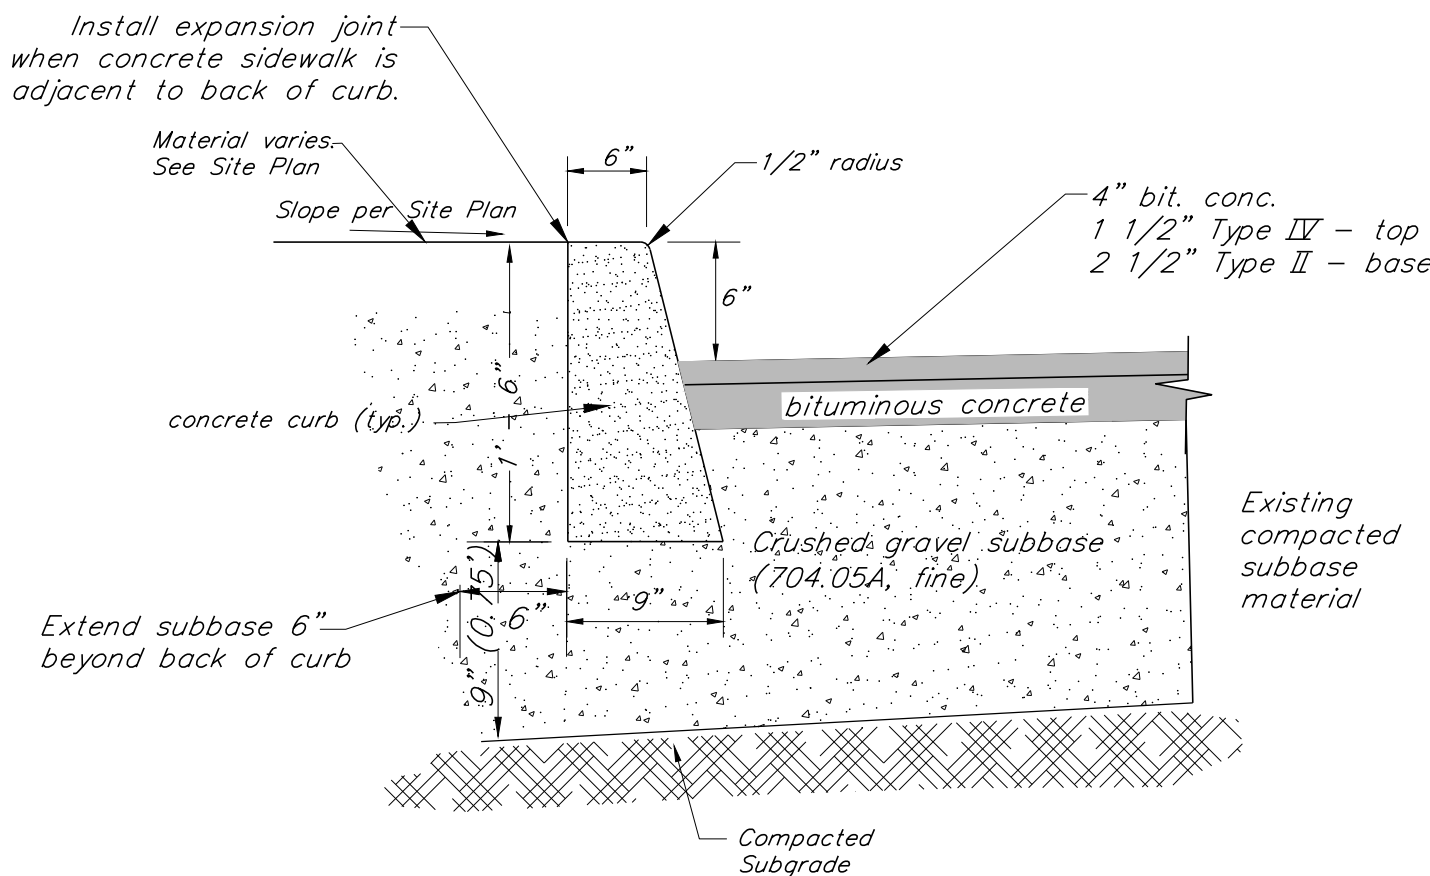
Typical New Concrete Curb Detail  
N.T.S.

- Broom finish concrete
- All joints to be tool finished
- Expansion/contraction joints every 20' with 1/2" joint filler. Joint filler shall be resilient non-extruding cellular fiber joint, uniformly saturated with asphalt, offering a minimum of 70% recovery after compression.
- Score 1/3 total depth at 10' intervals
- Apply 2 coats of Harris Emulsion Kurseal 309 cure/seal compound to all concrete surfaces per the manufacturer's specifications.
- Concrete may not be poured if frost is present or thawing in the subgrade, if the temperature is 40° F or less, or during unseasonable weather conditions.
- Concrete curb radii less than 200 ft shall be formed with flexible forms

All concrete used in the construction of concrete curb shall be air entrained (5% ±1%) and made with Portland cement. The concrete shall meet section 541 of the State of Vermont Standard Specification for Class A concrete and have min. 28 day compressive strength of 4,000 psi.

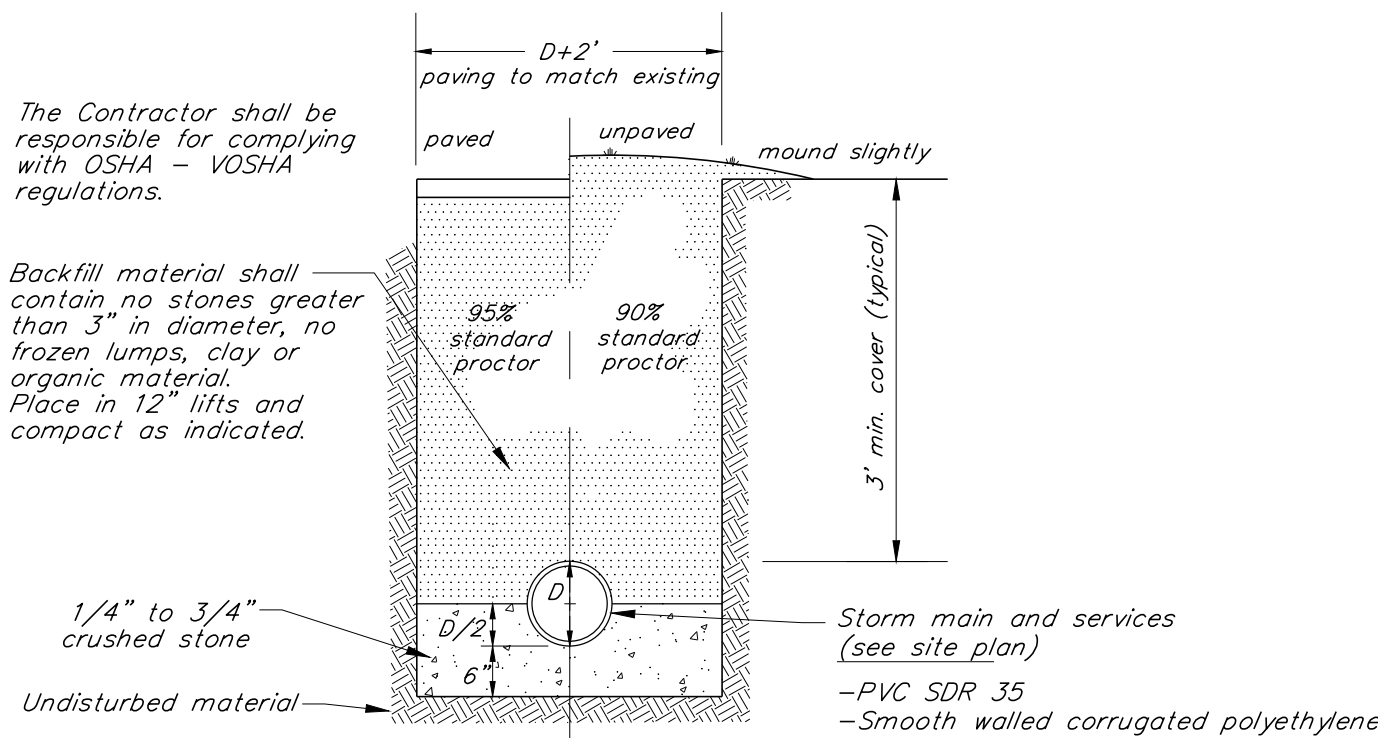
Typical Storm Trench Detail

Backfill material under roads or paved areas must pass subgrade proof roll. Any trench area that does not successfully proof roll shall, at the Contractor's expense, have sufficient material removed and replaced with acceptable embankment material and compacted to provide acceptable proof roll conditions.

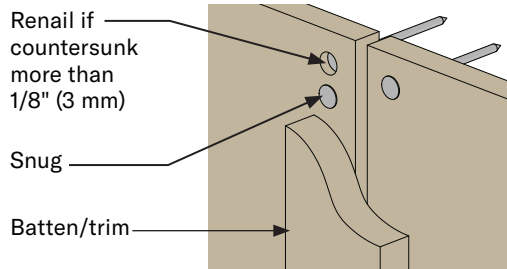
**Figure 5a**  
**BLIND NAILED CONDITION**

- Do not overdrive nails.
  - Nail head should seat snug to face of siding, but not flush to distort the siding surface.
    - Countersunk is considered overdriven.
  - Blind nails:** re-nailing will be required when nailhead is countersunk more than 1/8 inch (3 mm). (Figure 5a)
  - Face nails:** will occur immediately below window sills, soffit, frieze boards, and horizontal trim.
    - Renail and caulk if overdriven more than 1/8 inch (3 mm). (Figure 5b)
- Painting all exposed nail heads is recommended.

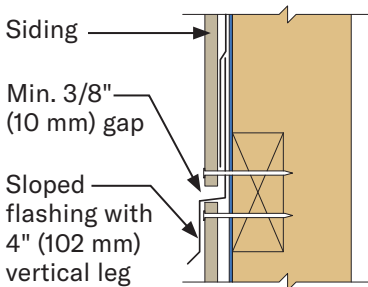
**Figure 5c**

**Flashing Detail at Horizontal Panel Seam**

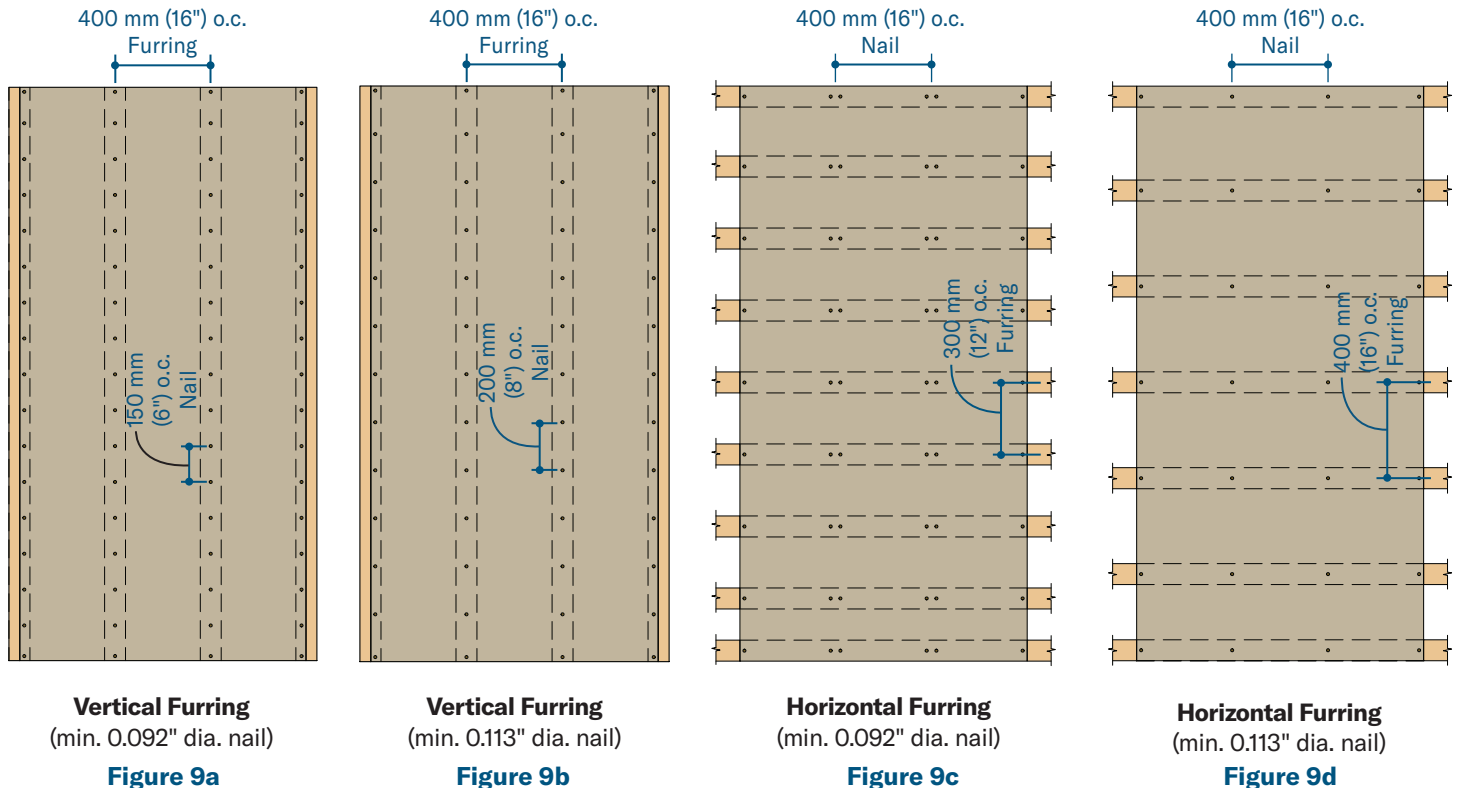
**FASTENING TO VERICAL FURRING**

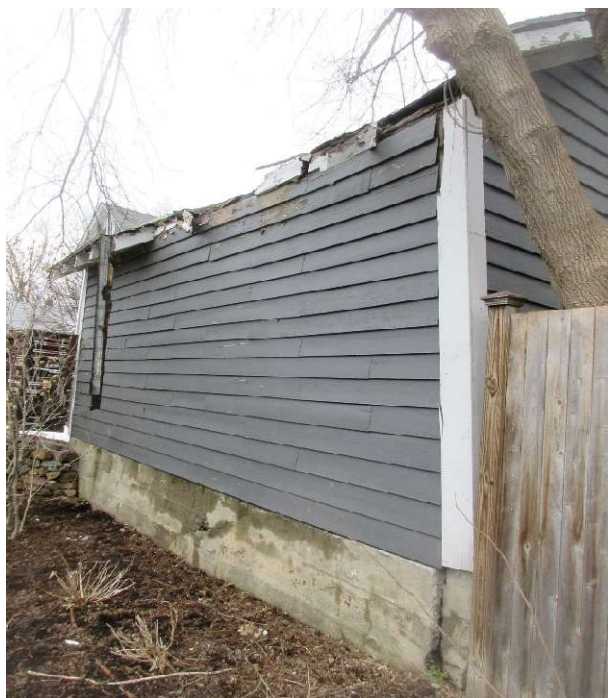
*PHOTO 3: Cracks & displacement in west foundation wall*

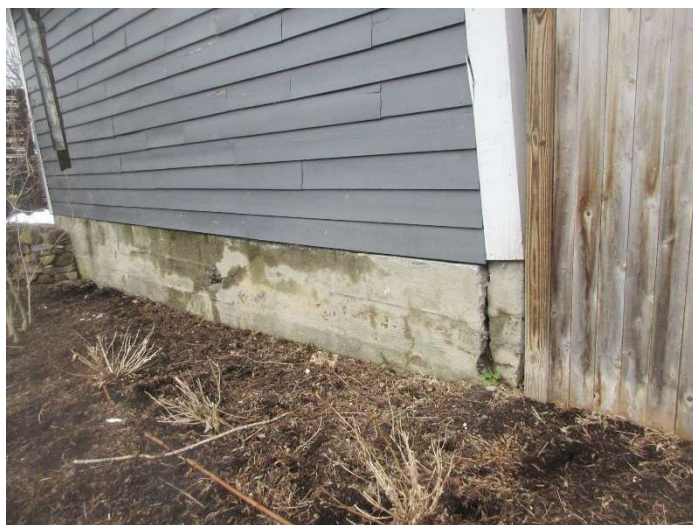
*PHOTO 4: Displacement in west foundation wall*

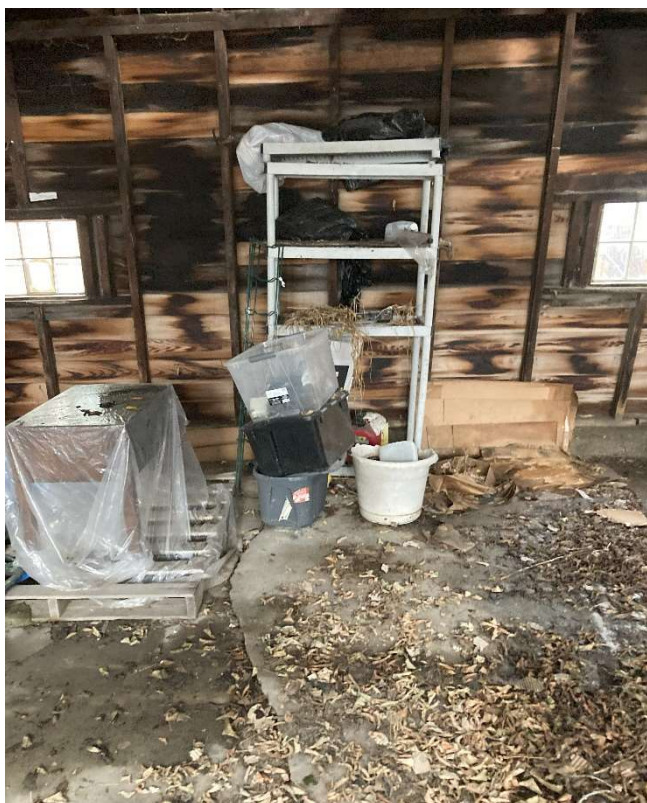
PHOTO 5: Cracking and displacement/settlement of garage slab

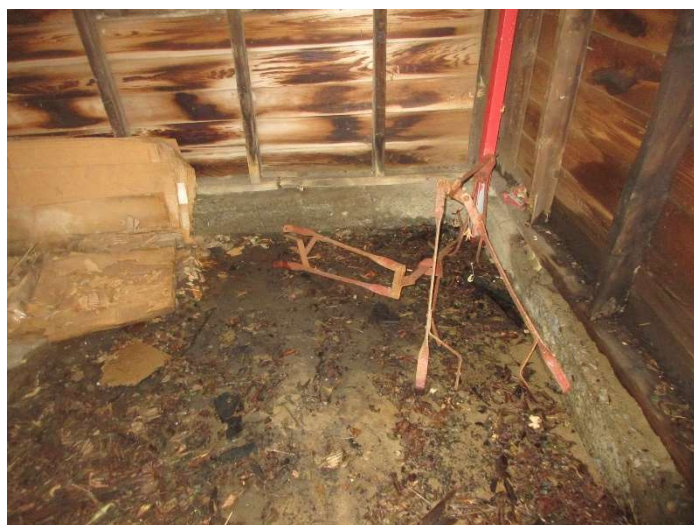
PHOTO 6: Slab settlement in south-west corner

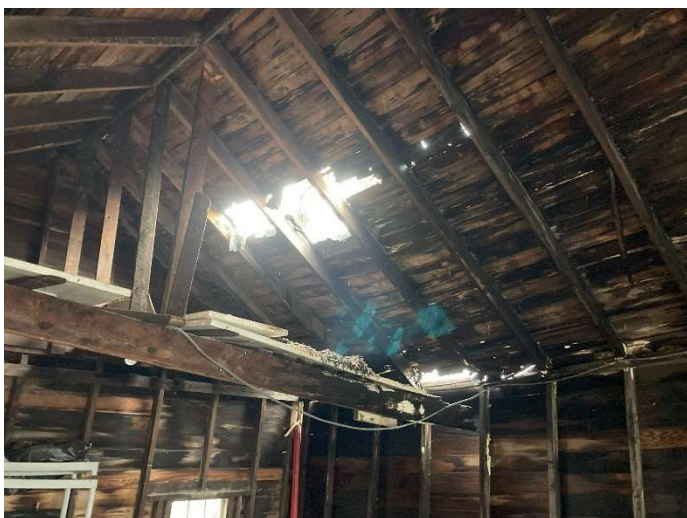
PHOTO 7: Failed section of roof at west side

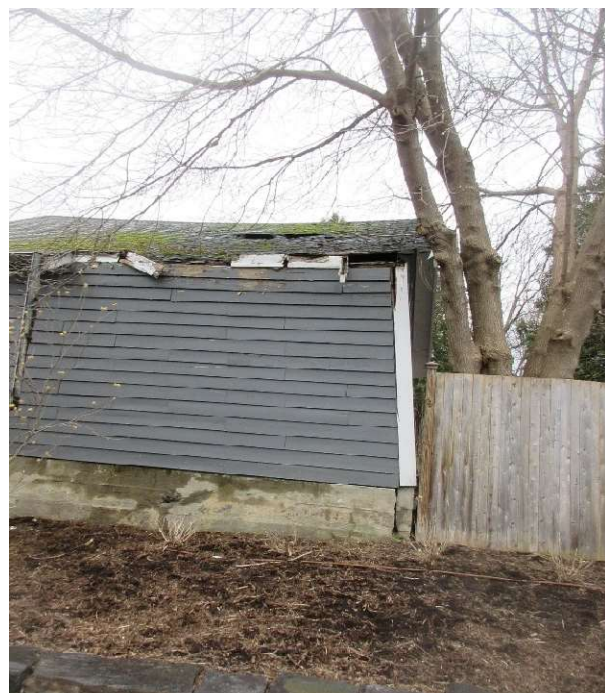
PHOTO 8: Warping of building due to tree growth
