City Council - Tax Abatement Committee

Tax Abatement Committee
Tuesday, January, 7, 2024, 4:30 p.m.
Sharon Bushor Conference Rm

At your request, Keystone Experts and Engineers, LLC (Keystone) inspected the above-referenced property to determine the extent of reported fire damage, and to provide conceptual repair recommendations. The inspection took place on October 15, 2024. The persons present during Keystone's on-site investigation included Scott Silverstein, P.E. (Forensic Engineer, Keystone), Kevin Clark (Senior Building Consultant, Keystone), and Filipp Lagun (property owner's son). This report contains the findings and conclusions reached as a result of that on-site investigation.

ORIGIN & CAUSE REPORT

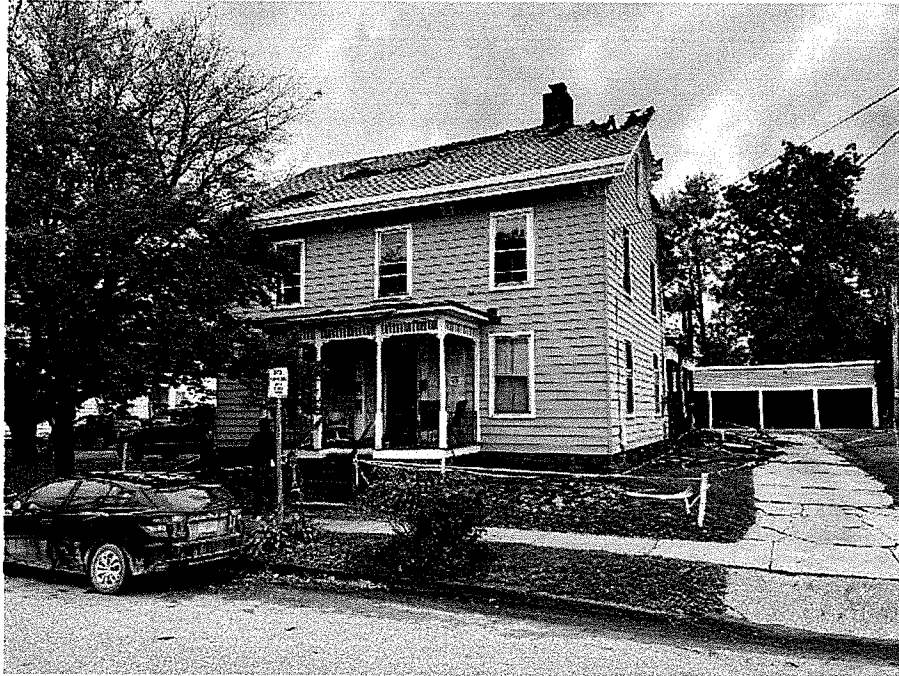
PHOTO 1

- Front (south) elevation.

- The structure was a two-story, wood-frame, multi-family dwelling over a basement covered with slate and asphalt shingles over 8:12 slopes, clad with aluminum siding, and supported by a stone and brick foundation system. **(Photos 1 through 4)**
- The building was surrounded by grass lawns and paved and unpaved access roads. There was a tree near the left front corner of the building. There was a separate parking/residential building at the rear of the property. **(Figure 1, Photos 1 through 4)**

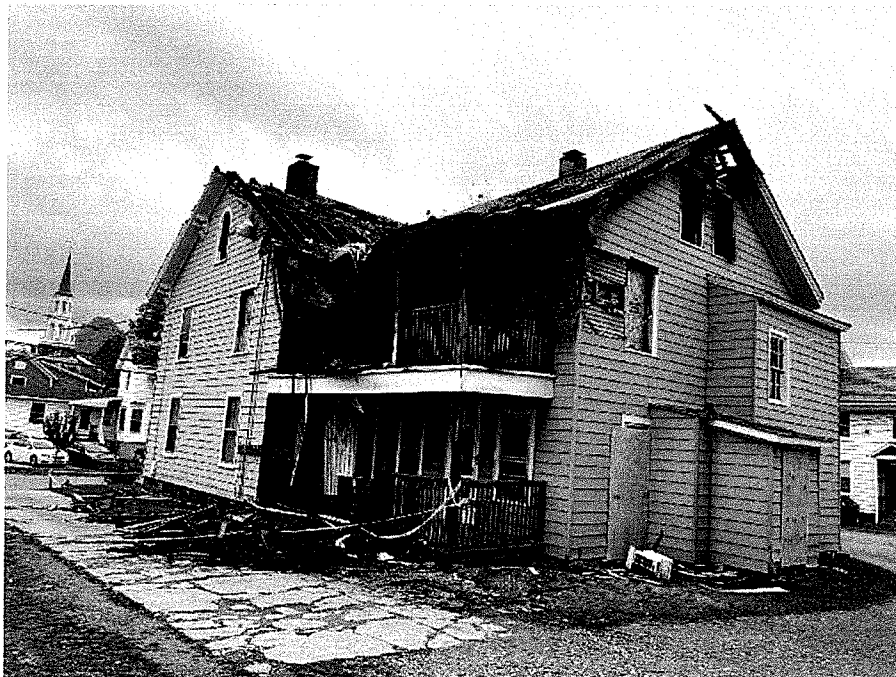
PHOTO 2

- Right (east) elevation.

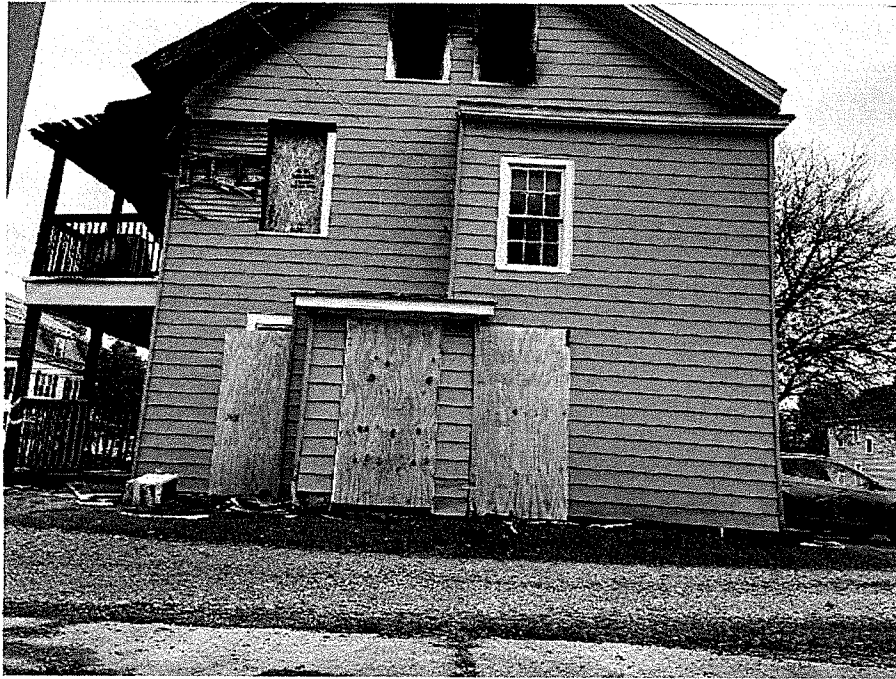
PHOTO 3

- Rear (north) elevation.

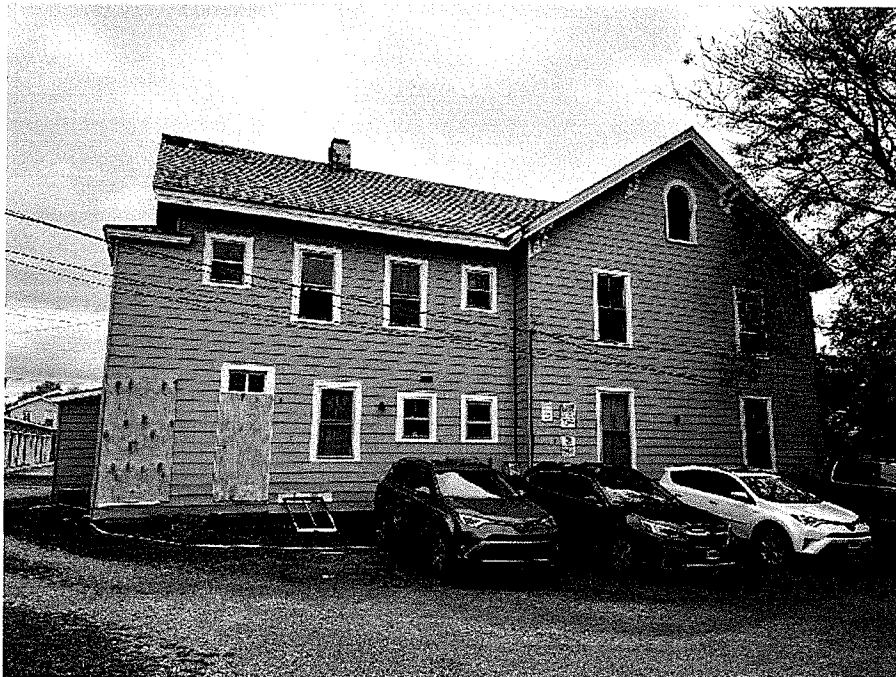
PHOTO 4

- Left (west) elevation.

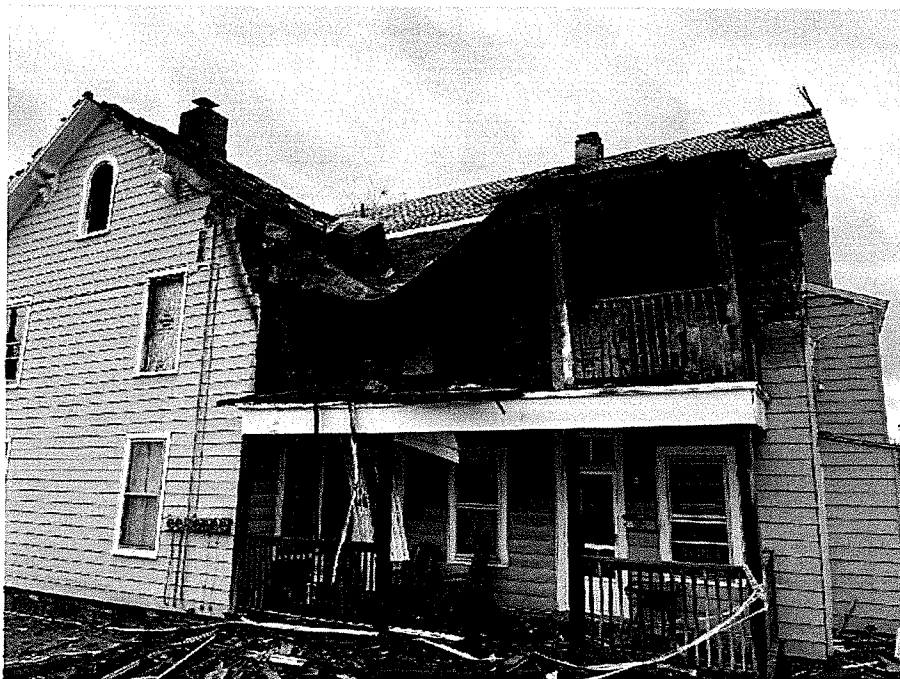
PHOTO 5

- The entire exterior wall cladding and roof, including several rafters, of the second-level northeast deck/porch had burned. The south end of the roof had collapsed. **(Photos 5, 6)**

- Right side rear porch/deck collapse looking west.
- Note severe blackening of exterior walls around the second floor deck and complete loss of several rafters above the deck.

- Replace the entire roof (approximately 66 2x12 rafters 24 feet long plus 80 feet of 2x12 ridge board and 33-2x6 collar ties 6 feet long, assuming new rafters are 24 inches on center).
- Replace attic joists above Unit 4 (approximately 8 2x6 joists, 16 feet long assuming new joists are 12 inches on center).
- Replace exterior studs on the east side of Unit 4 (approximately 12 2x6 studs 9 feet tall assuming new studs are 24 inches on center).
- Replace interior studs between bedroom and living room of Unit 4 (approximately 6 2x4 studs 9 feet tall assuming new studs are 16 inches on center).
- Replace the entire east-side deck and columns down to the porch (8x25 feet, including rafters, rafter support beams, and columns, deck joists, deck support beams, and columns, and ledgers).

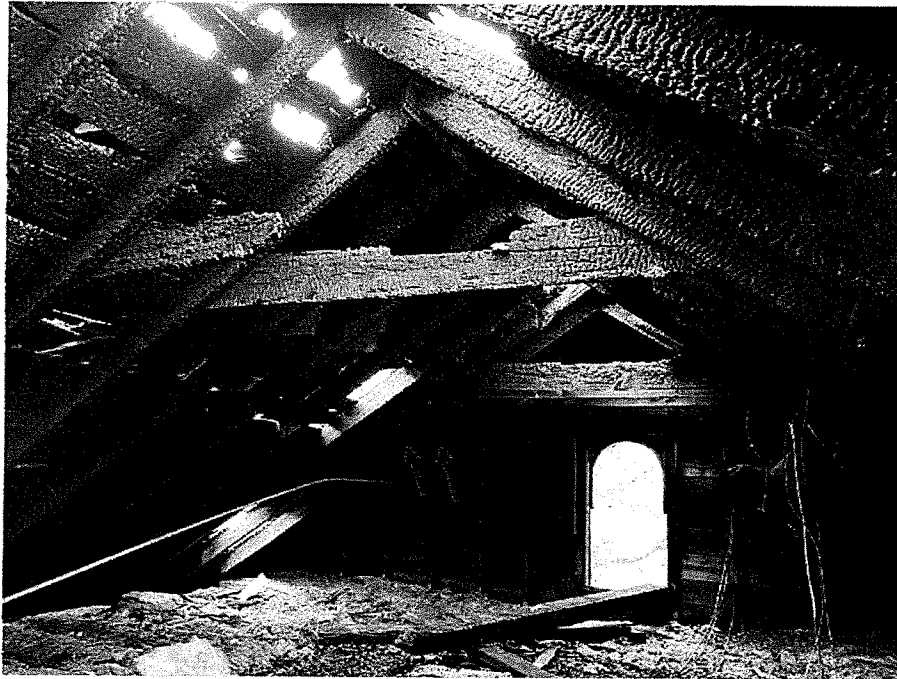
PHOTO 7

- Front part of attic looking west.
- All rafters were charred with moderate to significant section loss except two in the far southwest corner (red arrows).

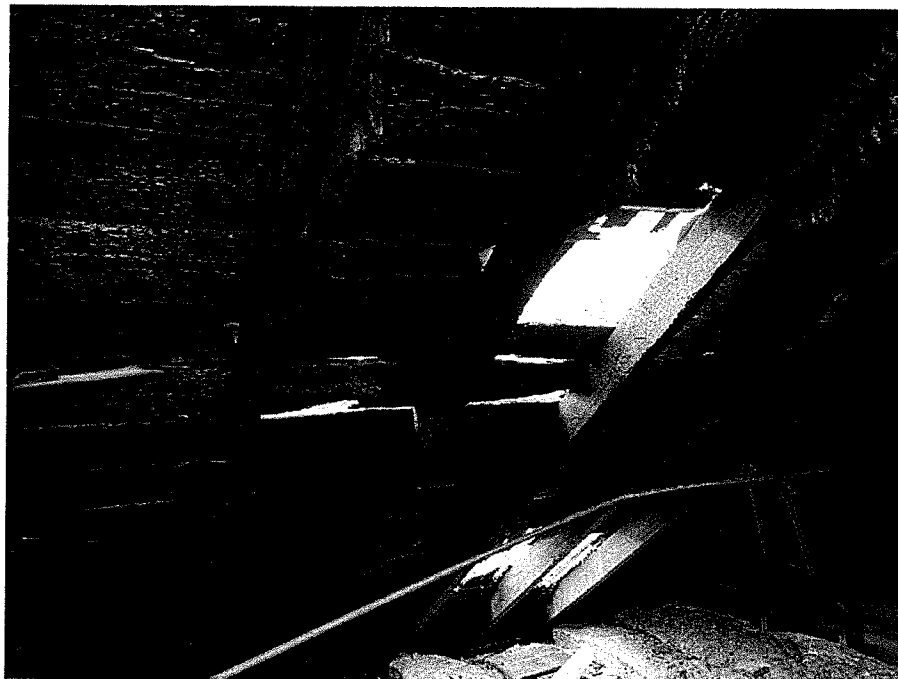
PHOTO 8

- Close-up of attic southwest corner showing two intact (but blackened) rafters - others exhibit char and moderate section loss.

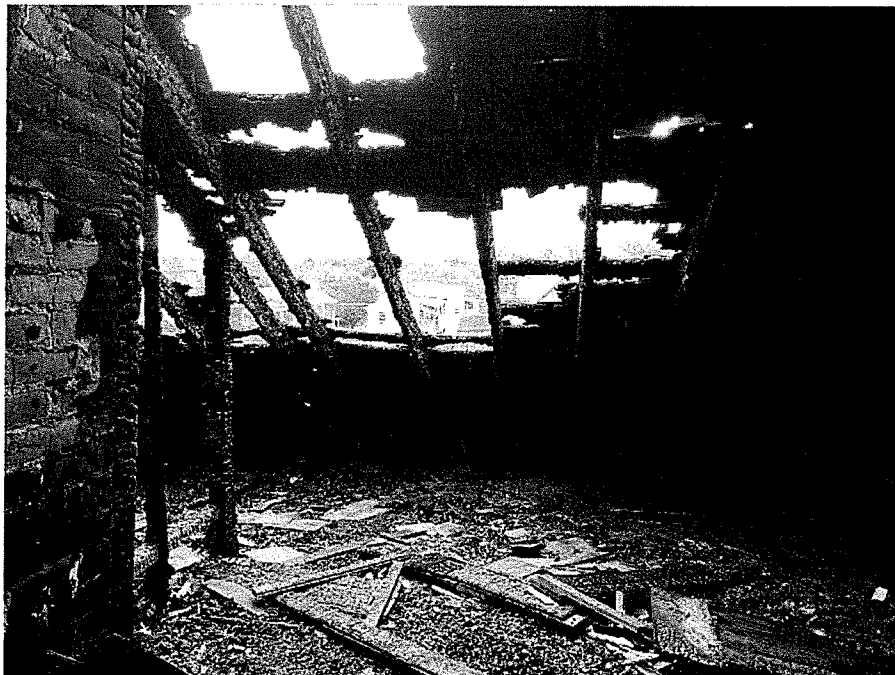
PHOTO 12

- North (rear) part of the attic looking east.
- All rafters were charred with significant section loss.

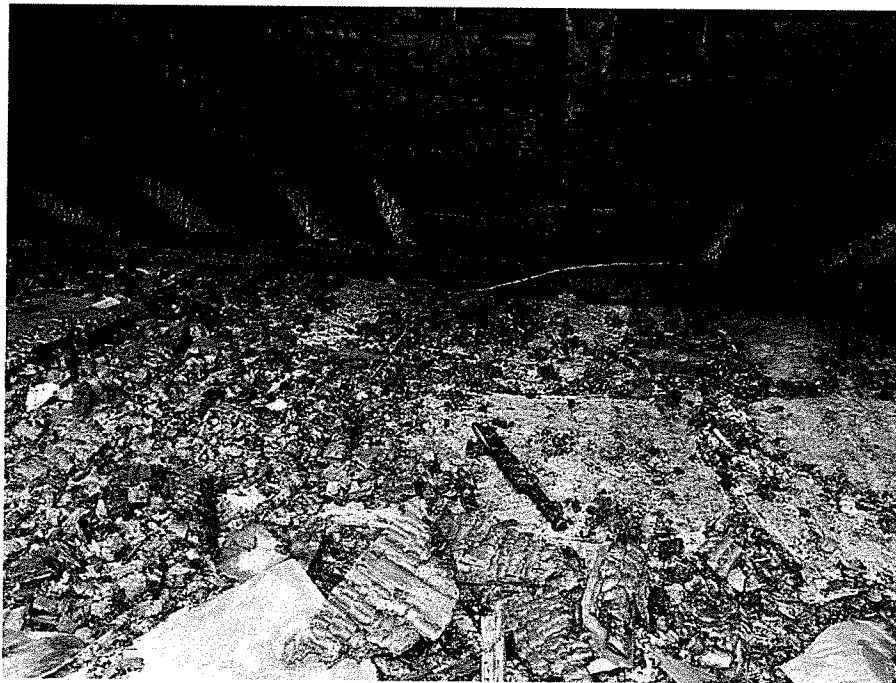
PHOTO 14

- North (rear) part of the attic looking west.
- All rafters were charred with moderate to significant section loss.
- Burned fiberglass insulation on floor.

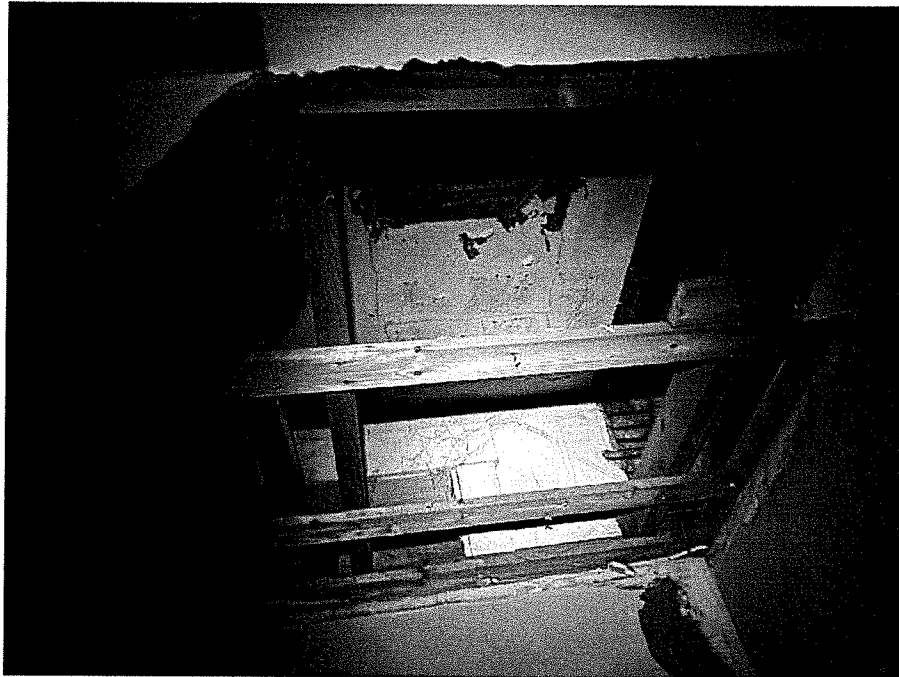
PHOTO 21

- The entire foundation wall **(Photos 30-31)**
- Nonstructural damage included the following.
 - Char/section loss of plaster lath and strapping **(Photos 21, 24)**

- Second level, Unit 4 bathroom on west side of building looking south/up.
- Collapsed drop ceiling; no blackening evident in exposed wood.

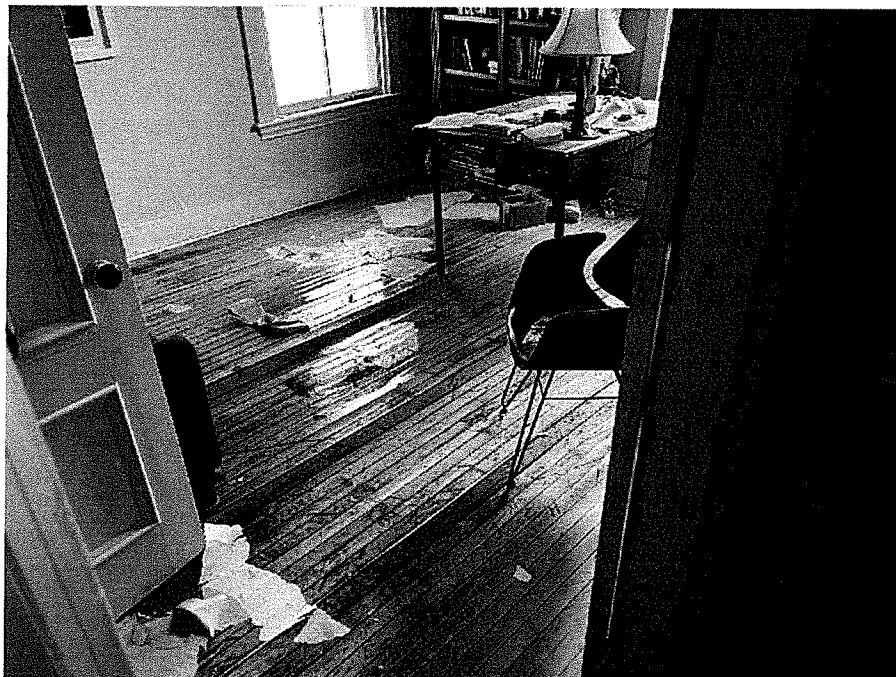
PHOTO 22

- Second level, Unit 3 on west side of building.
- Puddles and buckling of finish floor.

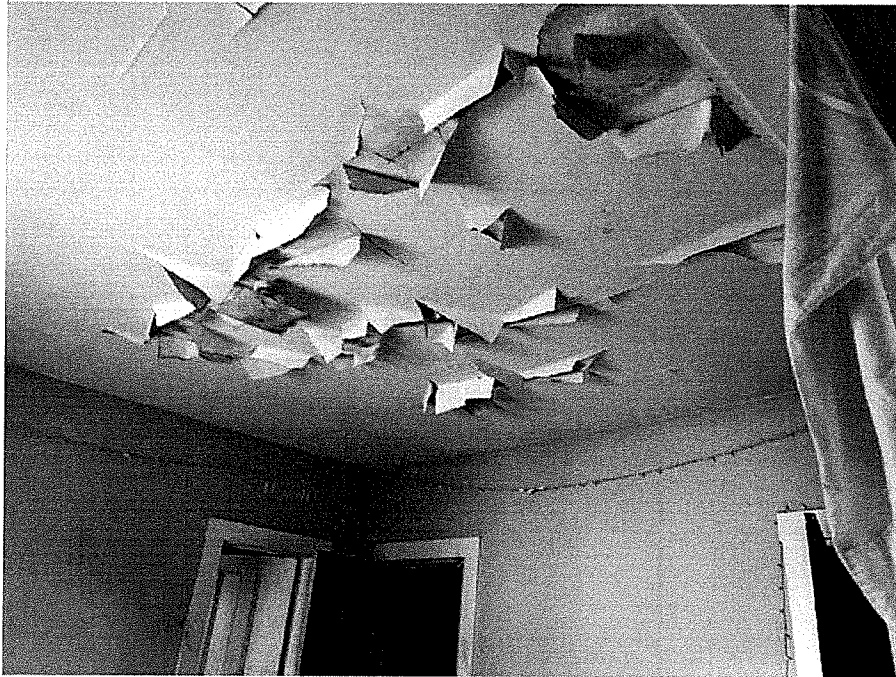
PHOTO 23

- Second level, Unit 3 on west side of building.
- Peeling of finish ceiling.

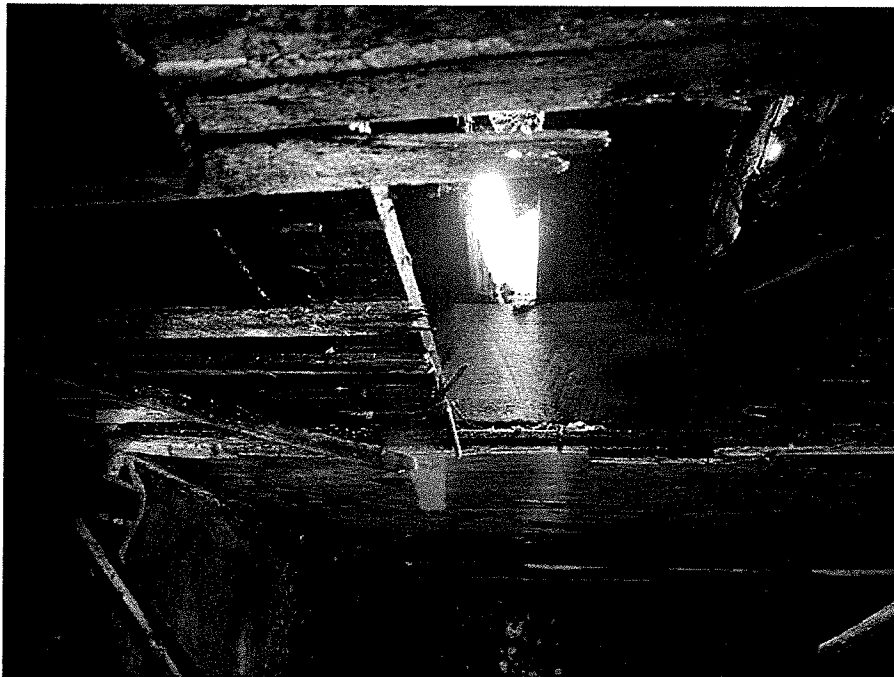
PHOTO 26

- Second level, Unit 2 looking east/up at ceiling adjacent to the wall facing deck.
- Daylight visible through damaged attic flooring.
- Ceiling joists appeared intact.
