**Monday, April 14, 2025, 7:30 PM,
Full Board of Abatement of Taxes
Contois Auditorium, 149 Church Street, 2nd Floor**

Subject 2.3. Request for Abatement of Taxes: 24 Grant LLC, Filipp Lagun, 24 Grant Street, 044-4-060-000

COMMITTEE'S RECOMMENDATION: Recommendation made in open public hearing. The Tax Abatement Committee recommends unanimously that the abatement request should be granted. Fire destroyed use of one of two rental buildings on the property. Abatement meets the criteria for abatement under Section 42 of the Charter. The Committee also recommends unanimously that the matter be placed on the consent calendar before the Full Board of Abatement.

ORIGIN & CAUSE REPORT

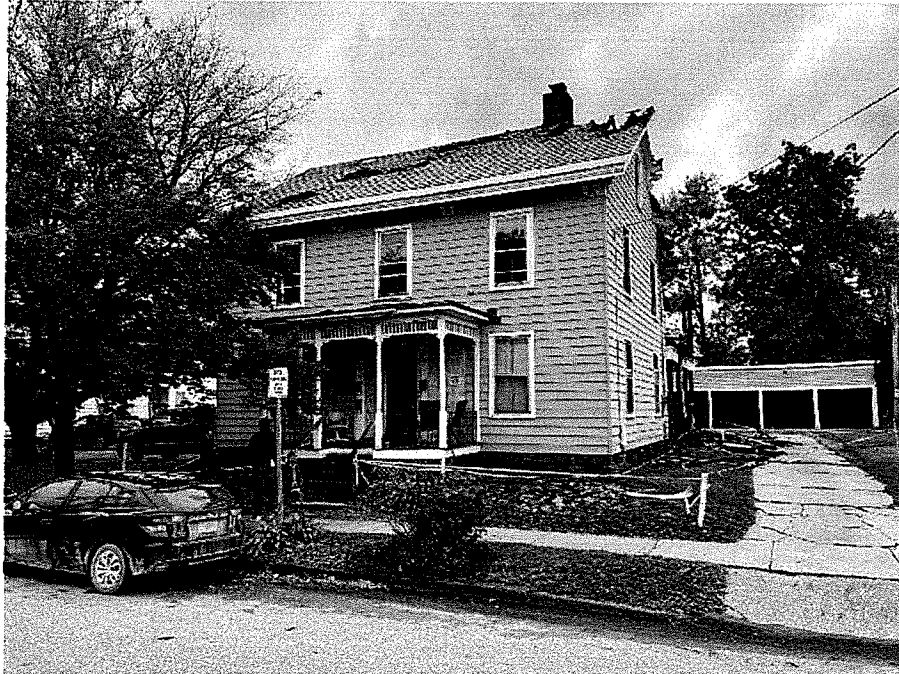
PHOTO 1

- Front (south) elevation.

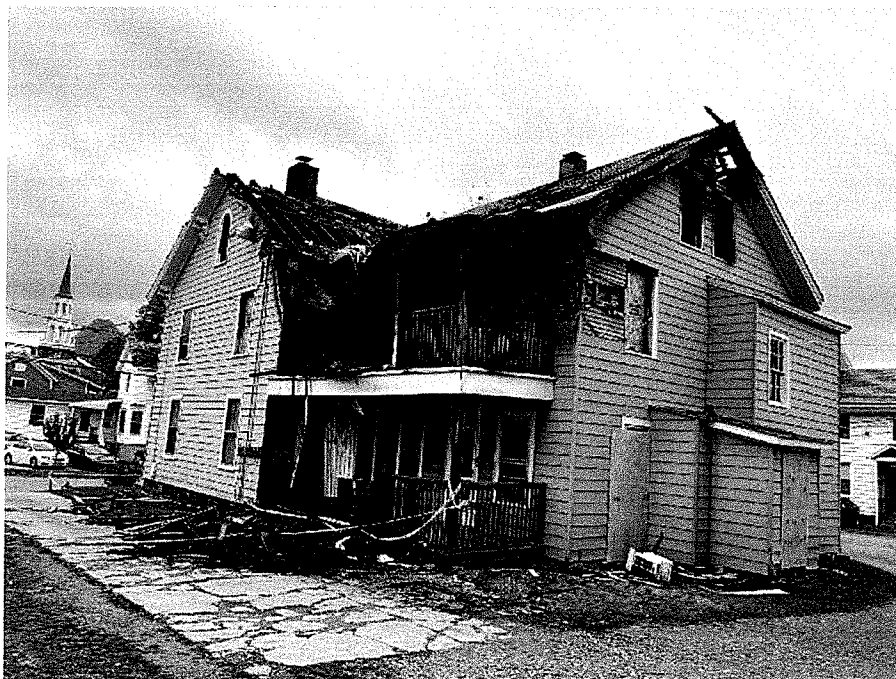
PHOTO 2

- Right (east) elevation.

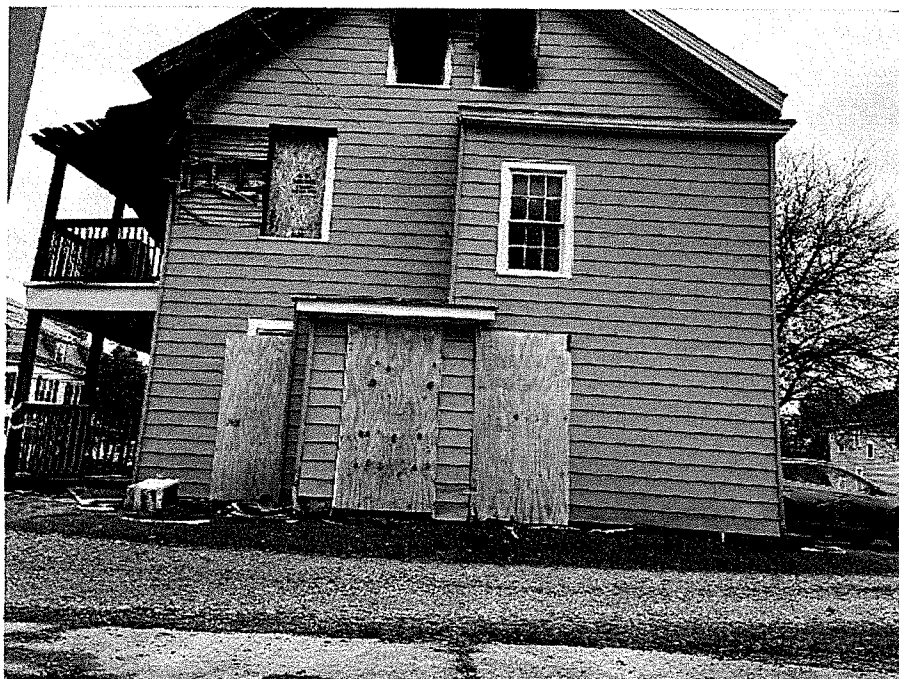
PHOTO 3

- Rear (north) elevation.

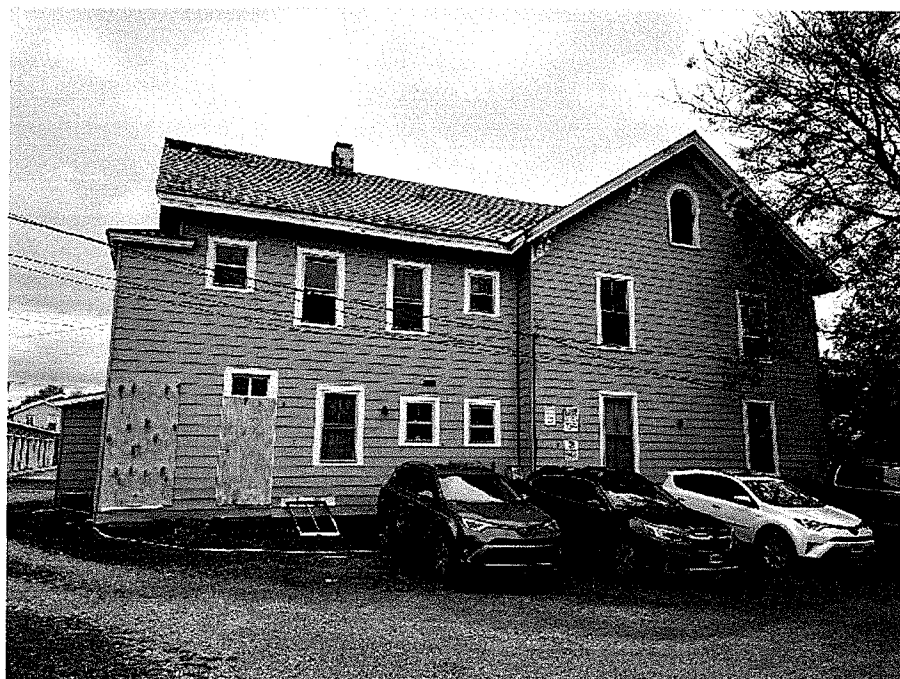
PHOTO 4

- Left (west) elevation.

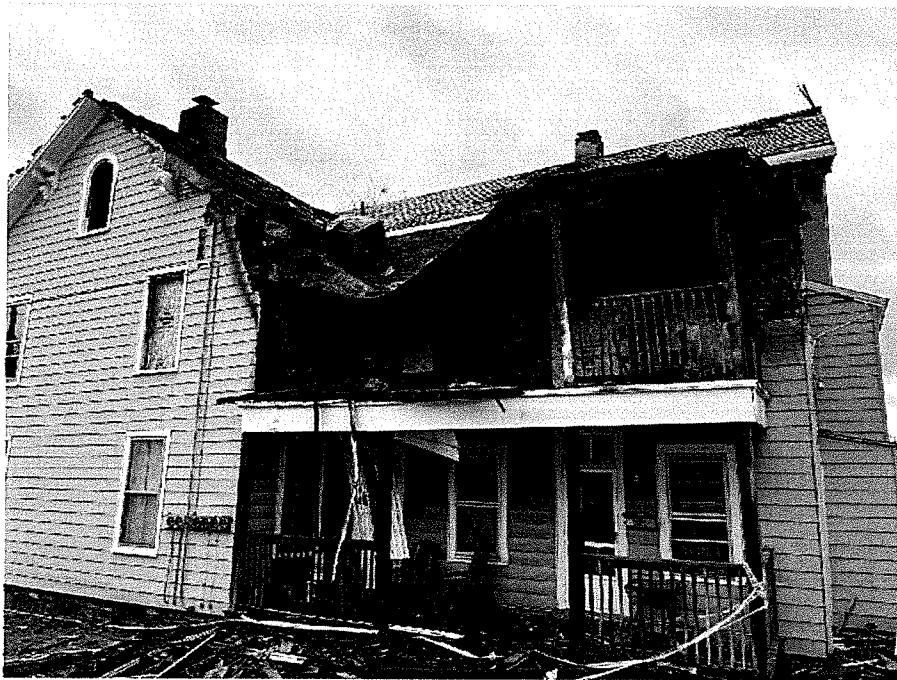
PHOTO 5

- The entire exterior wall cladding and roof, including several rafters, of the second-level northeast deck/porch had burned. The south end of the roof had collapsed. **(Photos 5, 6)**

- Right side rear porch/deck collapse looking west.
- Note severe blackening of exterior walls around the second floor deck and complete loss of several rafters above the deck.

- Replace the entire roof (approximately 66 2x12 rafters 24 feet long plus 80 feet of 2x12 ridge board and 33-2x6 collar ties 6 feet long, assuming new rafters are 24 inches on center).
- Replace attic joists above Unit 4 (approximately 8 2x6 joists, 16 feet long assuming new joists are 12 inches on center).
- Replace exterior studs on the east side of Unit 4 (approximately 12 2x6 studs 9 feet tall assuming new studs are 24 inches on center).
- Replace interior studs between bedroom and living room of Unit 4 (approximately 6 2x4 studs 9 feet tall assuming new studs are 16 inches on center).
- Replace the entire east-side deck and columns down to the porch (8x25 feet, including rafters, rafter support beams, and columns, deck joists, deck support beams, and columns, and ledgers).

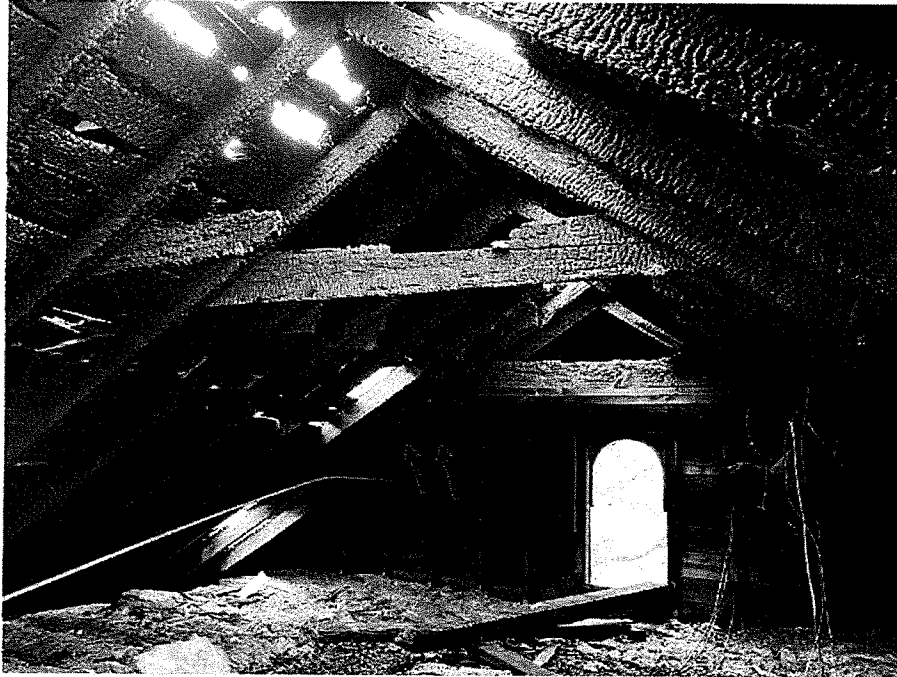
PHOTO 7

Structural elements that must be replaced due to fire damage (charring, section loss, and resulting loss of strength) include the entire roof, the northeast deck/porch, approximately eight attic joists, approximately 12 exterior studs, and approximately 6 interior studs.

- Front part of attic looking west.
- All rafters were charred with moderate to significant section loss except two in the far southwest corner (red arrows).

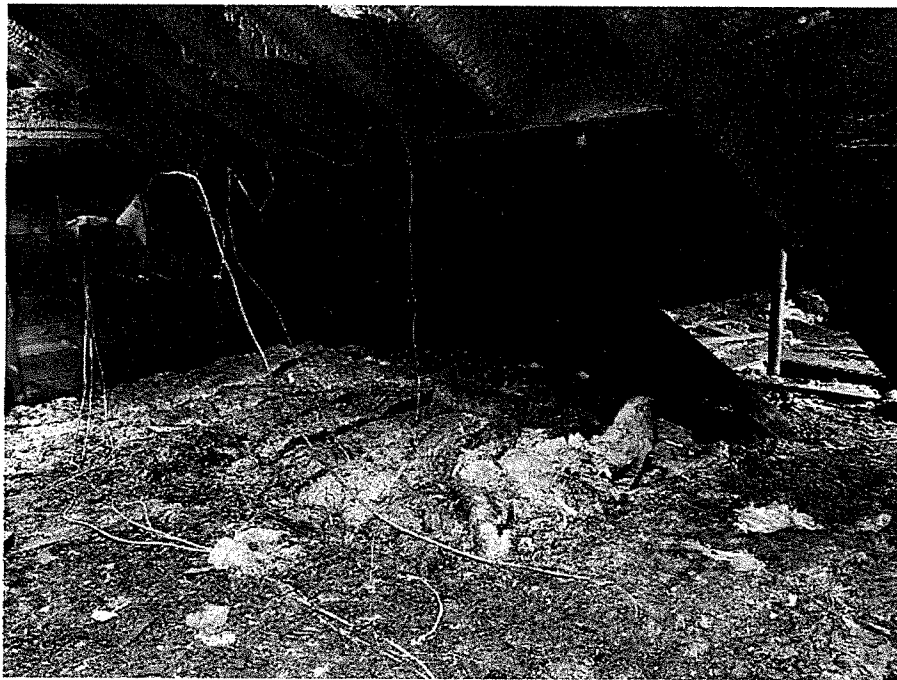
PHOTO 9

- Front part of attic looking northwest - all rafters exhibited char and moderate section loss.
- Burned fiberglass insulation on floor.

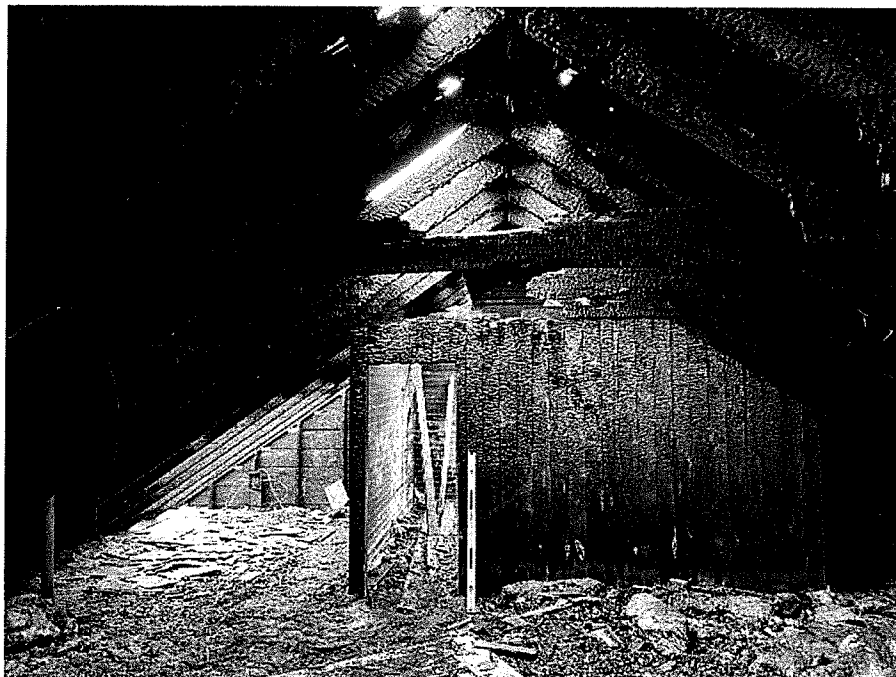
PHOTO 10

- South (front) part of attic looking east.
- All rafters were charred with significant section loss.

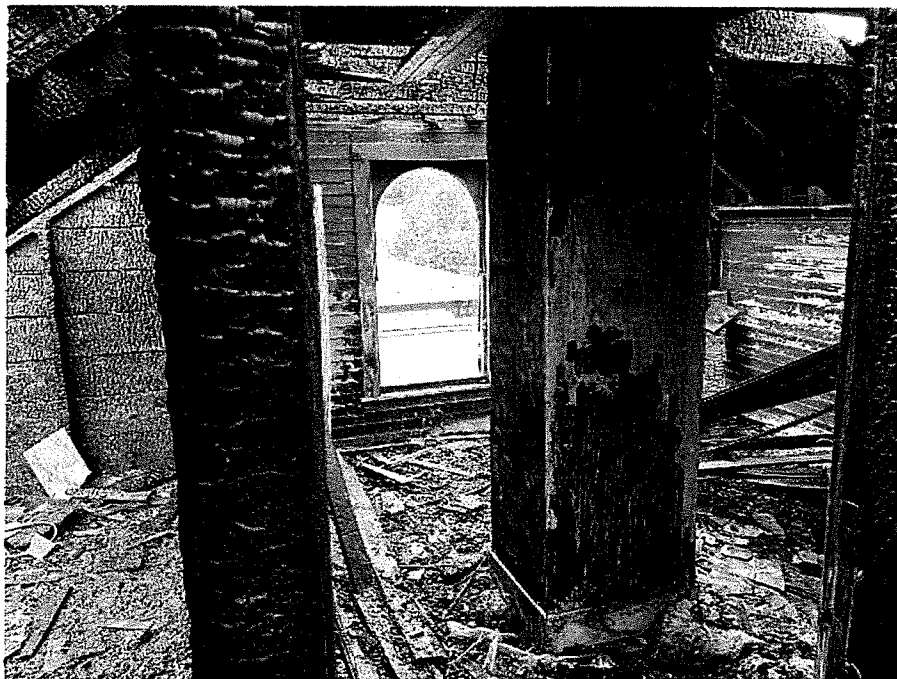
PHOTO 11

The concrete chimney did not display color changes, spalling, or widespread surface cracking, or other evidence of having been subjected to prolonged heat. As such, the concrete chimney may remain in-place.

- South (front) part of attic (behind wall in previous photo) looking east.
- Concrete chimney was intact.
- All rafters (top left and top right) were charred with significant section loss.

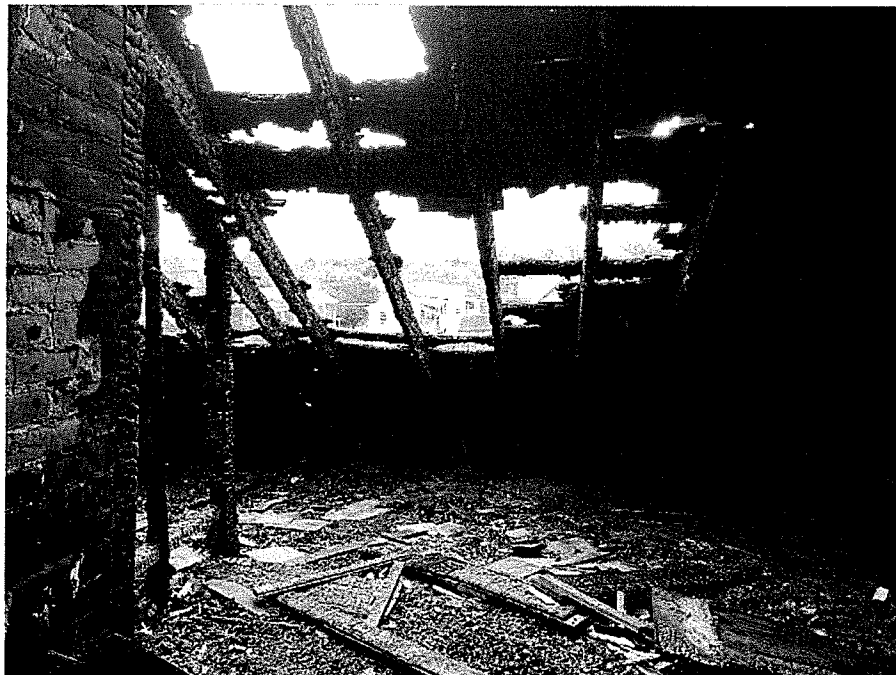
PHOTO 12

- North (rear) part of the attic looking east.
- All rafters were charred with significant section loss.

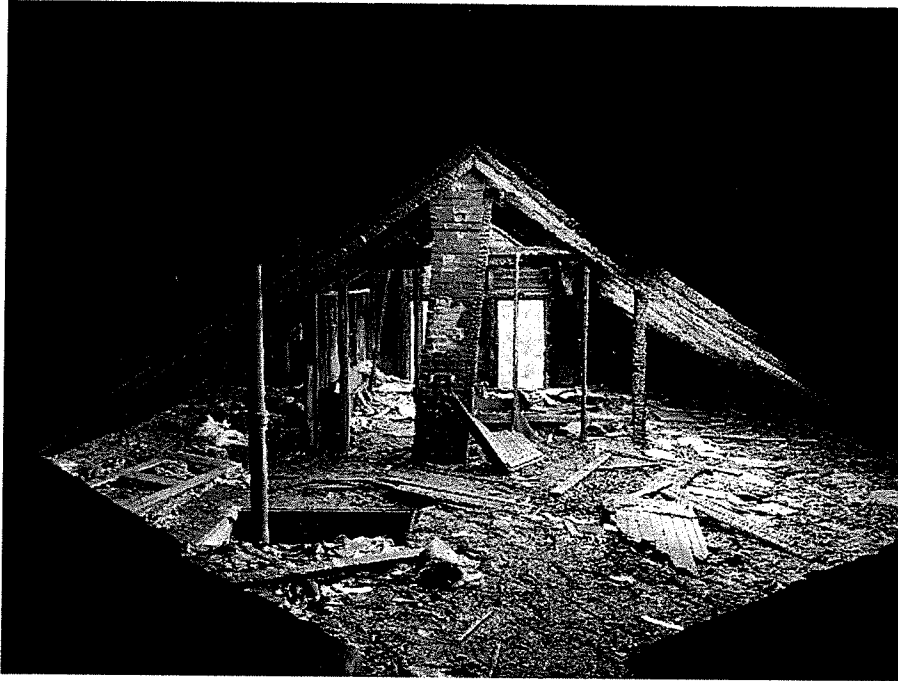
PHOTO 13

The brick chimney did not display cracks or spalls consistent with extended exposure to fire; similarly, the mortar was not soft and did not display widespread cracking and spalling.

- North (rear) part of the attic looking north.
- All rafters were charred with significant section loss.
- Brick chimney was blackened but intact.

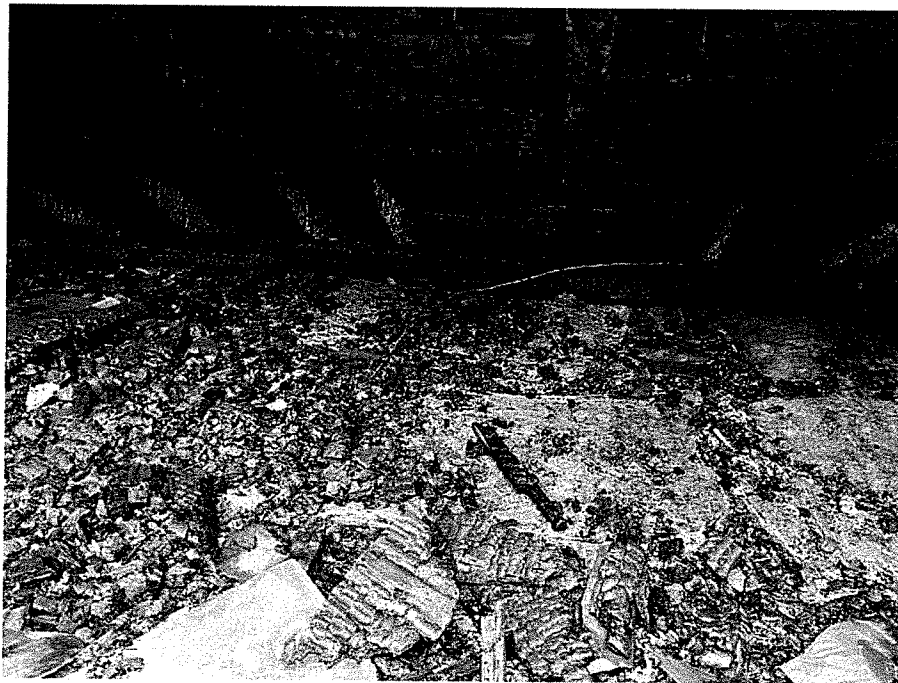
PHOTO 14

- North (rear) part of the attic looking west.
- All rafters were charred with moderate to significant section loss.
- Burned fiberglass insulation on floor.

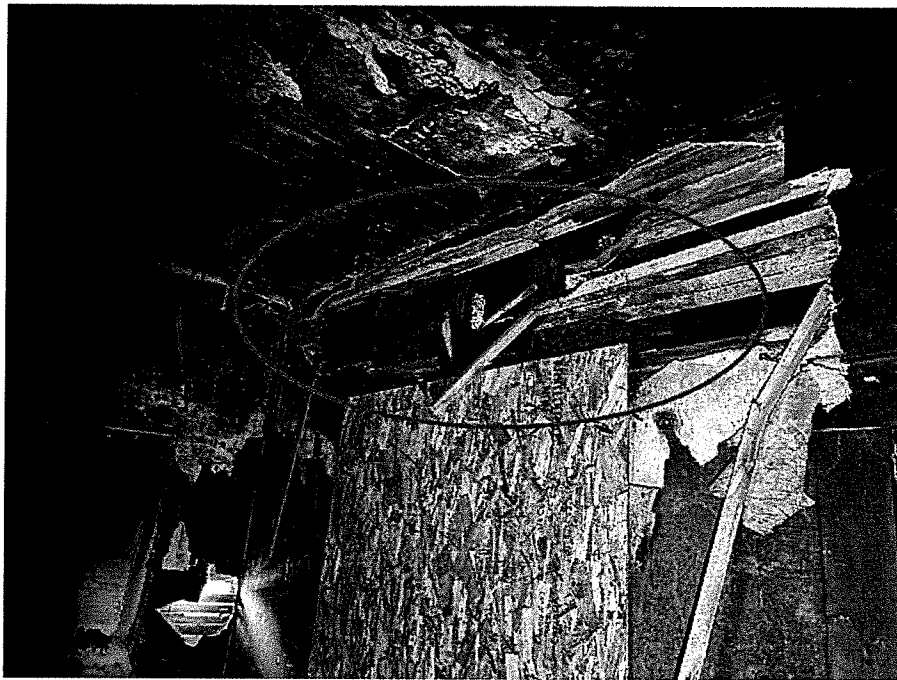
PHOTO 15

- Second level, Unit 4 living room looking northeast.
- Char and moderate section loss in exterior wall studs facing the deck (circled).

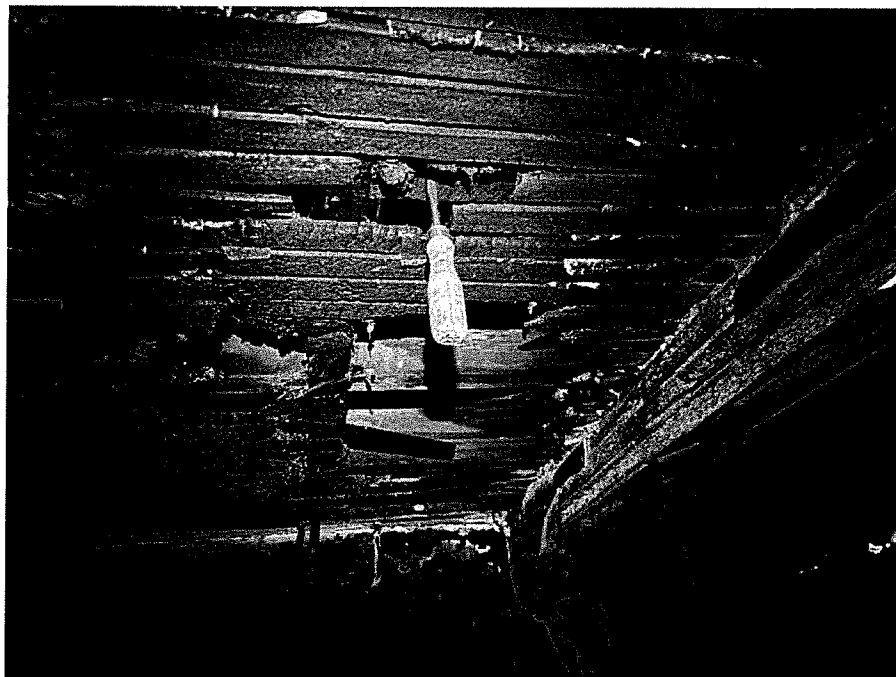
PHOTO 16

- Second level, Unit 4 living room looking north/up.
- Char and moderate section loss in ceiling joists adjacent to east wall; flat-head screwdriver penetrates bottom flange.

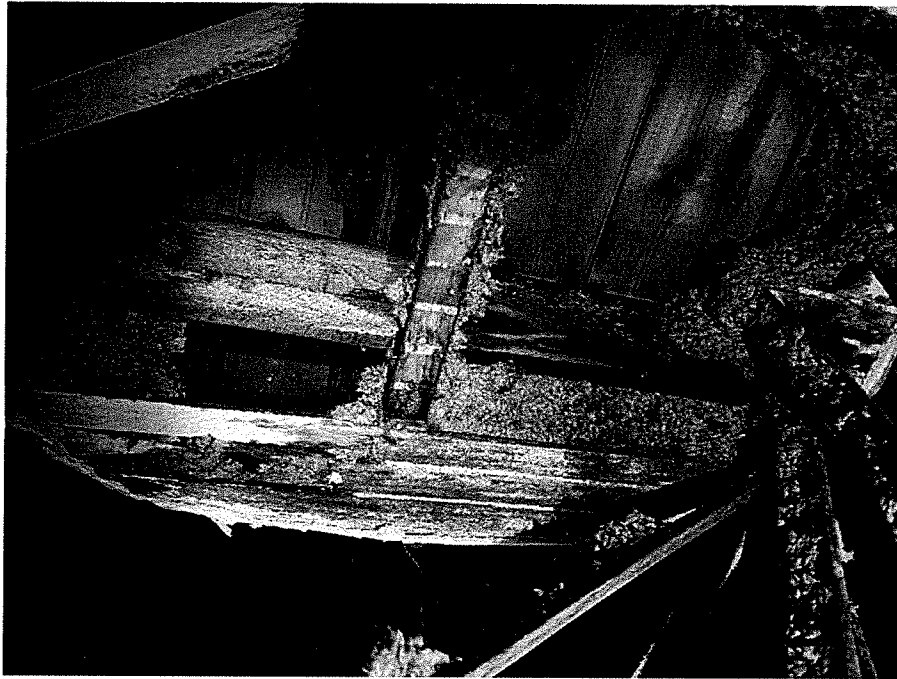
PHOTO 17

- Second level, Unit 4 living room looking up at ceiling about 10 feet west of the east exterior wall.
- Ceiling joists exhibited blackening on left (west), and char and minor section loss on right (east).

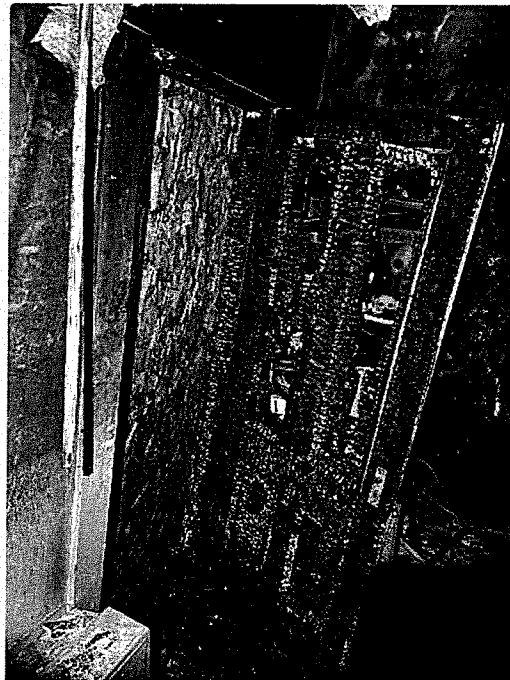
PHOTO 18

- Second level, Unit 4 living room looking southeast at door to deck; bedroom wall is behind (right side of photo).
- Severe char throughout.

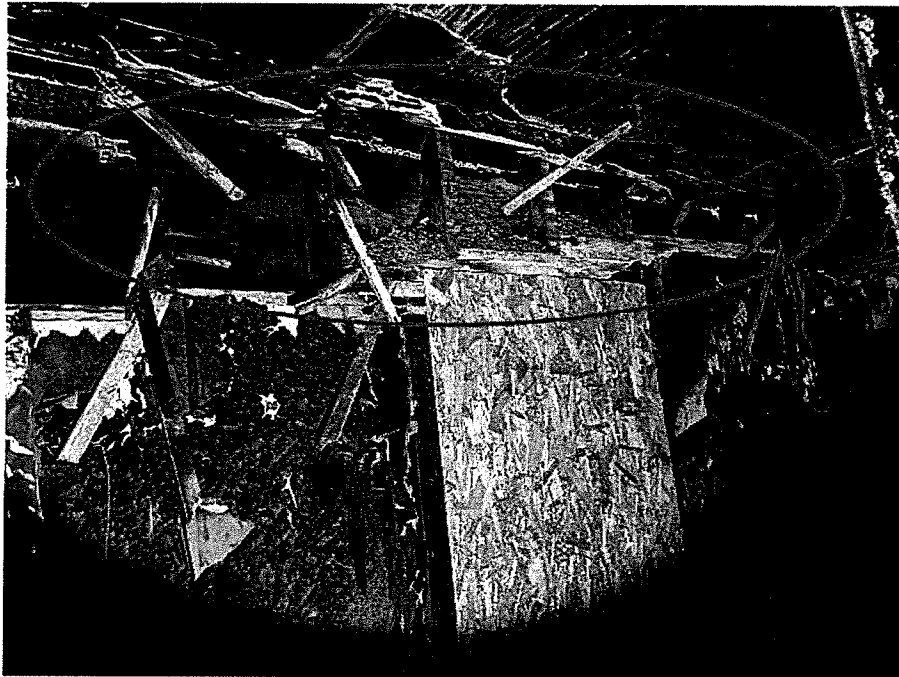
PHOTO 19

- Second level, Unit 4 bedroom looking southeast.
- Char and moderate section loss in exterior wall studs facing the deck (circled).

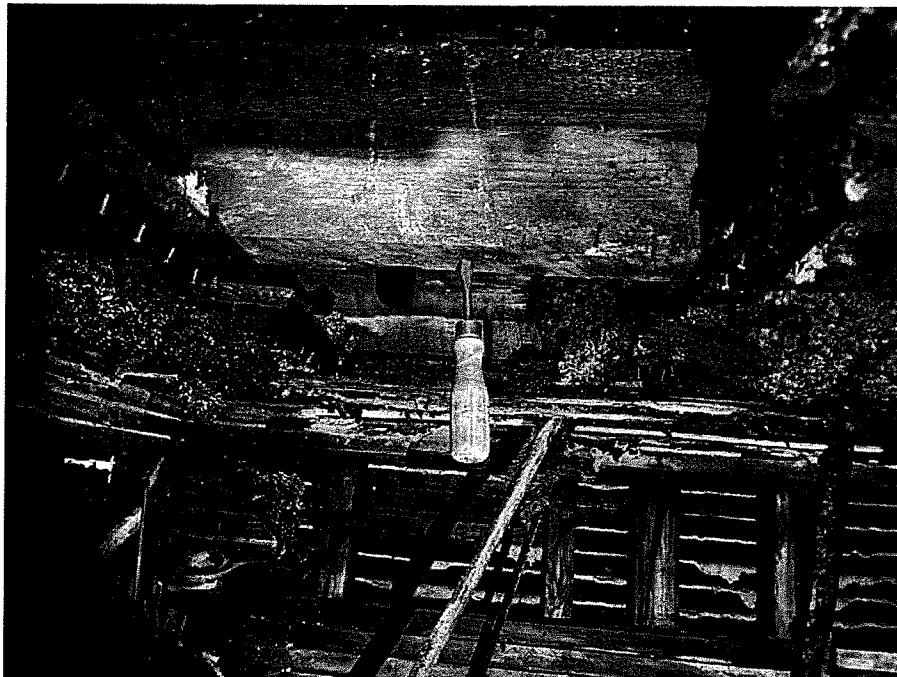
PHOTO 20

- Second level, Unit 4 bedroom looking south/up.
- Char and moderate section loss in ceiling joists; flat-head screwdriver penetrated bottom flange.

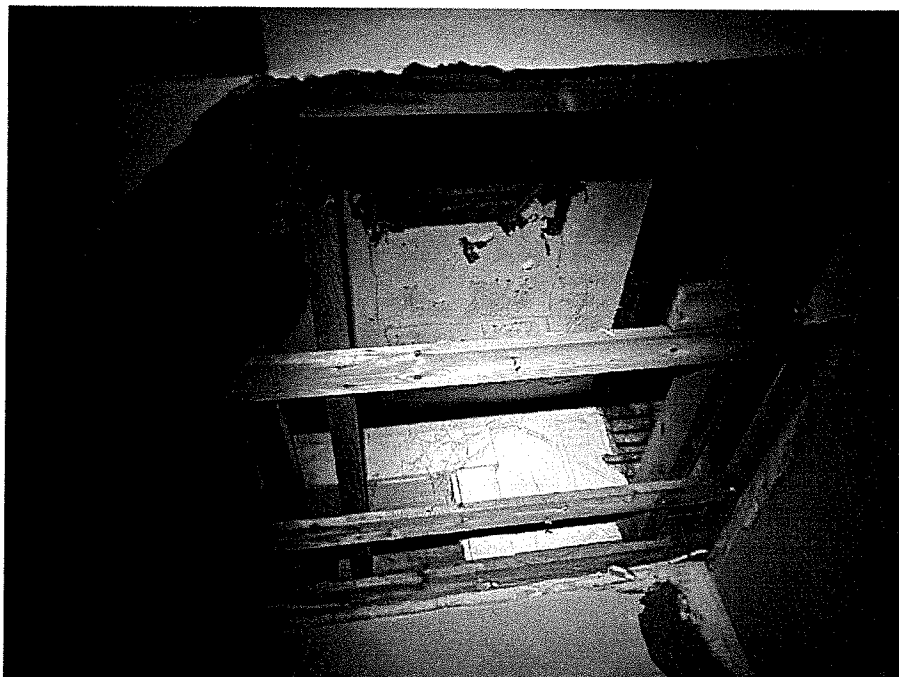
PHOTO 21

- The entire foundation wall **(Photos 30-31)**
- Nonstructural damage included the following.
 - Char/section loss of plaster lath and strapping **(Photos 21, 24)**

- Second level, Unit 4 bathroom on west side of building looking south/up.
- Collapsed drop ceiling; no blackening evident in exposed wood.

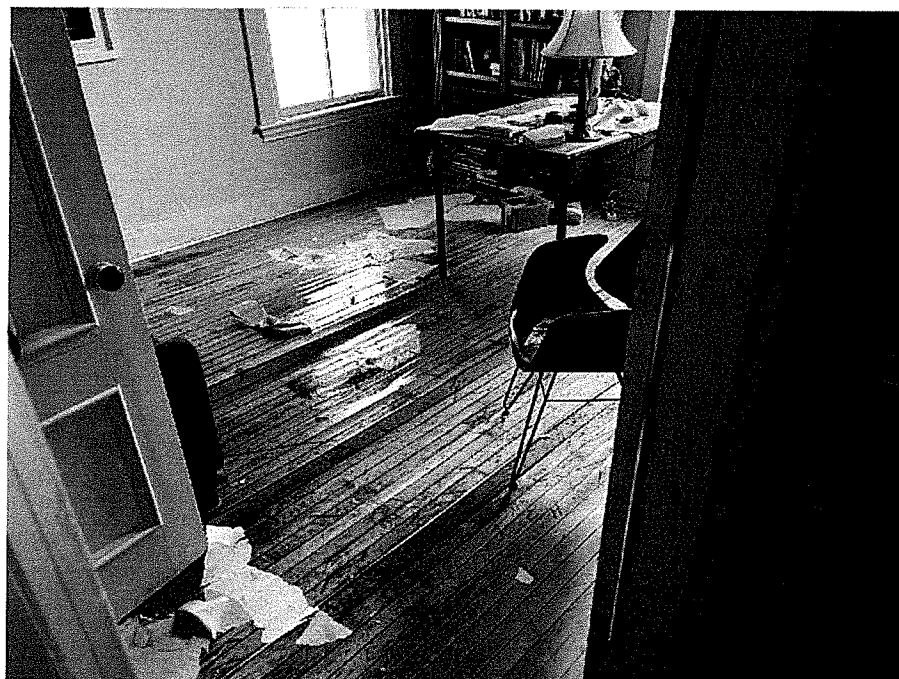
PHOTO 22

- Second level, Unit 3 on west side of building.
- Puddles and buckling of finish floor.

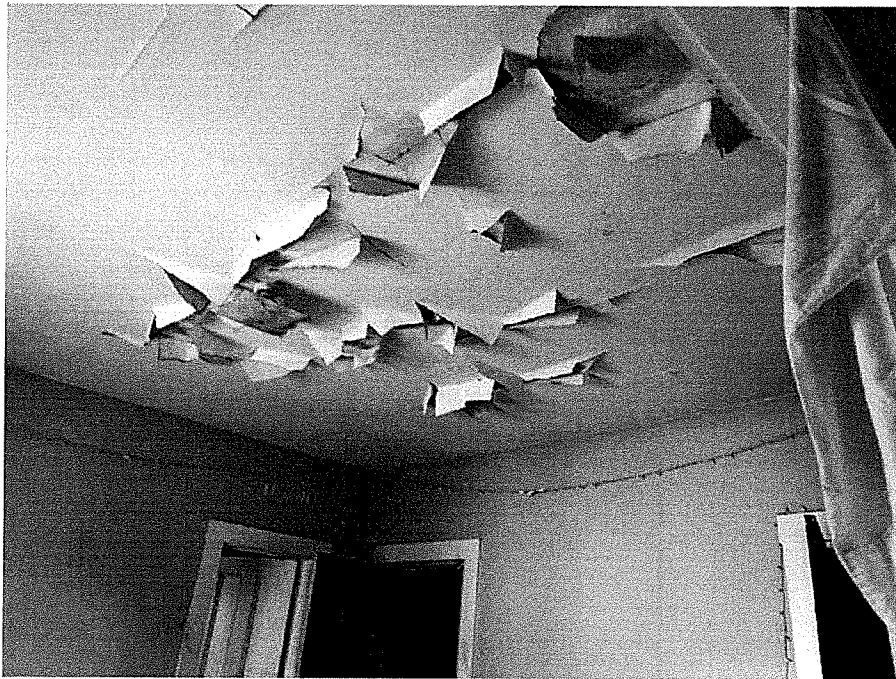
PHOTO 23

- Second level, Unit 3 on west side of building.
- Peeling of finish ceiling.

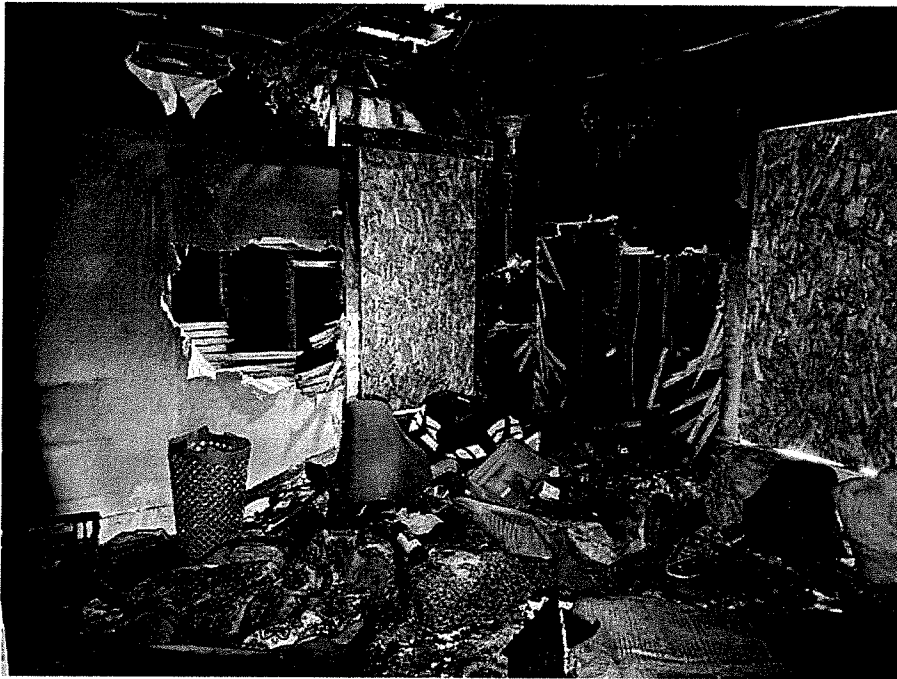
PHOTO 25

- Second level, Unit 2 on east side of building, looking north at wall facing deck.
- Plaster was waterlogged; visible studs showed blackening but were intact.
- Daylight visible through collapsed ceiling and damaged attic flooring.

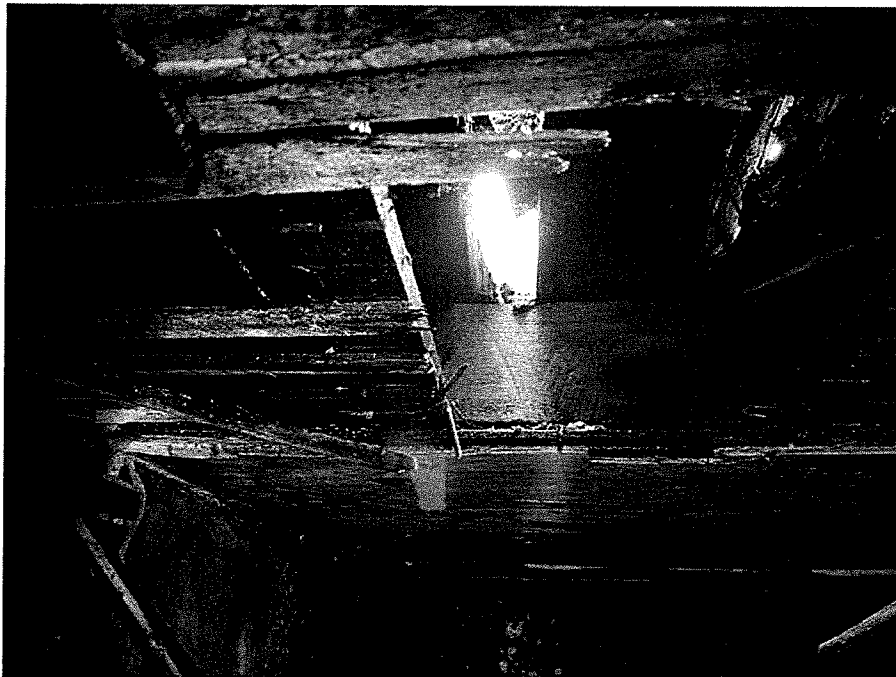
PHOTO 26

- Second level, Unit 2 looking east/up at ceiling adjacent to the wall facing deck.
- Daylight visible through damaged attic flooring.
- Ceiling joists appeared intact.

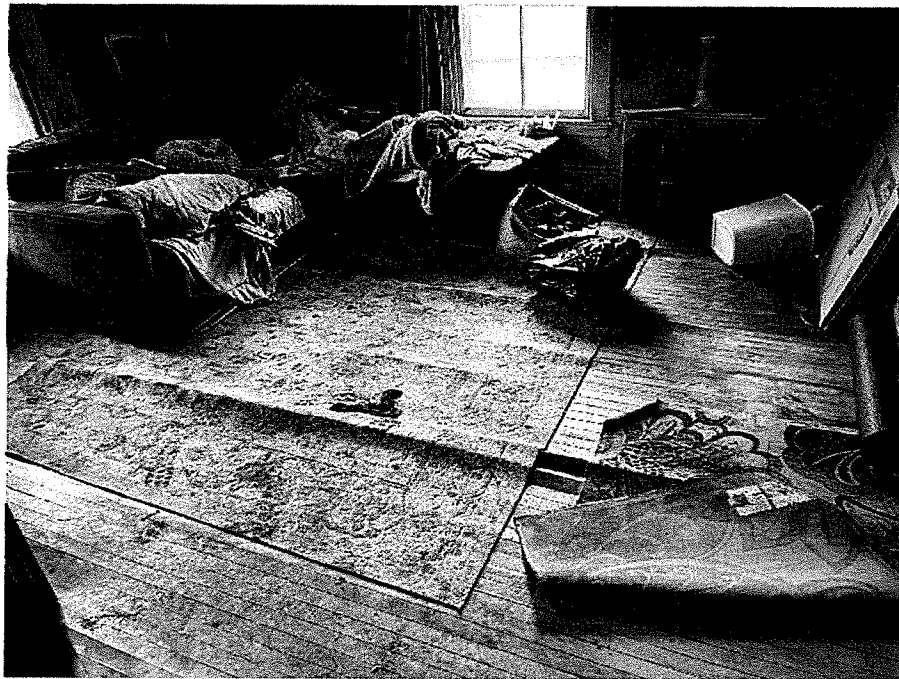
PHOTO 27

- Second level, Unit 2 south (front) room looking south.
- Blackening of walls; buckling of finish floor.

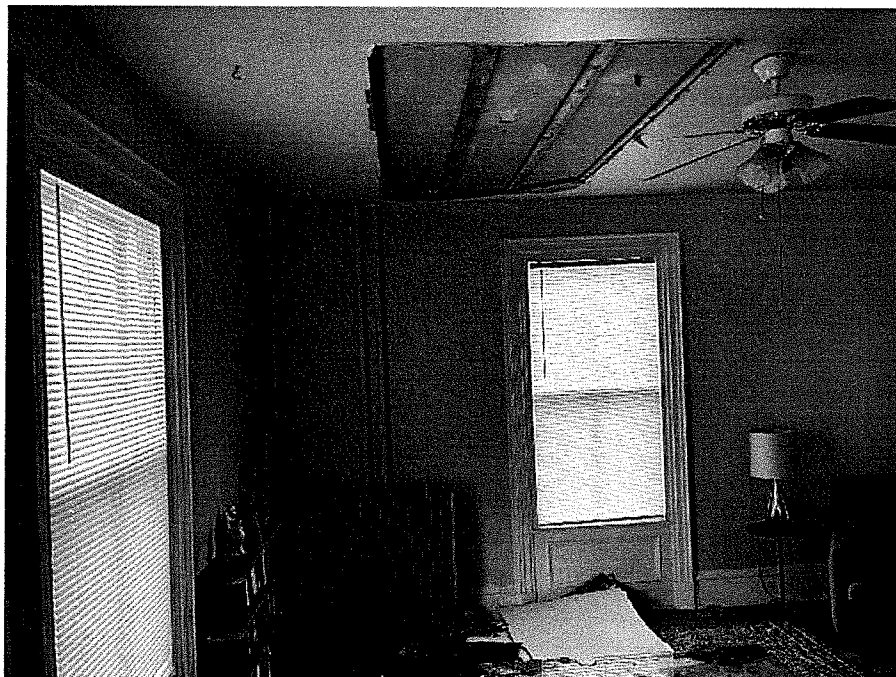
PHOTO 28

- First level, Unit 1 looking west.
- Collapsed finish ceiling and bulging of insulation above.
- No blackening evident in exposed wood.

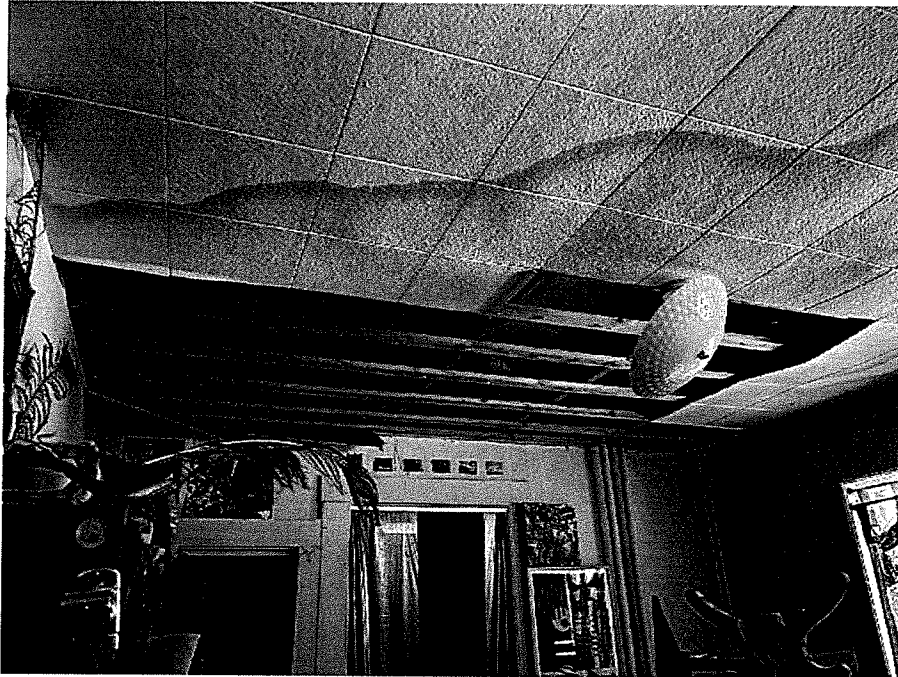
PHOTO 29

- First level, Unit 5 looking north/up.
- Collapsed ceiling tiles and staining of intact ceiling tiles.
- No blackening evident in exposed wood.
- Directly below Unit 4 living room.

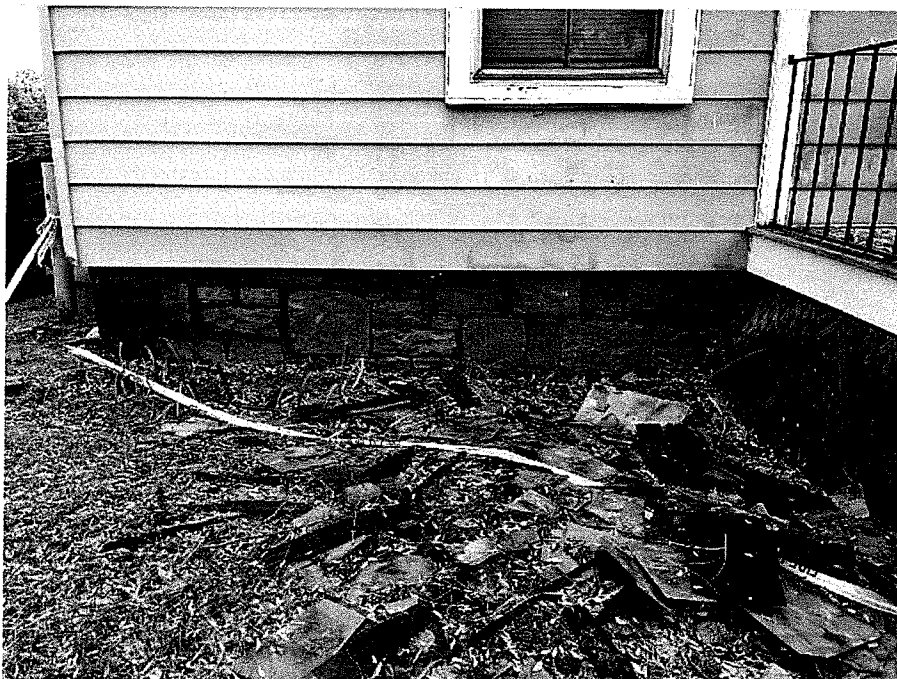
PHOTO 30

The foundation walls were located below the area of fire and did not experience elevated temperatures. There was no damage to the foundation walls consistent with exposure to fire.

- Typical exterior foundation wall (front wall looking north) with gaps in mortar.

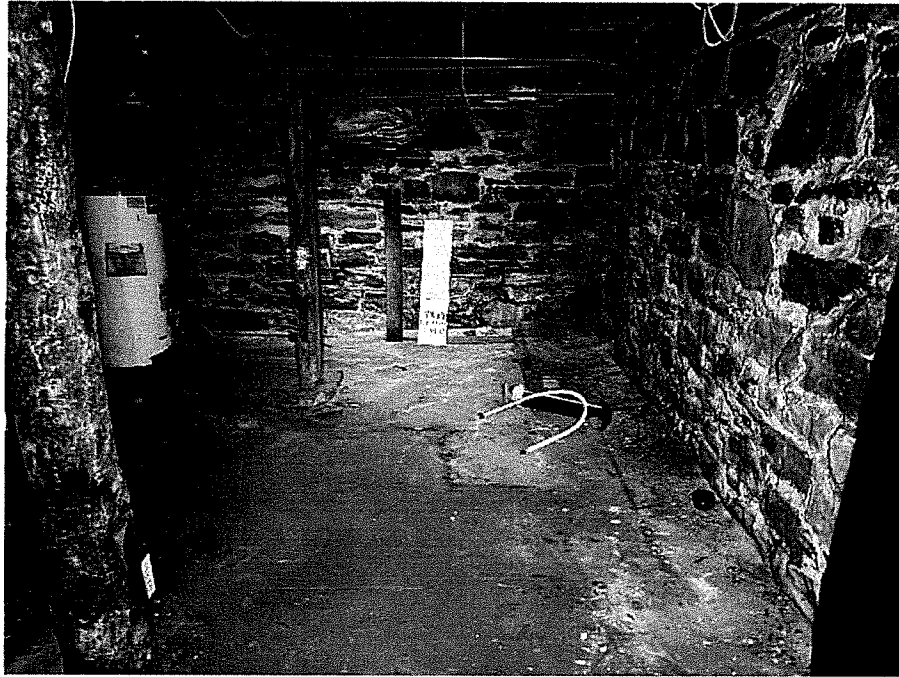
PHOTO 31

- Typical basement interior showing intact joists, foundation walls, and concrete slab with control joints.
