### MEMORANDUM

To: Development Review Board  
From: Mary O'Neil, AICP, Principal Planner  
Date: November 2, 2021  
RE: ZP21-614; 77-87 Pearl Street (6 Pine Street)

**Request:** Demolish carriage barn and return to green space. Structure is listed on the Vermont State Register of Historic Resources.

At the request of Mr. Jacob Hinsdale of Hinsdale Properties, CiS inspected exposed and accessible elements of the barn-like structure located at 6 Pine Street in Burlington VT (PHOTOS 1 & 2). The purpose of the July 6, 2021 inspection was to: observe and document the existing structure, assess the condition of the structure, evaluate (analyze) structural framing to determine compliance/non-compliance to structural requirements of the Building Code and determine whether the building is safe, sound and stable.

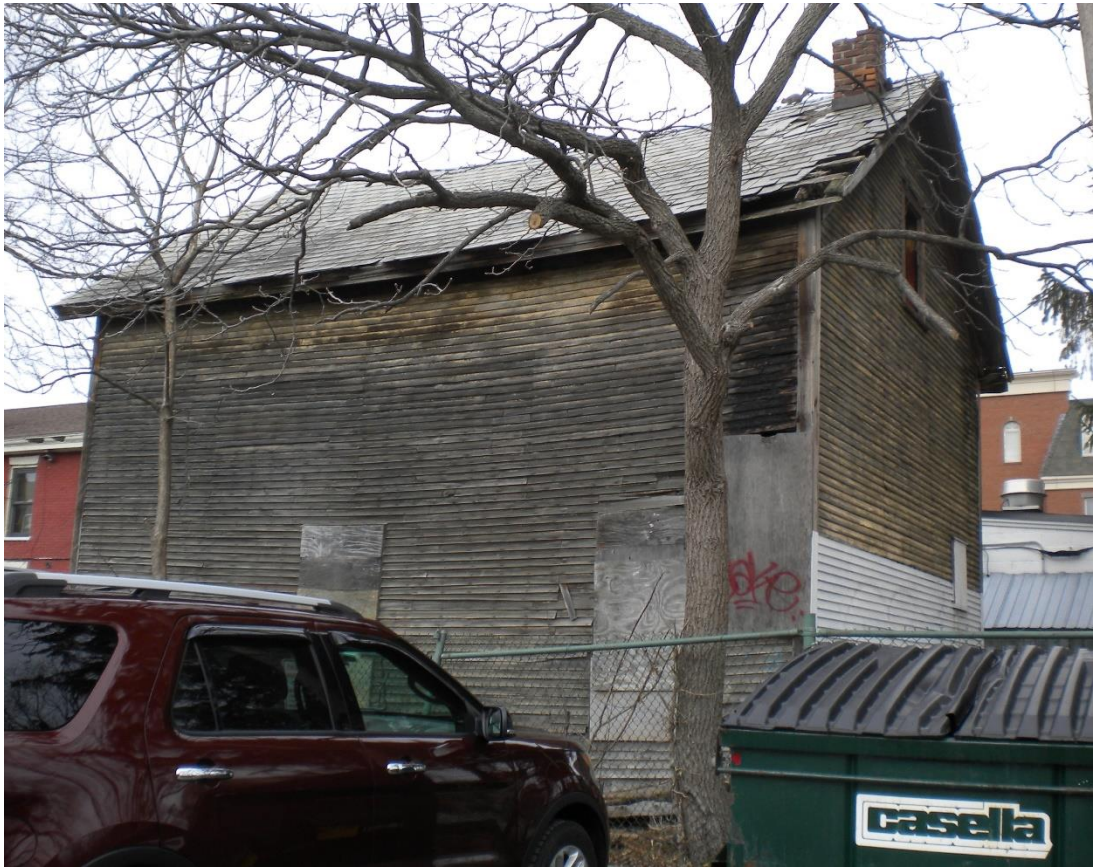
Observation shows evidence of fire damage (south elevation, boarded over), a failing chimney and soffit with holes. There are no building permits on file specifically for repair of the barn.

This photograph was taken for the 2016 review. Similar photographs are within the Van Dyk report.

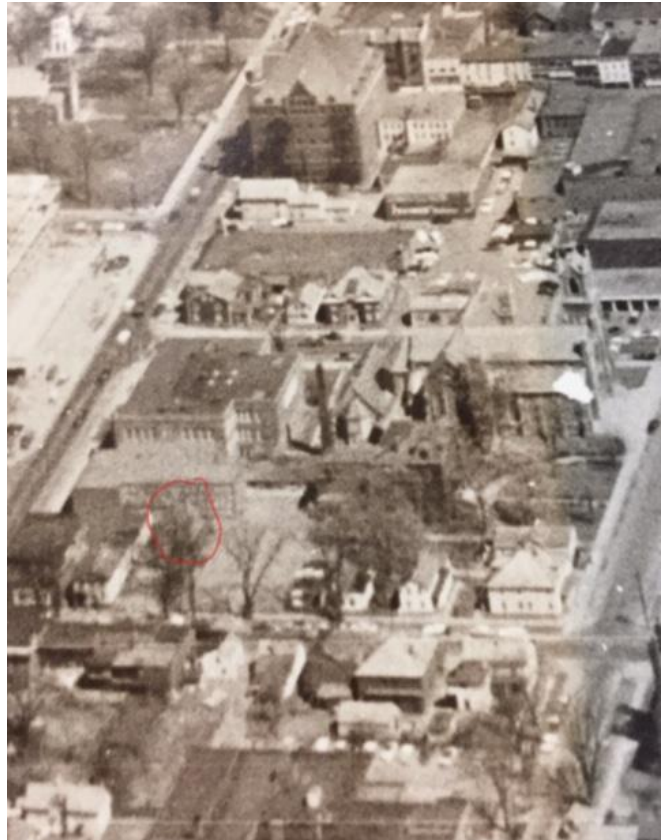
This aerial image from 1961 shows the carriage barn (circled), with the Cathedral School and its addition to the east (center left), and The Cathedral of the Immaculate Conception to the south east (center right.) Homes between 6 and 28 Pine were razed after the Cathedral burned, include the Bishop’s residence on Cherry Street. Everything on the east side of St. Paul was demolished for construction of the state office building. Cathedral school was razed in 1977.

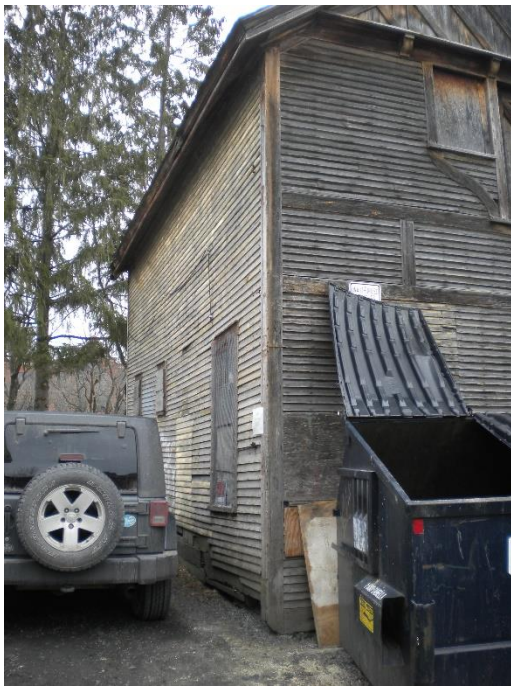
Both current and 2016 photographs demonstrate dumpsters located in close proximity to this building. There is no site plan on file that has approved dumpsters, which are not screened and are visually unattractive as well as a potential for fire calamity for the wood frame barn. A plan will be required for the location and screening of all dumpsters and oil drums. **Affirmative finding if conditioned.**

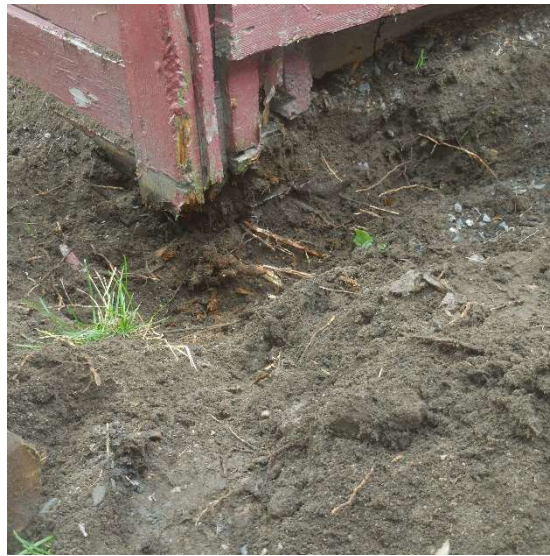
1. Wood framed walls bear on a foundation that appears to be 6” or more below grade. Wood components (mudsill, studs, sheathing, etc.) that are at or below grade show signs of decay and deterioration (PHOTOS 3 & 4).

*PHOTO 4: North-East Corner – Note wood decay at base of building*

- wood elements are elevated sufficiently above grade to minimize/eliminate wood decay at the base of the walls.
- b. Repair/replacement of decayed wood framing at the base of the building.
- c. Reinforcement/replacement of existing roof framing to increase stiffness and strength to meet current Code requirements.
- d. Reinforcement/replacement of existing 2<sup>nd</sup> Floor framing to increase stiffness and strength to meet current Code requirements.
- e. Repair/re-construction of the chimney to stabilize the brick.

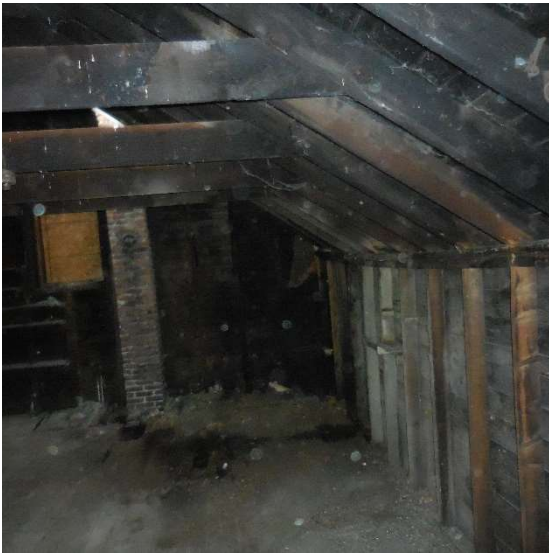
3. There is a sag in the second floor which appears to indicate that floor framing elements are undersized for current use.
4. There are holes in both the roof (south-east corner -PHOTO 1) and in the second floor (east end -PHOTO 5) where a past fire damaged the structure (rafters, roof sheathing, floor joists and floor sheathing – PHOTOS 6 & 7).

*PHOTO 5: South-East Corner (2<sup>nd</sup> Floor) - Note hole in floor near chimney*

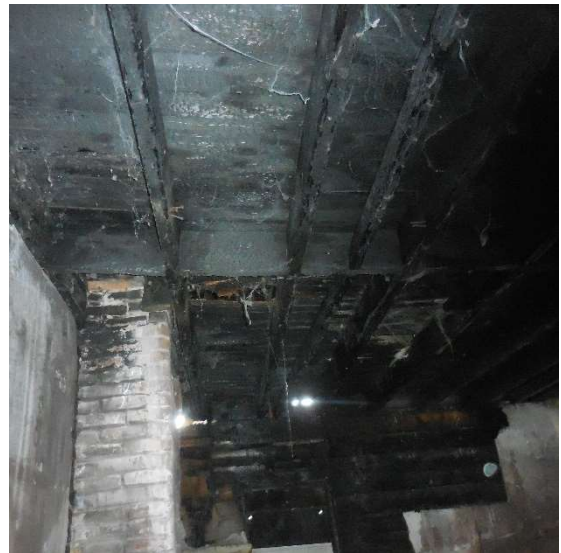
*PHOTO 6: South-East Corner - Note charred framing at bottom of 2<sup>nd</sup> Floor framing*

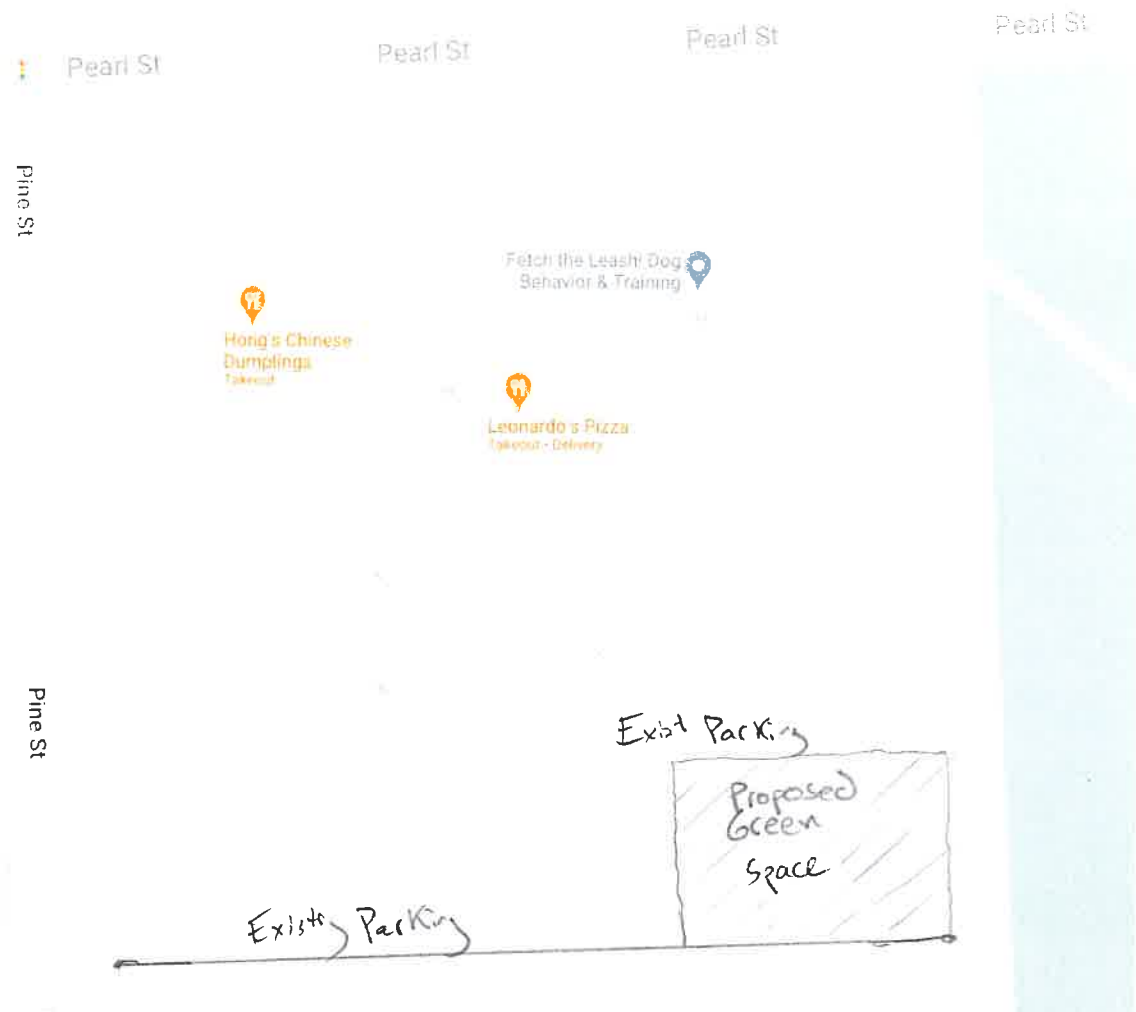
77-87 Pearl St. / 6 Pine St. – Site Plan

Additional 543.25  
square feet of  
new green space

Total Green Space  
 $24.5' \times 32' = 784$

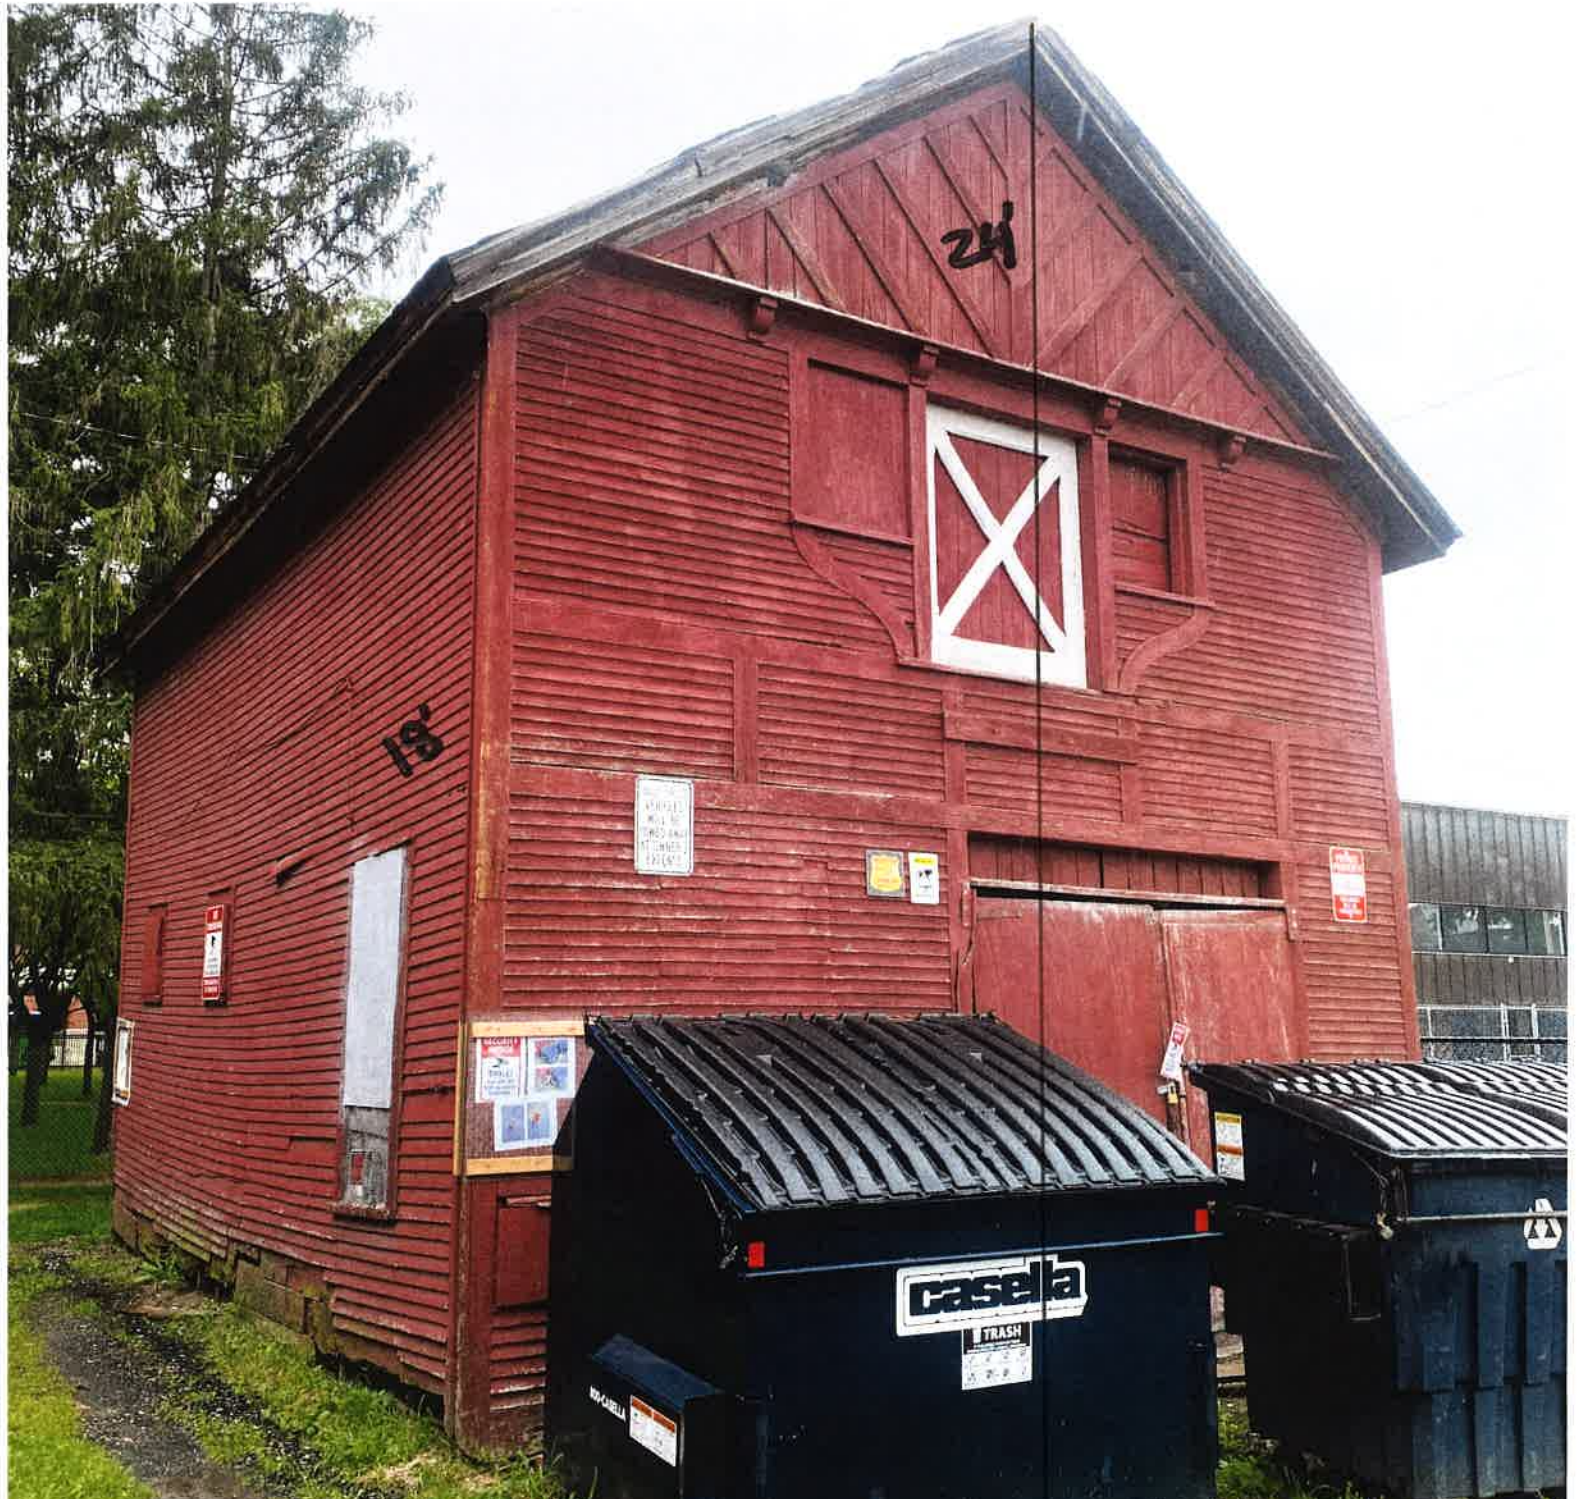
The submitted plan is an annotated Google image with the location of the barn identified as green space. An overall coverage calculation has not been submitted.

→ Existing Barn,  
Proposed new  
green Space
