## **Burlington Design Advisory Board**

### **DESIGN ADVISORY BOARD Tuesday September 14, 2021 3:00 PM**

## MEMORANDUM

**To:** The Design Advisory Board  
**From:** Mary O'Neil, AICP, Principal Planner  
**RE:** ZP21-457, 43 Adams Court  
**Date:** July 13, 2021, **September 14, 2021**

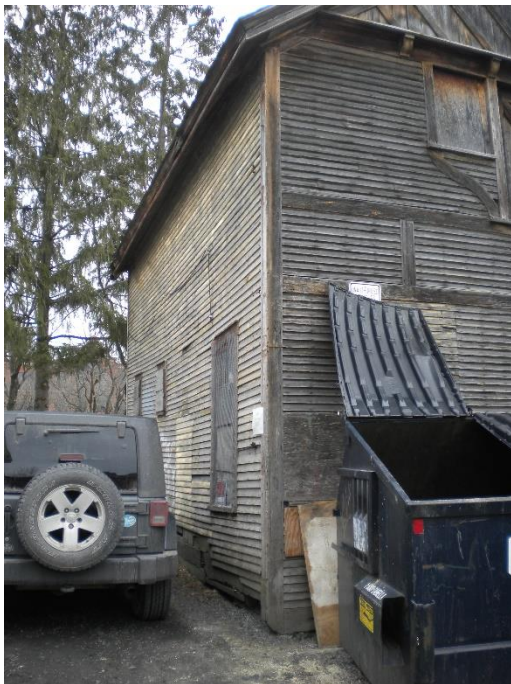
Both current and 2016 photographs demonstrate dumpsters located in close proximity to this building. There is no site plan on file that has approved dumpsters, which are not screened and are visually unattractive as well as a potential for fire calamity for the wood frame barn. A plan will be required for the location and screening of all dumpsters and oil drums.

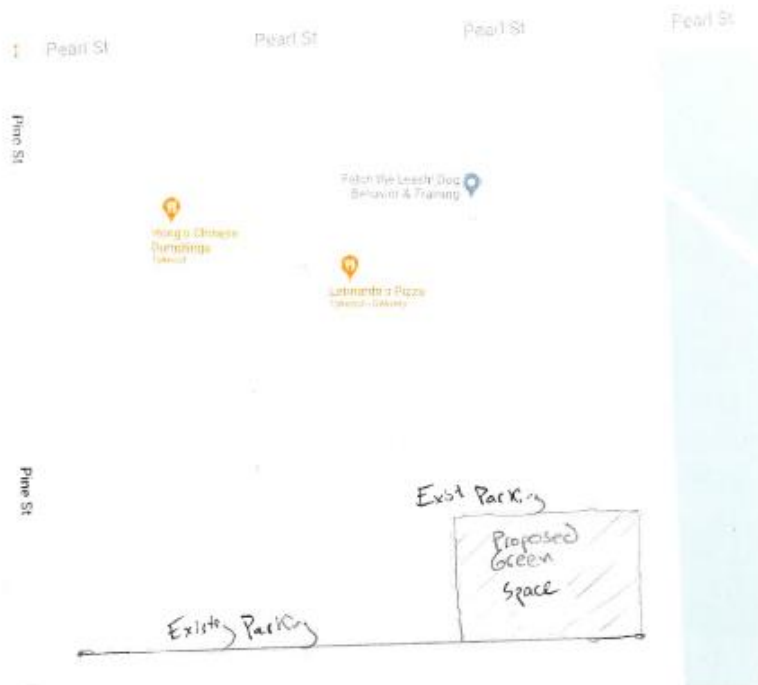
77-87 Pearl St. / 6 Pine St. - Site Plan

Additional 543.25  
square feet of  
new green space

Total Green Space  
 $24.5' \times 32' = 784$

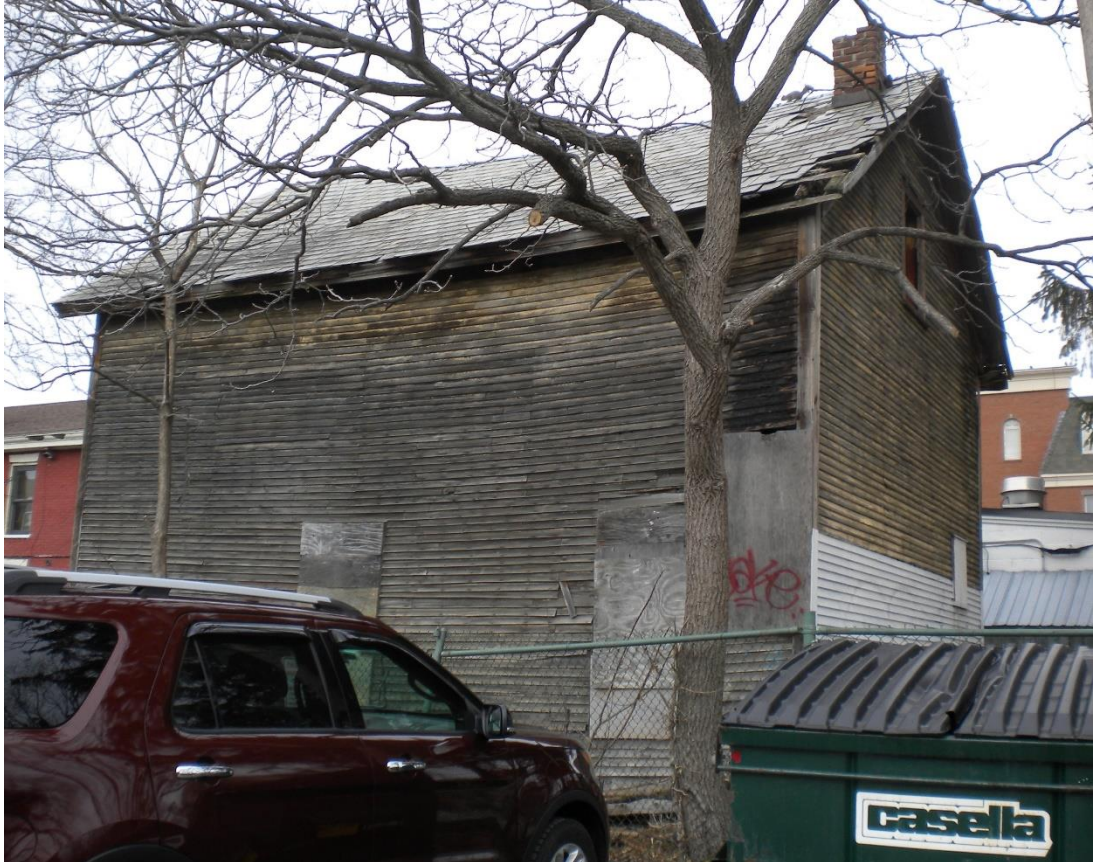
Observation shows evidence of fire damage (south elevation, boarded over), a failing chimney and soffit with holes. There are no building permits on file specifically for repair of the barn. Please refer to report by Van Dyck for assessment of structural stability and building condition, which he determines to be in “progressive failure.”

This photograph was taken for the 2016 review. Similar photographs are within the Van Dyck report.

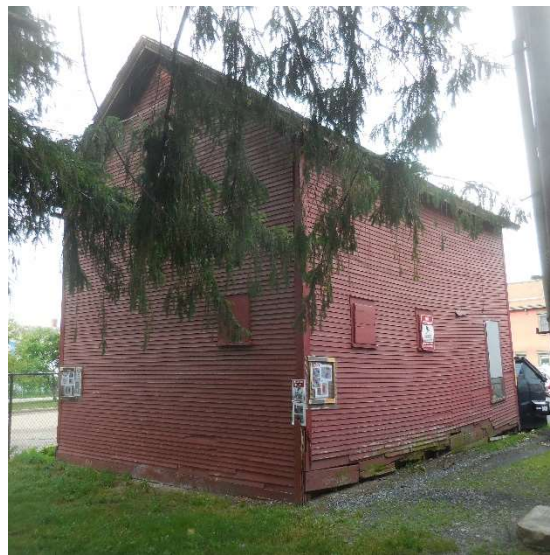
*PHOTO 2: North-East Corner - Note deteriorated siding along bottom of structure*

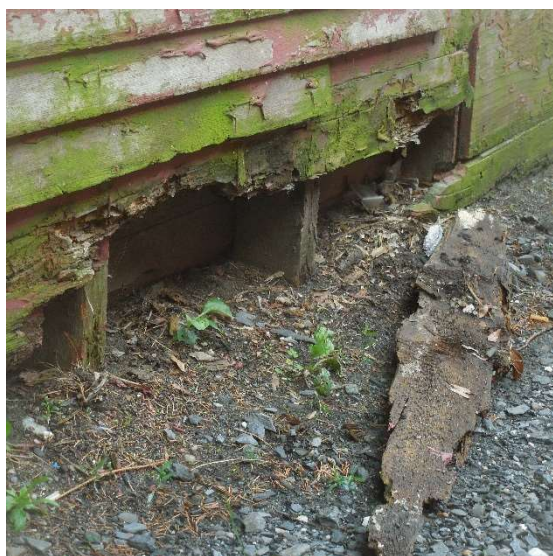
*PHOTO 3: North Side – Top of stone foundation. Note wood decay at base of building*

1. Wood framed walls bear on a foundation that appears to be 6” or more below grade. Wood components (mudsill, studs, sheathing, etc.) that are at or below grade show signs of decay and deterioration (PHOTOS 3 & 4).

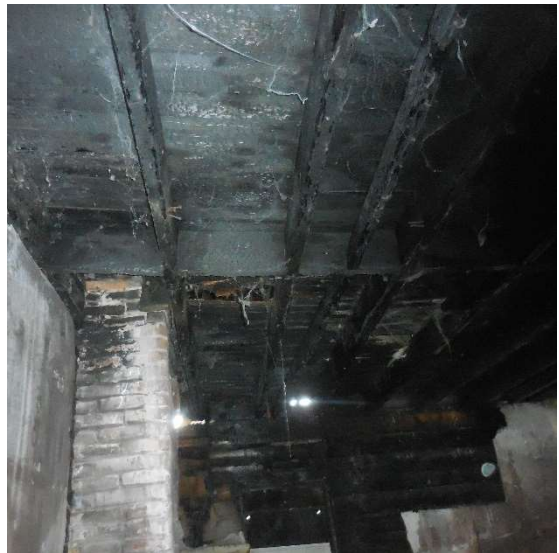
*PHOTO 6: South-East Corner - Note charred framing at bottom of 2<sup>nd</sup> Floor framing*

3. There is a sag in the second floor which appears to indicate that floor framing elements are undersized for current use.
4. There are holes in both the roof (south-east corner -PHOTO 1) and in the second floor (east end -PHOTO 5) where a past fire damaged the structure (rafters, roof sheathing, floor joists and floor sheathing – PHOTOS 6 & 7).

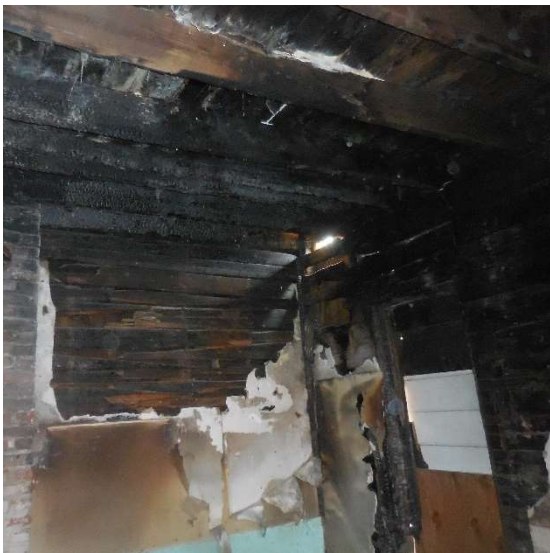
*PHOTO 7: South-East Corner - Note charred framing at bottom of 2<sup>nd</sup> Floor framing*

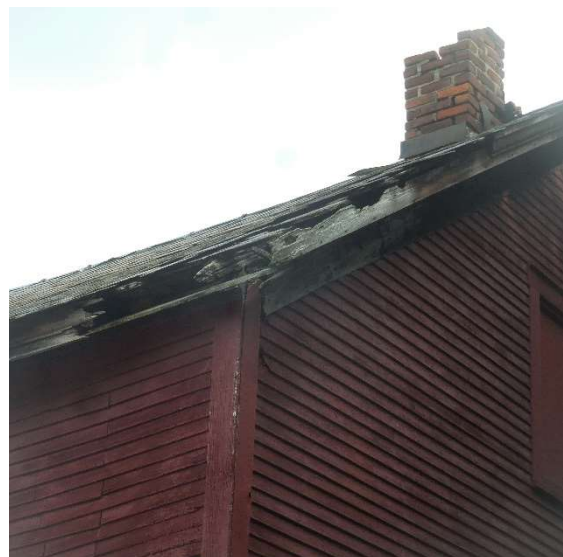
*PHOTO 8: South-East Corner - Note loose & missing brick at top of chimney*

5. The brick chimney is in a state of deterioration and it appears that several bricks have been dislodged (PHOTO 8), most likely having fallen to the ground below.

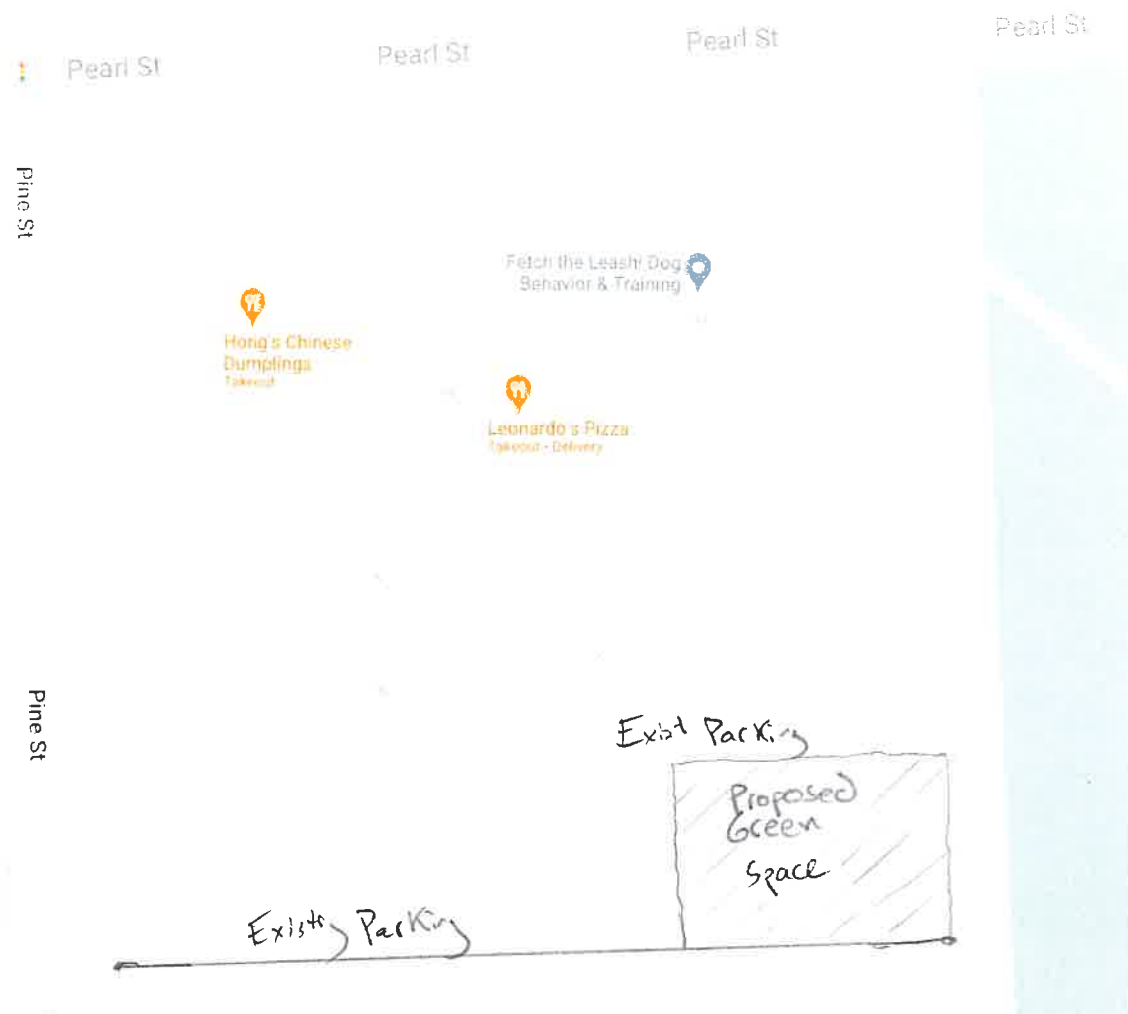
77-87 Pearl St. / 6 Pine St. – Site Plan

Additional 543.25  
square feet of  
new green space

Total Green Space  
 $24.5' \times 32' = 784$

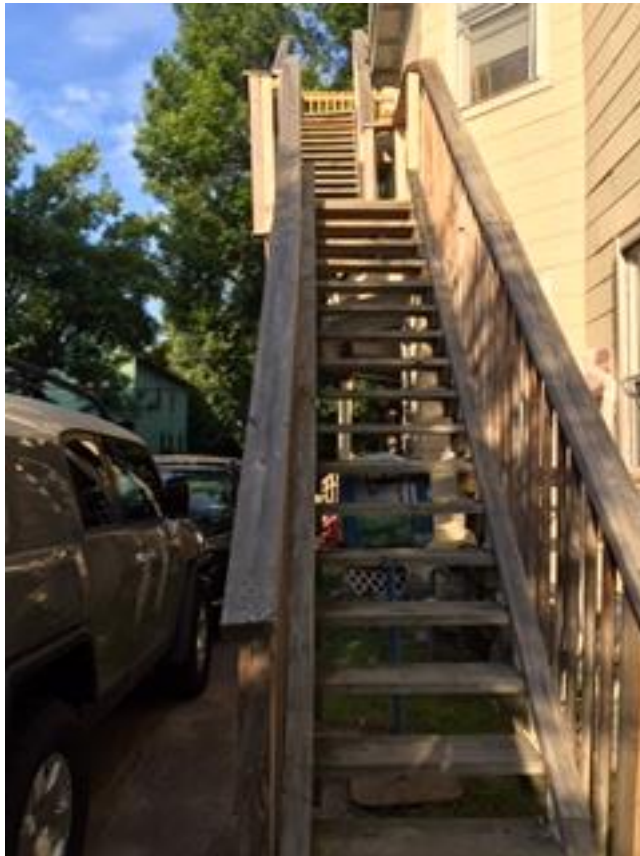
The top of the landing has no canopy, other than the roof eave. The stair, itself, is uncovered. Building code typically requires that egress stairs be covered if the steps are wooden and the building is not occupied by an owner, who could attend to ice and snow.

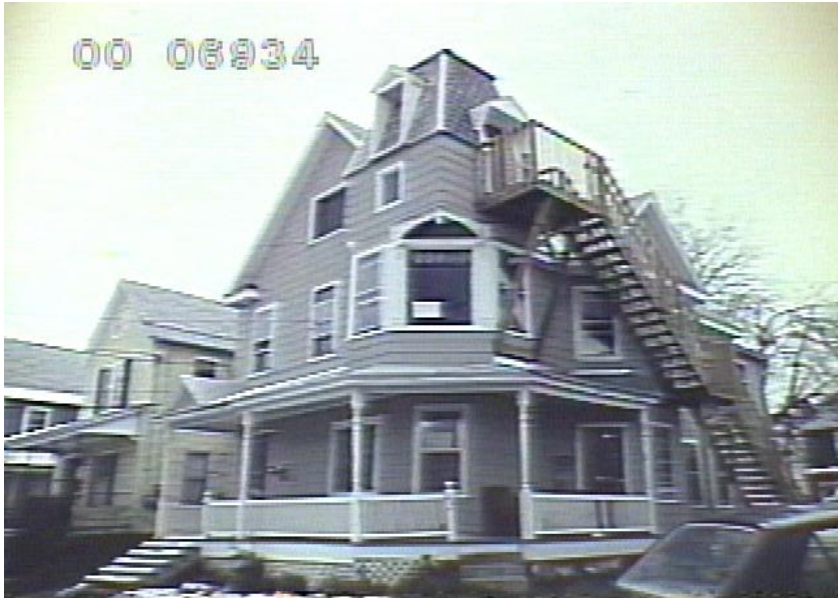
1984-85 Assessor Revaluation photograph  
Stairs are new build

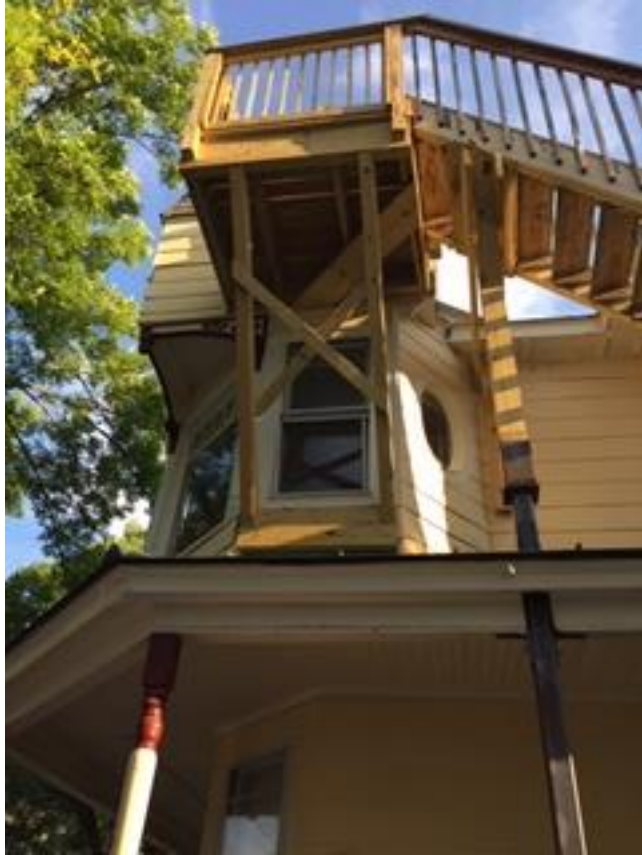
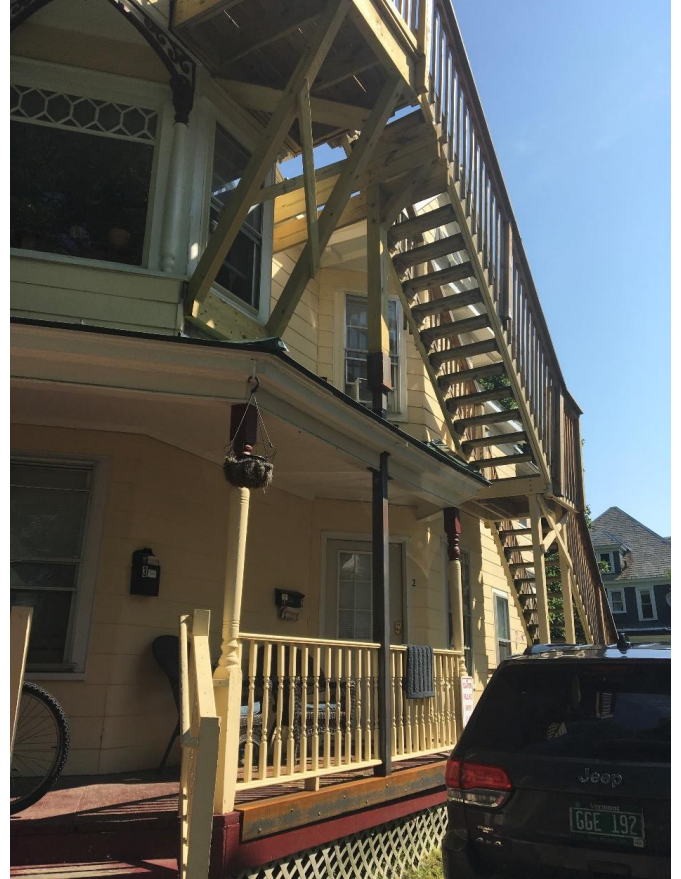
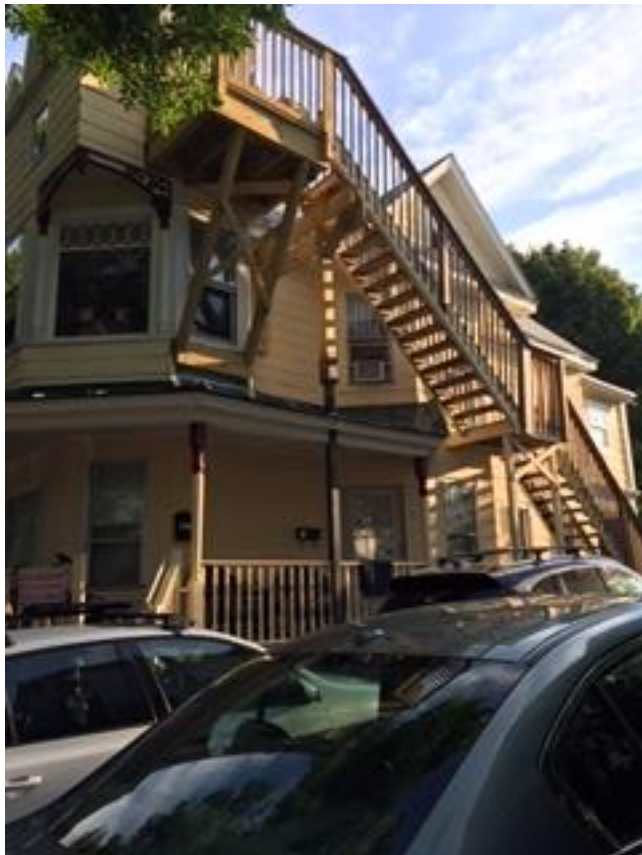
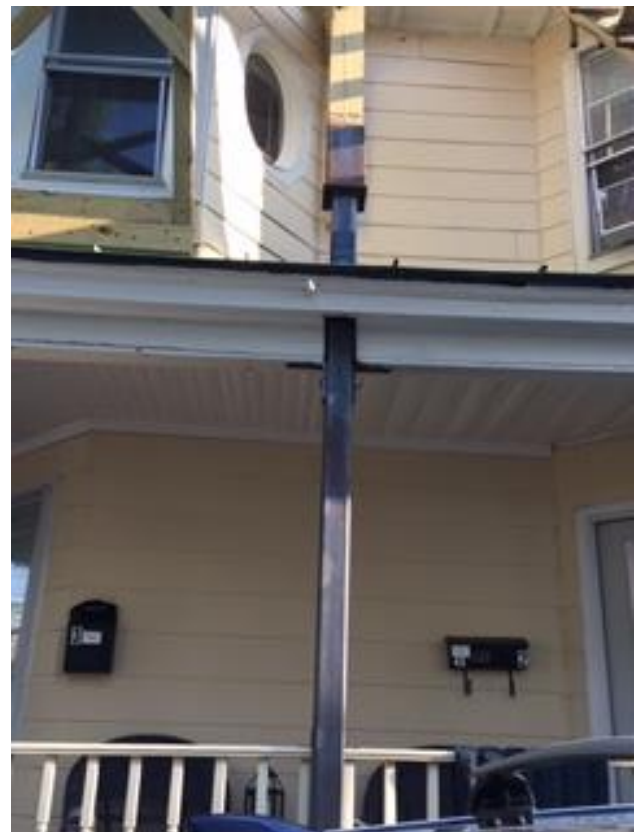
A site visit confirmed that multiple alterations have occurred to the property without benefit of building or zoning permits. Windows have been replaced; doors altered and locations changed. Code enforcement will be alerted to review current conditions at the property.

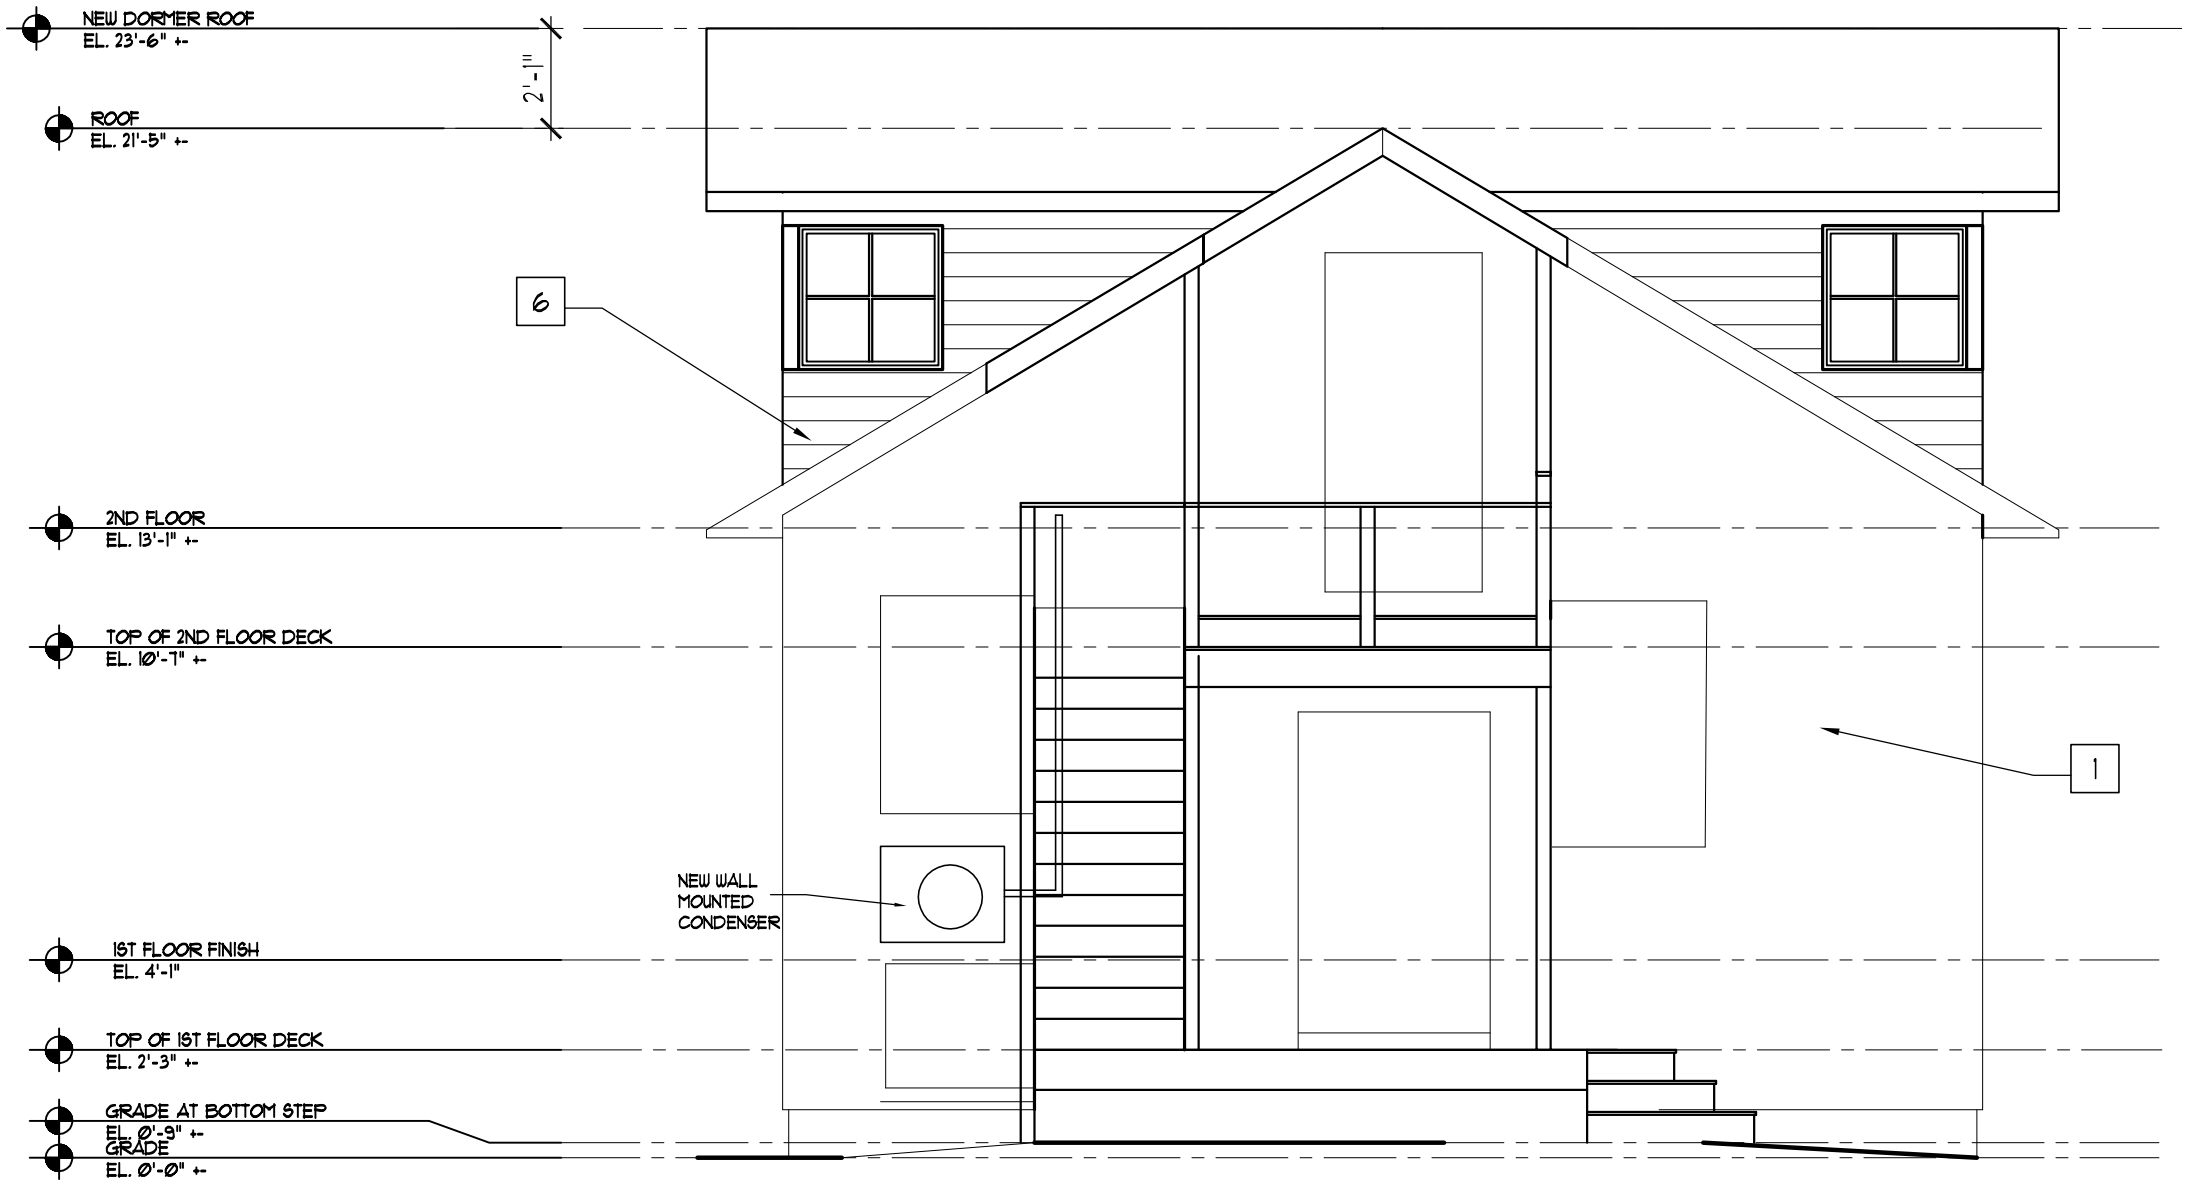
NEW DORMER ROOF  
EL. 23'-6" +-  
2'-11"

ROOF  
EL. 21'-5" +-  
2'-11"
