## Burlington Design Advisory Board

149 Church Street, City Hall

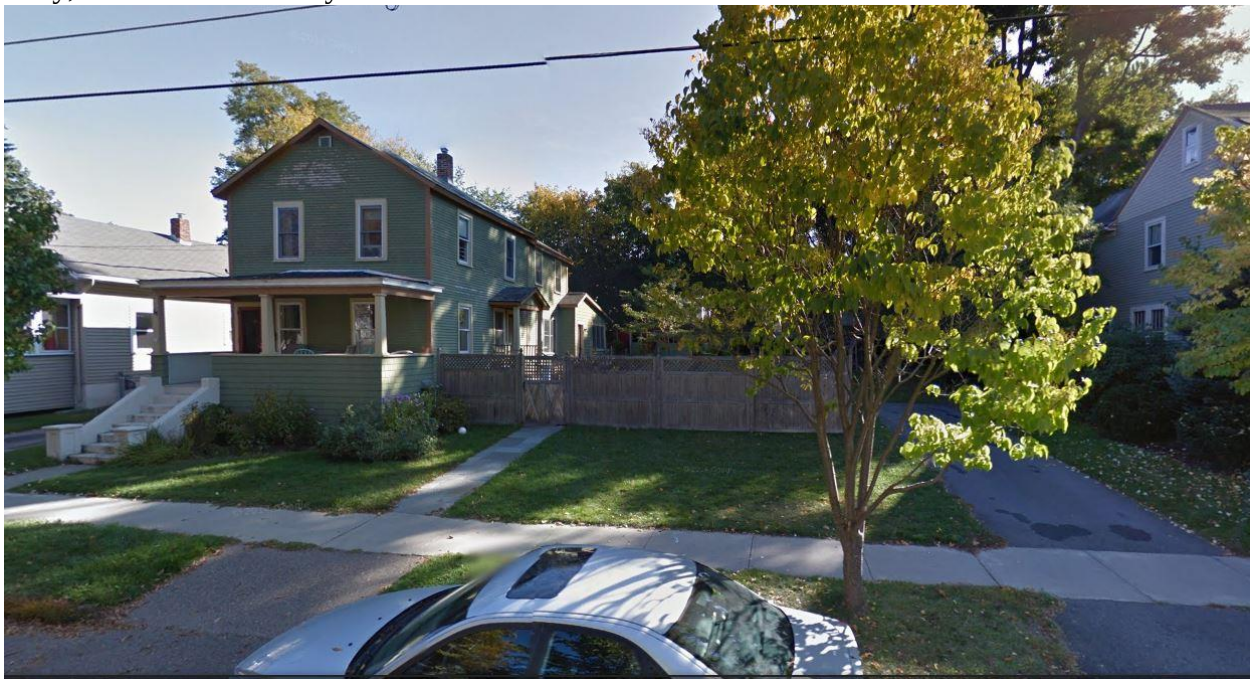
**File:** ZP17-0882CA  
**Location:** 64 Charlotte Street  
**Zone:** RL Ward: 5S  
**Date application accepted:** March 22, 2017  
**Applicant/ Owner:** Robert Behrens  
**Request:** Addition to existing single family home; adding second story over existing single story, and attached 2 story addition to the south.

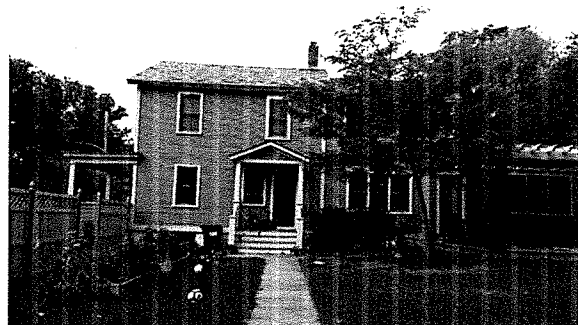
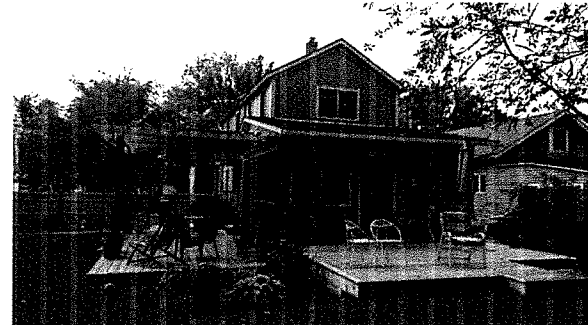
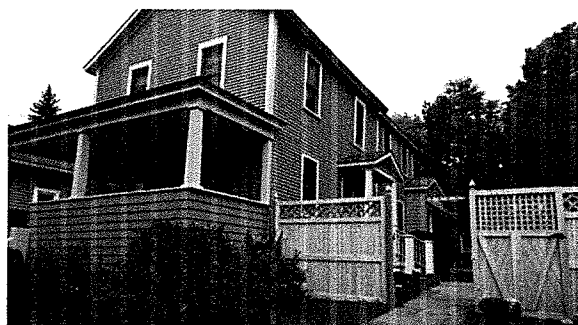
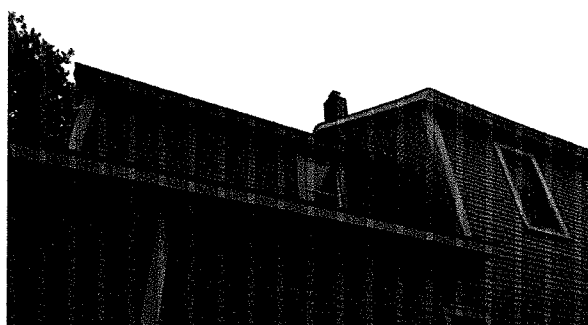
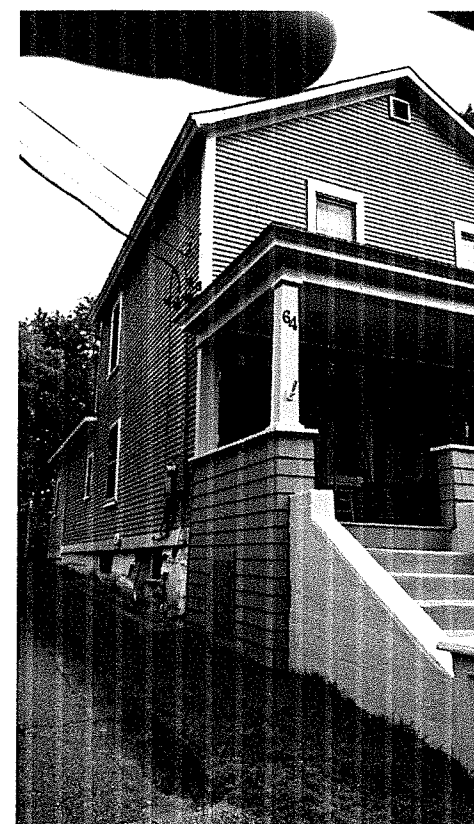
**RECEIVED**  
MAR 22 2017  
DEPARTMENT OF  
PLANNING & ZONING
