# FACILITY CONDITION ASSESSMENT AND LEVEL I ENERGY AUDIT

## FACILITY CONDITION ASSESSMENT AND LEVEL I ENERGY AUDIT of LAKEVIEW CEMETERY BUILDING

455 North Avenue  
Burlington, Vermont 05401

**EMG Project #:** 110226.14R-014.294  
**Date of Report:** November 11, 2014  
**On site Date:** August 26, 2014 and August 29, 2014

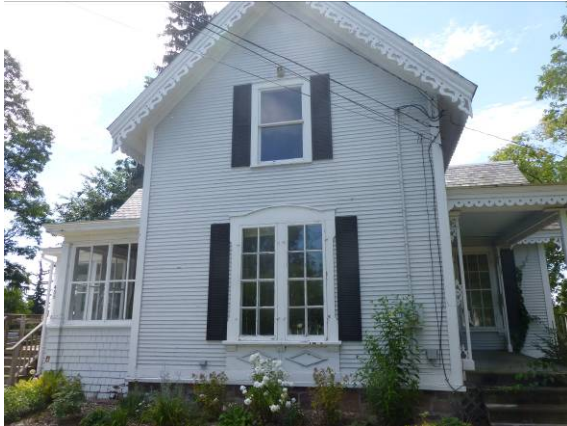
Photo #1: East elevation of cemetery building

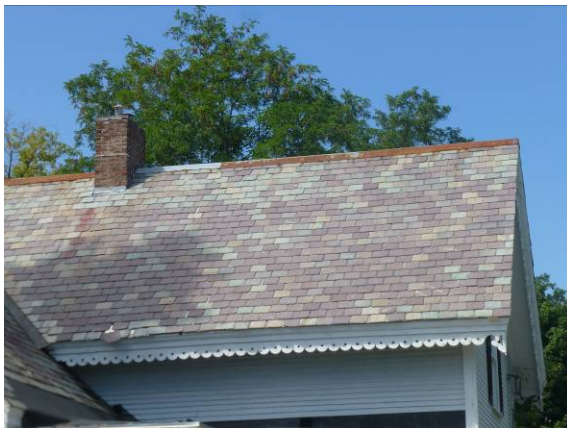
Photo #5: Cemetery building roof

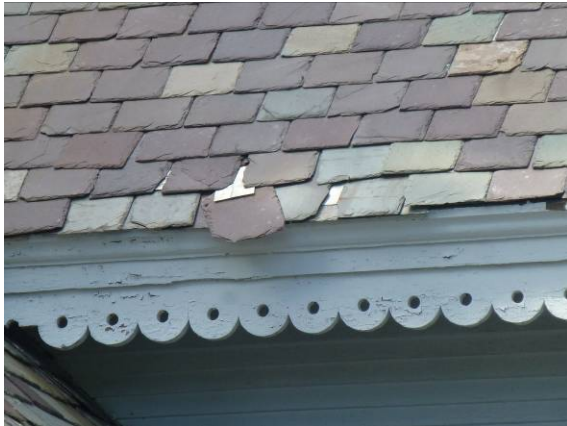
Photo #7: Cemetery building roof detail

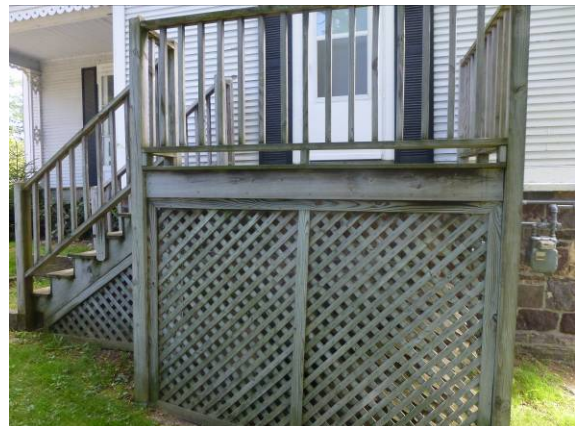
Photo #10: Cemetery building stairs

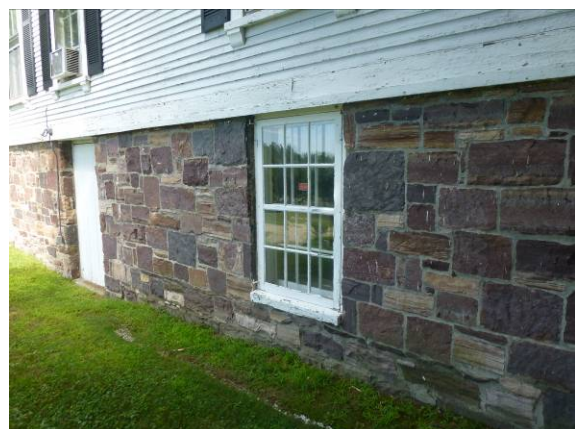
Photo #12: Cemetery building foundation

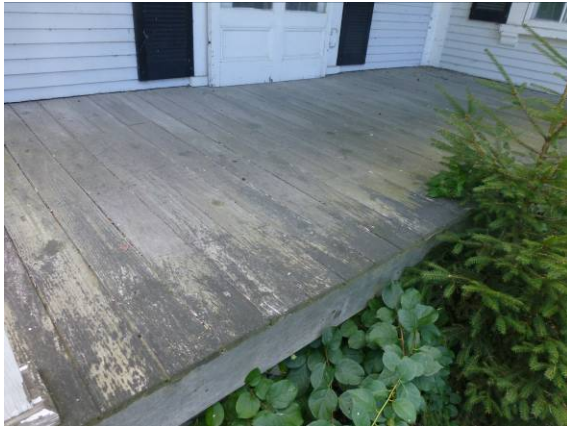
Photo #13: Cemetery building porch

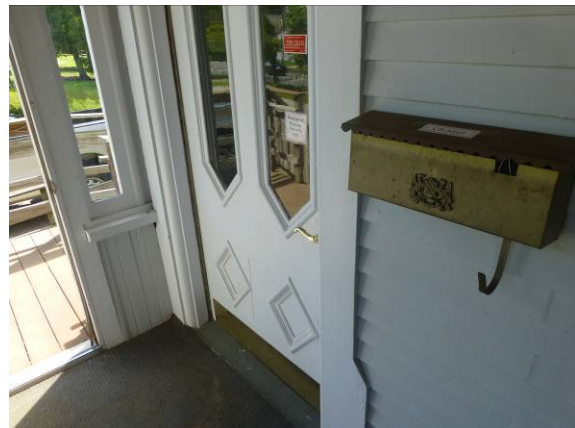
Photo #16: Entrance door

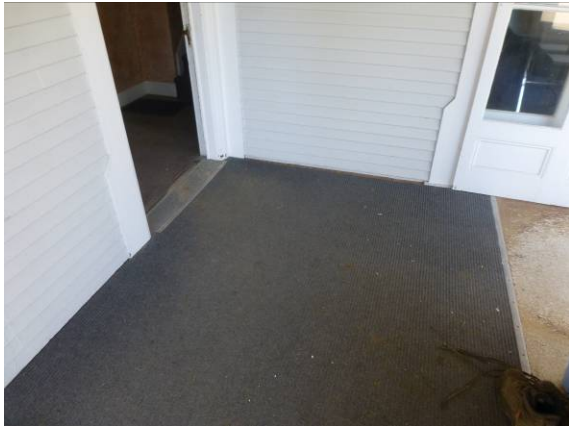
Photo #25: Porch flooring detail

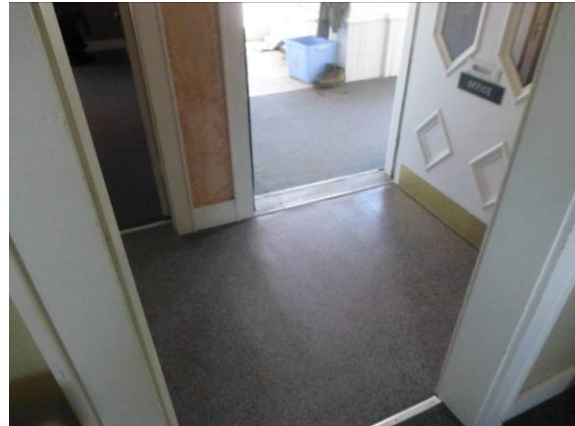
Photo #26: Entrance flooring detail

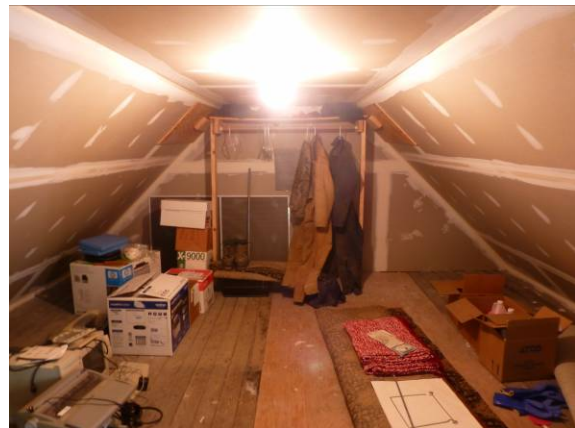
Photo #28: Attic storage area

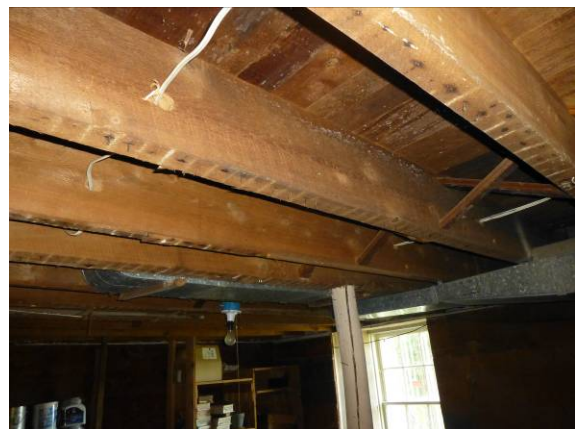
Photo #30: Floor structure

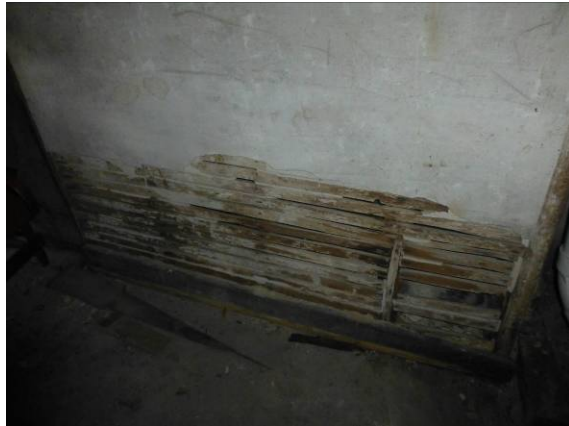
Photo #31: Wall detail

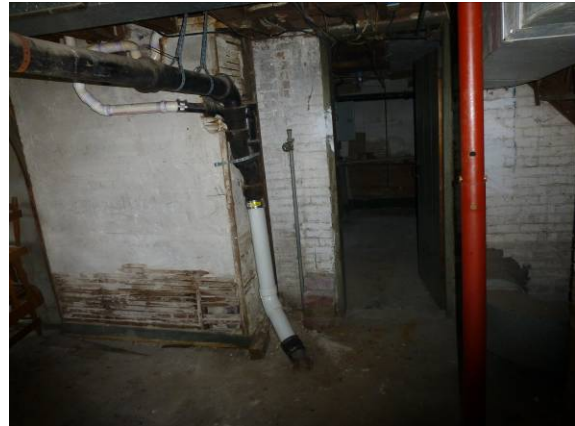
Photo #32: Basement area

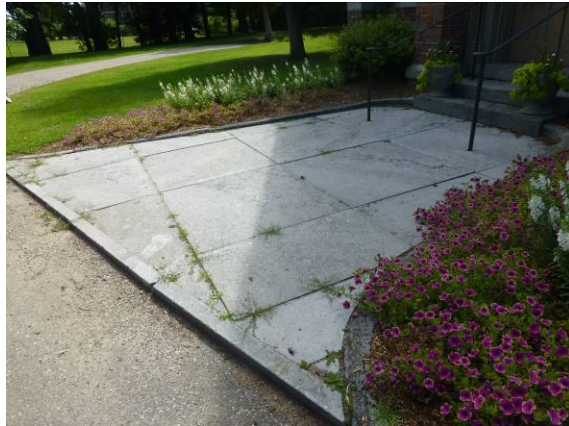
Photo #37: Chapel paving detail

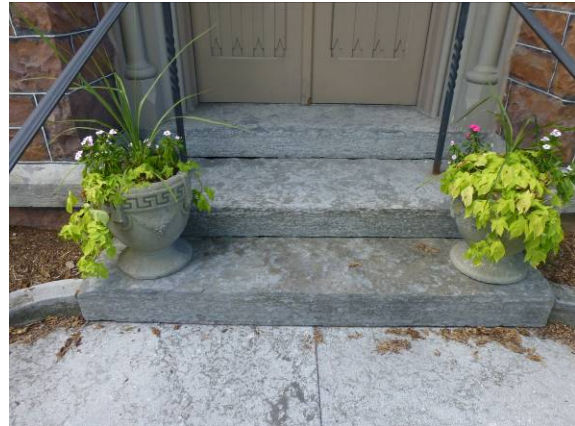
Photo #38: Chapel stair detail

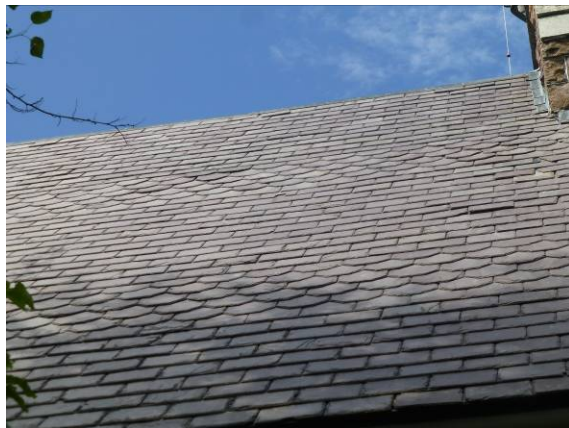
Photo #39: Chapel slate roof

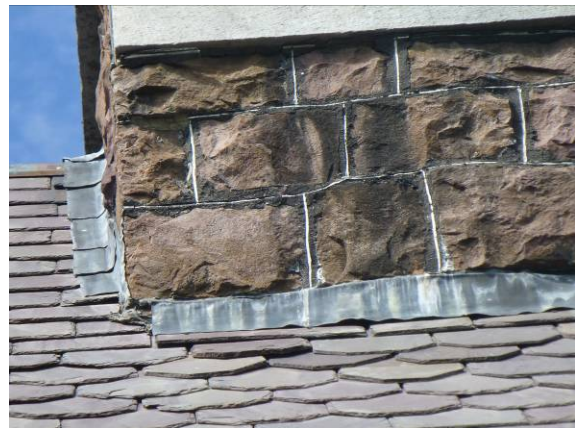
Photo #40: Chapel chimney detail

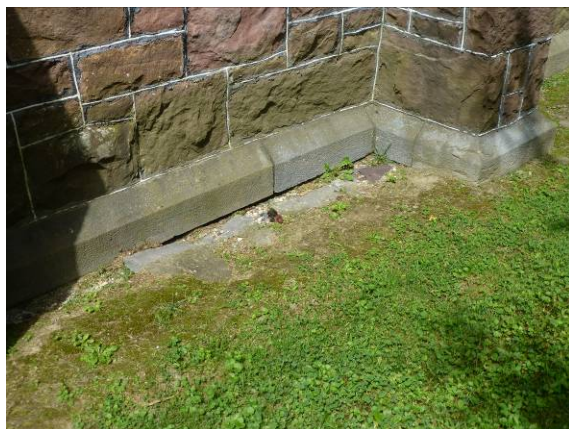
Photo #41: Chapel foundation detail

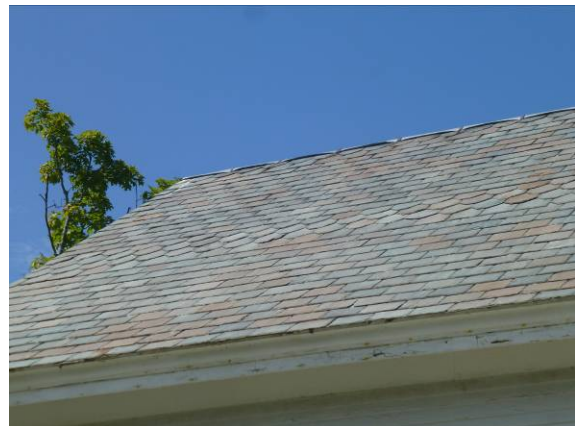
Photo #46: Maintenance building roof

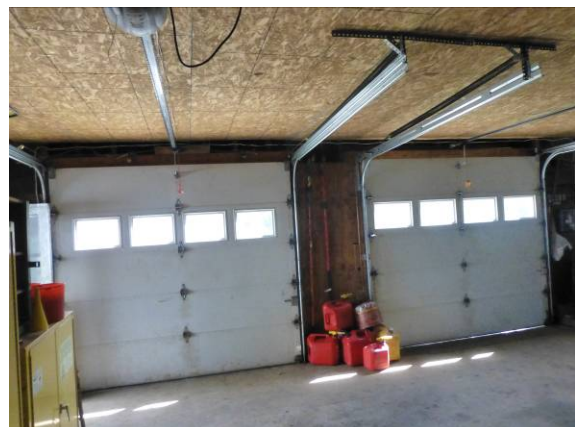
Photo #48: Maintenance building overhead doors

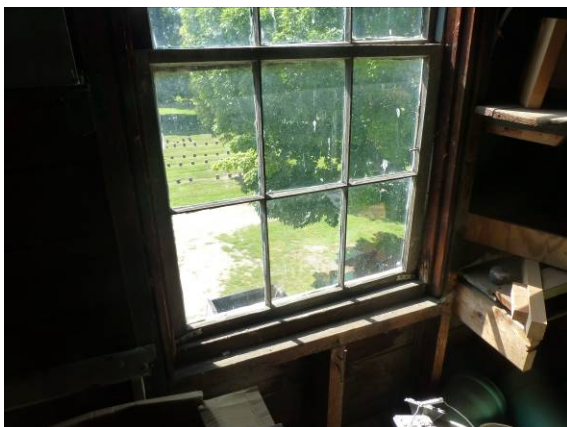
Photo #53: Maintenance building window

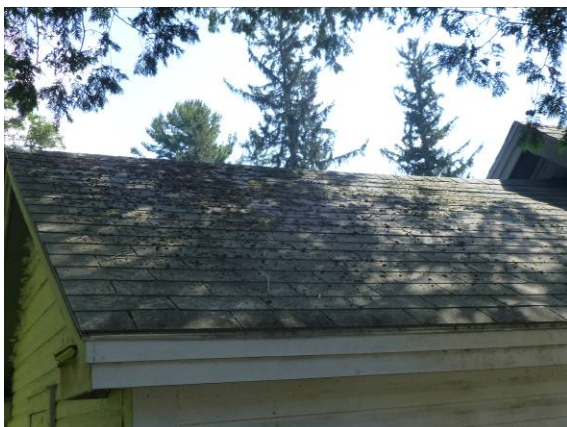
| Photo<br>#59: | Break house roof |

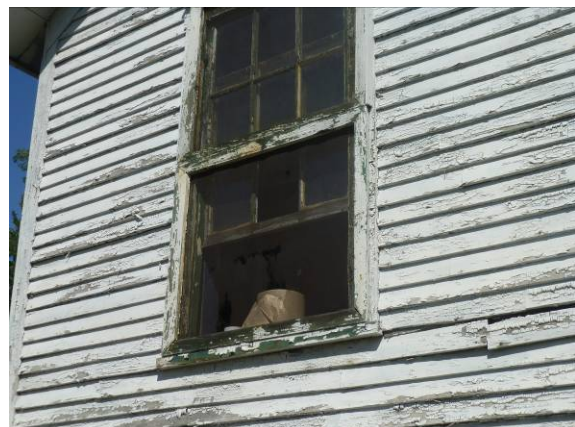
| Photo<br>#60: | Break house window |

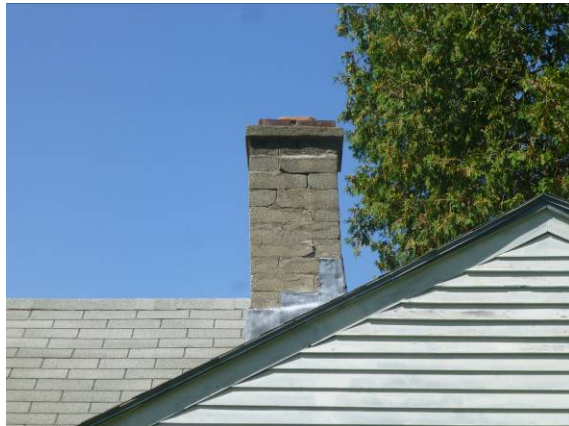
Photo #61: Break house chimney

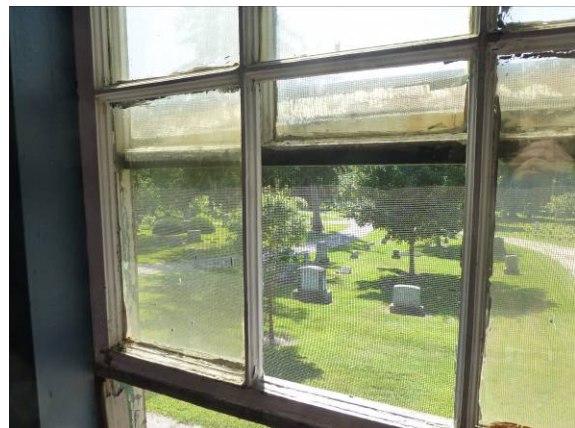
Photo #64: Break house window detail

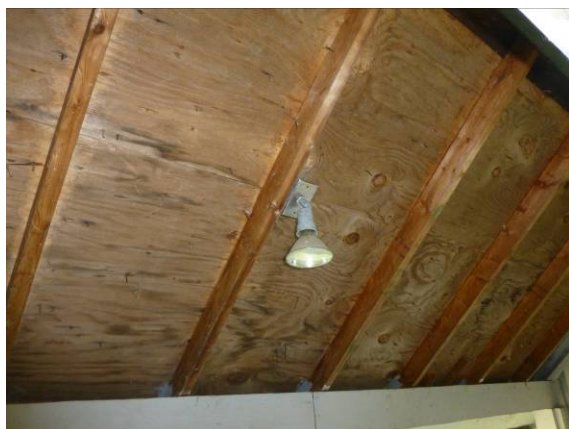
Photo #65: Break house roof structure
