## **Burlington Conservation Board**

## Conservation Board Meeting Minutes

## FY20 Burlington Slope Inspections

**CITY OF BURLINGTON, VERMONT  
SLOPE STABILITY INSPECTION**

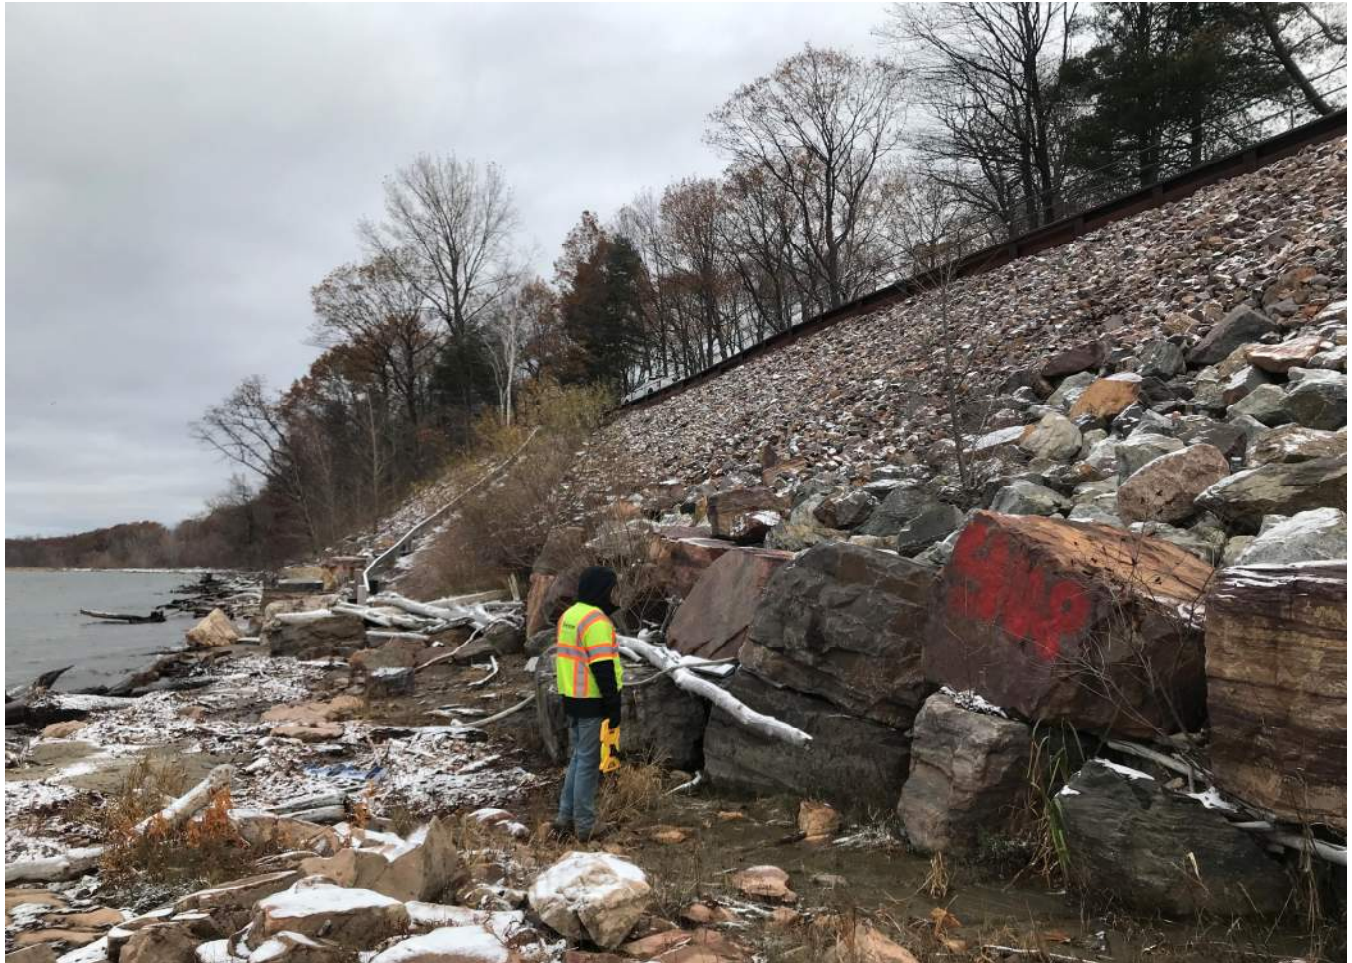
Slope Location: Bike Path Near Starr Farm Date: 11/11/2019  
City: Burlington State: Vermont  
Description : Photograph 1 – Northern Portion of Remediated Slope

**Photograph 1:** View to north of northern section of remediated slope showing boulder and cobble rip-rap armor and large basal blocks; natural vegetated slope located to north of remediated area, and bike path at top of slope

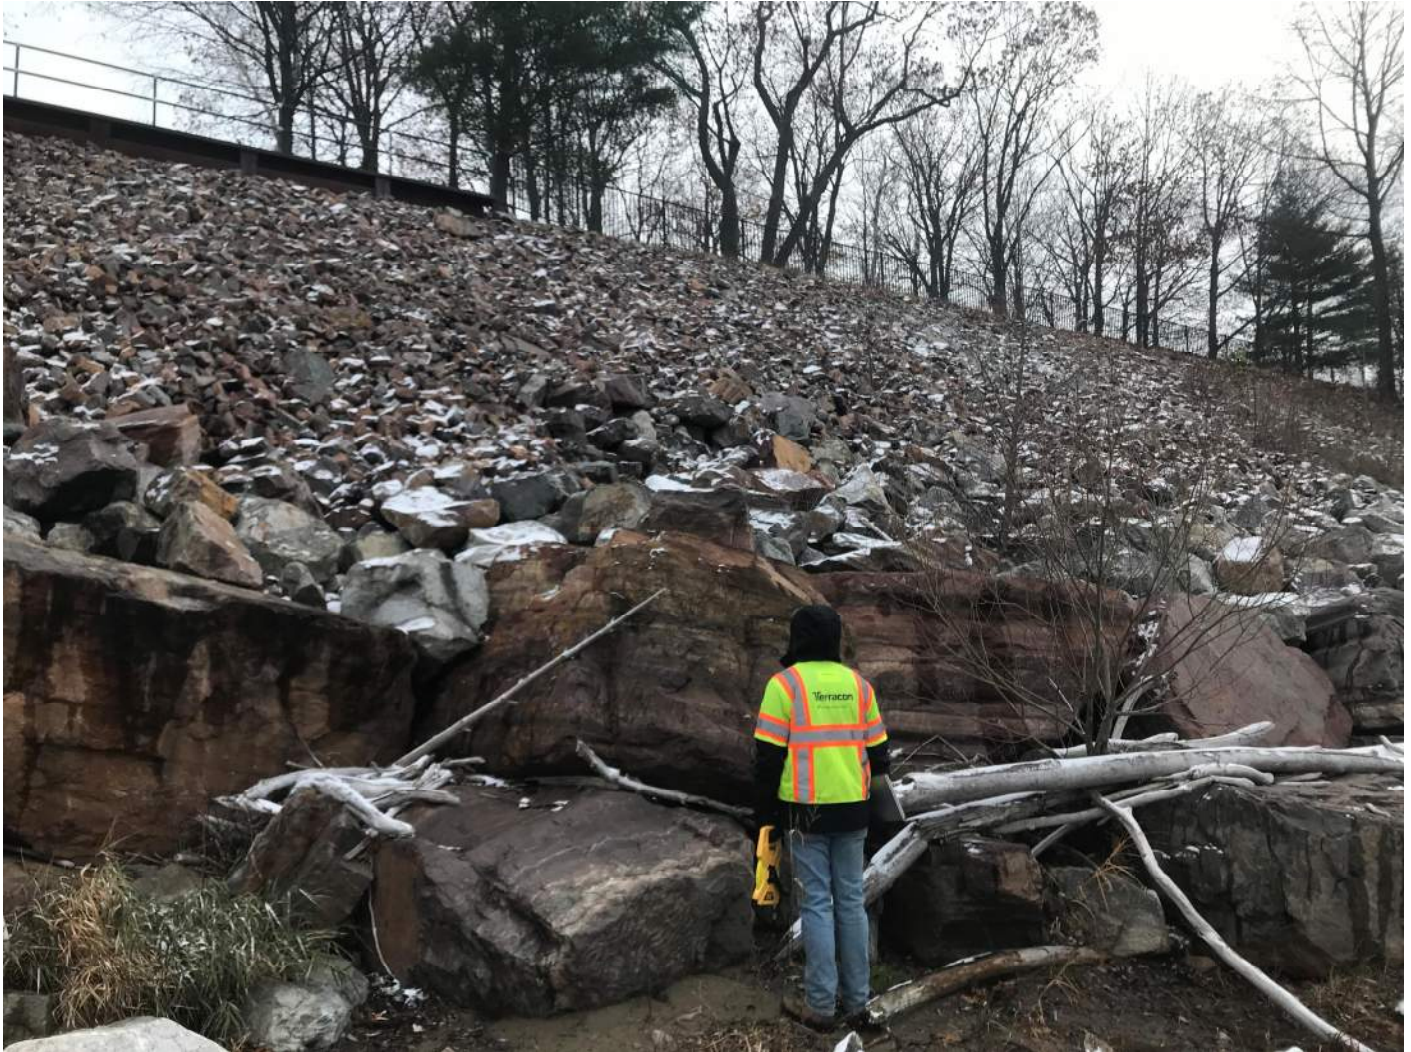
Description : Photograph 2 – Central Portion of Remediated Slope

**Photograph 2:** View to east of central portion of remediated slope showing cobble and boulder rip-rap armor and large basal blocks; bike path is located beyond fence; slope appears stable

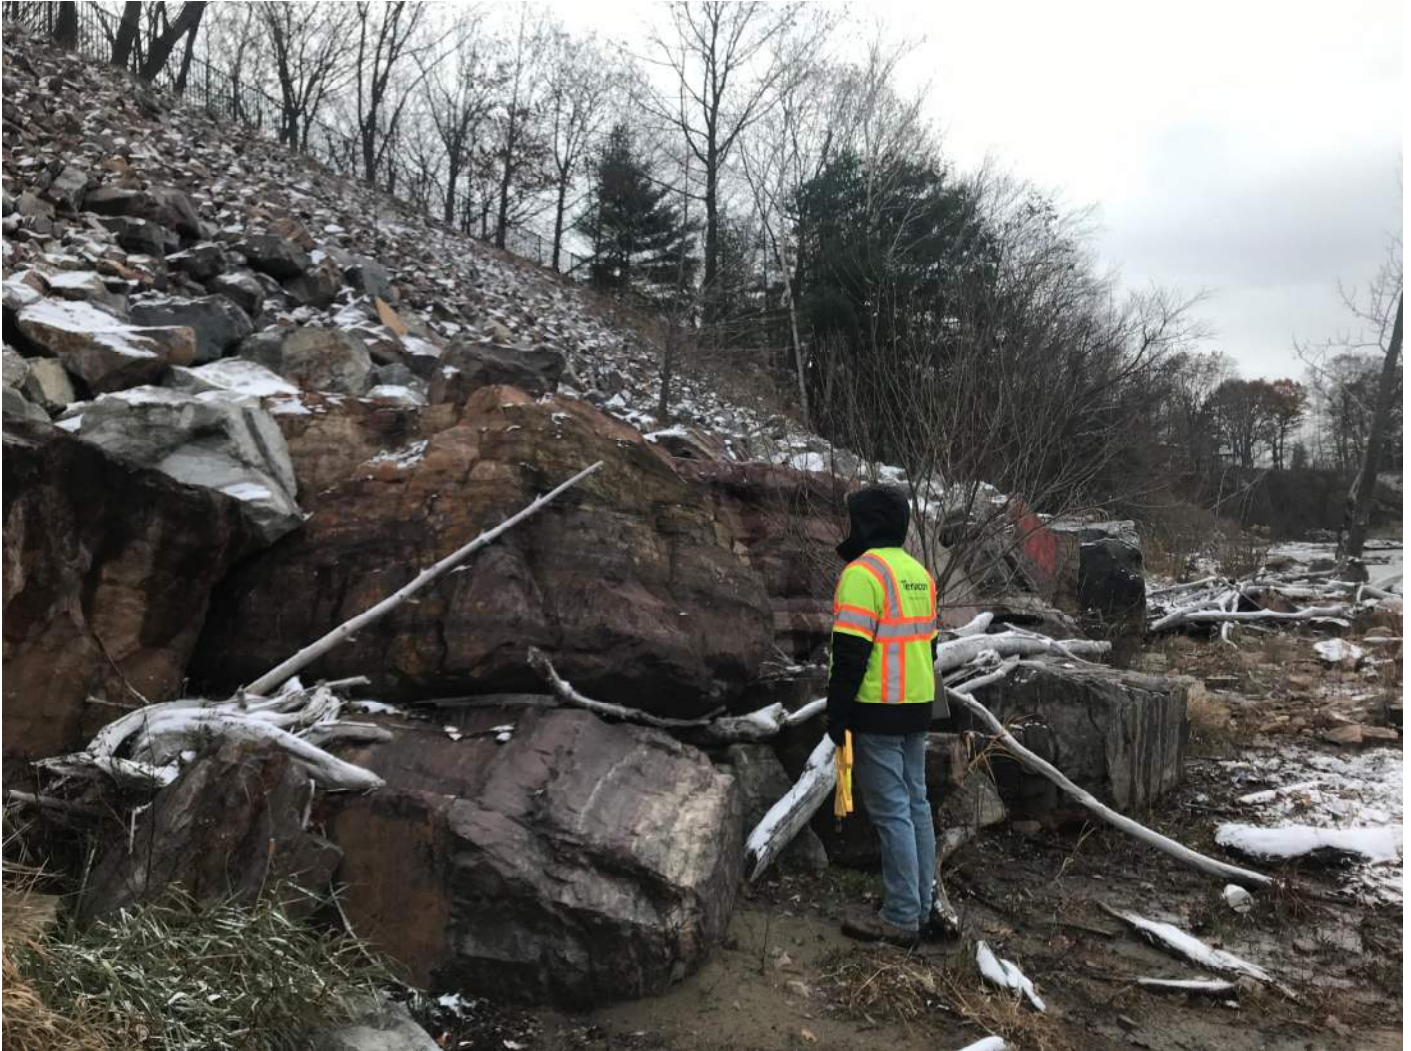
Description : Photograph 3 – Southern Portion of Remediated Slope

**Photograph 3:** View to south of southern portion of remediated slope; natural vegetated slope at southern flank located in background

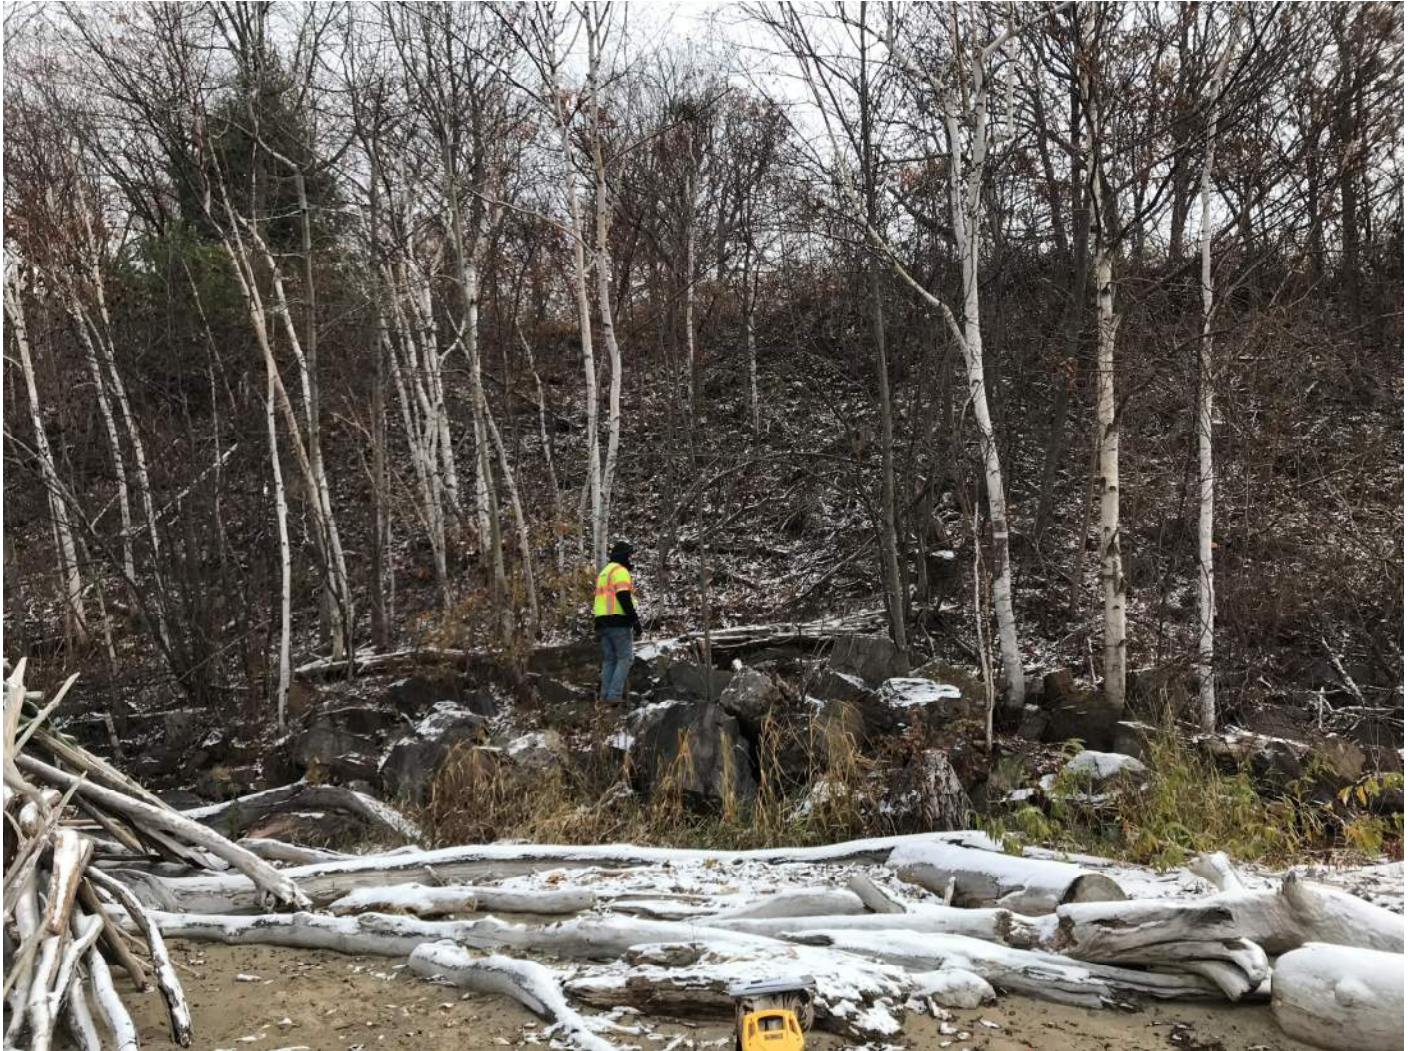
Slope Location: Bike Path Near Starr Farm Date: 11/11/2019  
City: Burlington State: Vermont  
Description : Photograph 4 – Vegetated Natural Slope on South Flank of Remediated Slope

**Photograph 4:** View to south of vegetated natural slope on south flank of remediated slope

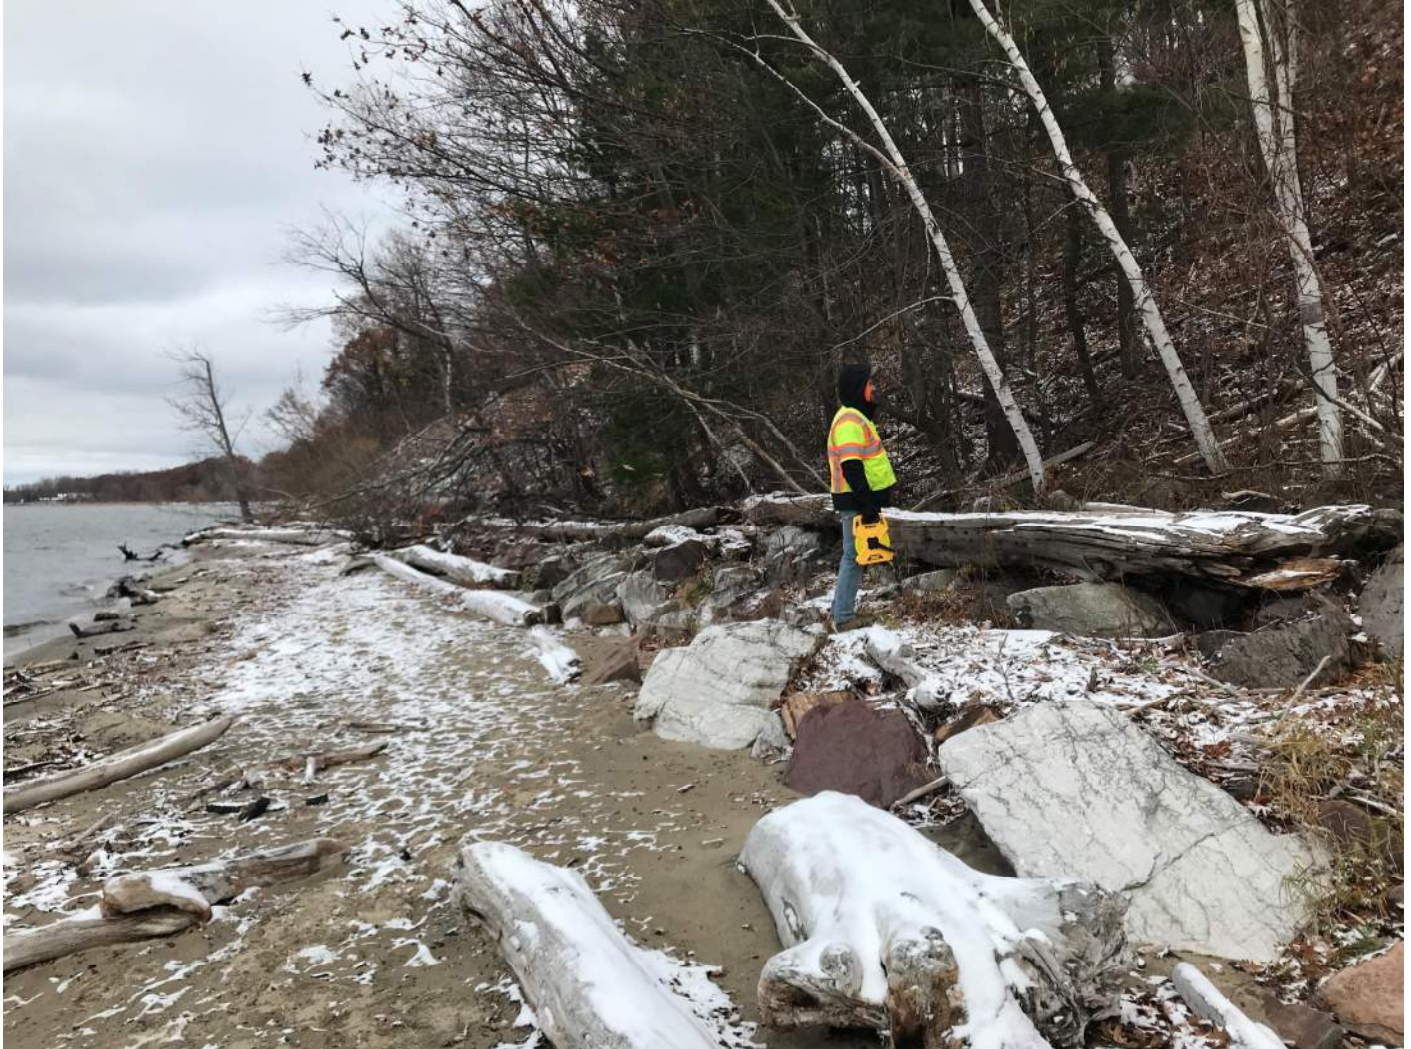
Description : Photograph 5 – Base of Natural Slope on Southern Flank of Remediated Slope

**Photograph 5:** View to north; base of natural slope on southern flank of remediated slope; remediated slope is shown in the background; note lean of birch trees down-slope indicative of slope creep

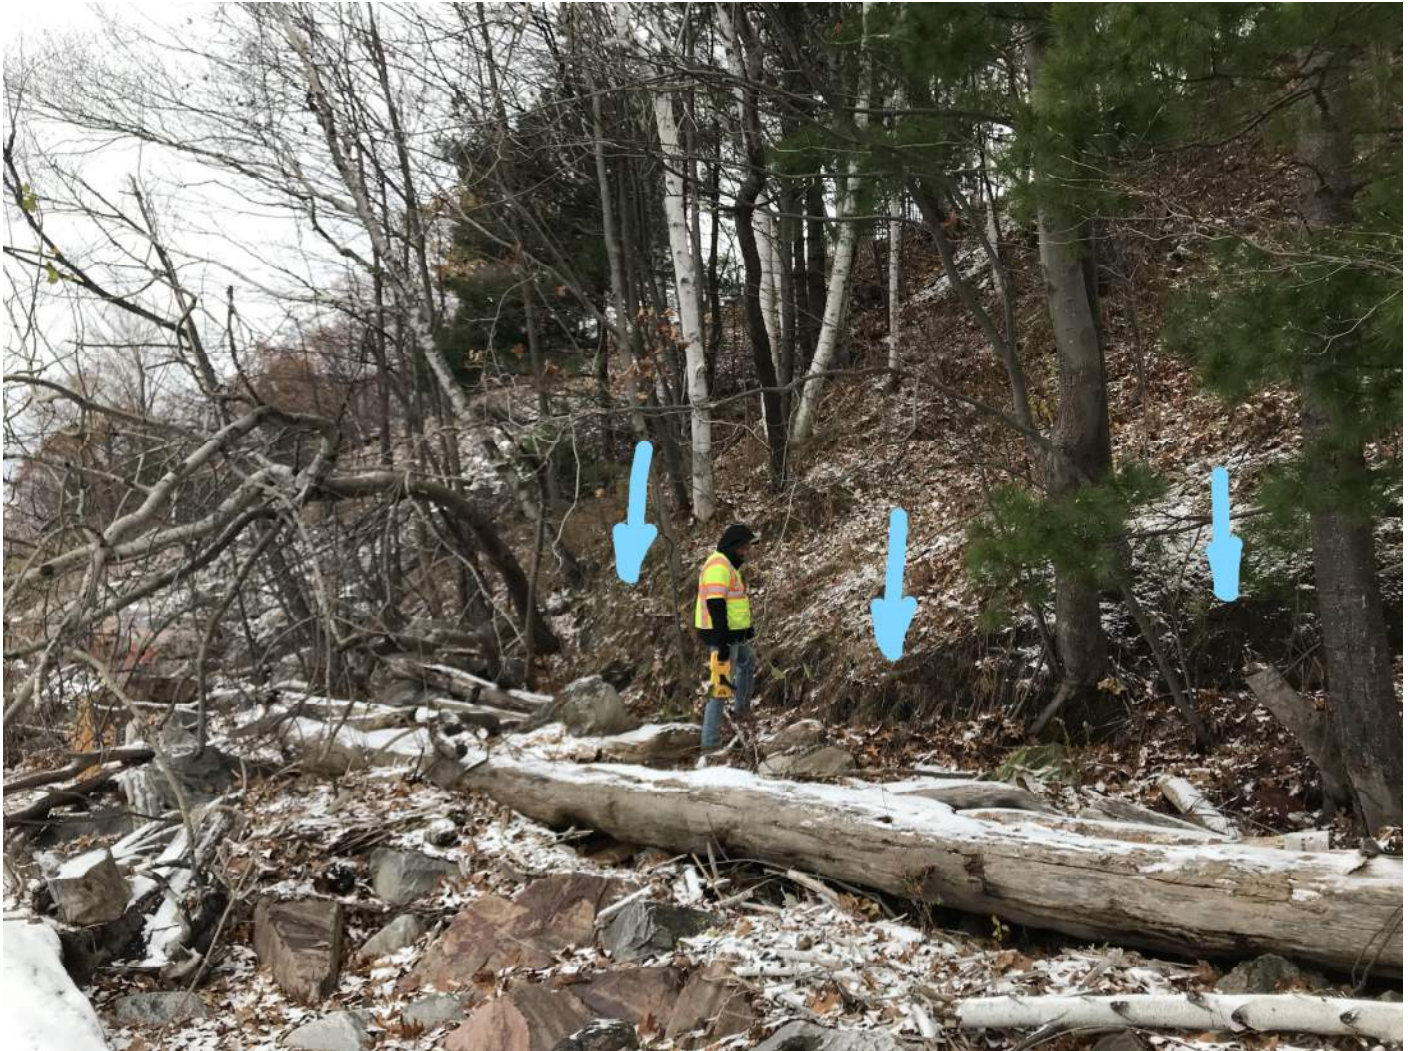
Description : Photograph 6 – Wave-Cut Scarp at Base of Natural Slope on Southern Flank

**Photograph 6:** View to northeast of wave-cut scarp at base of natural slope located on the southern flank of the remediated slope

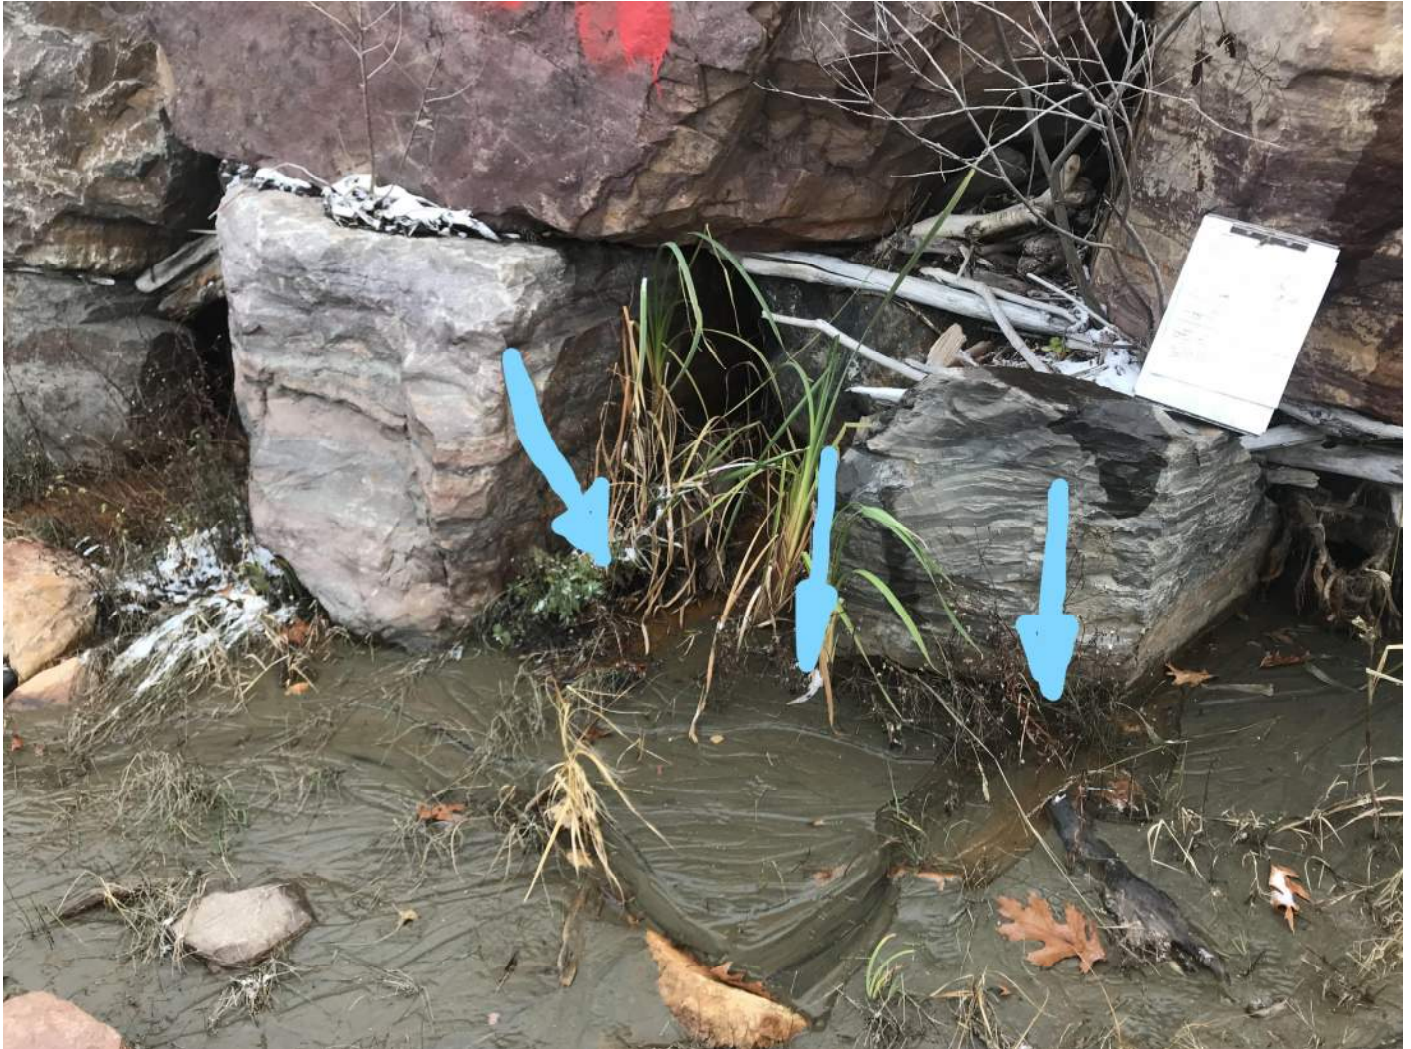
Description : Photograph 8 – Seepage at Base of Remediated Slope

**Photograph 8:** View to east; seepage at base of rip-rap and basal blocks of remediated slope

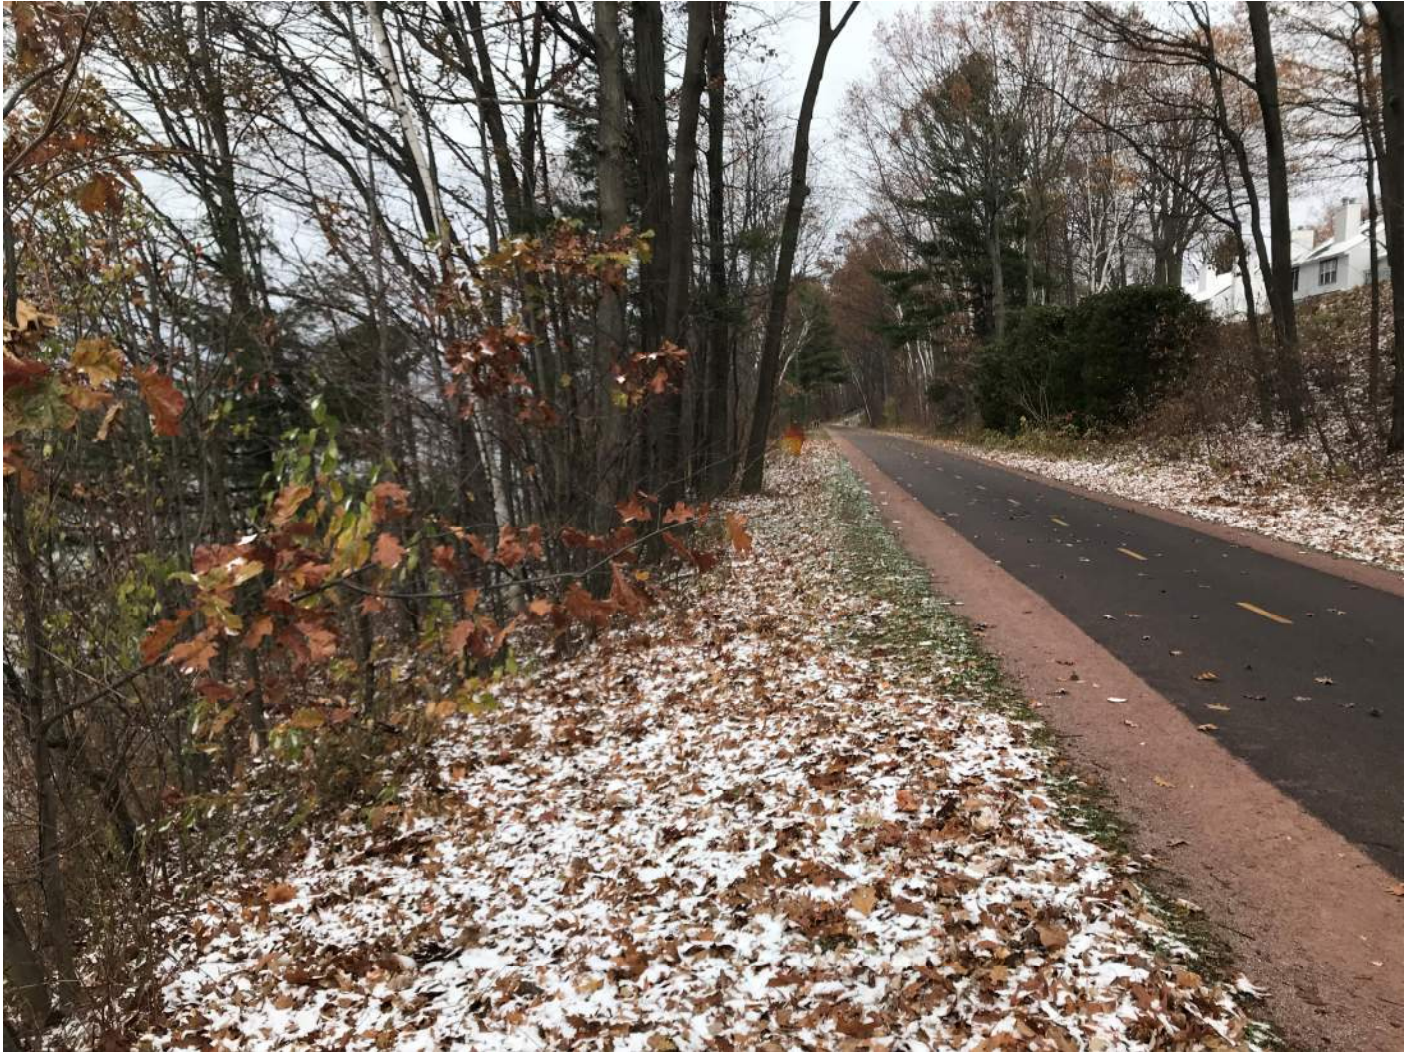
Slope Location: Bike Path Near Starr Farm Date: 11/11/2019  
City: Burlington State: Vermont  
Description : Photograph 11 – Top of Natural Slope North of Remediated Slope

**Photograph 11:** View to north; top of natural slope north of remediated slope; possible beginning of minor ground disturbance in vegetated area directly adjacent to bike path?

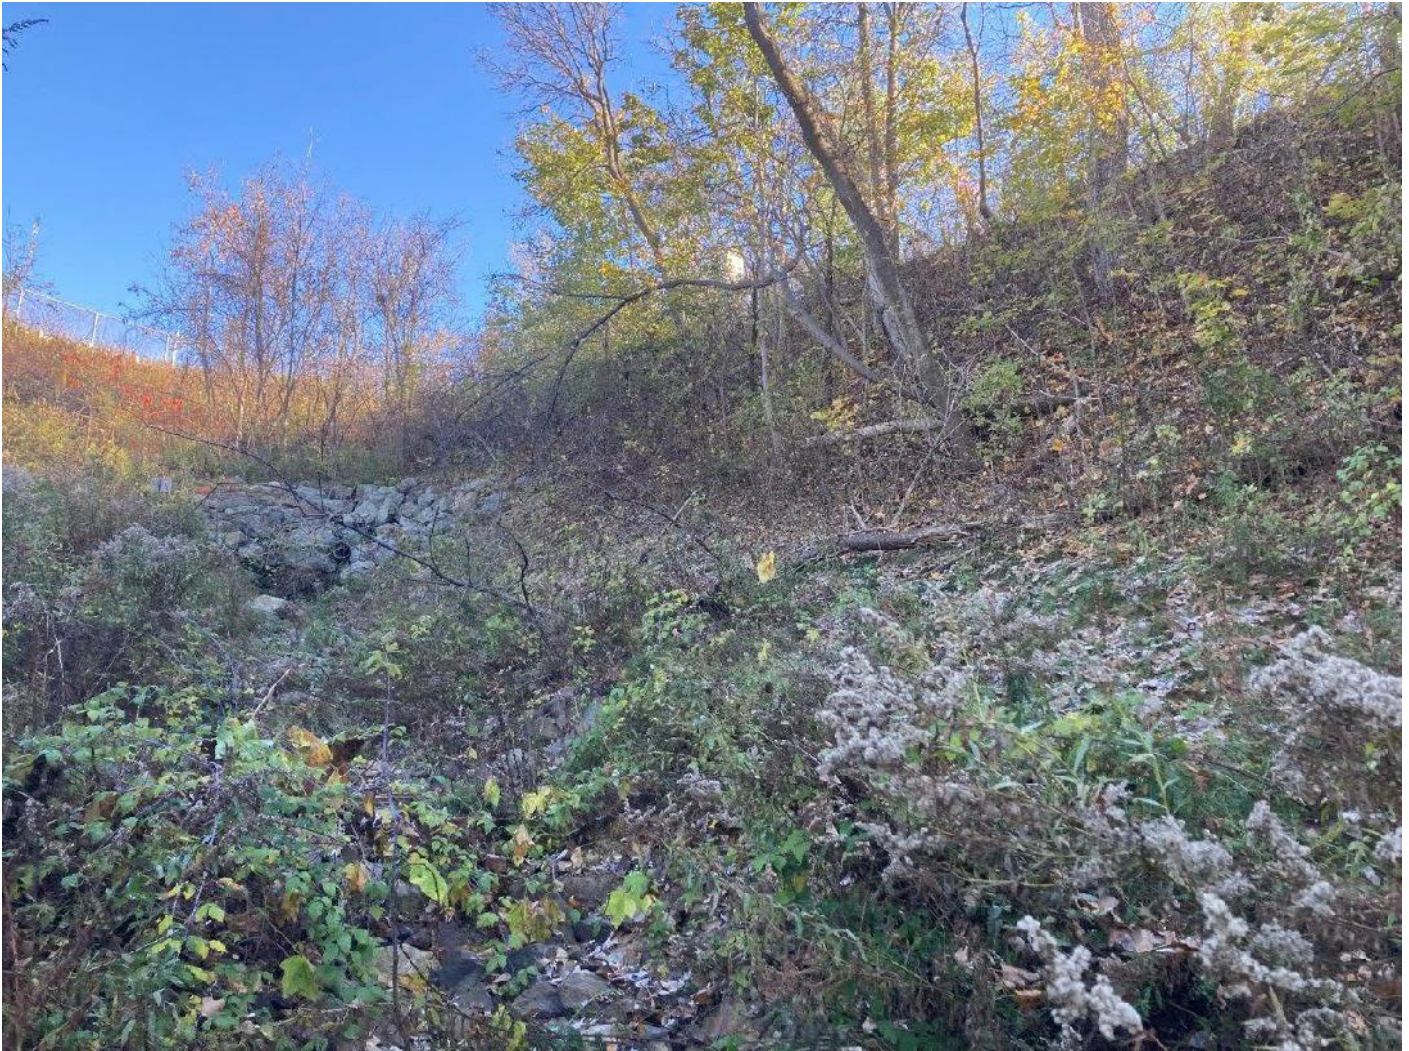
Slope Location: Manhattan Drive and Route 127 (Beltline) Date: Oct. 2020  
City: Burlington State: Vermont  
Description : Photograph 1: Stormwater Discharge Pipe and Stone-Lined Channel (Culvert 1)

**Photograph 1:** View to southeast, toward intersection of Manhattan Drive and Route 127 showing stormwater discharge point (designated herein as Culvert 1) and stone-lined drainage channel.

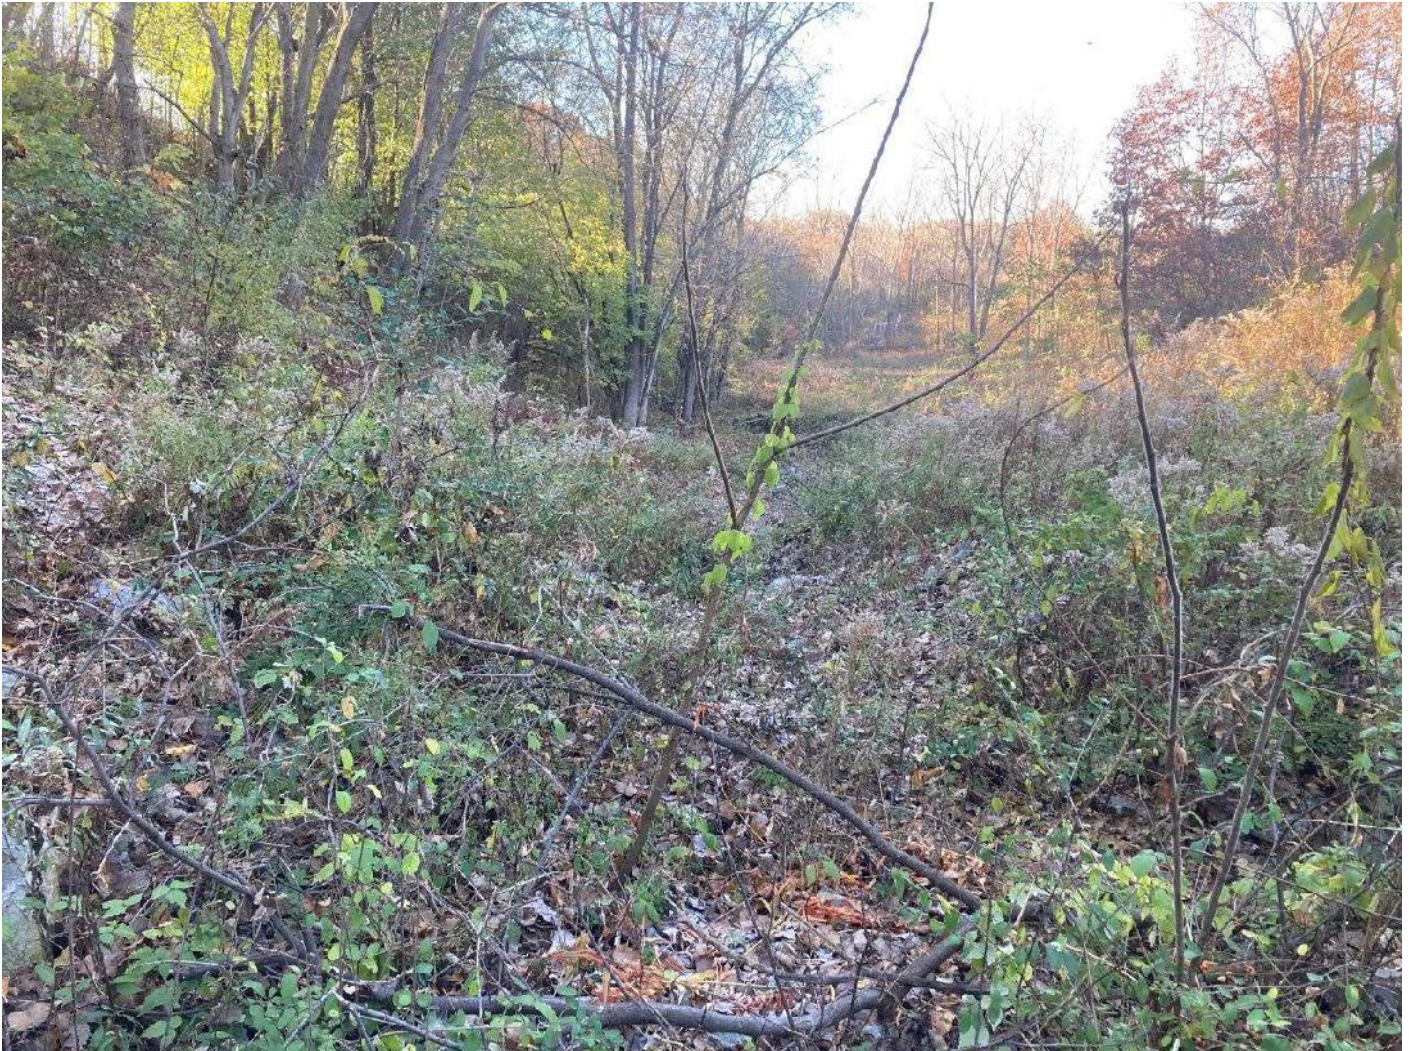
Slope Location: Manhattan Drive and Route 127 (Beltline) Date: Oct. 2020  
City: Burlington State: Vermont  
Description : Photograph 2: Stone-Lined Stormwater Discharge Channel at Base of Slope

**Photograph 2:** View to northwest of stone-lined stormwater discharge channel at base of slope and downstream from Culvert 1; drainage designed to discharge to wetlands at top right of photograph; note density of vegetative overgrowth within channel (compare with Photographs 3 and 4).

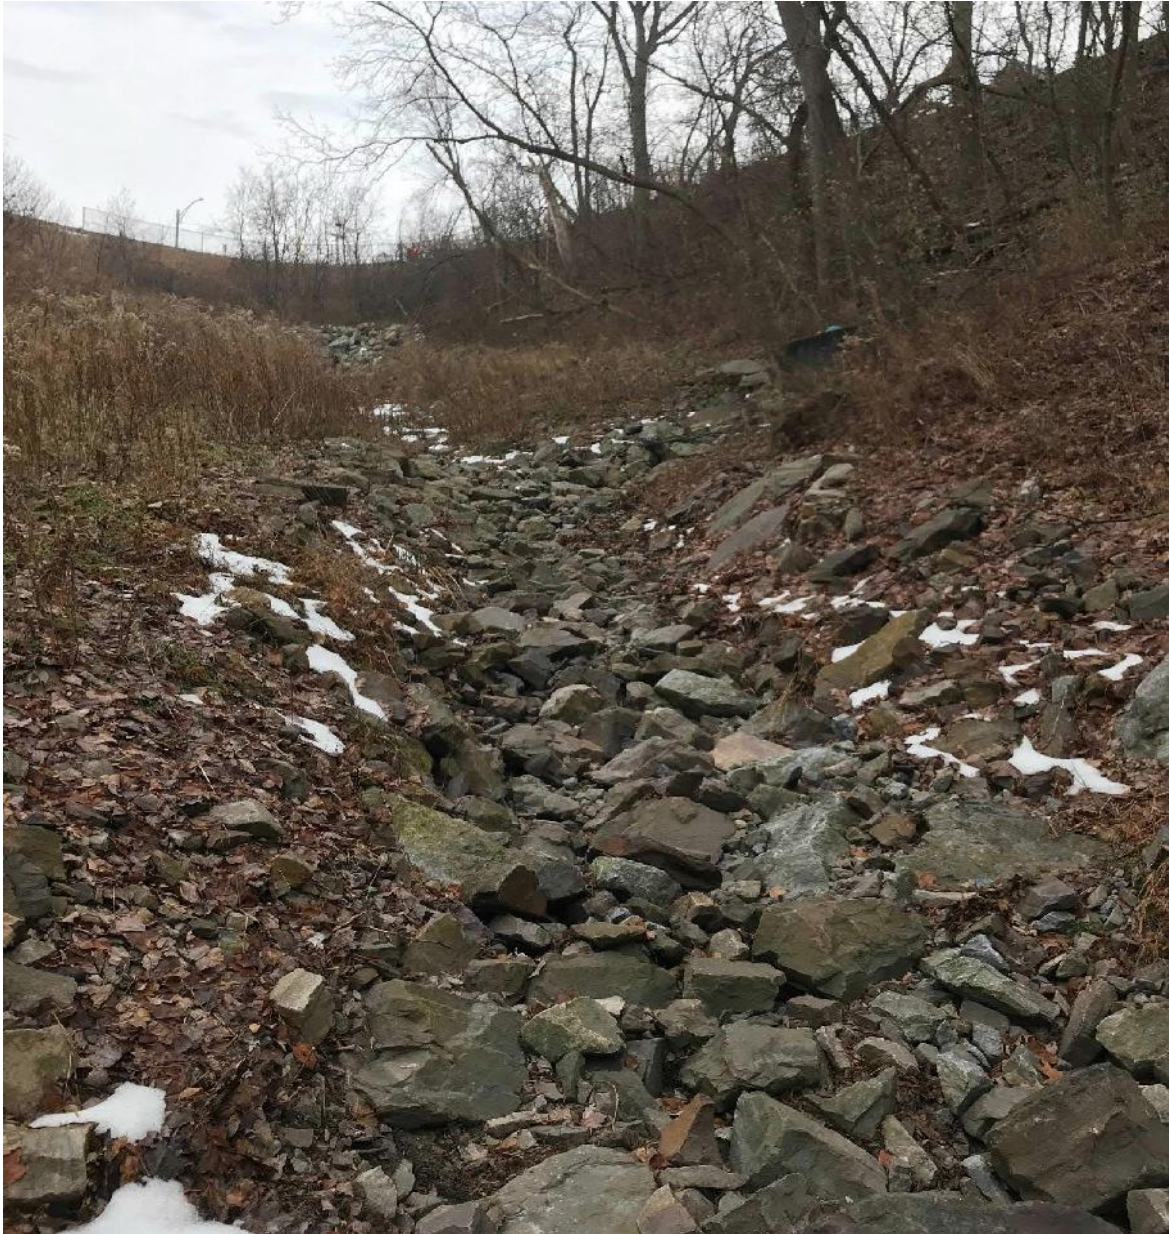
Slope Location: Manhattan Drive and Route 127 (Beltline) Date: Oct. 2020  
City: Burlington State: Vermont  
Description : Photograph 3: Culverts 1 and 2 Discharge Channel in November 2019

**Photograph 3:** View to southeast taken in November 2019 by Hoyle, Tanner & Associates of well-lined discharge channel from Culvert 1.

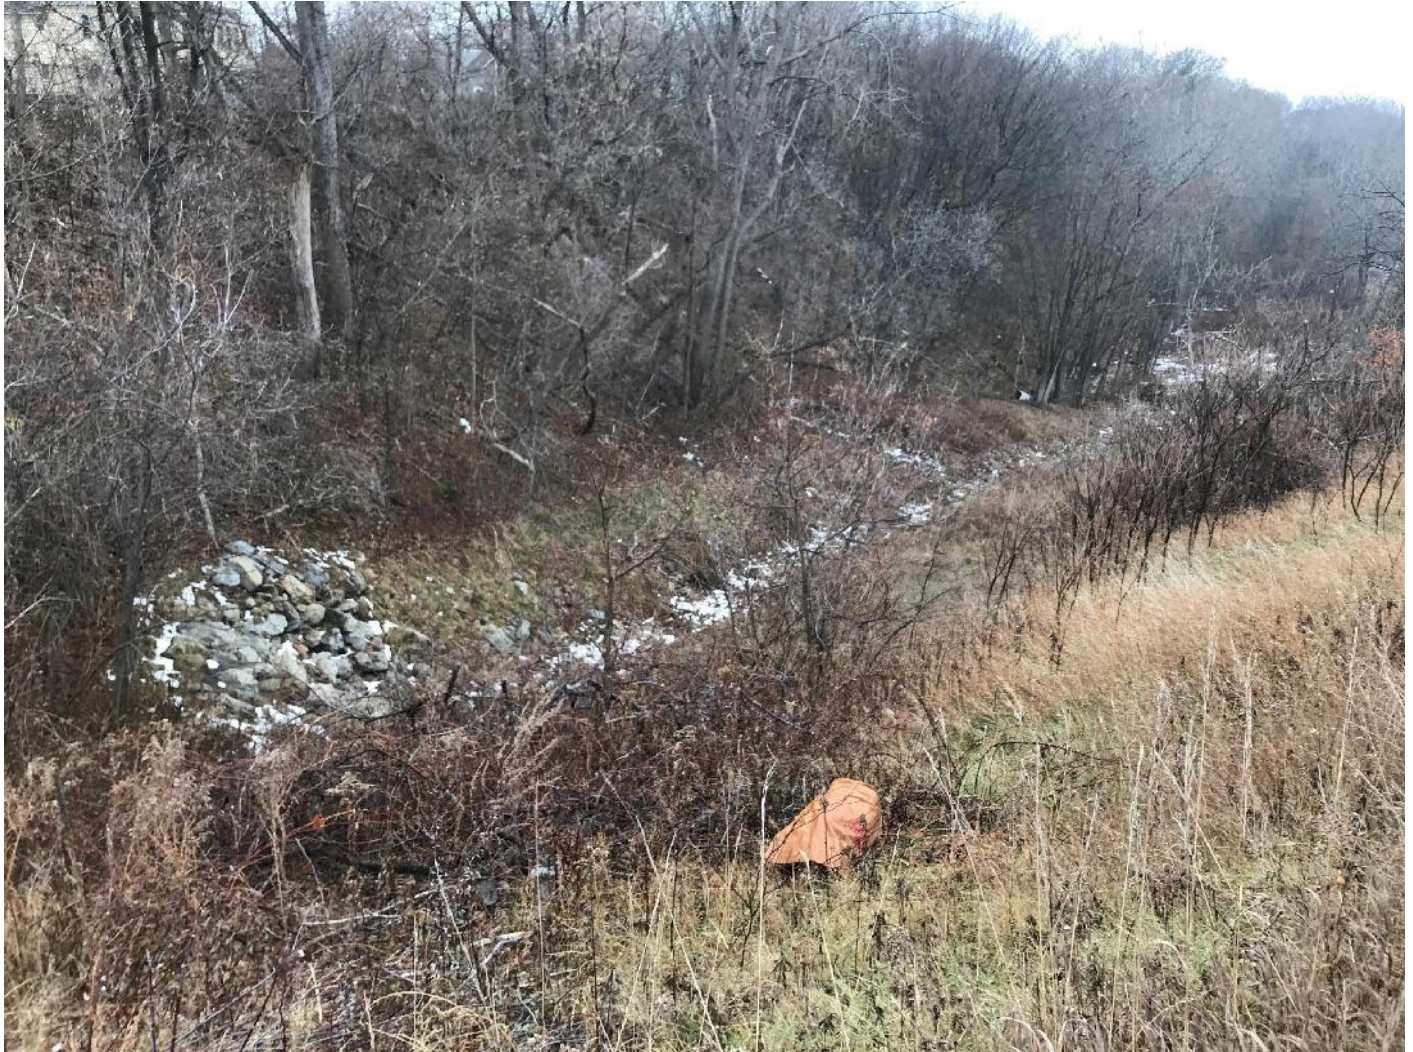
Slope Location: Manhattan Drive and Route 127 (Beltline) Date: Oct. 2020  
City: Burlington State: Vermont  
Description : Photograph 4: Culverts 1 and 2 Discharge Channel in November 2019

**Photograph 4:** View to west south-west taken in November 2019 during Hoyle, Tanner & Associates inspection showing well-defined Culvert 1 discharge channel at base of slope.

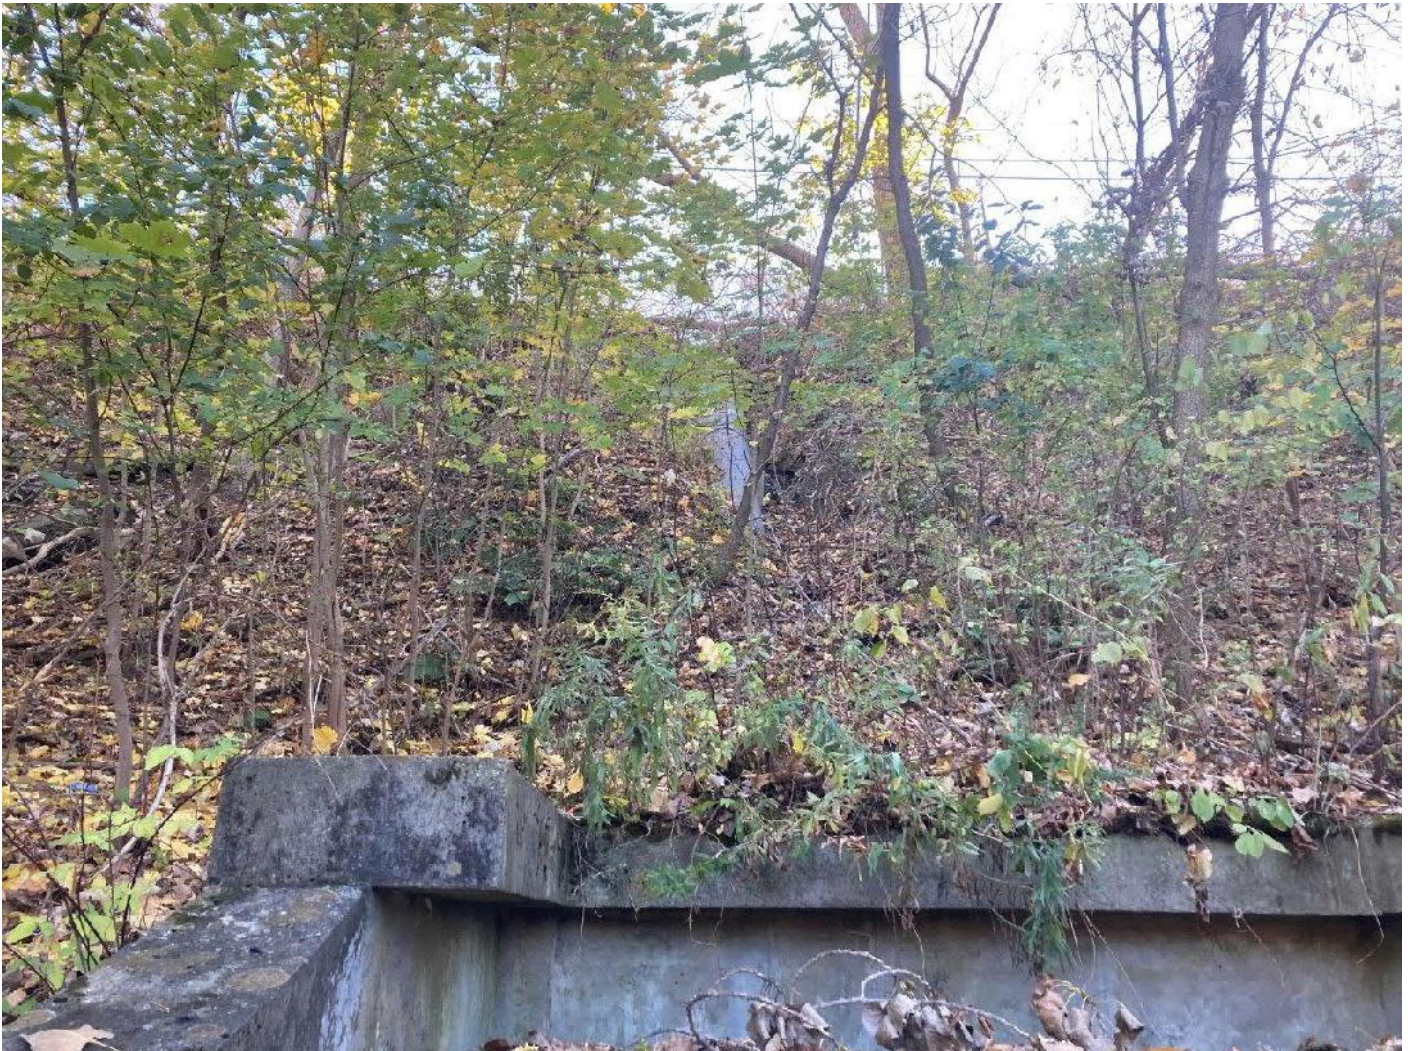
Slope Location: Manhattan Drive and Route 127 (Beltline) Date: Oct. 2020  
City: Burlington State: Vermont  
Description : Photograph 5: Manhattan Drive Discharge Pipe and Culvert

**Photograph 5:** View to south towards Manhattan Drive of stormwater discharge pipe and top of culvert (designated herein as Culvert 2); note soil erosion around exposed pipe.

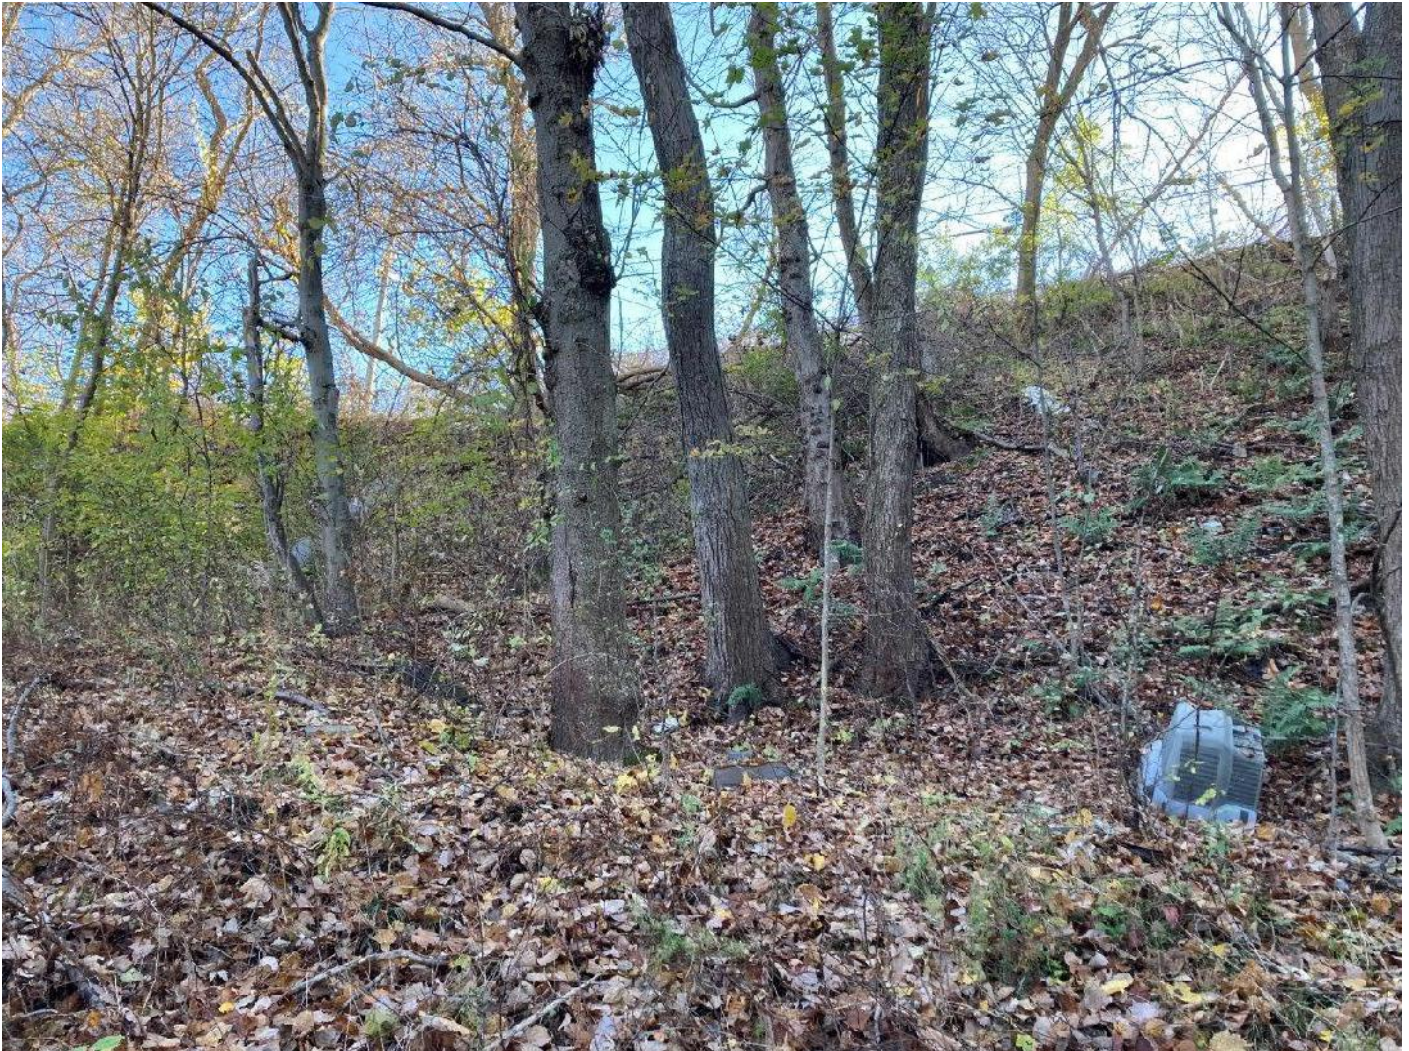
Slope Location: Manhattan Drive and Route 127 (Beltline) Date: Oct. 2020  
City: Burlington State: Vermont  
Description : Photograph 6: View of Slope West of Discharge Culvert 2

**Photograph 6:** View to south-southeast toward Manhattan Drive of portion of slope to the west of Culvert 2 discharge pipe (right-center of photograph).
