## **Burlington Conservation Board**

## Conservation Board Meeting Minutes

## FY20 Burlington Slope Inspections

**CITY OF BURLINGTON, VERMONT  
SLOPE STABILITY INSPECTION**

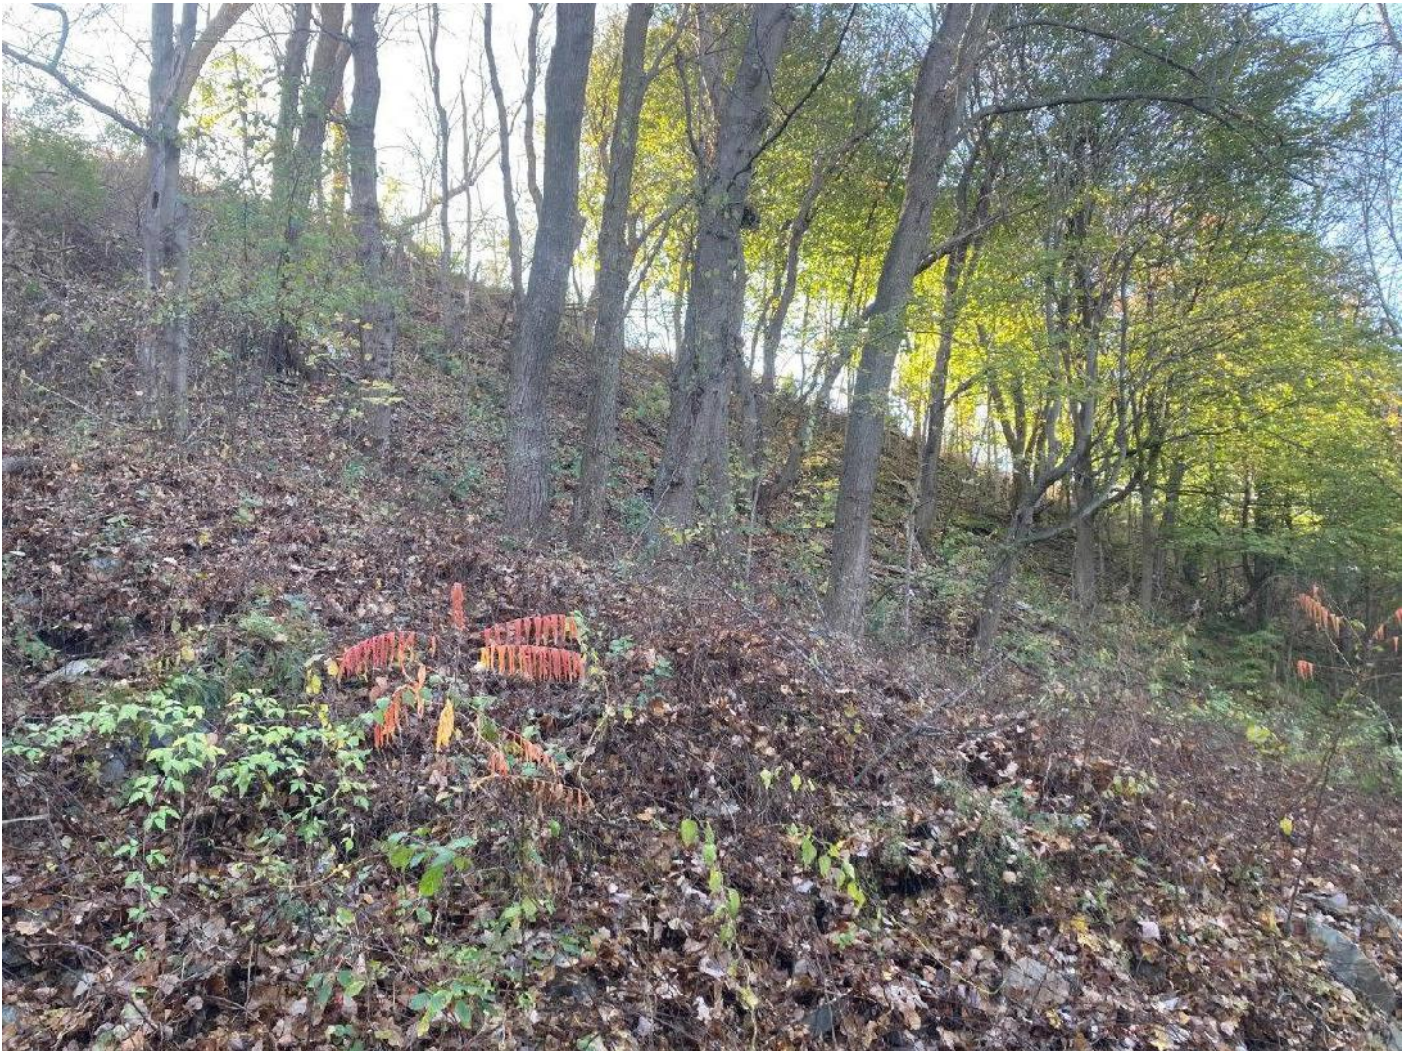
Slope Location: Manhattan Drive and Route 127 (Beltline) Date: Oct. 2020  
City: Burlington State: Vermont  
Description : Photograph 7: View of Slope West of Culvert 2

**Photograph 7:** View to southwest toward Manhattan Drive showing slope west of Culvert 2; stone-lined discharge channel from Culvert 1 at toe of slope in foreground; note lack of distinct lean of trees mid-slope.

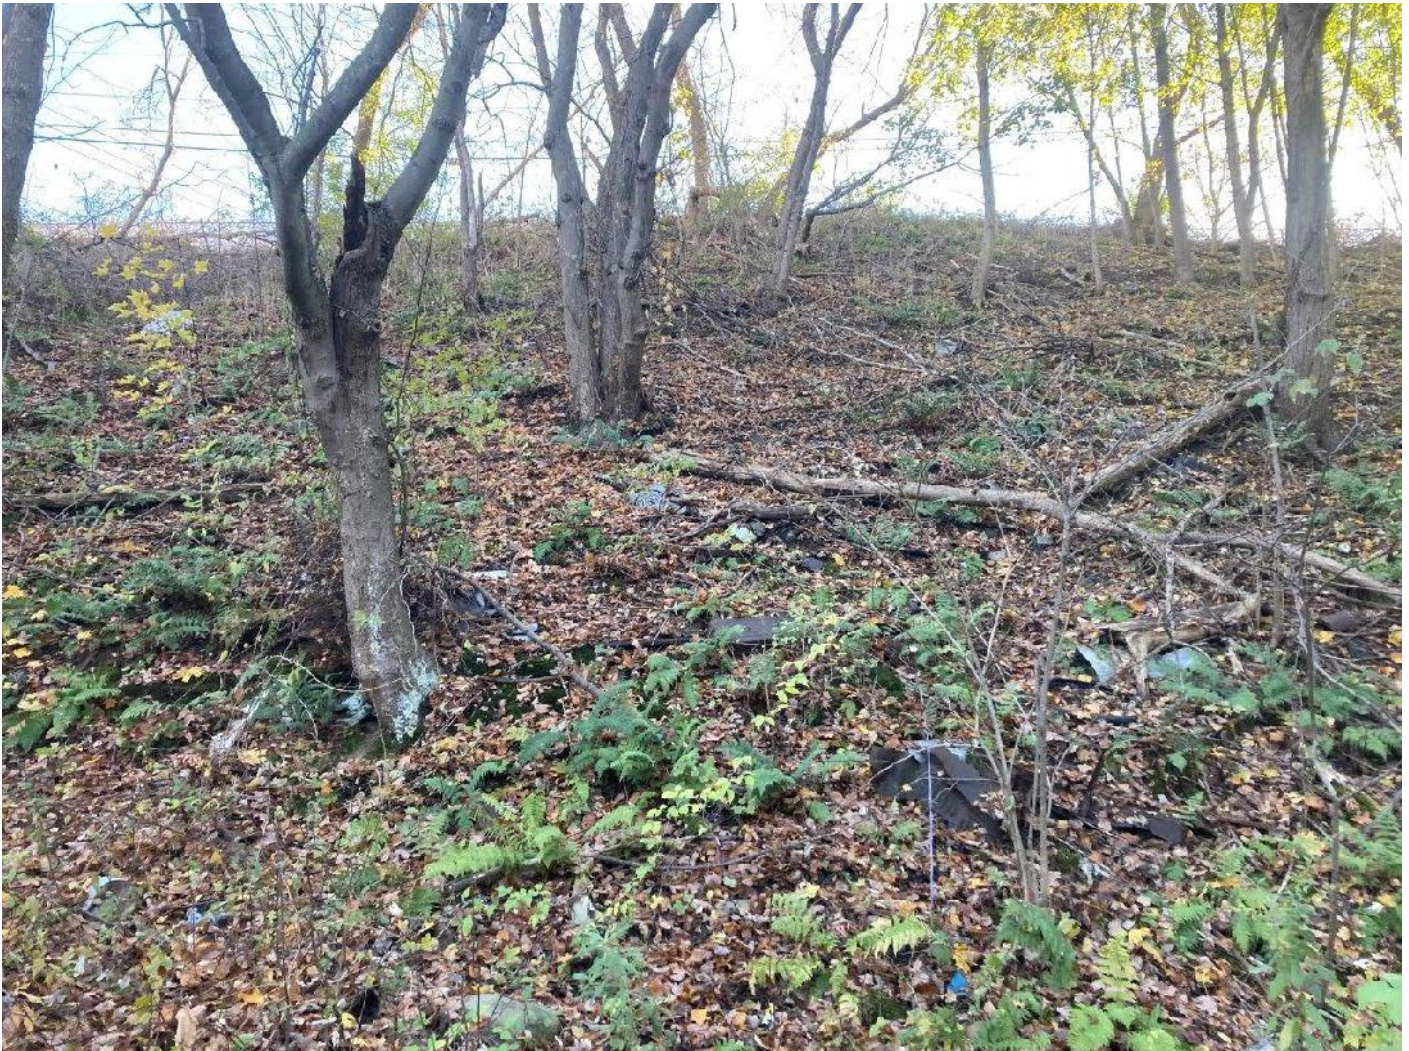
Slope Location: Manhattan Drive and Route 127 (Beltline) Date: Oct. 2020  
City: Burlington State: Vermont  
Description : Photograph 8: Surface Erosion and Beginning of Gully Formation

**Photograph 8:** View to south towards Manhattan Drive, west of Culvert 2, showing surface soil erosion from sheet wash generated during heavy precipitation events; surface expression of gully formation beginning to appear; note lean of trees at top of slope.

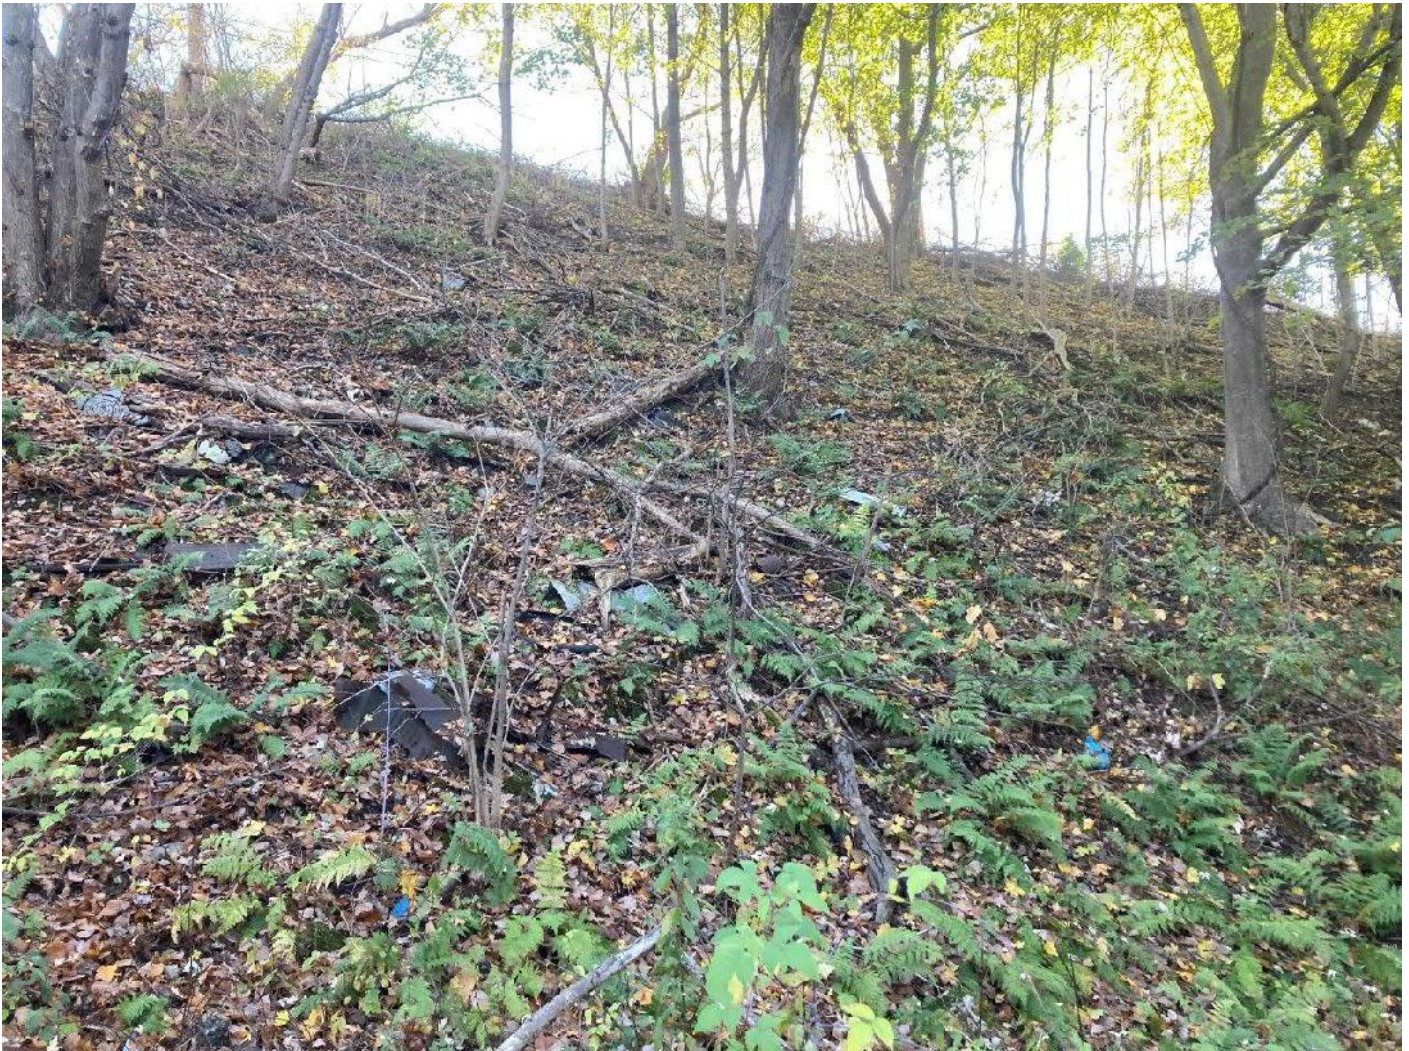
Slope Location: Manhattan Drive and Route 127 (Beltline) Date: Oct. 2020  
City: Burlington State: Vermont  
Description : Photograph 9: View of Slope West of Photo 8 Showing Surface Soil Erosion

**Photograph 9:** View southwest from toe of slope, west of Photograph 8, showing surface soil erosion from sheet wash generated during heavy precipitation events; surface expression of gully formation beginning to appear; note lean of trees at top of slope (top center and top left).

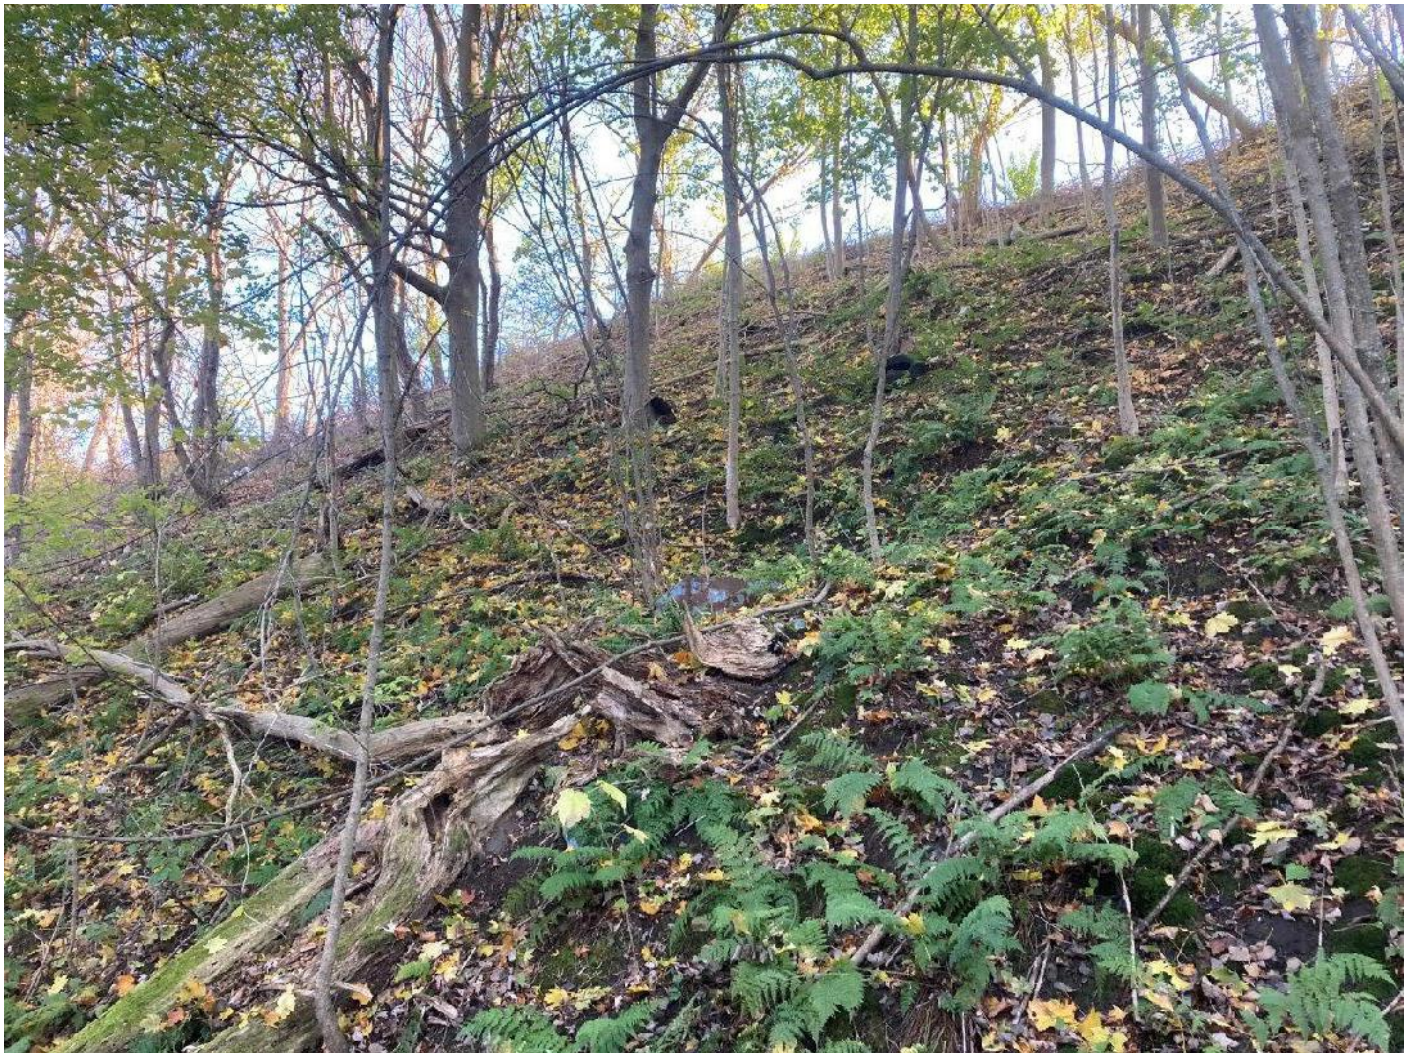
Slope Location: Manhattan Drive and Route 127 (Beltline) Date: Oct. 2020  
City: Burlington State: Vermont  
Description : Photograph 10: View of Slope West of Culvert 2

**Photograph 10:** View to southeast from toe of slope showing surface soil erosion from sheet wash during precipitation events; surface expression of gully formation beginning to appear;

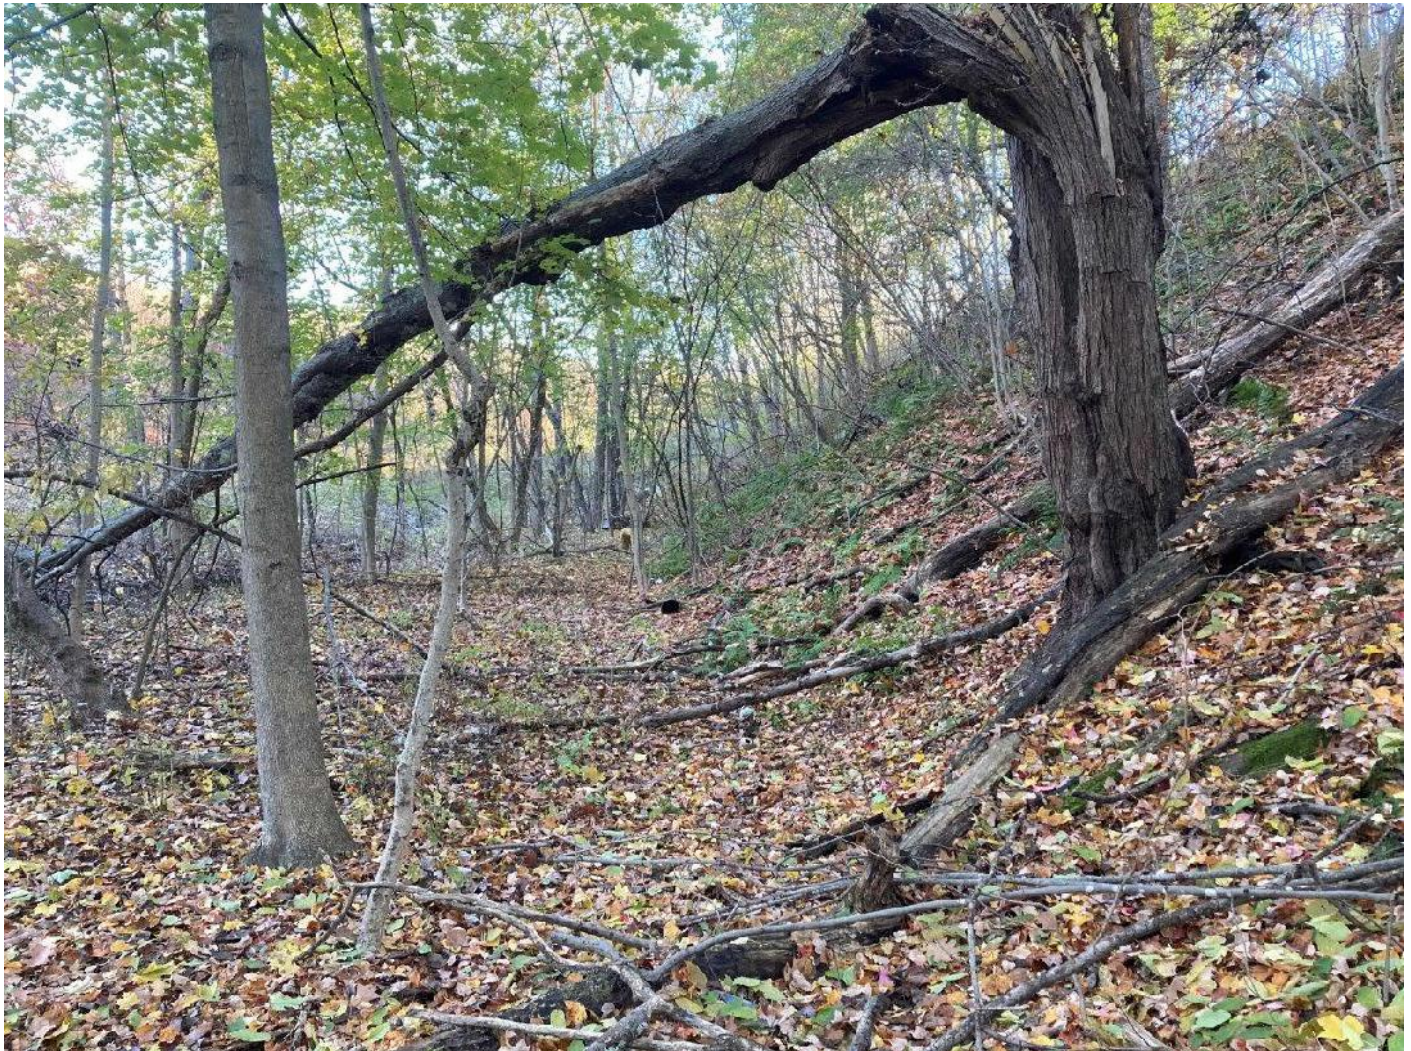
Slope Location: Manhattan Drive and Route 127 (Beltline) Date: Oct. 2020  
City: Burlington State: Vermont  
Description : Photograph 11: Toe of Slope Looking East to Culvert 2

**Photograph 11:** View to east showing toe of slope west of Culvert 2 and east of Culvert 3; unlined discharge channel from Culverts 1 and 2 at left-center of photograph.

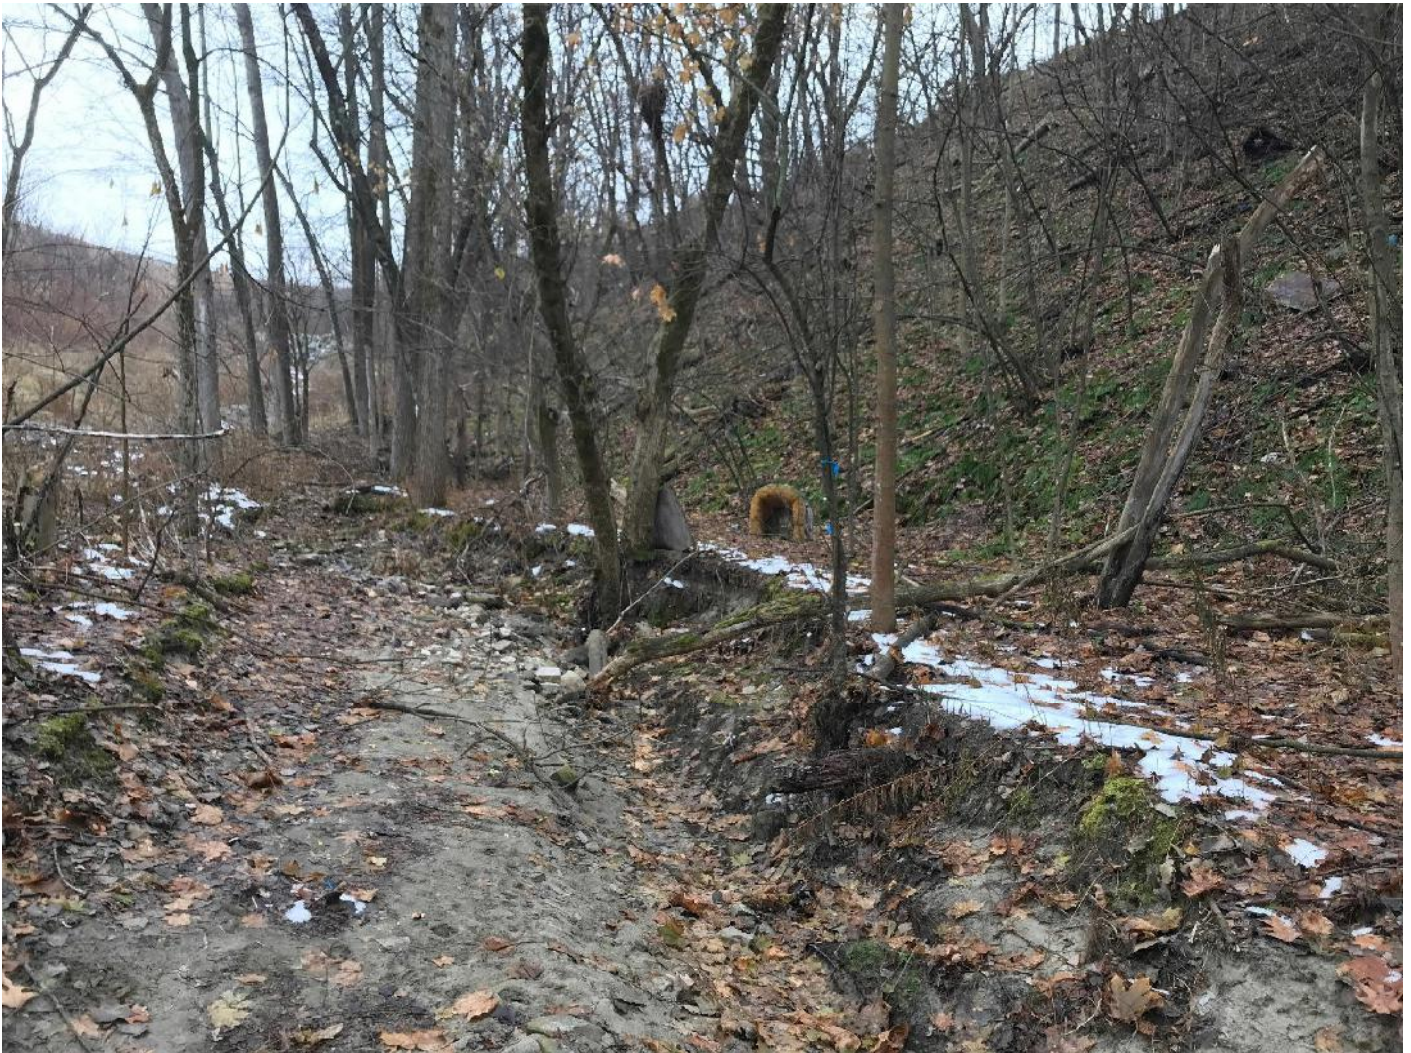
Slope Location: Manhattan Drive and Route 127 (Beltline) Date: Oct. 2020  
City: Burlington State: Vermont  
Description : Photograph 12: Toe of Slope Looking East to Culvert 2 - November 2019

**Photograph 12:** View to east taken by Hoyle, Tanner & Associates in November 2019 showing toe of slope west of Culvert 2 and east of Culvert 3; unlined discharge channel from Culverts 1 and 2 in foreground; note intensity of erosion from surface flow cutting back towards toe of the slope.

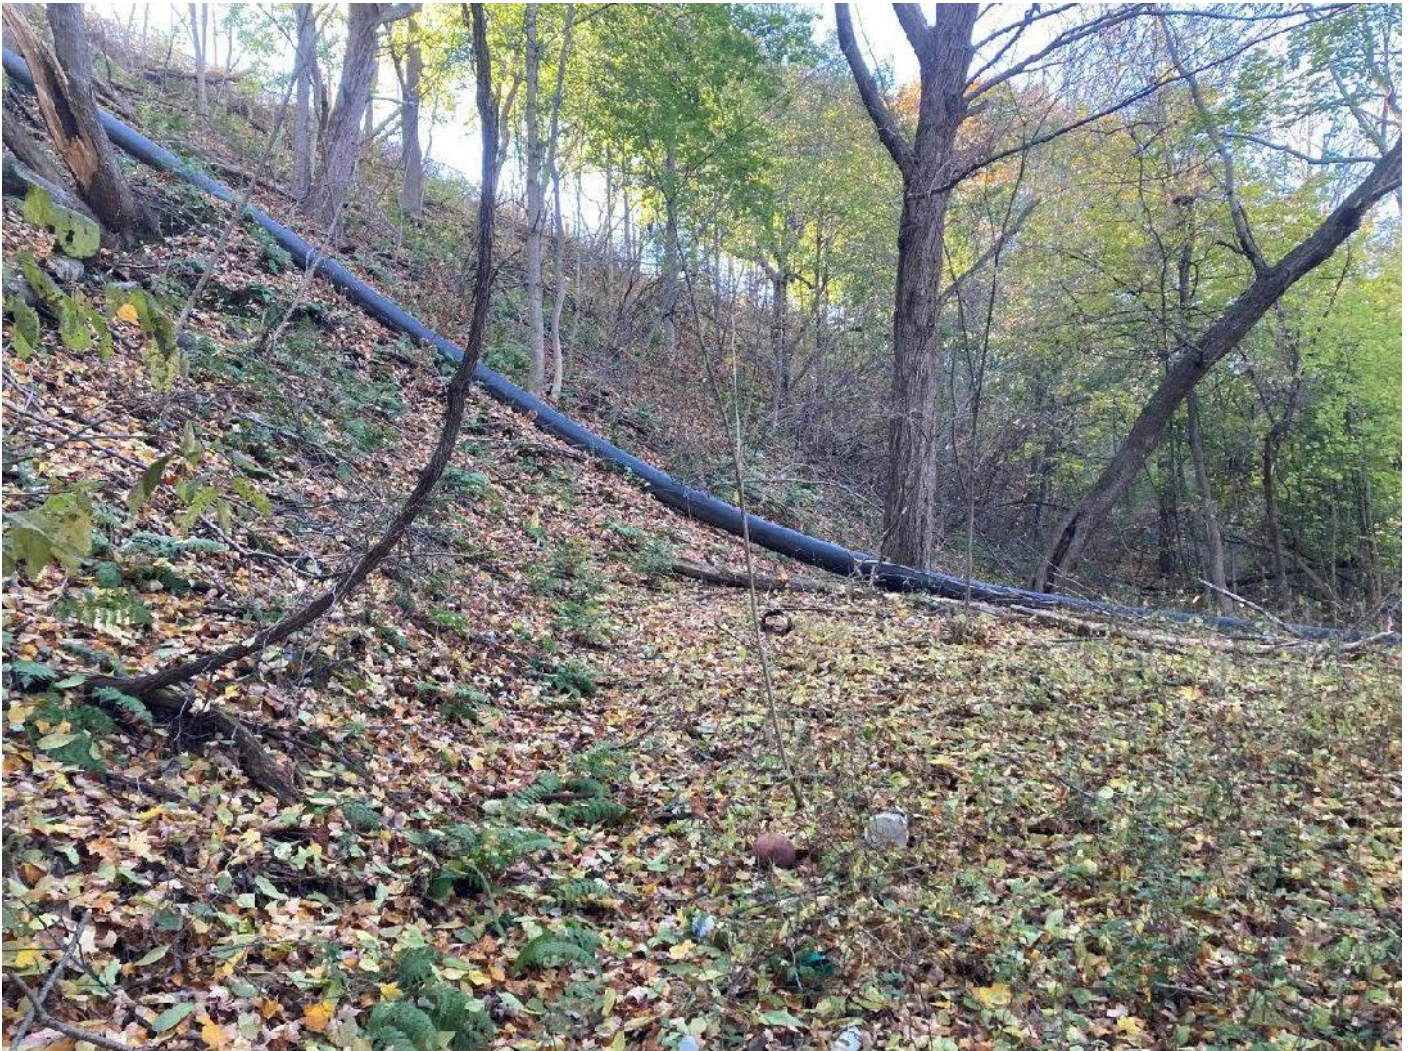
Slope Location: Manhattan Drive and Route 127 (Beltline) Date: Oct. 2020  
City: Burlington State: Vermont  
Description : Photograph 13: Stormwater Discharge Pipe from Manhattan Drive to Culvert 3

**Photograph 13:** View to southwest of exposed discharge pipe from Manhattan Drive to Culvert 3.

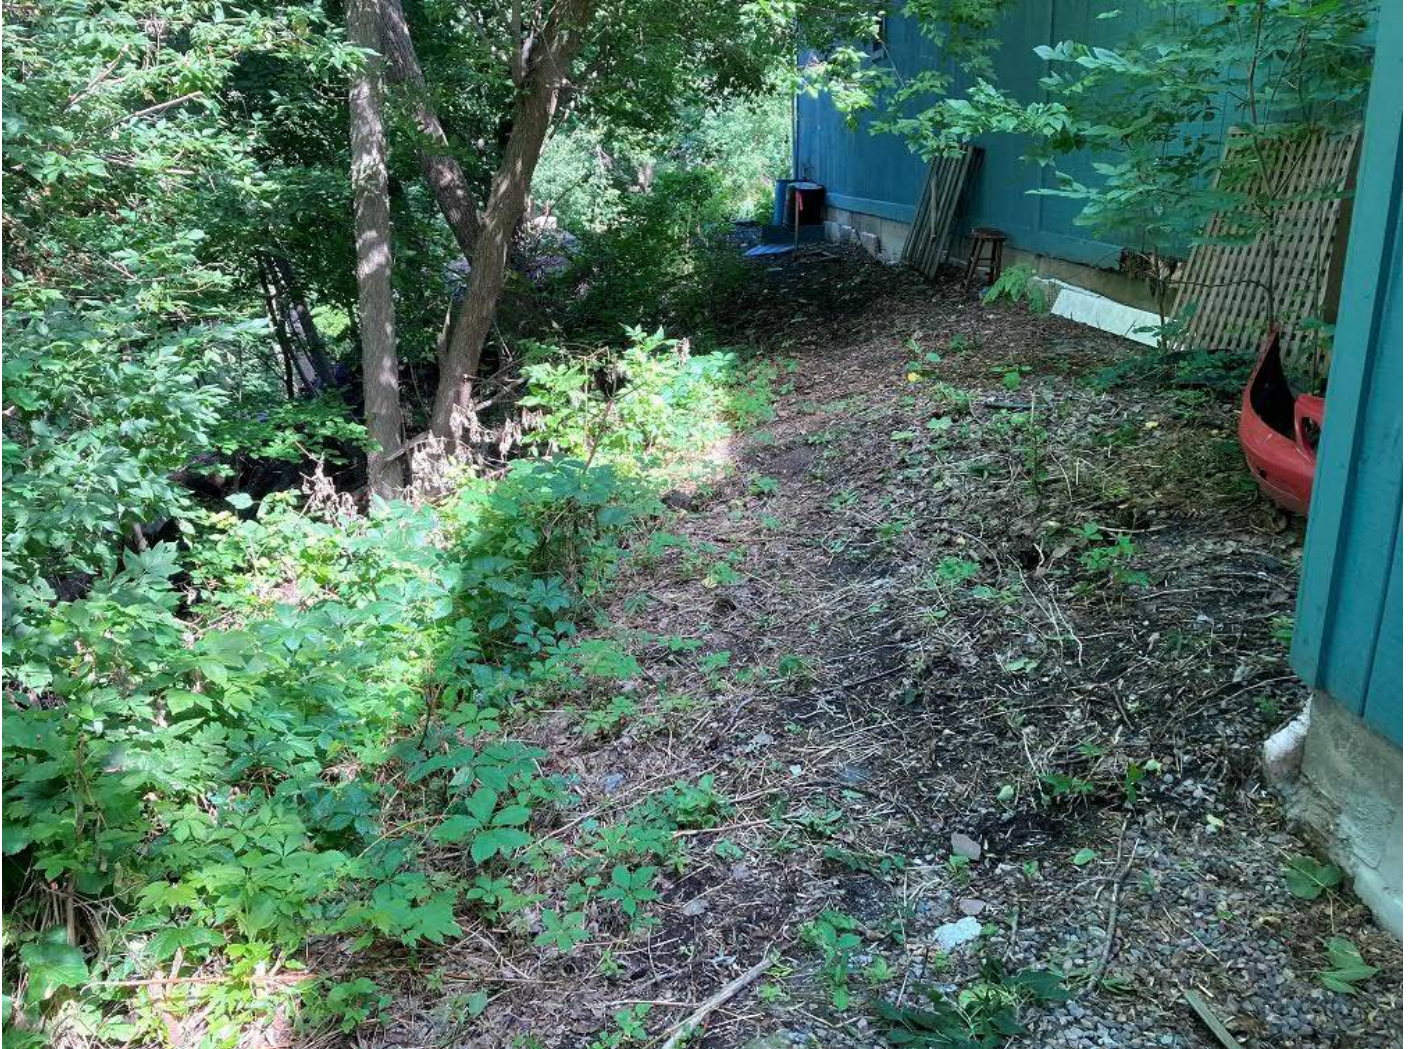
Slope Location: 411 Riverside Avenue – Burlington Collision Date: 8/5/2020  
City: Burlington State: Vermont  
Description : Photograph 1: Top of Slope Behind Burlington Collision Building

**Notes:** Presence of crown cracks at top of slope indicate recent movement. Incipient soil slumping observed at the top of the slope behind the Burlington Collision building. The slope in these areas will continue to experience small-scale, localized sliding and/or slumping.

**Photograph 1:** View to east behind Burlington Collision showing incipient slumping (center and center foreground) of photograph) at top of slope; note leaning trees top left

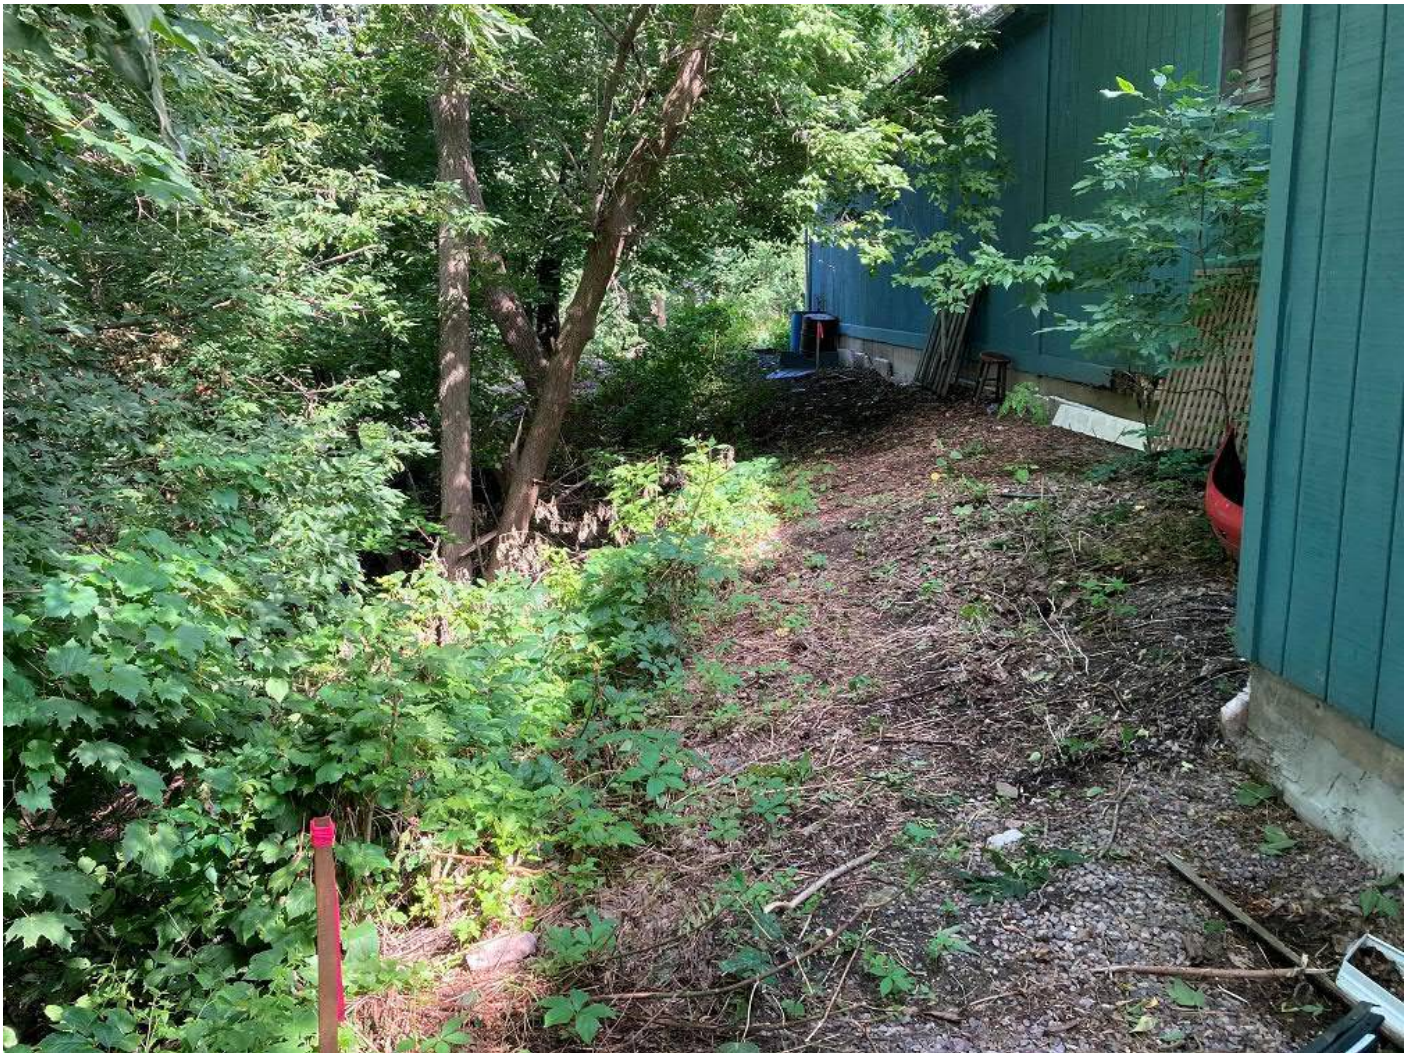
Slope Location: 411 Riverside Avenue – Burlington Collision Date: 8/5/2020  
City: Burlington State: Vermont  
Description : Photograph 2: Top of Slope Behind Burlington Collision

**Photograph 2:** Additional view of incipient slumping behind Burlington Collision Building

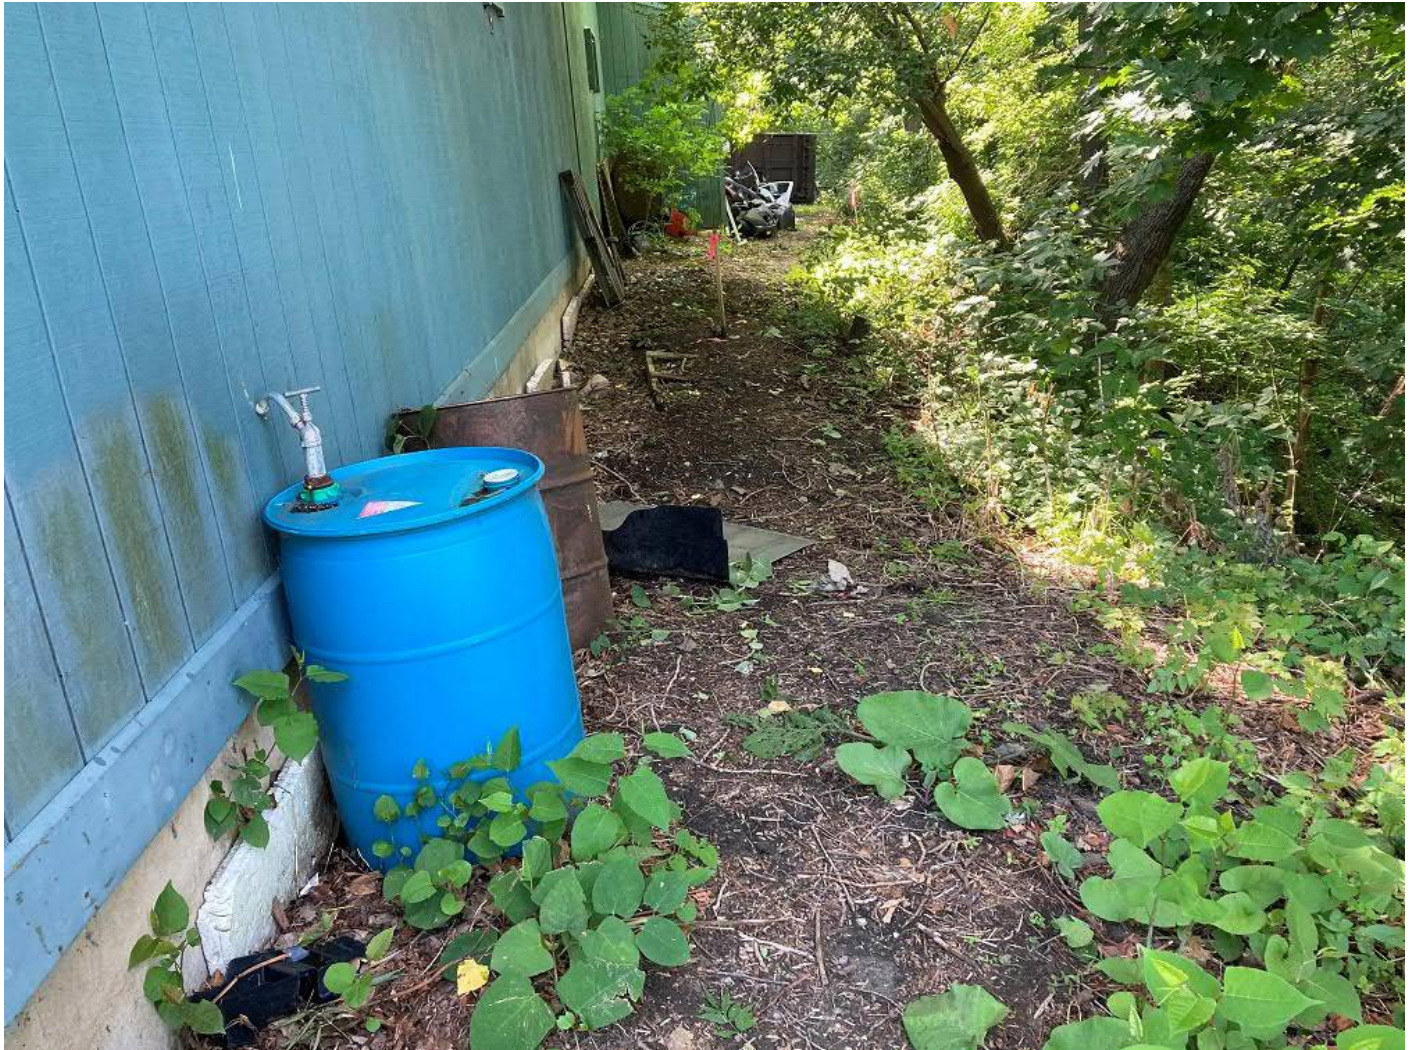
Slope Location: 411 Riverside Avenue – Burlington Collision Date: 8/5/2020  
City: Burlington State: Vermont  
Description : Photograph 3: Top of Slope Behind Burlington Collision

**Photograph 3:** View to west behind Burlington Collision showing incipient slumping at center of photograph; note leaning trees top right; soil scarp obscured by vegetation at center-right of photograph.

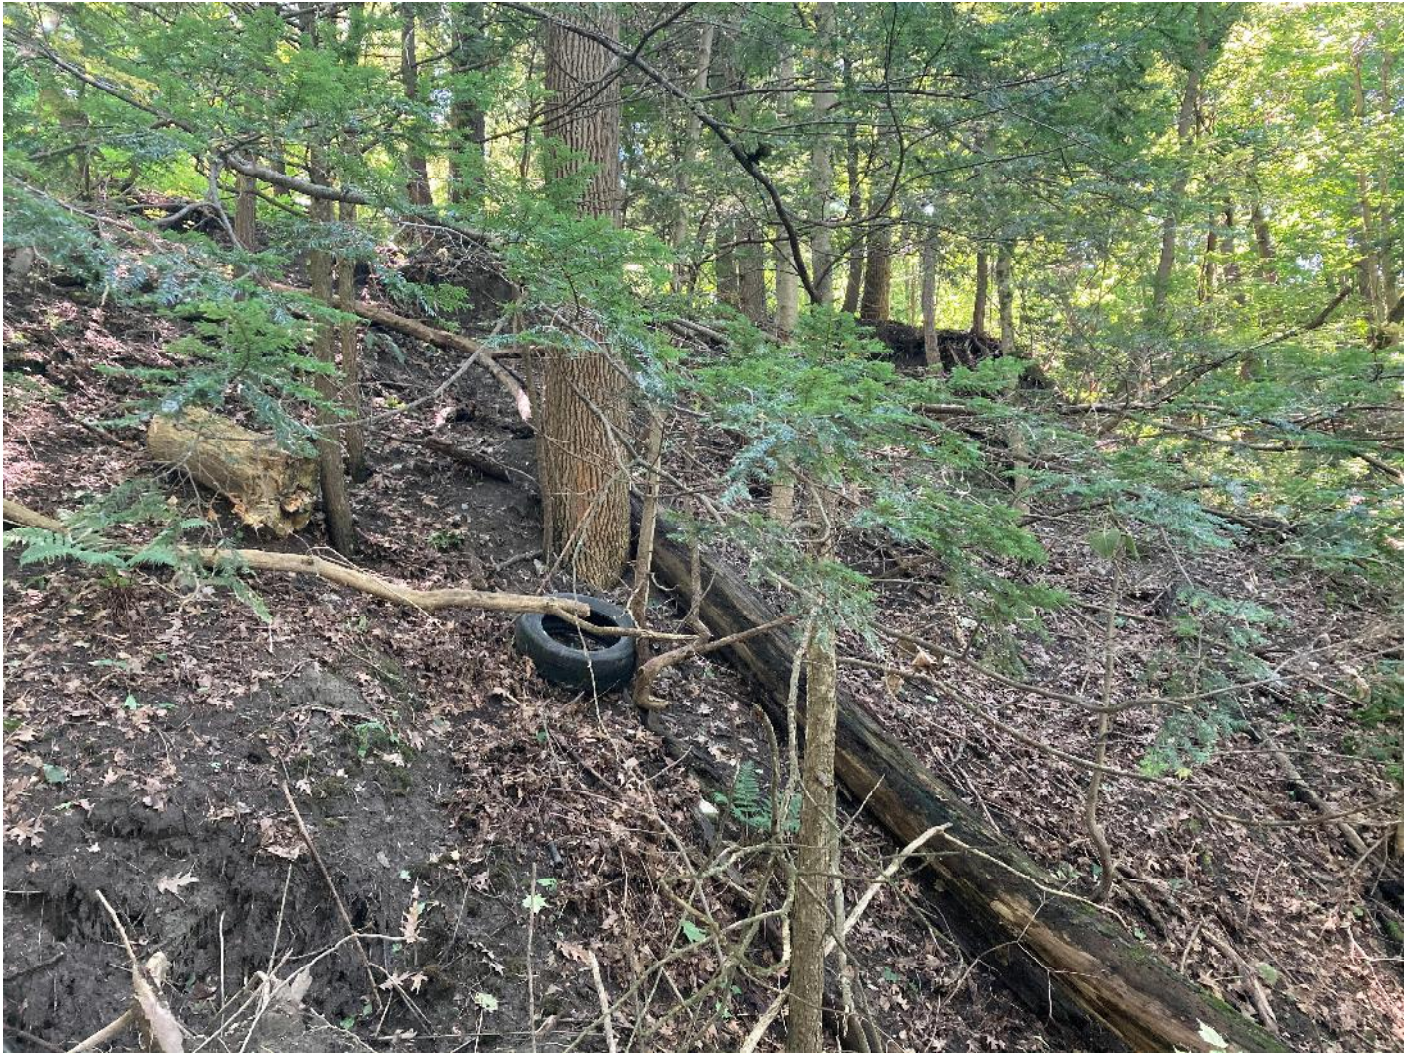
Slope Location: 411 Riverside Avenue – Burlington Collision Date: 8/13/2020  
City: Burlington State: Vermont  
Description : Photograph 9: Scarps Downslope from Burlington Collision

**Photograph 9:** View to southwest of soil scarps in historic slide debris downslope from Burlington Collision

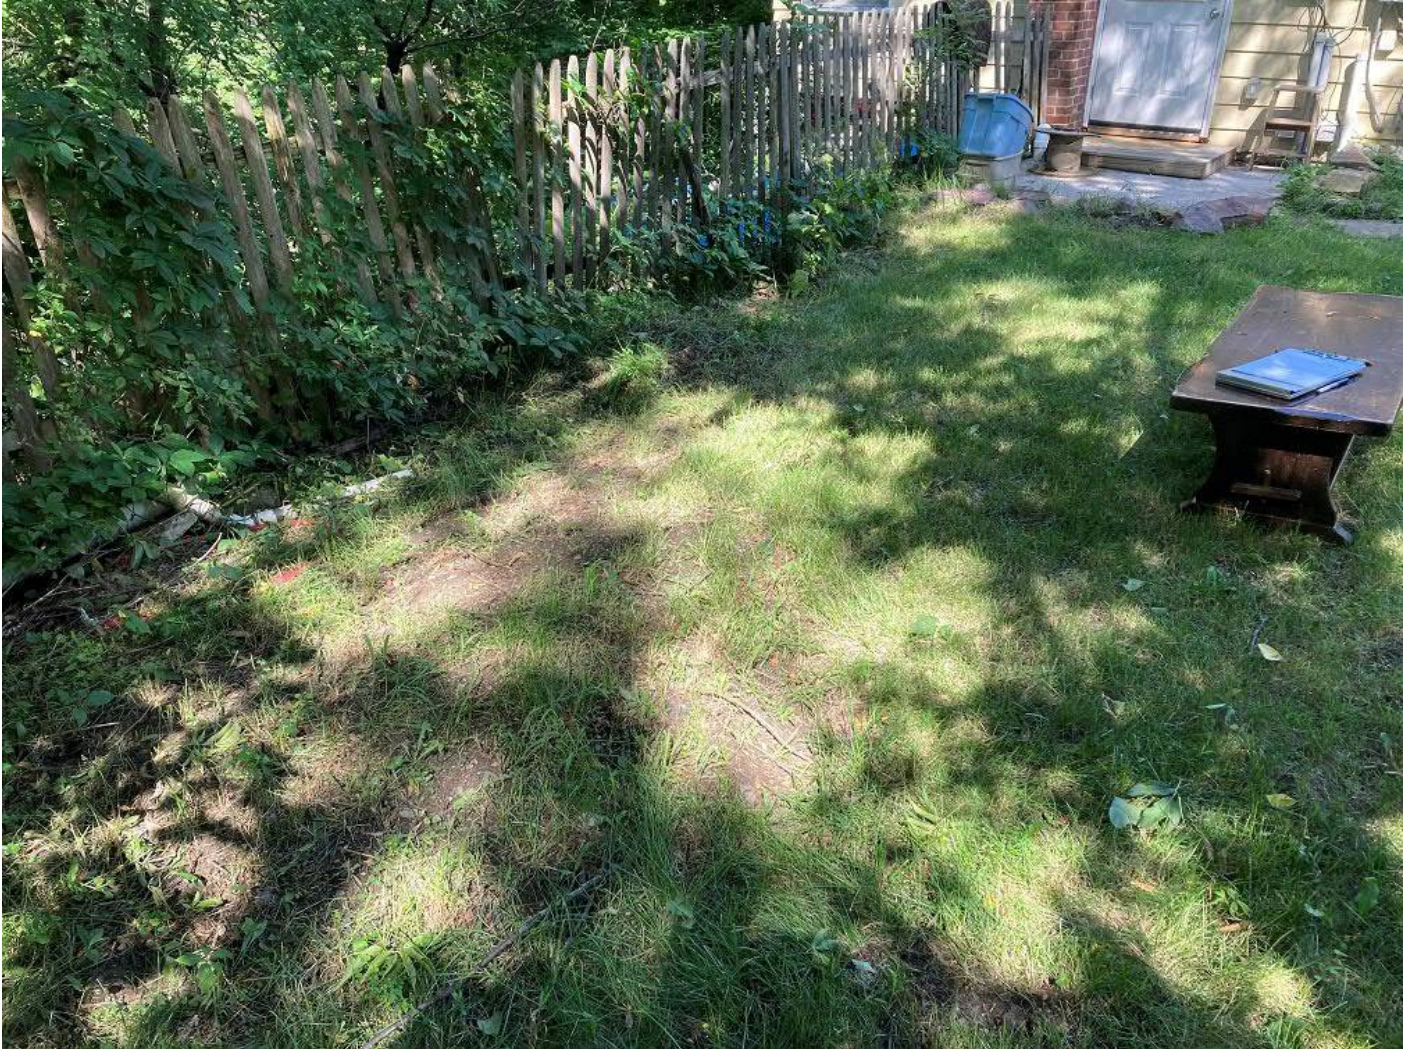
Slope Location: 389 Riverside Avenue – Private Residence Date: 8/5/2020  
City: Burlington State: Vermont  
Description : Photograph 11: Incipient Slumping Top of Slope West of House

**Photograph 11:** View to northeast, west of residence, showing incipient slumping at top of slope, left-center of photograph; note disturbed fencing where soil scarp is beginning to form.

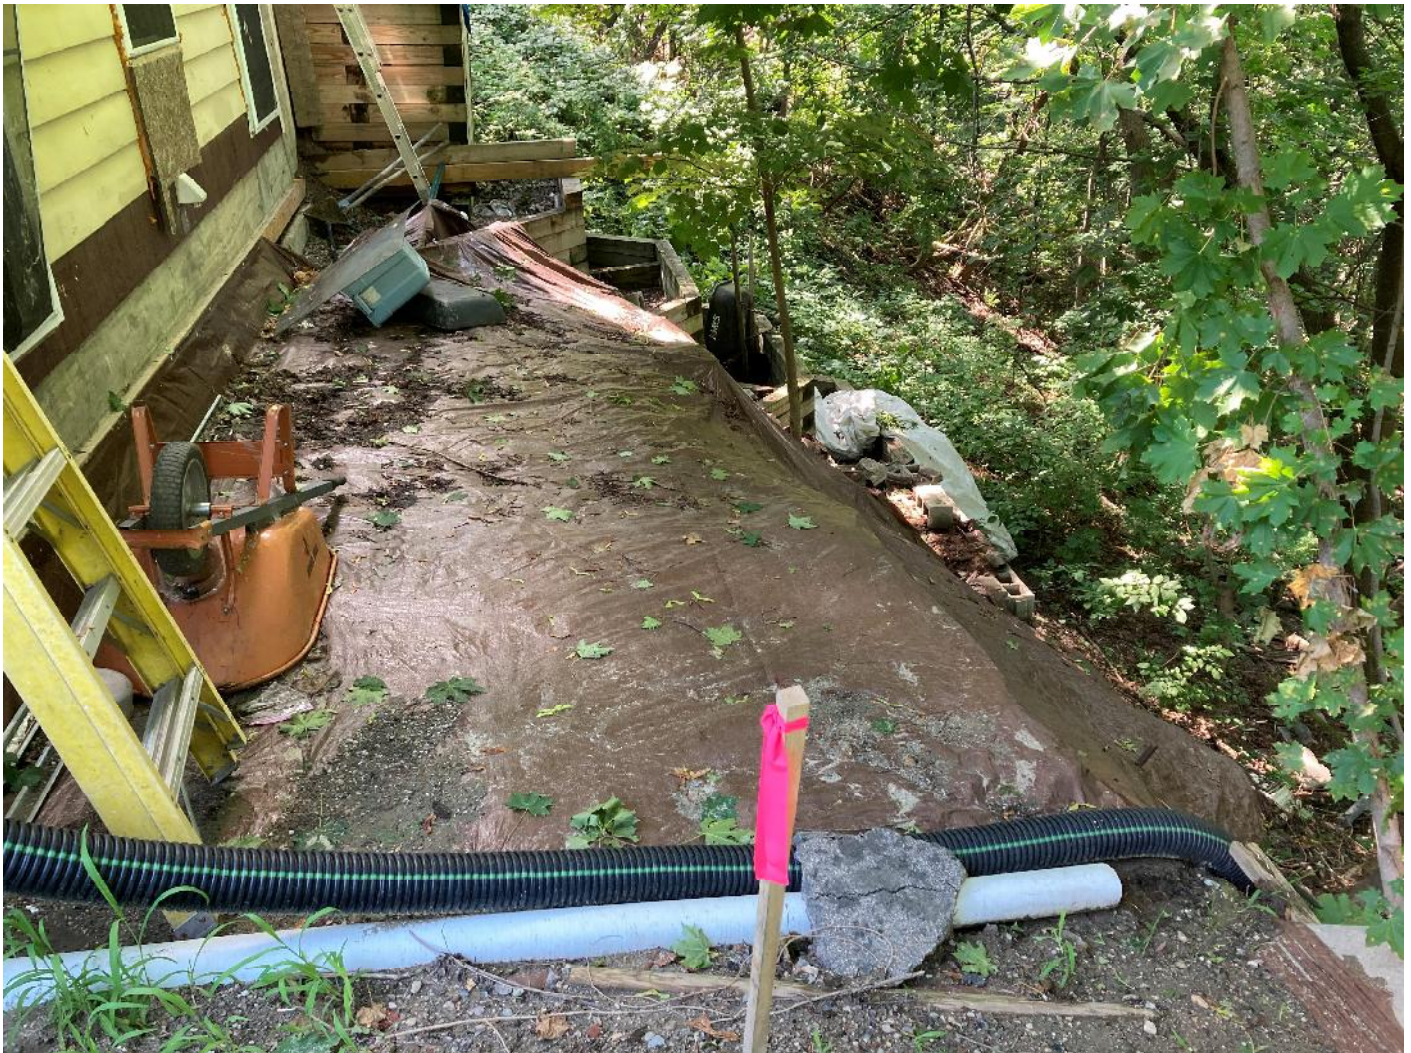
Slope Location: 389 Riverside Avenue – Private Residence Date: 8/5/2020  
City: Burlington State: Vermont  
Description : Photograph 12: View Behind Residence

**Photograph 12:** View to west of the top of the slope behind the residence showing covered scarp and slump mass downslope from scarp

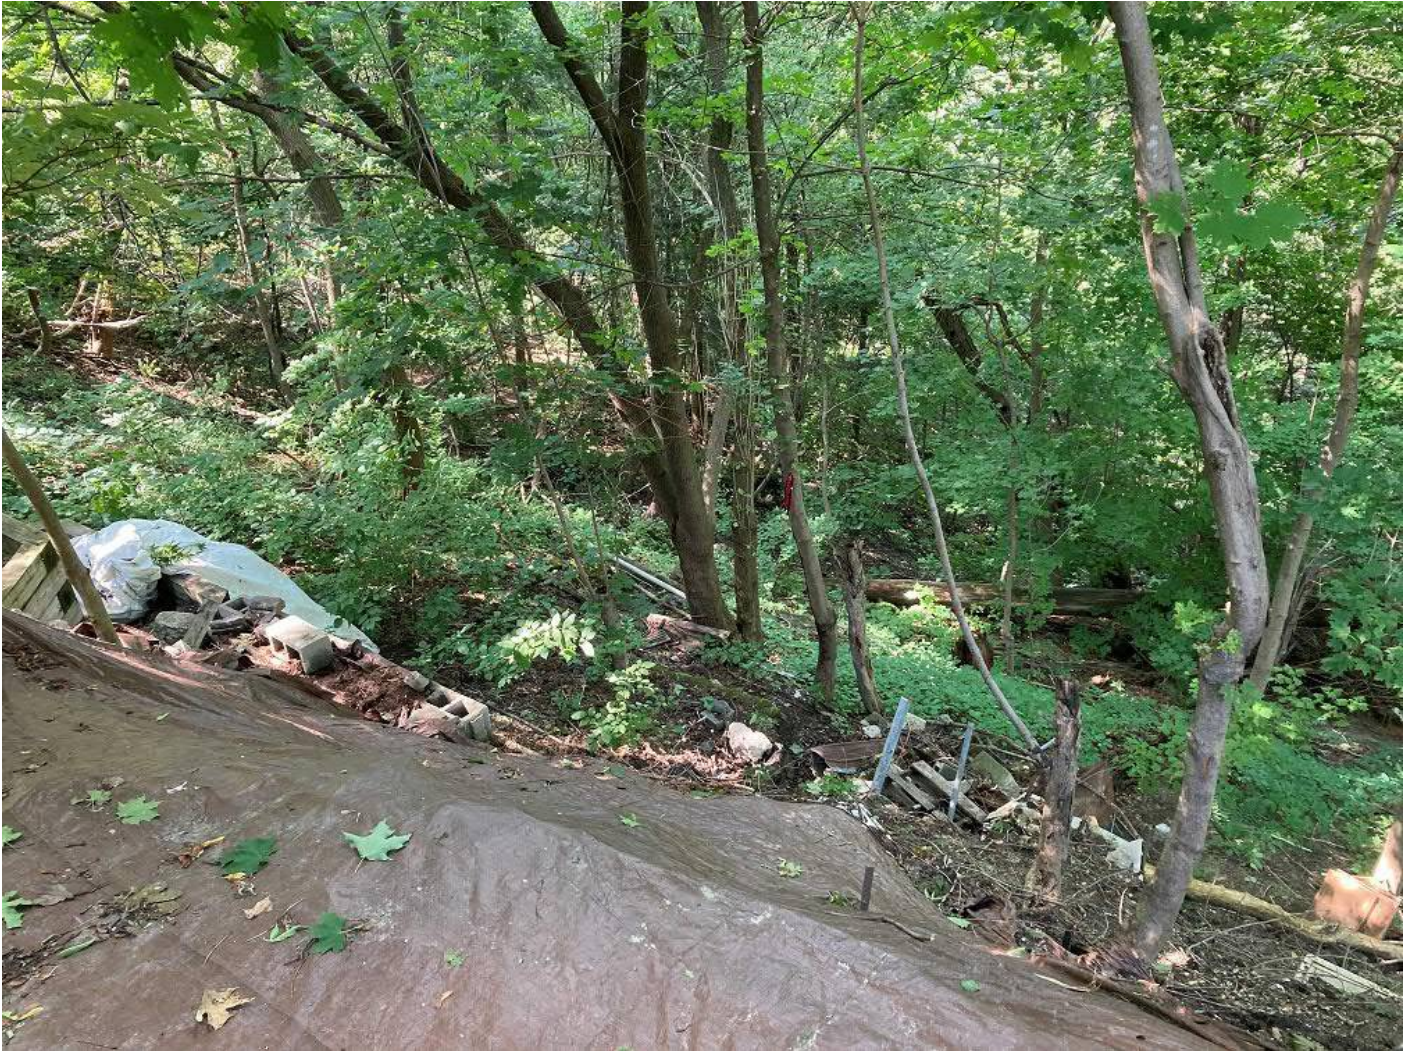
Slope Location: 389 Riverside Avenue – Private Residence Date: 8/5/2020  
City: Burlington State: Vermont  
Description : Photograph 13: View Downslope Behind Residence

**Photograph 13:** View to southwest behind residence showing covered scarp at top of slope and head scarp of historic soil slump downslope; note lean of trees upslope at center and left-center of photograph
