## **Burlington Conservation Board**

## Conservation Board Meeting Minutes

## FY20 Burlington Slope Inspections

**CITY OF BURLINGTON, VERMONT  
SLOPE STABILITY INSPECTION**

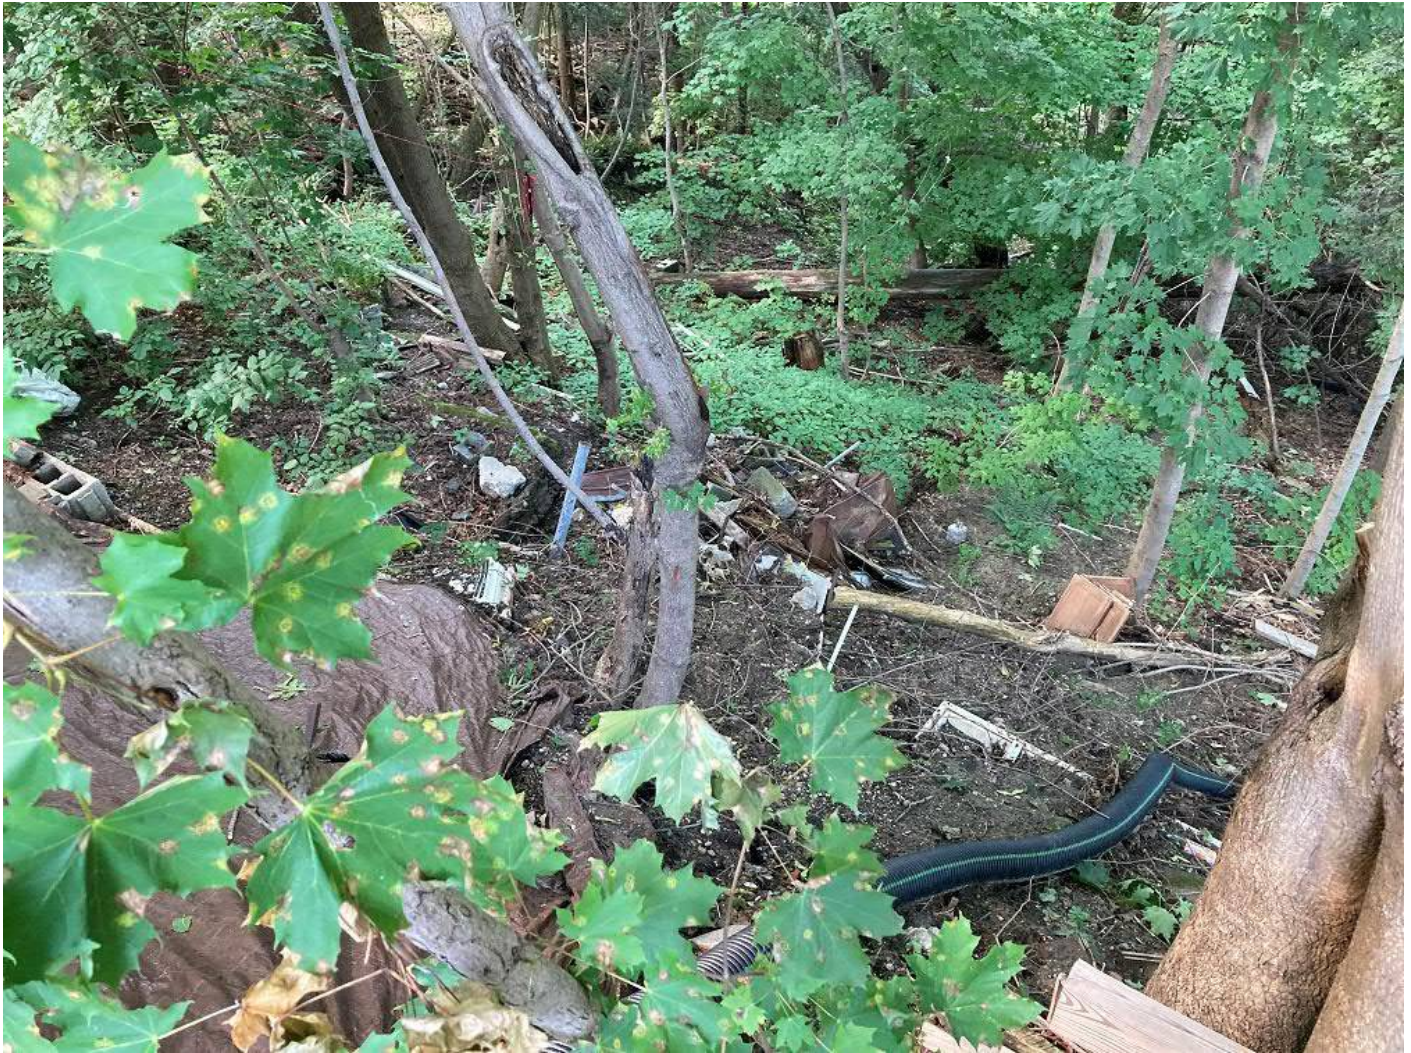
Slope Location: 389 Riverside Avenue – Private Residence Date: 8/5/2020  
City: Burlington State: Vermont  
Description : Photograph 14: View Downslope from Behind Residence

**Photograph 14:** View to north northwest from behind residence showing head scarps from historic slumps and exposed soil surfaces subject to continued erosion during precipitation events; note discharge hose at bottom right and refuse debris in center; note lean of trees upslope in center of photograph

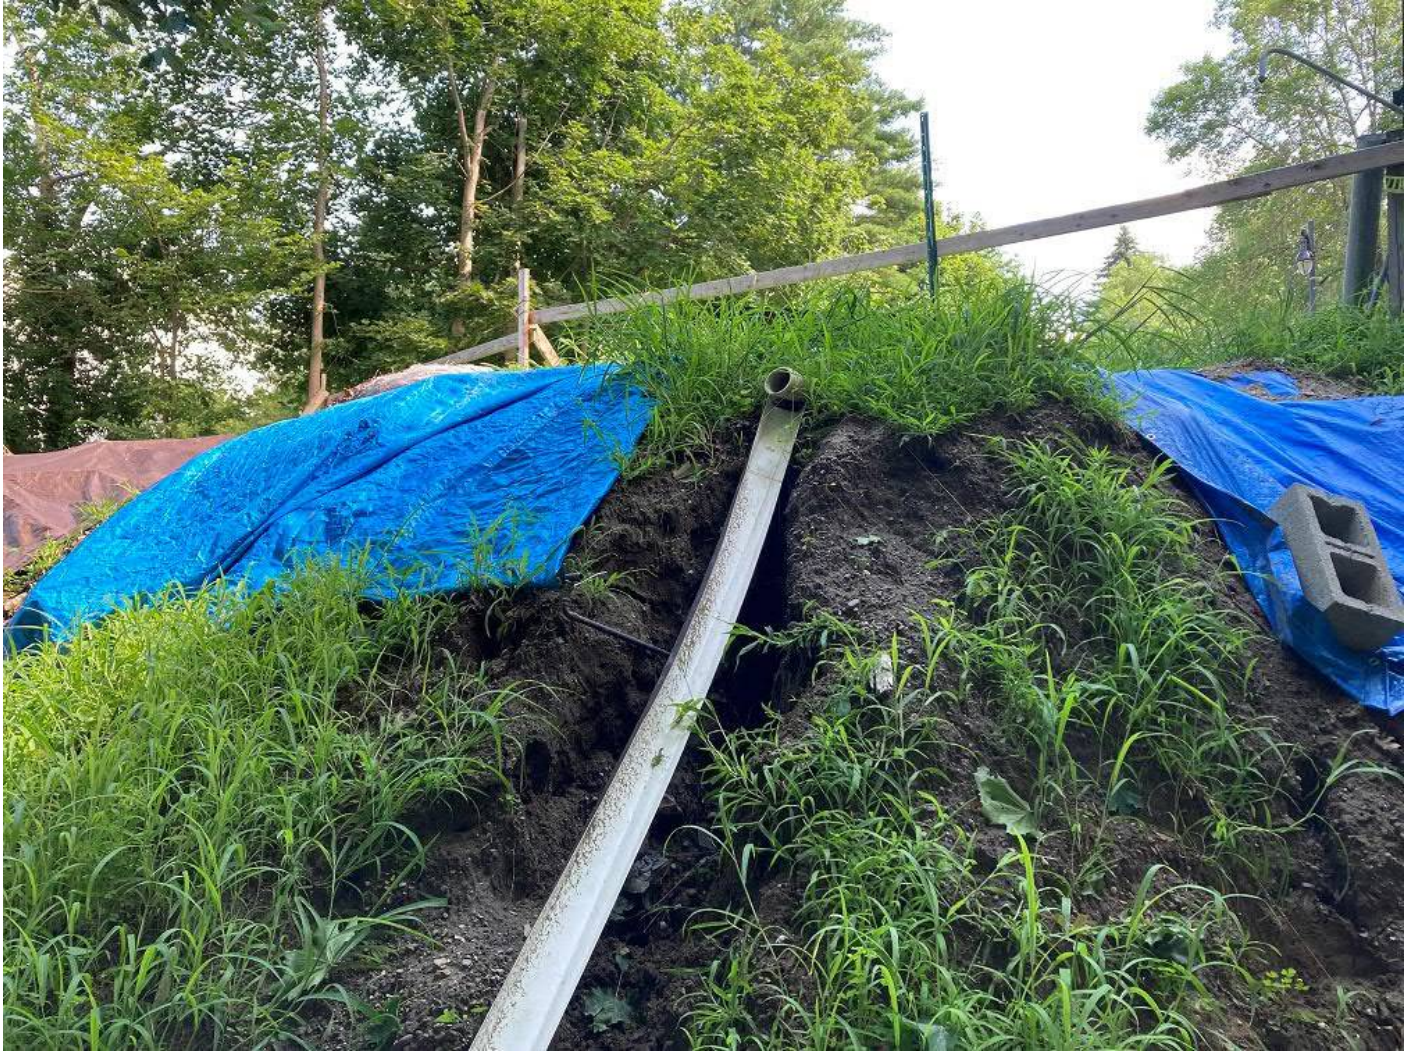
Slope Location: 389 Riverside Avenue – Private Residence Date: 8/5/2020  
City: Burlington State: Vermont  
Description : Photograph 15: Discharge Pipe at Top of Slope

**Photograph 15:** View to southeast, east of residence, showing discharge pipe; ongoing discharge flow will contribute to surface erosion and creation of flow gully in unvegetated portions downslope

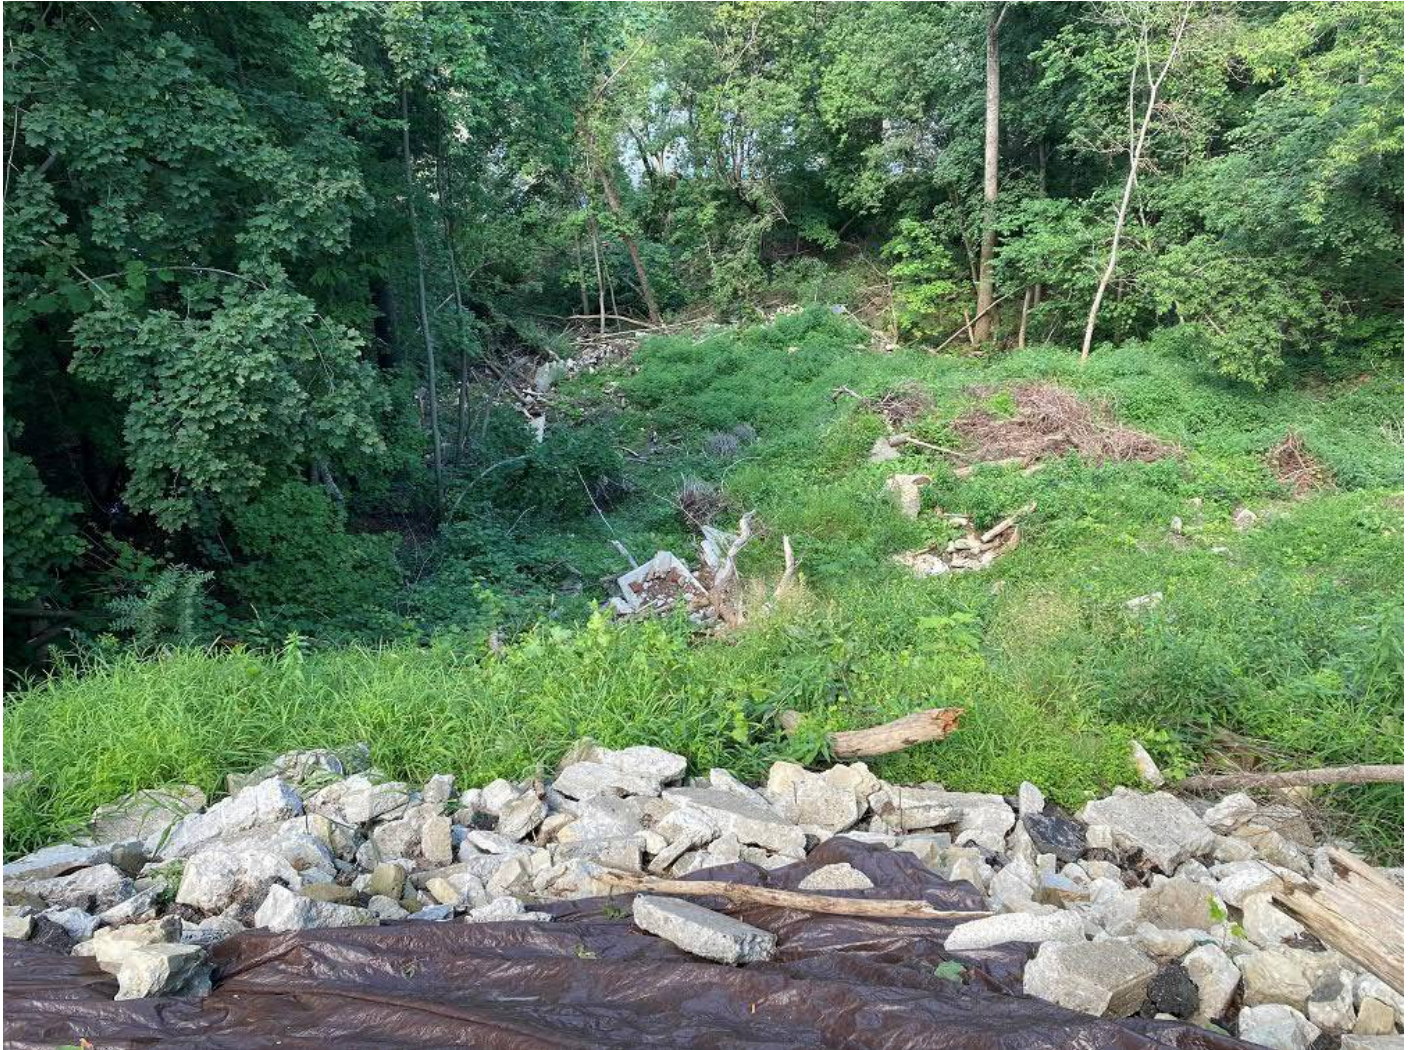
Slope Location: 389 Riverside Avenue – Private Residence Date: 8/5/2020  
City: Burlington State: Vermont  
Description : Photograph 18: View Downslope from Remediated Area

**Photograph 18:** View to north showing historic slide debris downslope from remediated area east of residence (see Photographs 15 and 16); note vegetative cover on historic slide debris

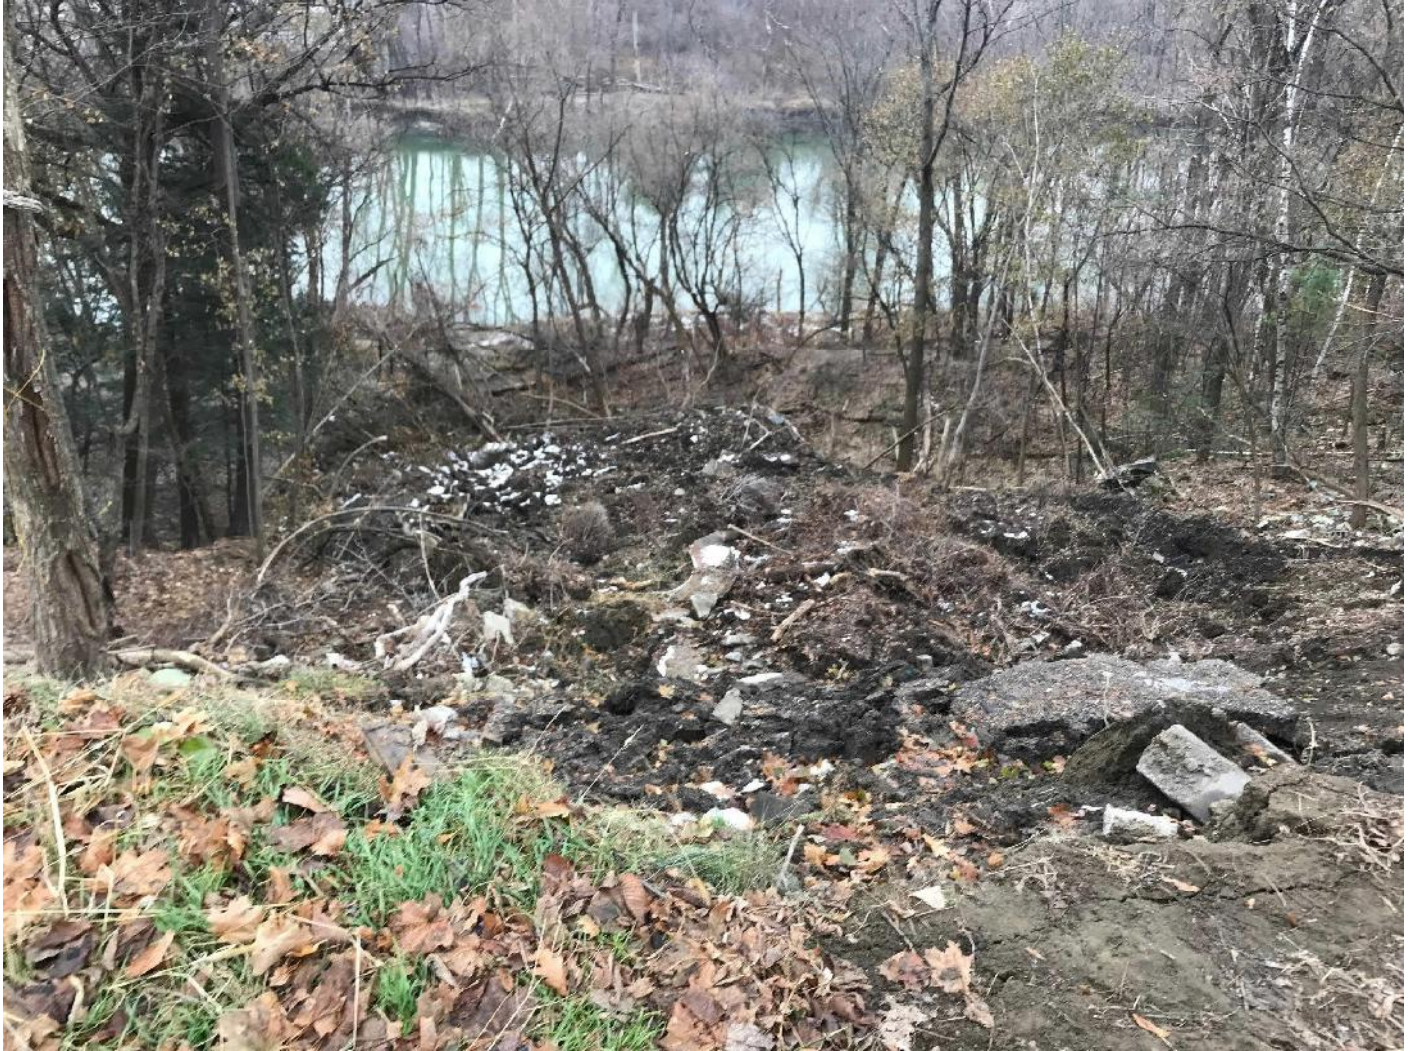
Slope Location: 389 Riverside Avenue – Private Residence Date: 12/2019  
City: Burlington State: Vermont  
Description : Photograph 19: View of Slide Mass in December 2019

**Photograph 19:** View to north between 389 and 365 Riverside Avenue showing slide debris in December 2019 during inspection by Hoyle Tanner Associates; Photo 17 above shows same view taken in August 2020.

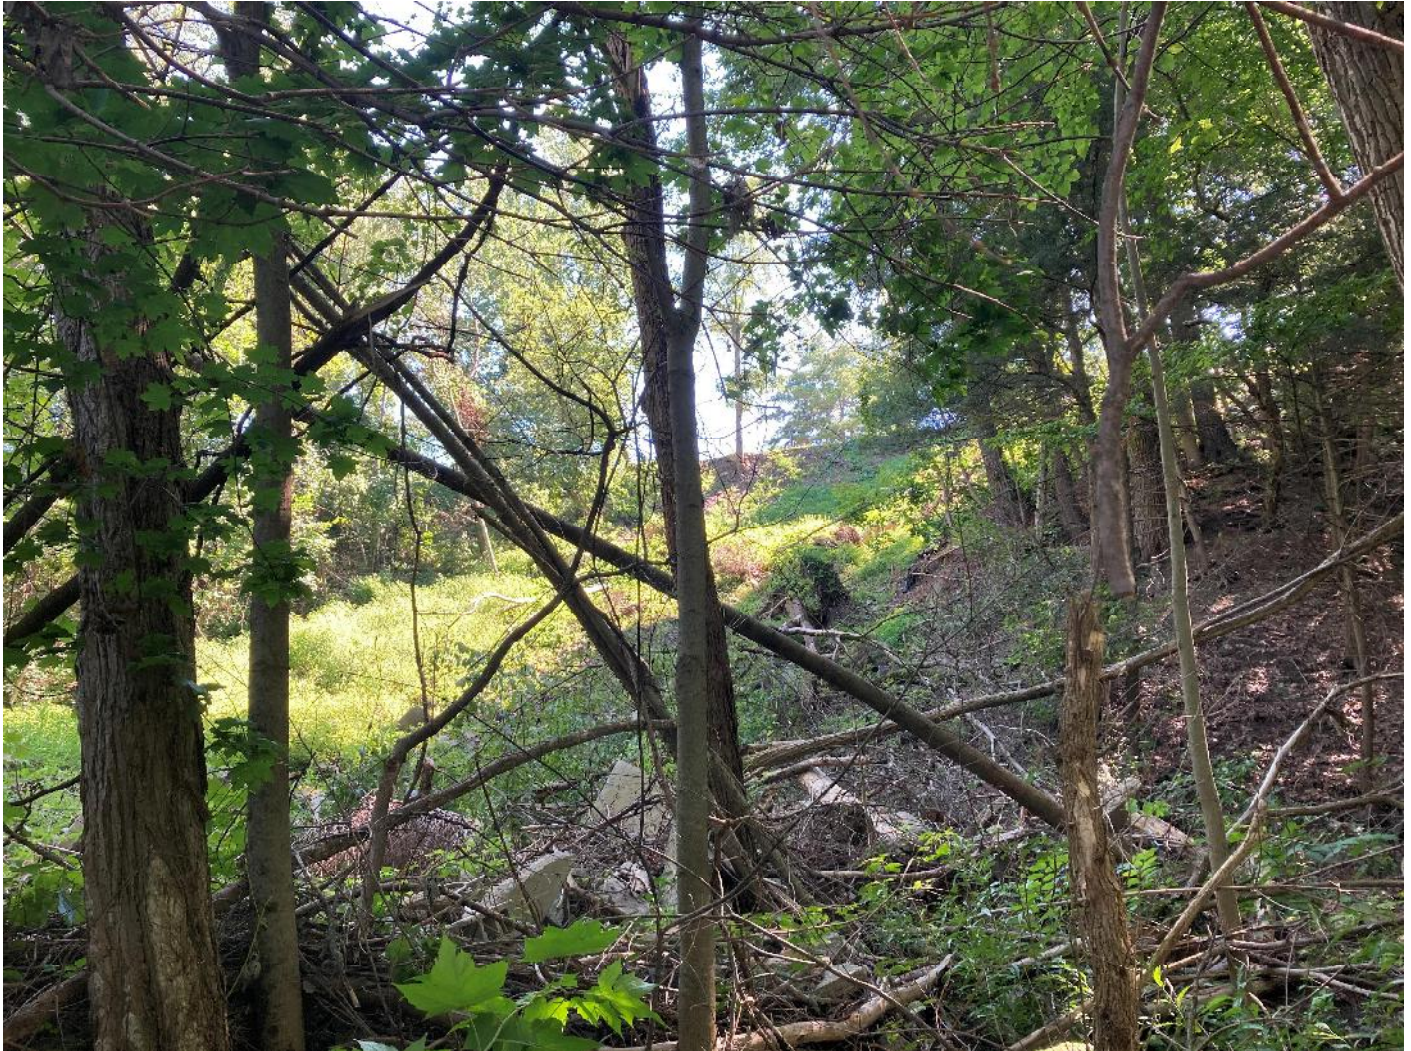
Slope Location: 389 Riverside Avenue – Private Residence Date: 8/13/2020  
City: Burlington State: Vermont  
Description : Photograph 22: Soil Slide Between 389 and 365 Riverside Avenue

**Photograph 22:** View to southeast of exposed scarp and slide/slump debris (center of photograph) downslope from area between 389 (private residence) and 365 Riverside Avenue (Hall's Hitches and Welding)

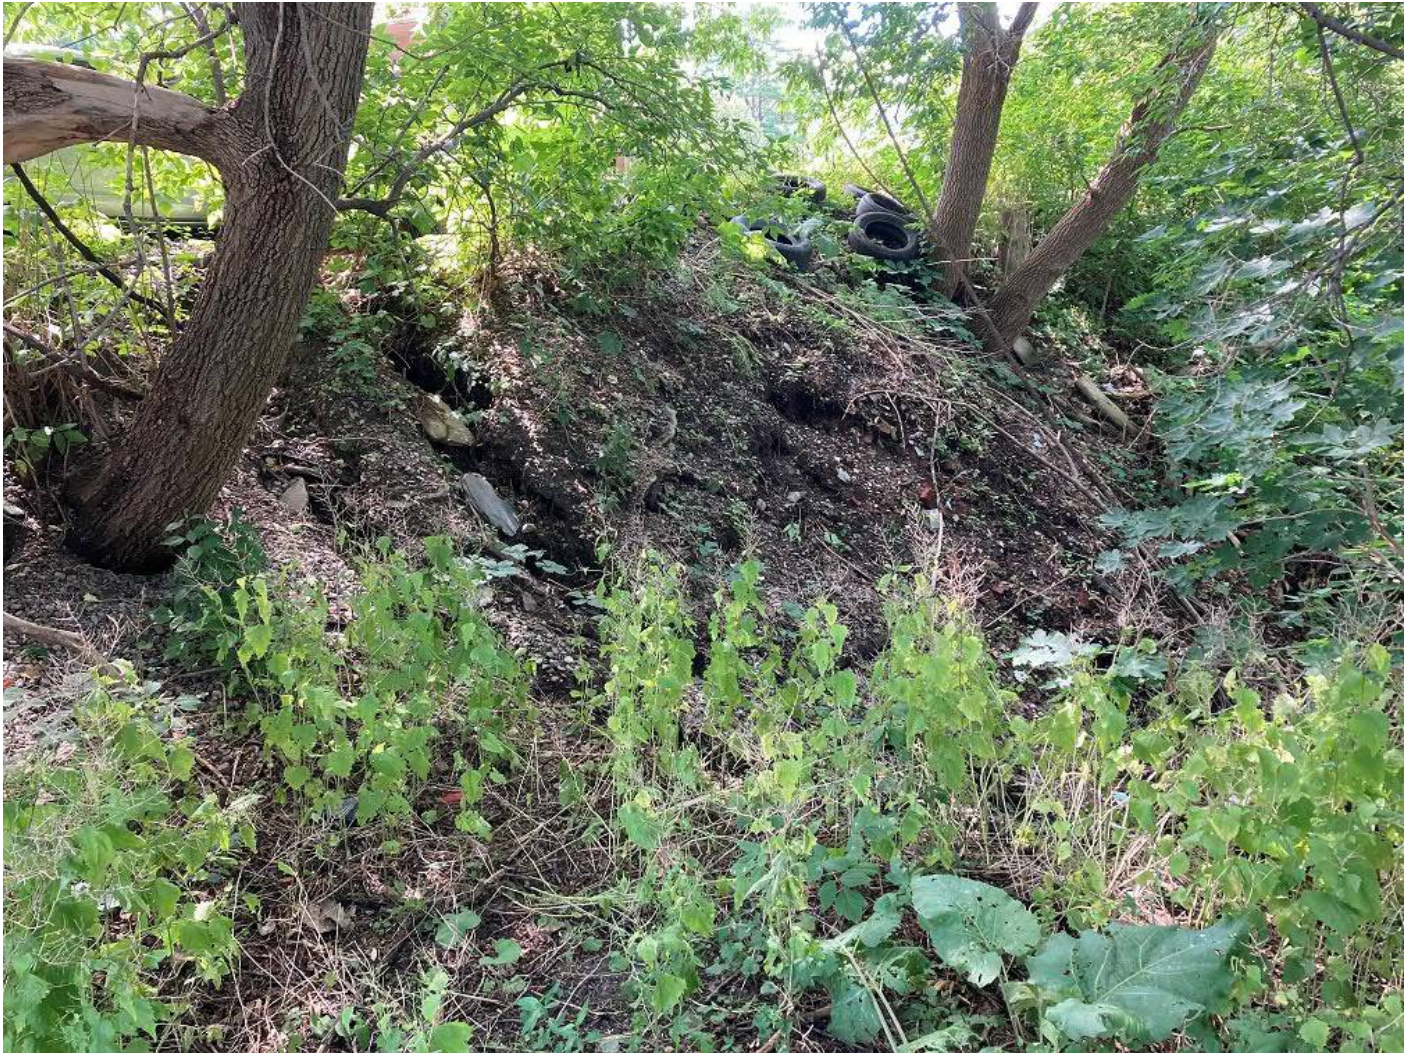
Slope Location: 365 Riverside Avenue – Hall's Hitches and Welding Date: 8/5/2020  
City: Burlington State: Vermont  
Description : Photograph 29: Eastern Portion of Slope at 365 Riverside Avenue – Hall's Hitches

**Photograph 29:** View to southwest of eroded slope at eastern boundary between 365 Riverside Avenue and 317 Riverside Avenue (Bluebird BBQ); brick fragments within mass indicate historic filling; note gully formation at left and lean of trees at extreme left and top right; exposed soil subject to continual erosion and gully formation during precipitation events (photo taken from 317 Riverside Avenue property).

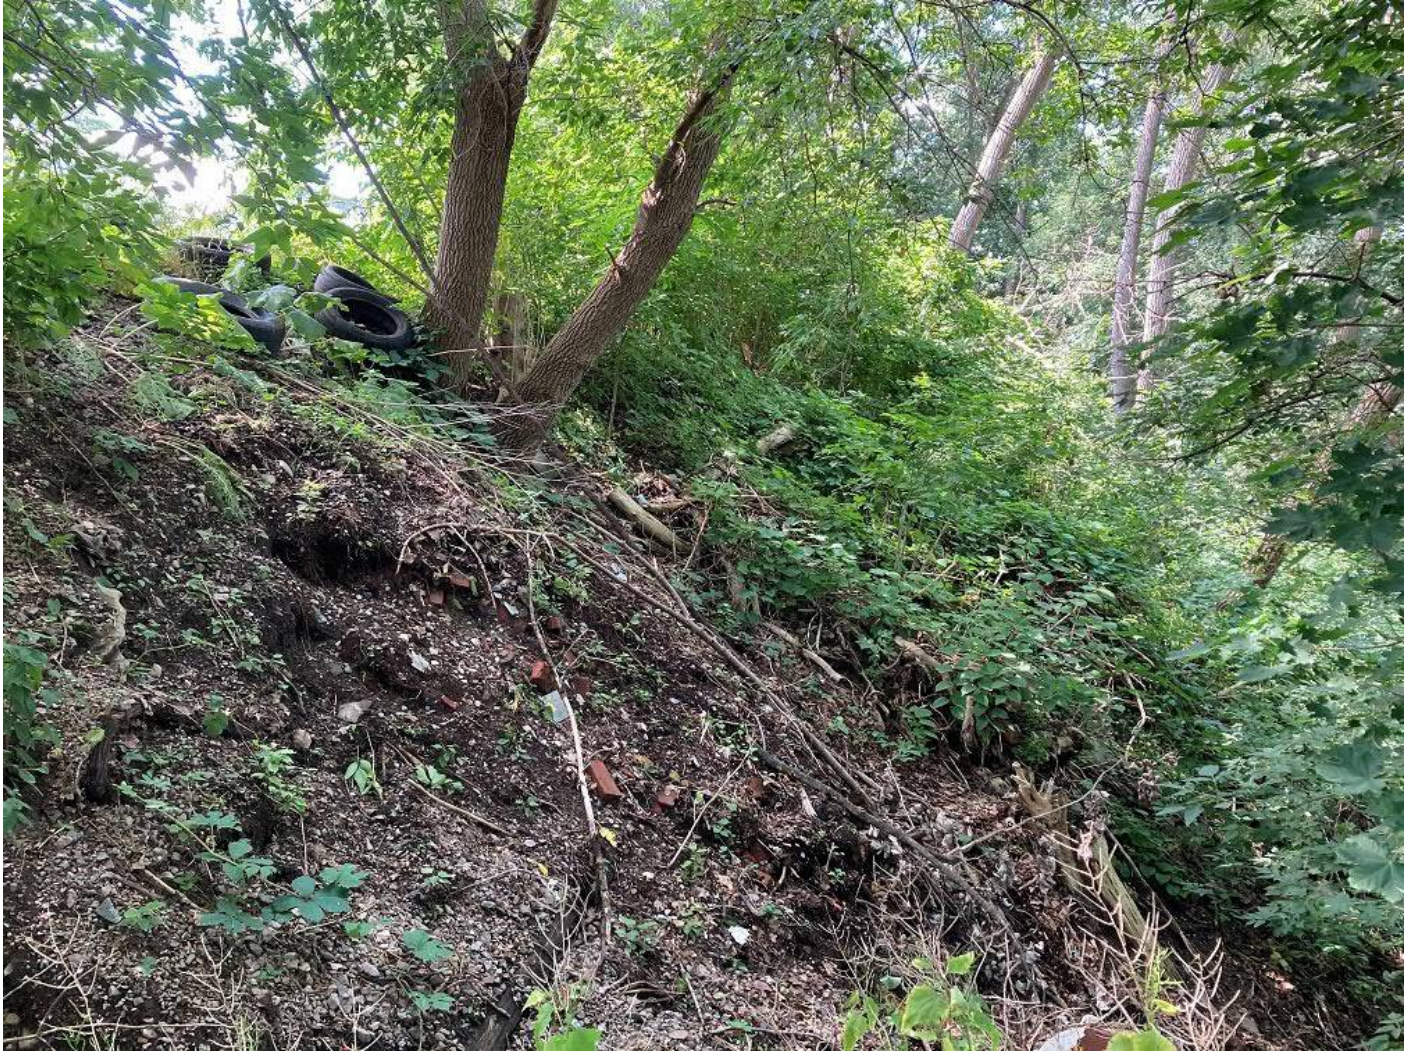
Slope Location: 365 Riverside Avenue – Hall's Hitches and Welding Date: 8/5/2020  
City: Burlington State: Vermont  
Description : Photograph 30: Eroded Scarp at East Property Boundary 365 Riverside Avenue

**Photograph 30:** Additional view to west of eroded slope between 365 and 317 Riverside Avenue; note brick fragments and density of vegetation to west; (photograph taken from 317 Riverside Avenue property – Bluebird BBQ west parking area)

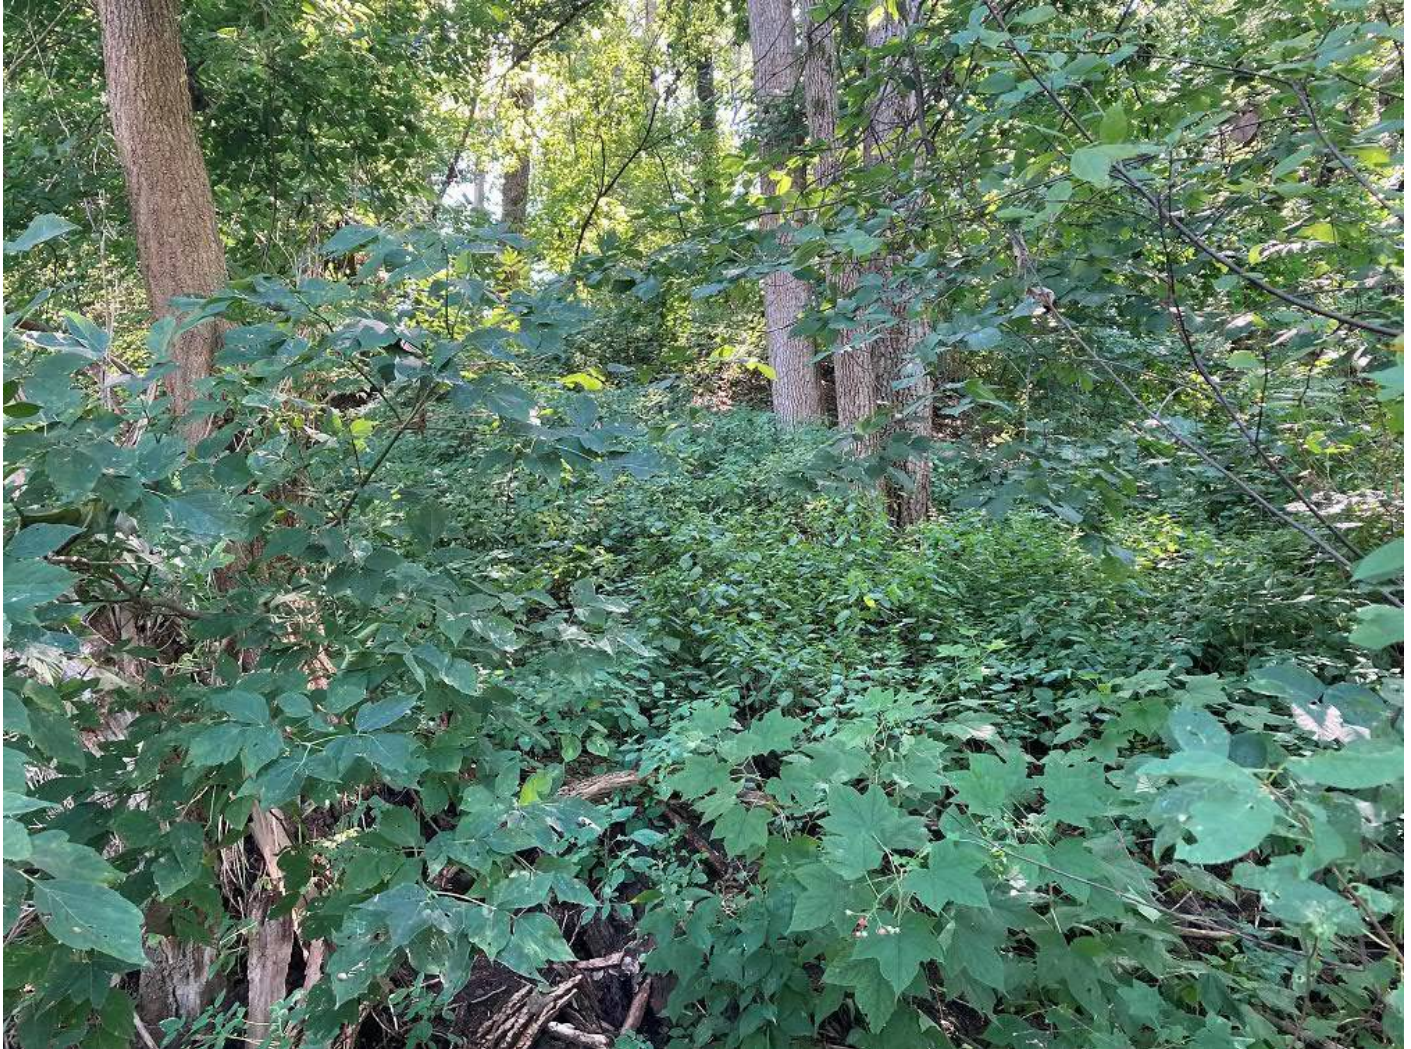
Slope Location: 365 Riverside Avenue – Hall's Hitches and Welding Date: 8/13/2020  
City: Burlington State: Vermont  
Description : Photograph 33: Density of Vegetation Downslope from 365 Riverside Avenue

**Photograph 33:** View to south southeast showing density of vegetation overgrown on historic slump/slide mass downslope from 365 Riverside Avenue, Hall's Hitches and Welding

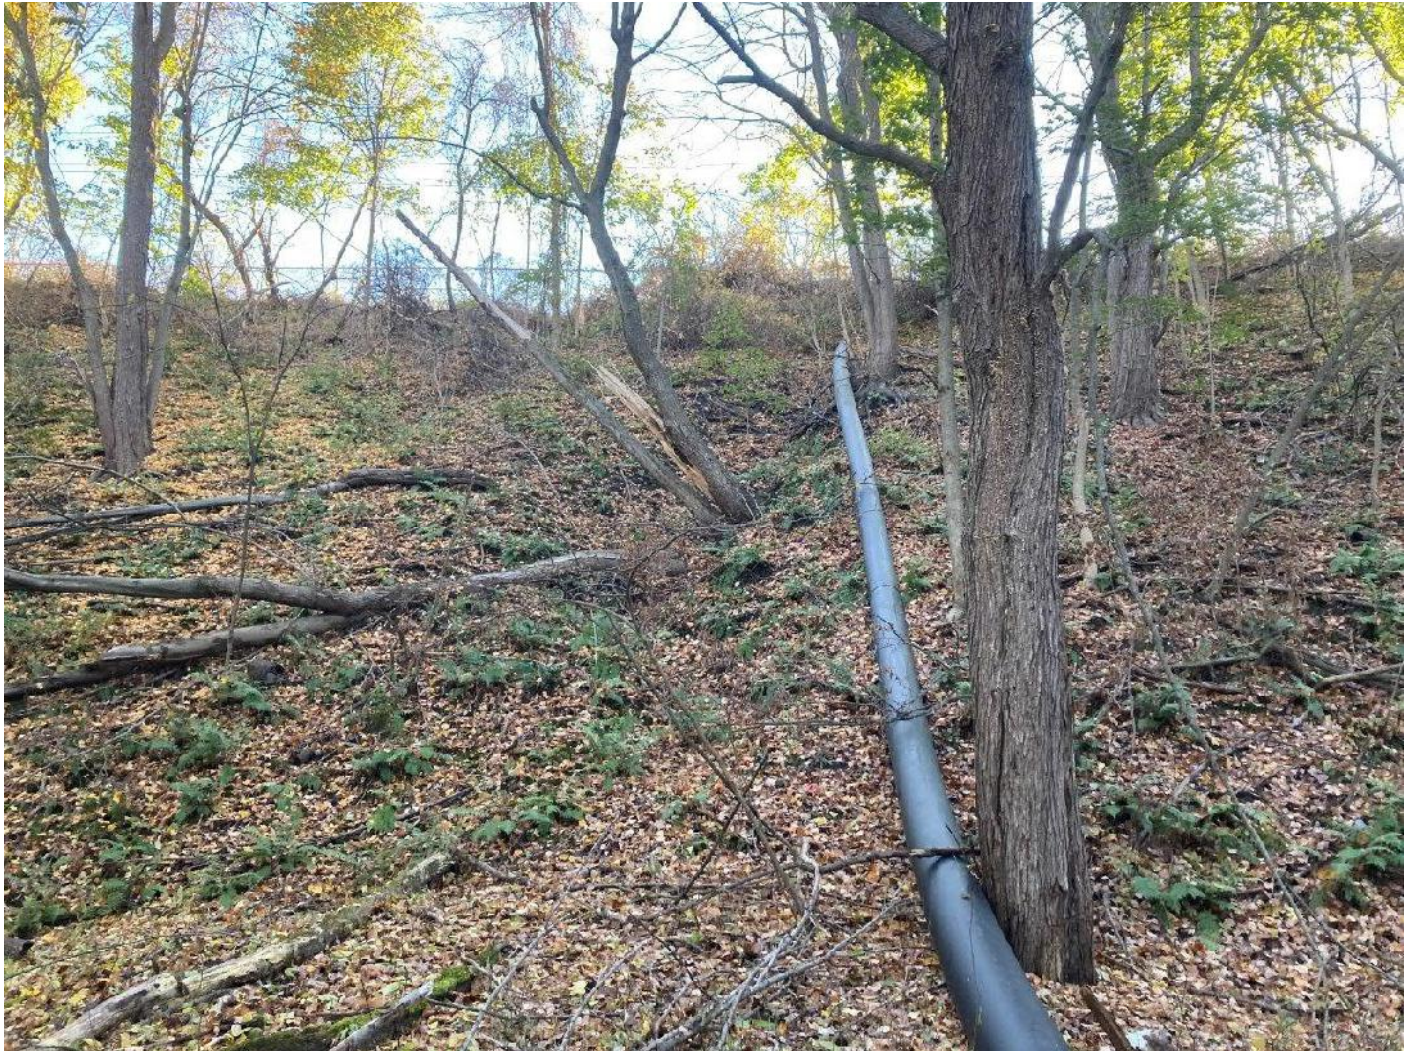
Slope Location: Manhattan Drive and Route 127 (Beltline) Date: Oct. 2020  
City: Burlington State: Vermont  
Description : Photograph 14: Soil Erosion and Gully Formation at Pipe to Culvert 3

**Photograph 14:** View to south towards Manhattan Drive showing exposed discharge pipe to Culvert 3, and soil erosion and gully formation at top and mid-slope.

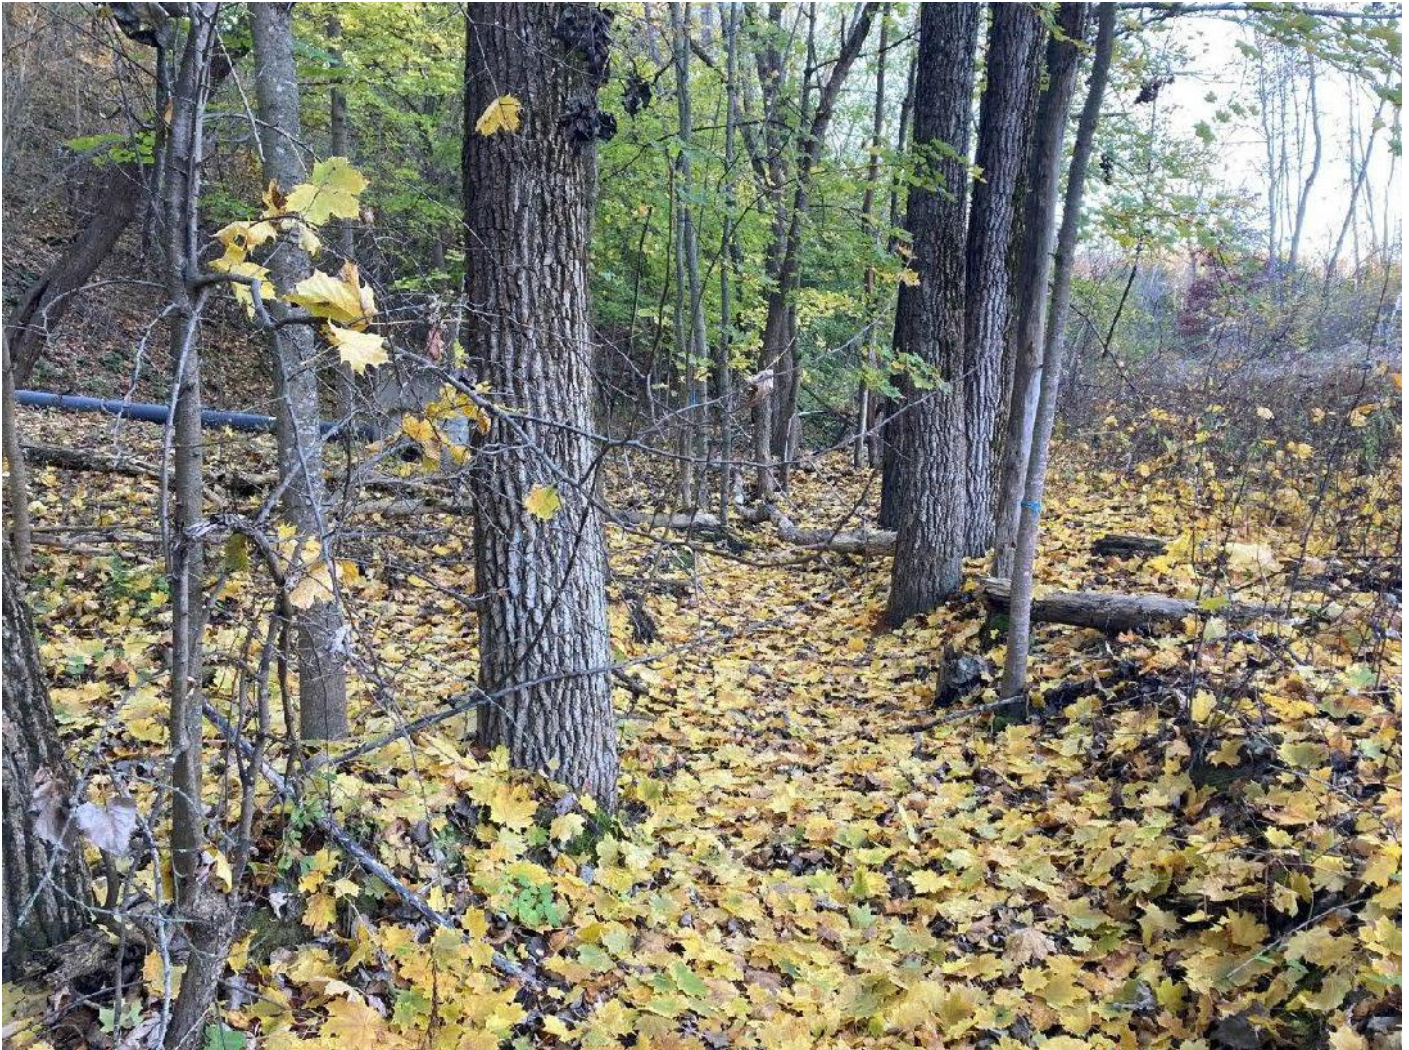
Slope Location: Manhattan Drive and Route 127 (Beltline) Date: Oct. 2020  
City: Burlington State: Vermont  
Description : Photograph 15: Culvert 3 and Unlined Discharge Channel from Culverts 1 and 2

**Photograph 15:** View to west of unlined discharge channel from Culverts 1 and 2; Culvert 3 at center-left of photograph.

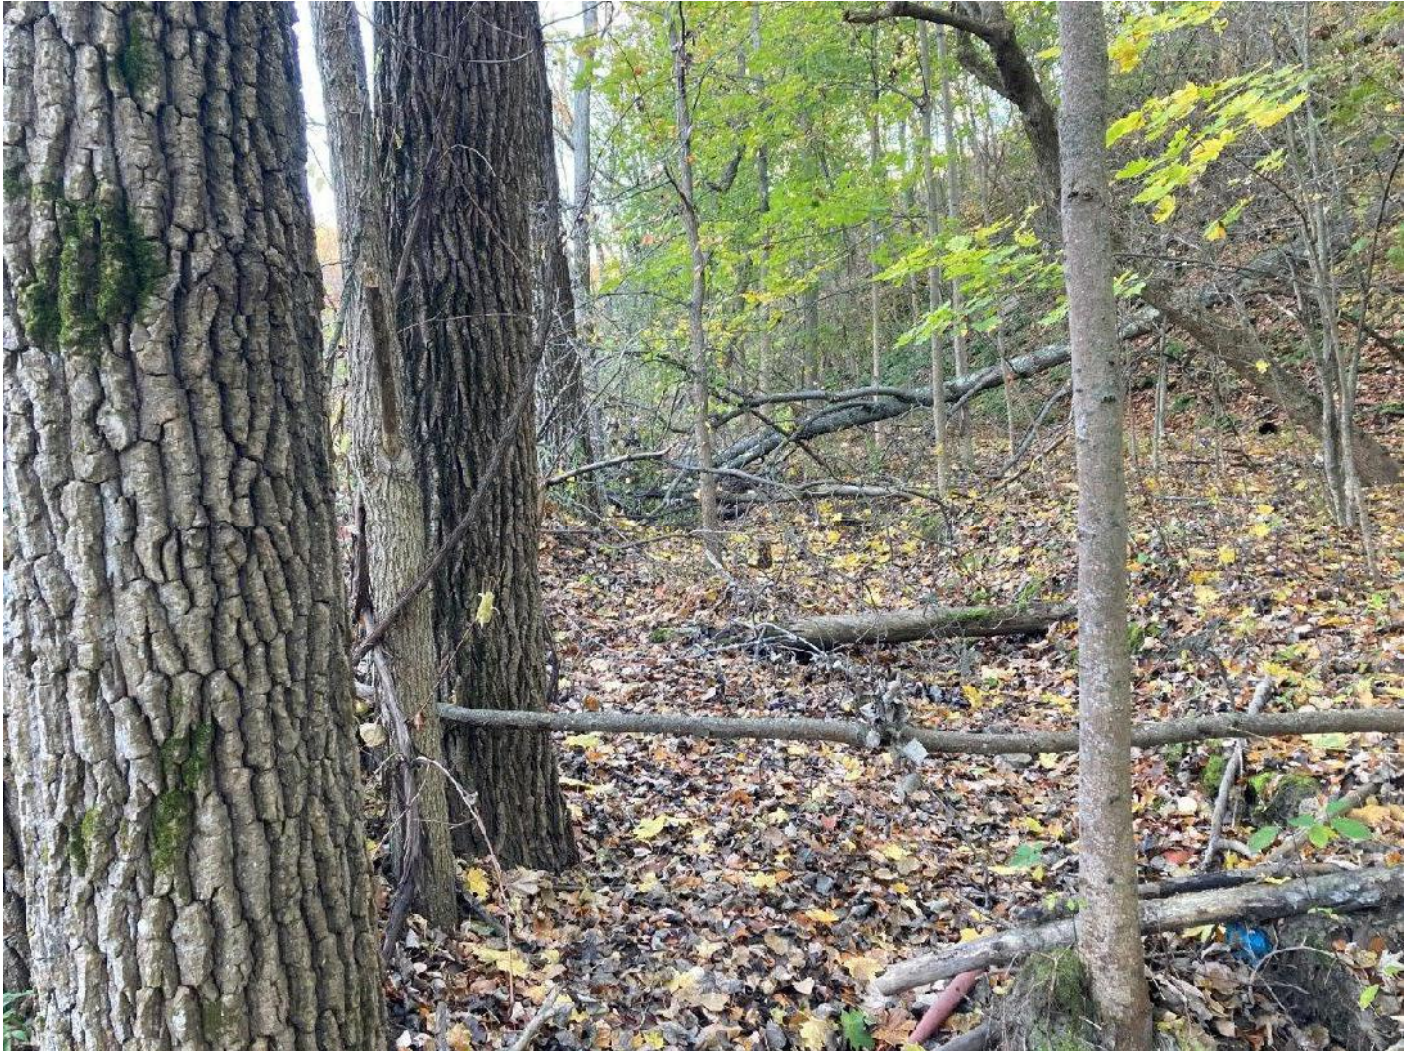
Slope Location: Manhattan Drive and Route 127 (Beltline) Date: Oct. 2020  
City: Burlington State: Vermont  
Description : Photograph 16: Unlined Culverts 1 and 2 Discharge Channel East of Culvert 3

**Photograph 16:** View to east of unlined discharge channel at toe of slope; note density of overgrowth as compared to Photograph 17.

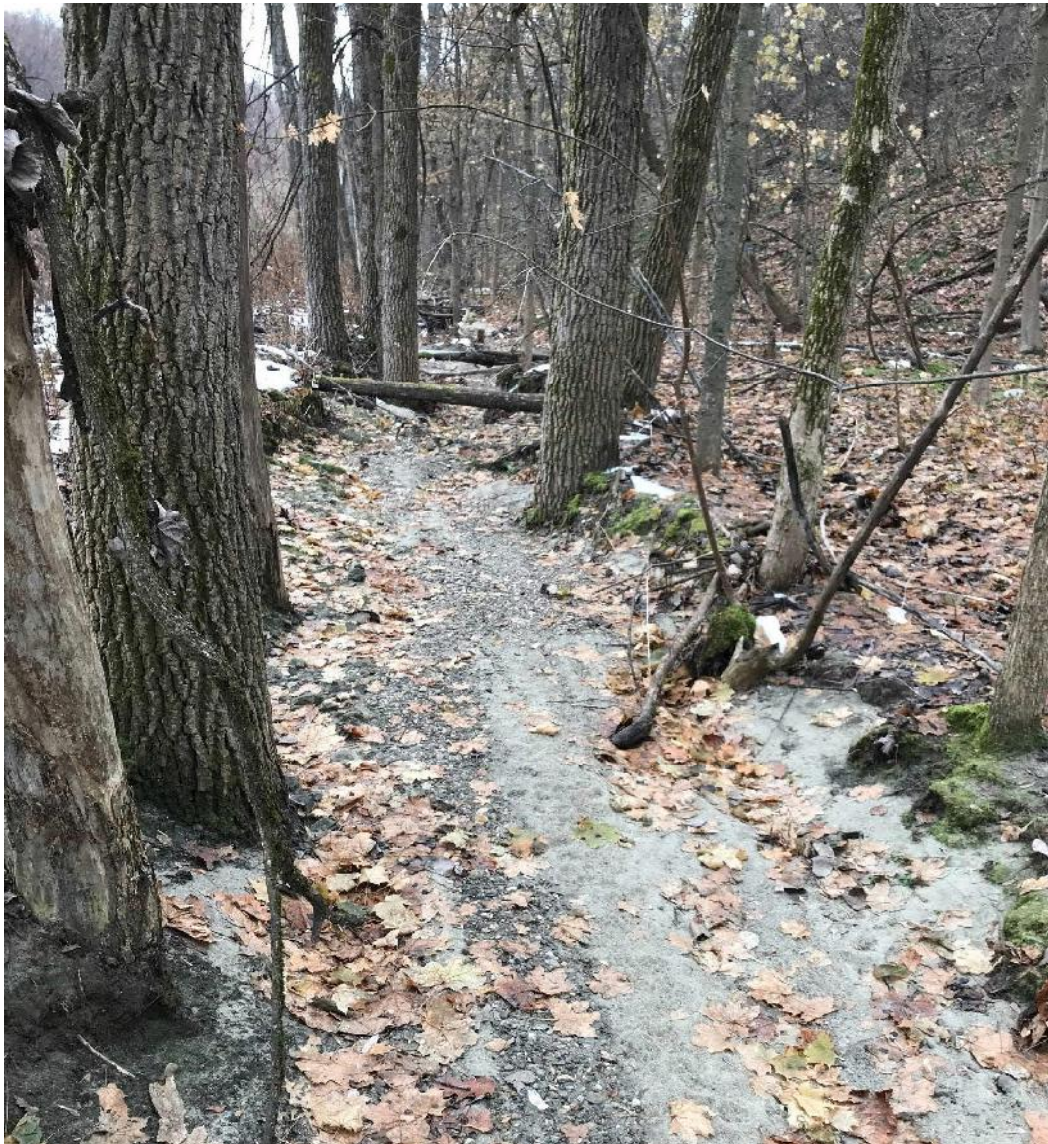
Slope Location: Manhattan Drive and Route 127 (Beltline) Date: Oct. 2020  
City: Burlington State: Vermont  
Description : Photograph 17: November 2019 - Unlined Discharge Channel East of Culvert 3

**Photograph 17:** View to east of unlined discharge channel at toe of slope; note lack of overgrowth and sediment infilling channel (compare to Photograph 16).

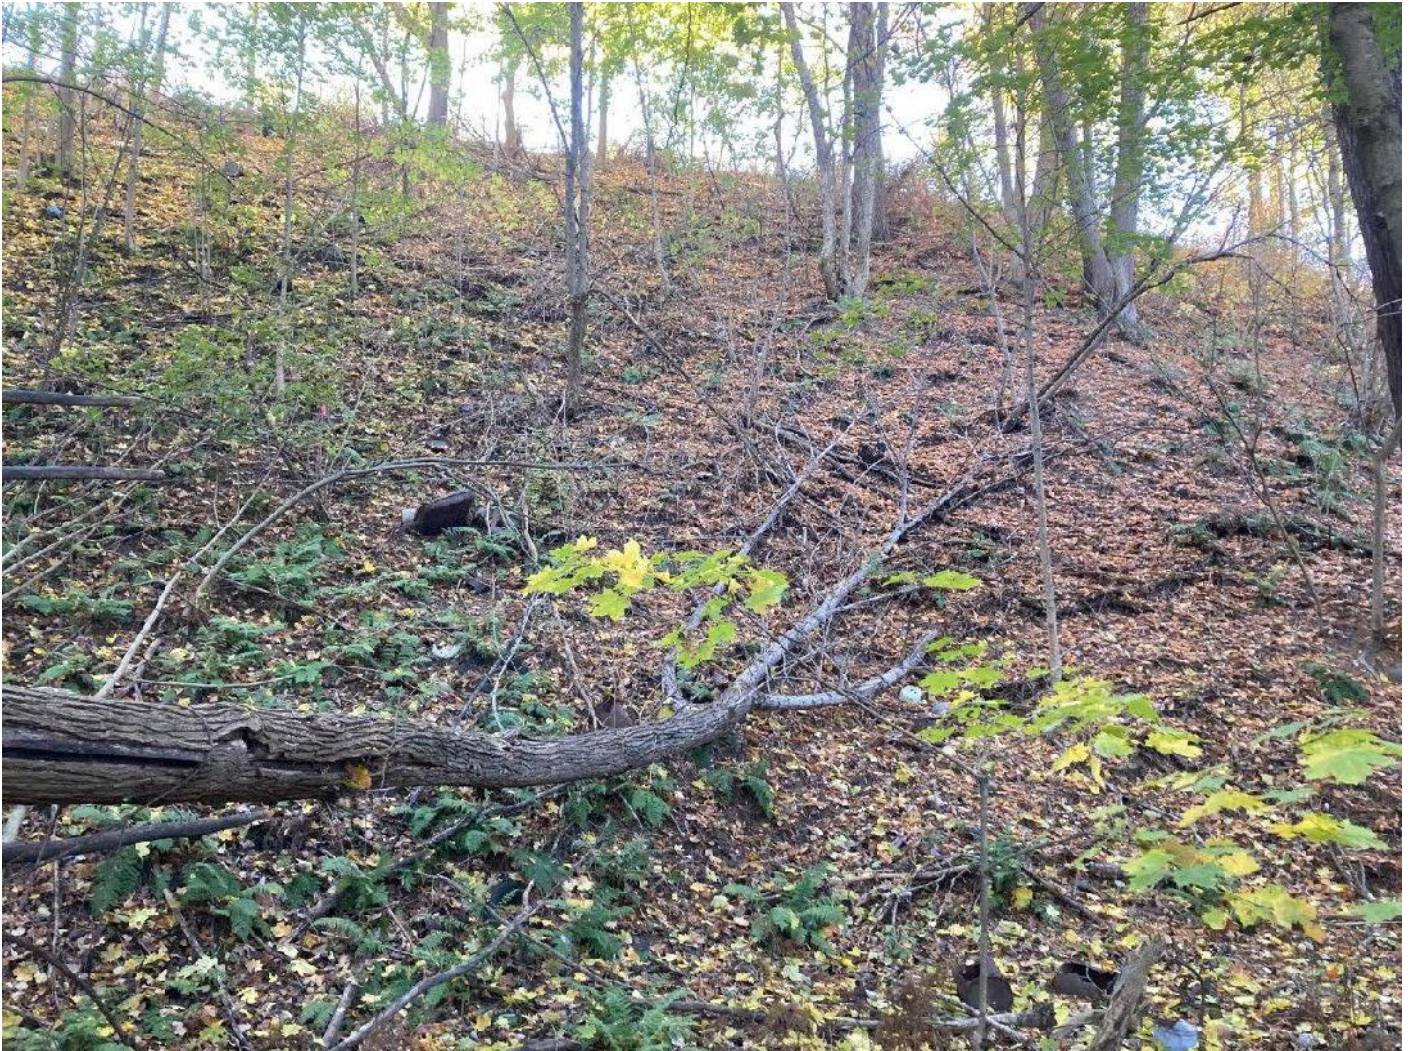
Slope Location: Manhattan Drive and Route 127 (Beltline) Date: Oct. 2020  
City: Burlington State: Vermont  
Description : Photograph 18: View of Slope West of Culvert 3 Pipe

**Photograph 18:** View to southwest of slope west of Culvert 3 pipe showing exposed soil surface exposed to erosion during precipitation events; exposed surfaces will continue to erode; note no distinct lean of trees at mid and top of slope.

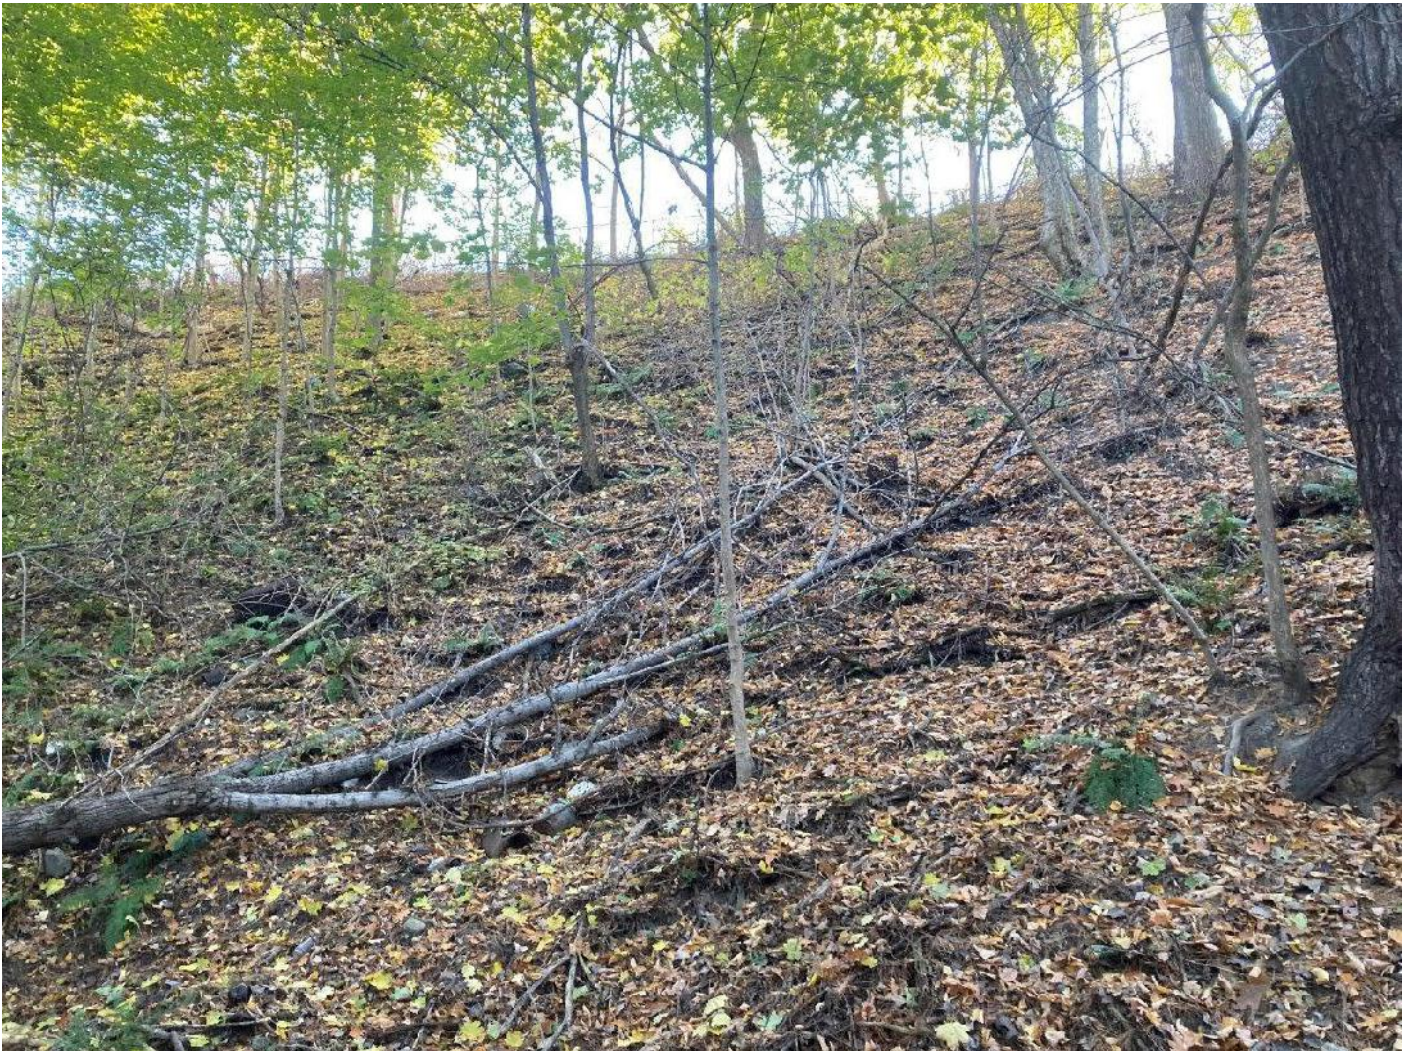
Slope Location: Manhattan Drive and Route 127 (Beltline) Date: Oct. 2020  
City: Burlington State: Vermont  
Description : Photograph 19: Another View of Slope from Position of Photograph 18

**Photograph 19:** View to south-southwest from toe of slope, from position of Photograph 18, providing another view of the slope.
