## **Burlington Conservation Board**

## Conservation Board Meeting Minutes

## FY20 Burlington Slope Inspections

**CITY OF BURLINGTON, VERMONT  
SLOPE STABILITY INSPECTION**

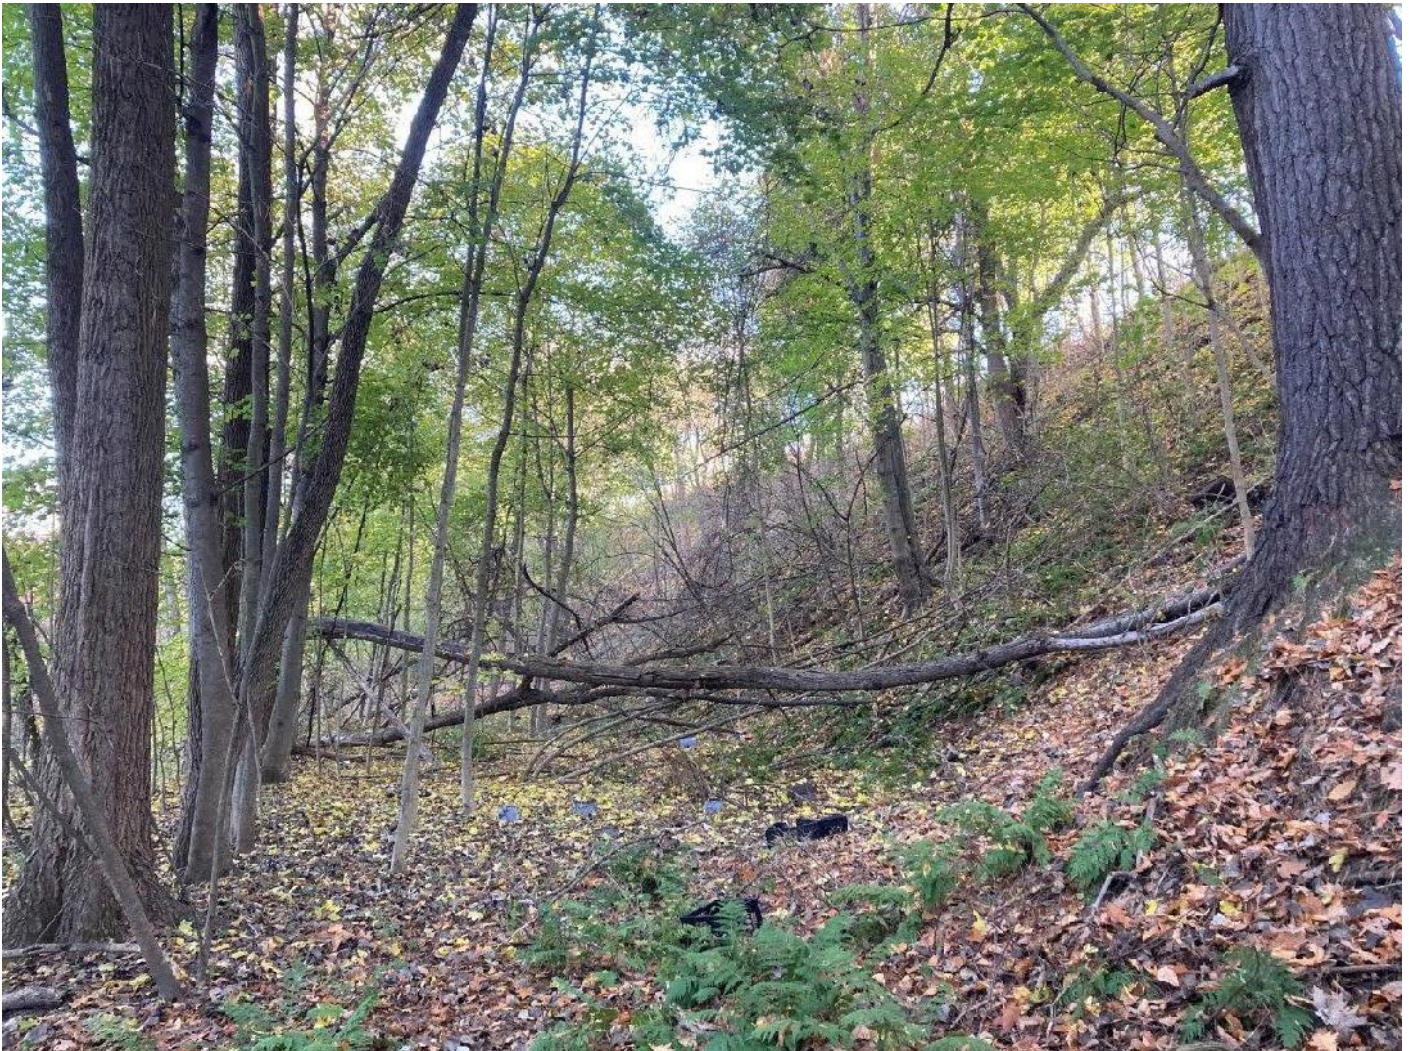
Slope Location: Manhattan Drive and Route 127 (Beltline) Date: Oct. 2020  
City: Burlington State: Vermont  
Description : Photograph 20: Toe of Slope West of Culvert 3

**Photograph 20:** View to east of toe of slope west of Culvert 3; culvert pipe can be seen at left-center of photograph; discharge channel from Culvert 1 extreme left of photograph, obscured by trees.

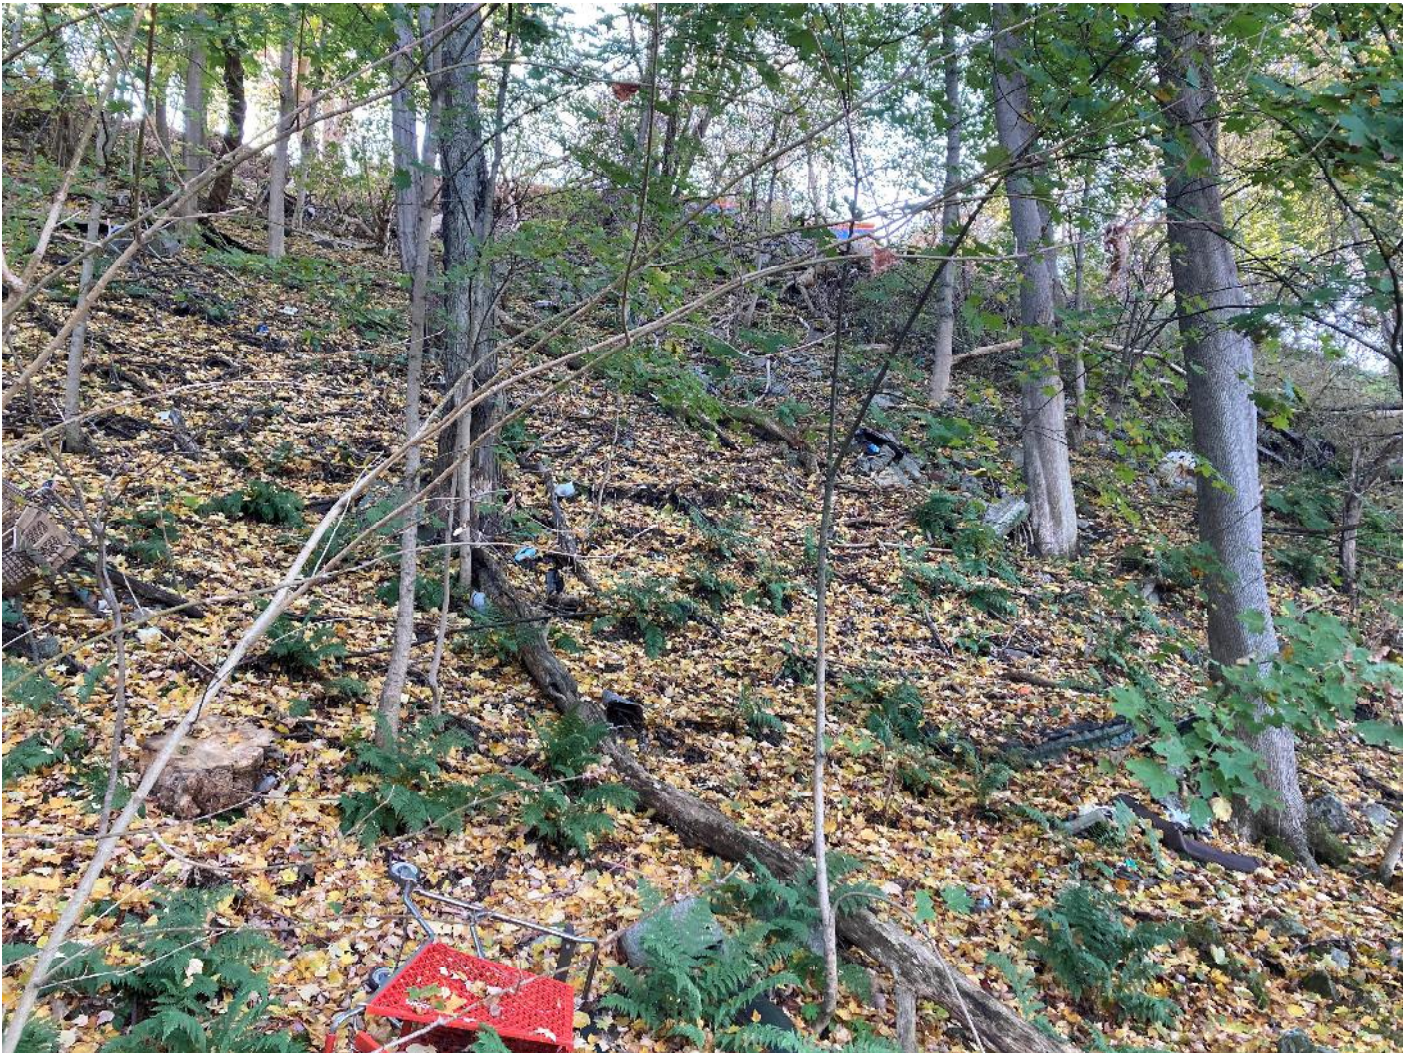
Slope Location: Manhattan Drive and Route 127 (Beltline) Date: Oct. 2020  
City: Burlington State: Vermont  
Description : Photograph 27: Western End of Slope

**Photograph 27:** View to southwest upslope to Manhattan Drive at Convent Square; note the amount of debris on slope.

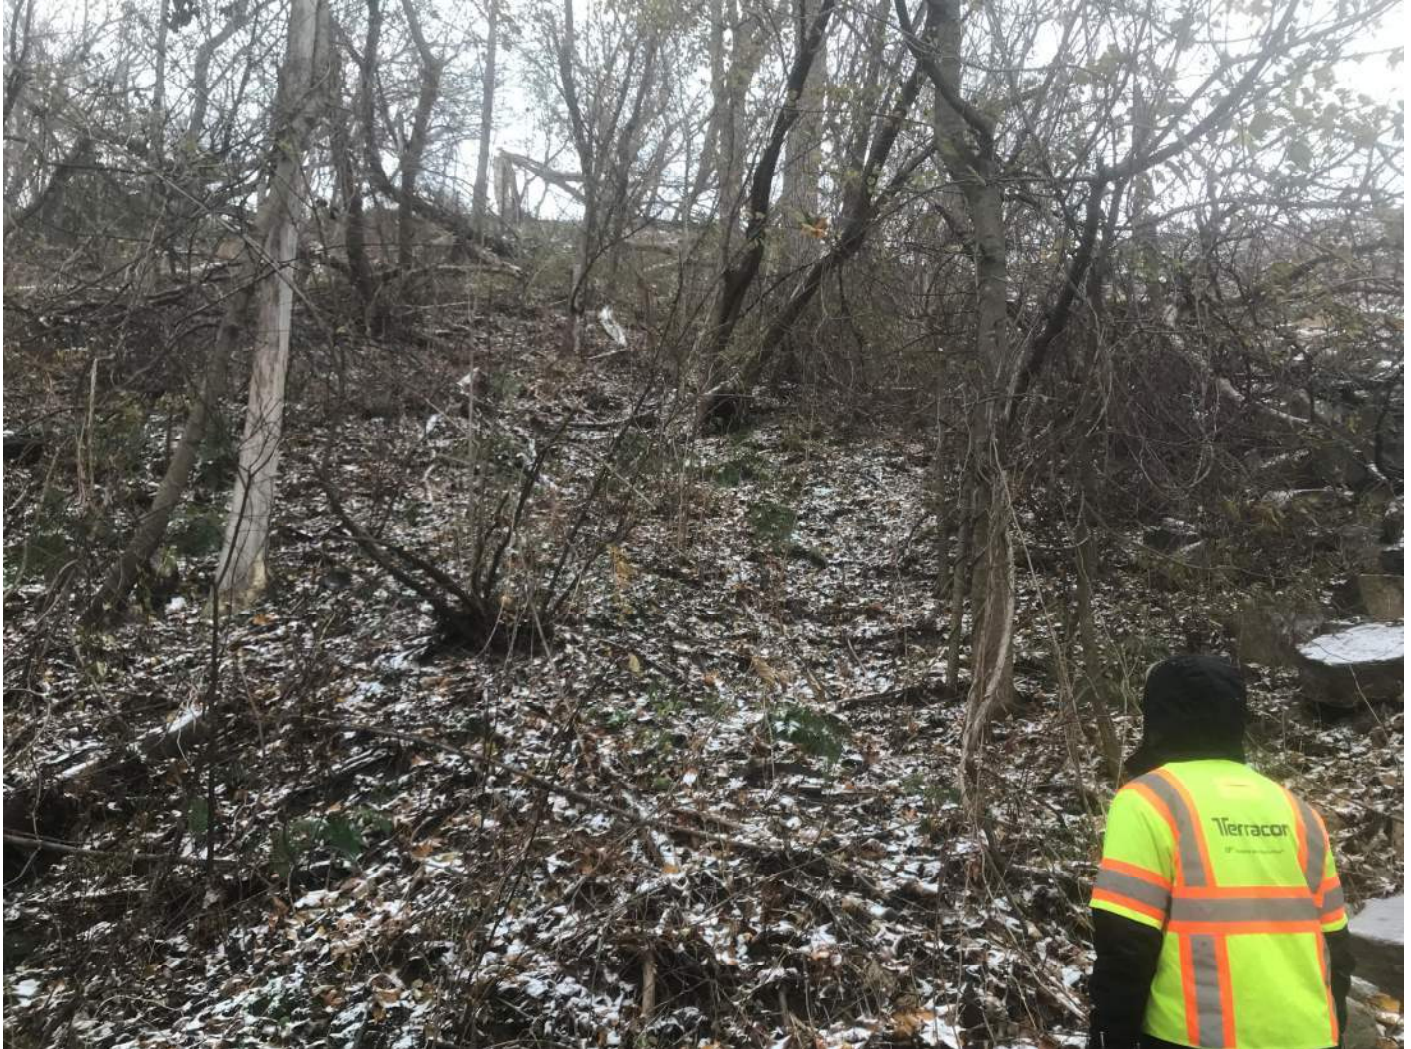
Slope Location: Manhattan Drive at North Champlain Street Date: 11/11/2019  
City: Burlington State: Vermont  
Description : Photograph 6 – Natural Slope on Eastern Flank of Remediated Slope

**Photograph 6:** View to south of natural vegetated slope on western flank of remediated slope; photo shows density of vegetation and leaf mat

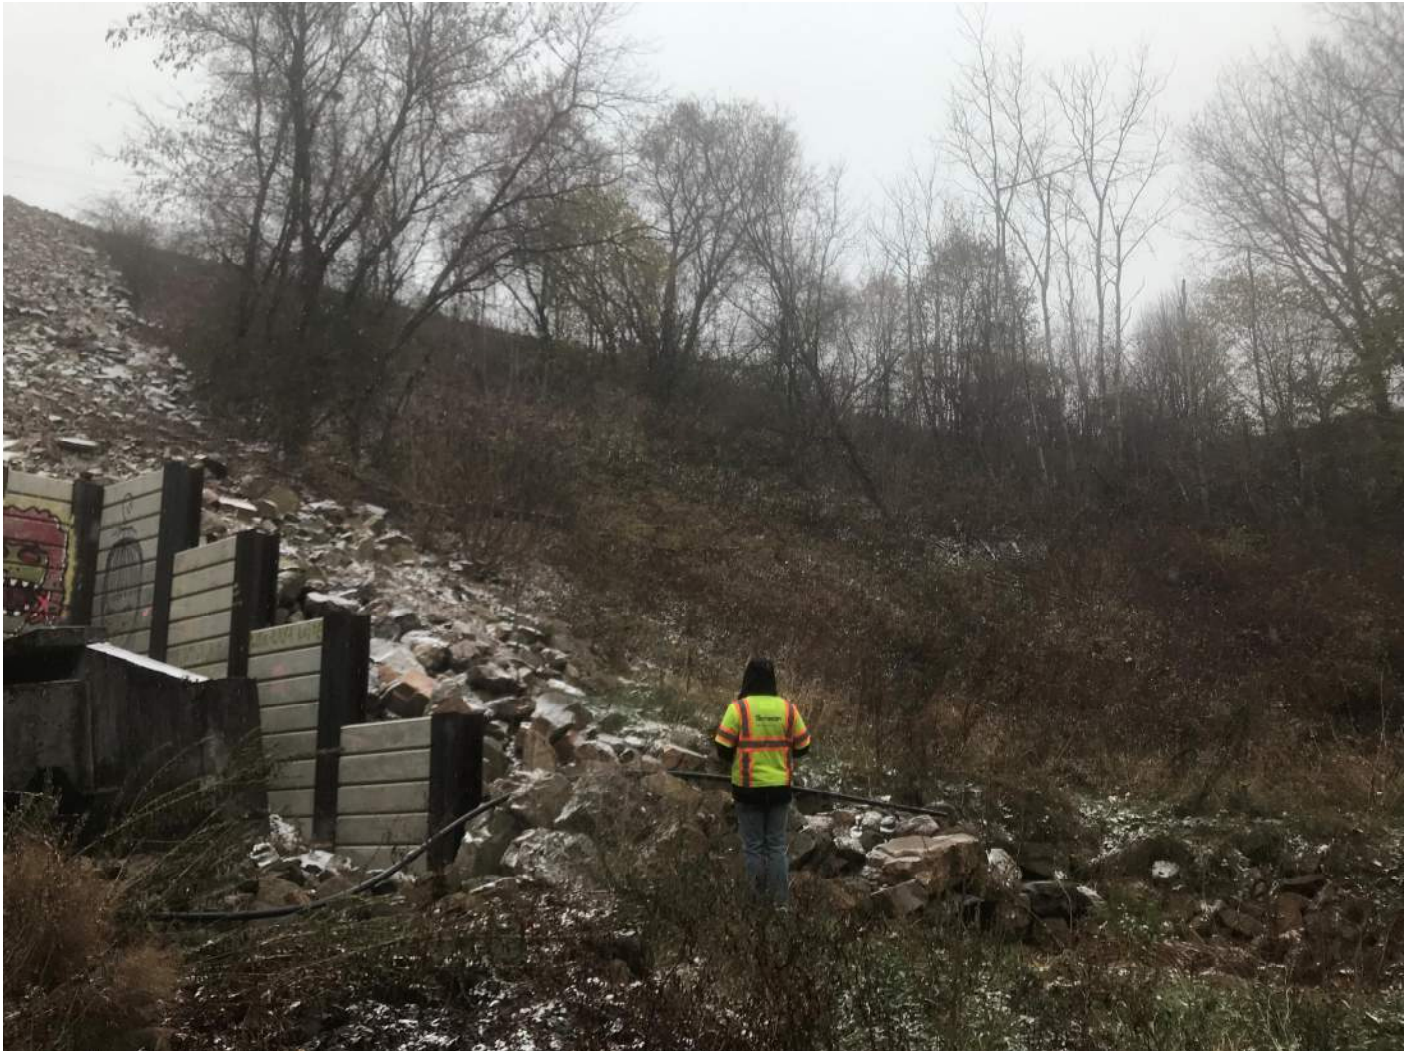
Slope Location: Manhattan Drive at North Champlain Street Date: 11/11/2019  
City: Burlington State: Vermont  
Description : Photograph 7 – Natural Slope on Western Flank of Remediated Slope

**Photograph 7:** View to southwest of natural vegetated slope on western flank of remediated slope; stormwater drainage outlet is shown left foreground

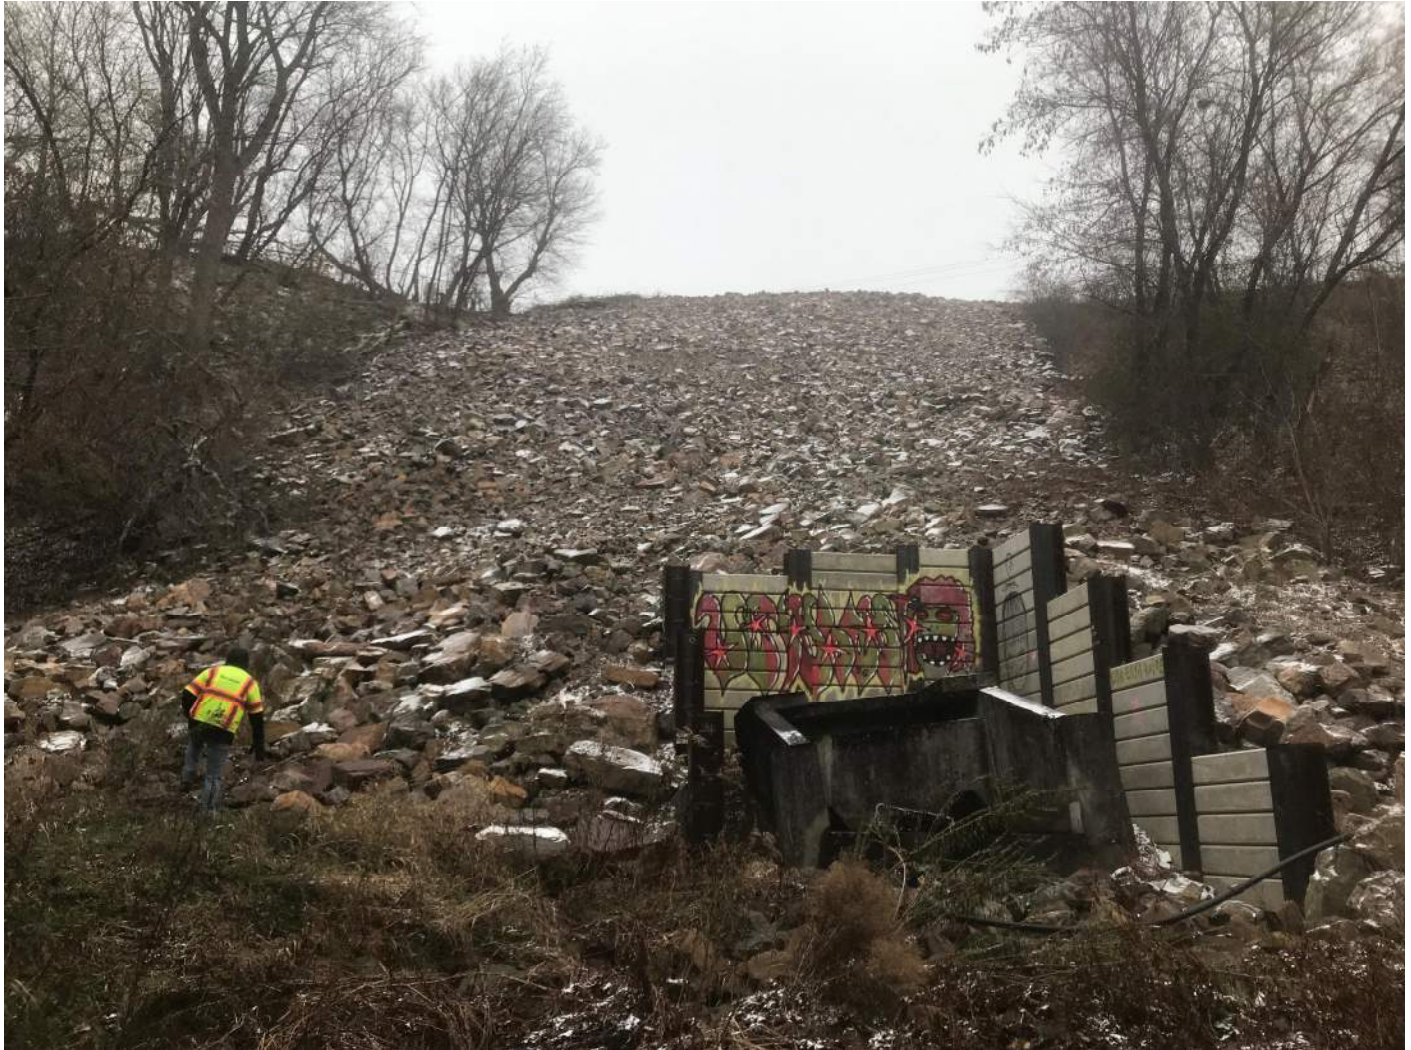
Slope Location: Manhattan Drive at North Champlain Street Date: 11/11/2019  
City: Burlington State: Vermont  
Description : Photograph 1 – Remediated Slope

**Photograph 1:** View to south showing remediated section of slope with boulder rip-rap; stormwater drainage outlet shown in foreground; natural vegetated slopes occur on flanks of remediated slope

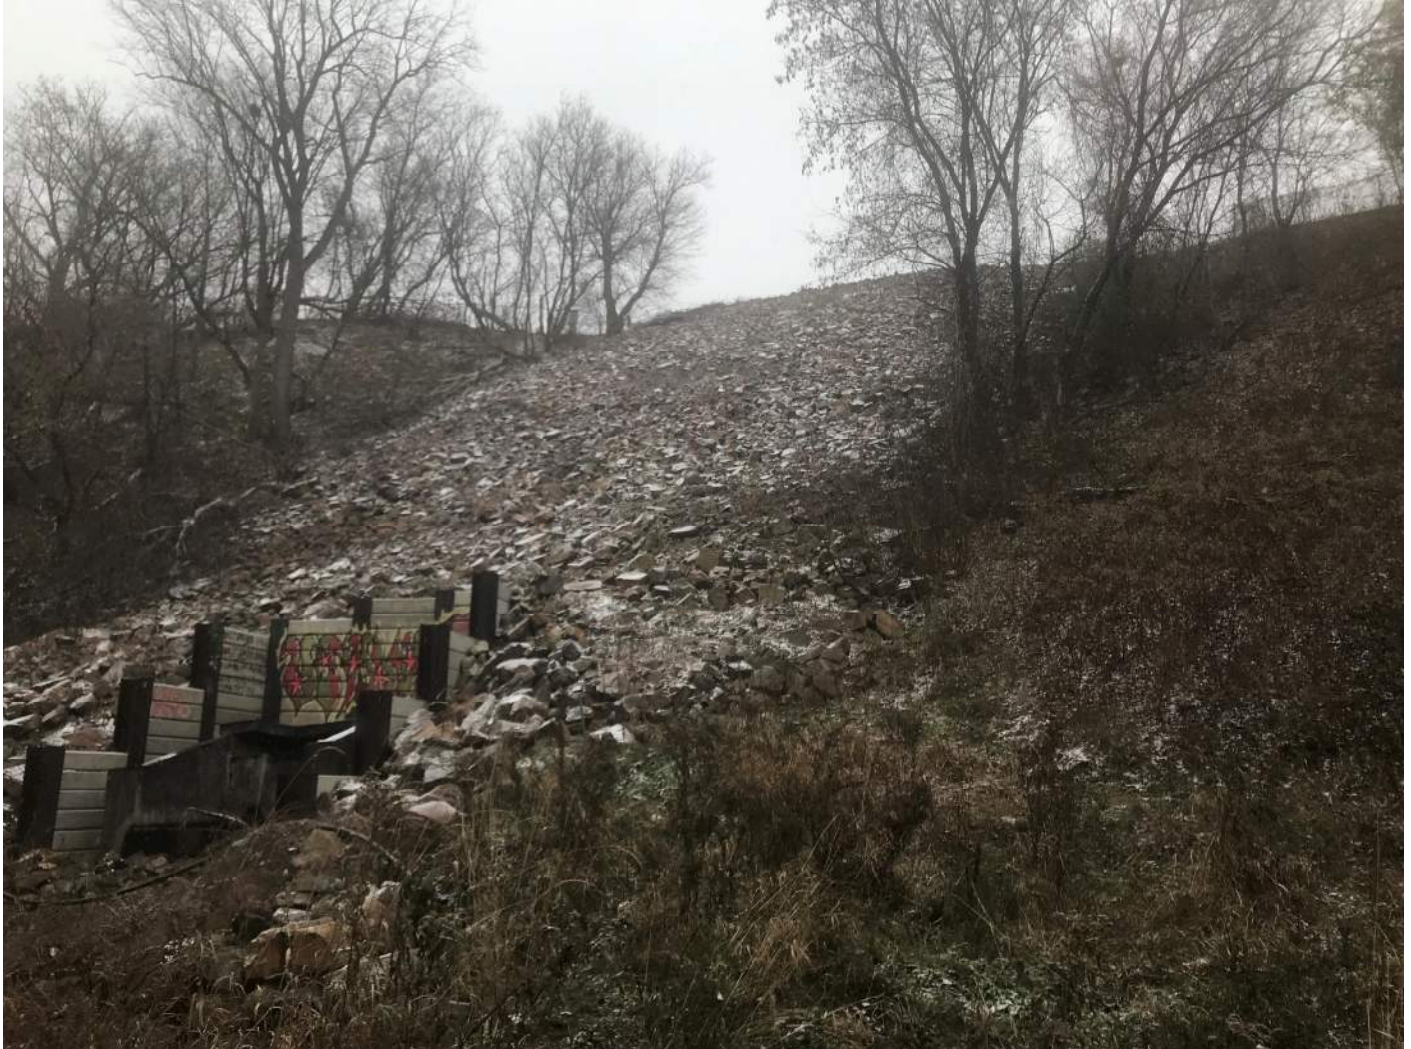
Slope Location: Manhattan Drive at North Champlain Street Date: 11/11/2019  
City: Burlington State: Vermont  
Description : Photograph 2 – Remediated Slope with Natural Slopes on Flanks

**Photograph 2:** View to southeast of remediated slope and natural vegetated slopes on eastern and western flanks

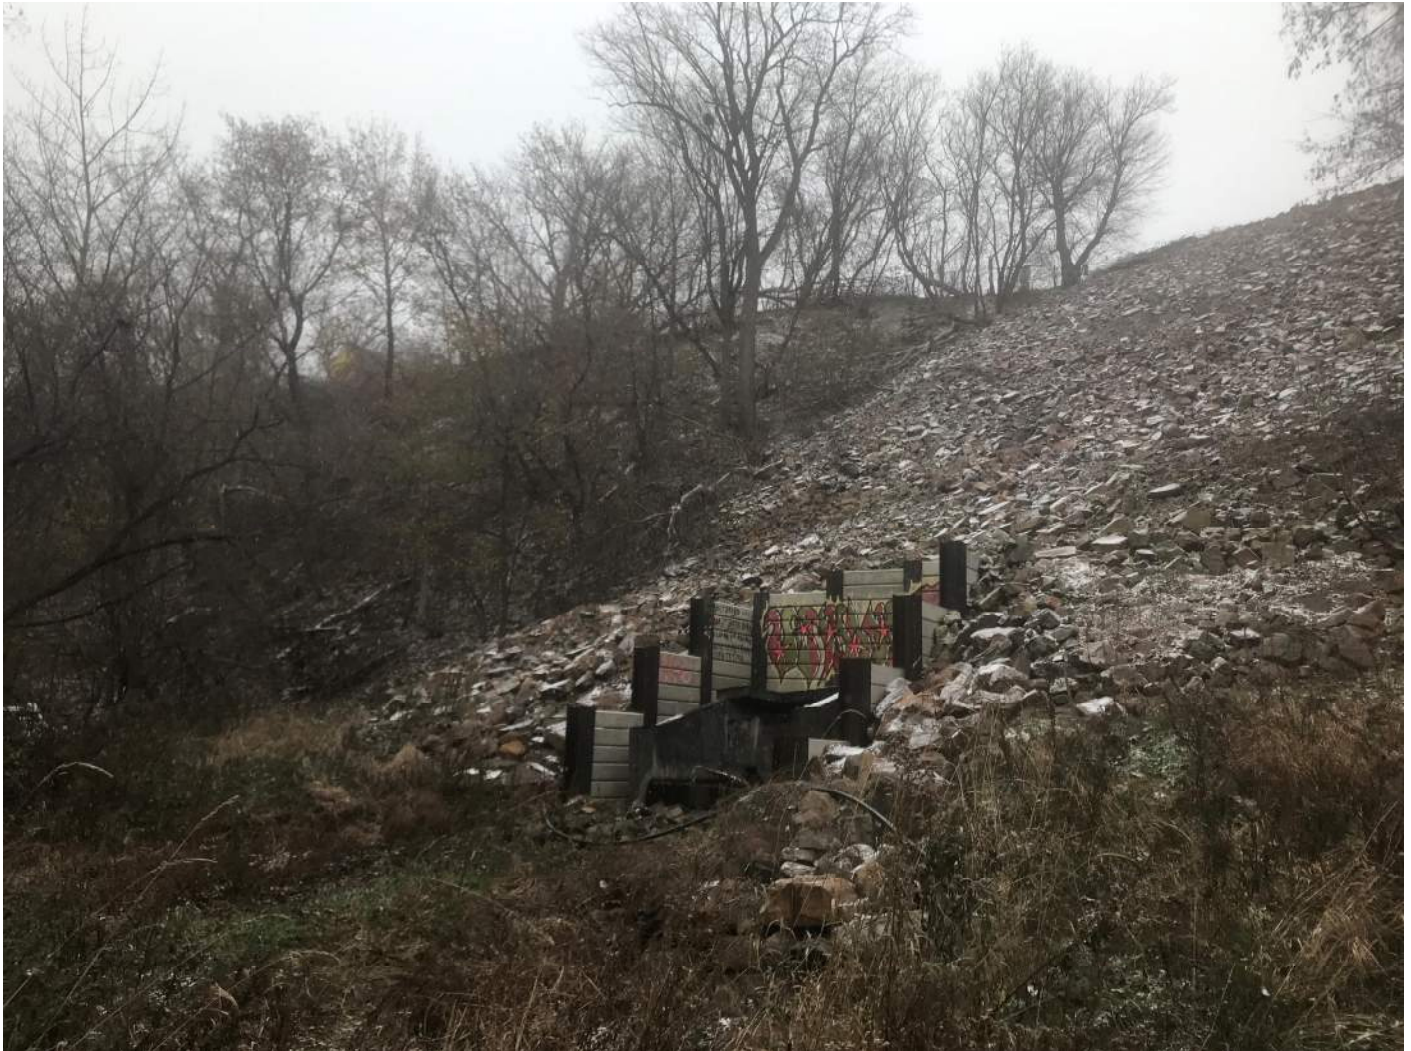
Slope Location: Manhattan Drive at North Champlain Street Date: 11/11/2019  
City: Burlington State: Vermont  
Description : Photograph 3 – Remediated Slope with Natural Slope on Eastern Flank

**Photograph 3:** View to southeast of remediated slope and natural vegetated slopes on eastern flank; stormwater drainage outlet in foreground

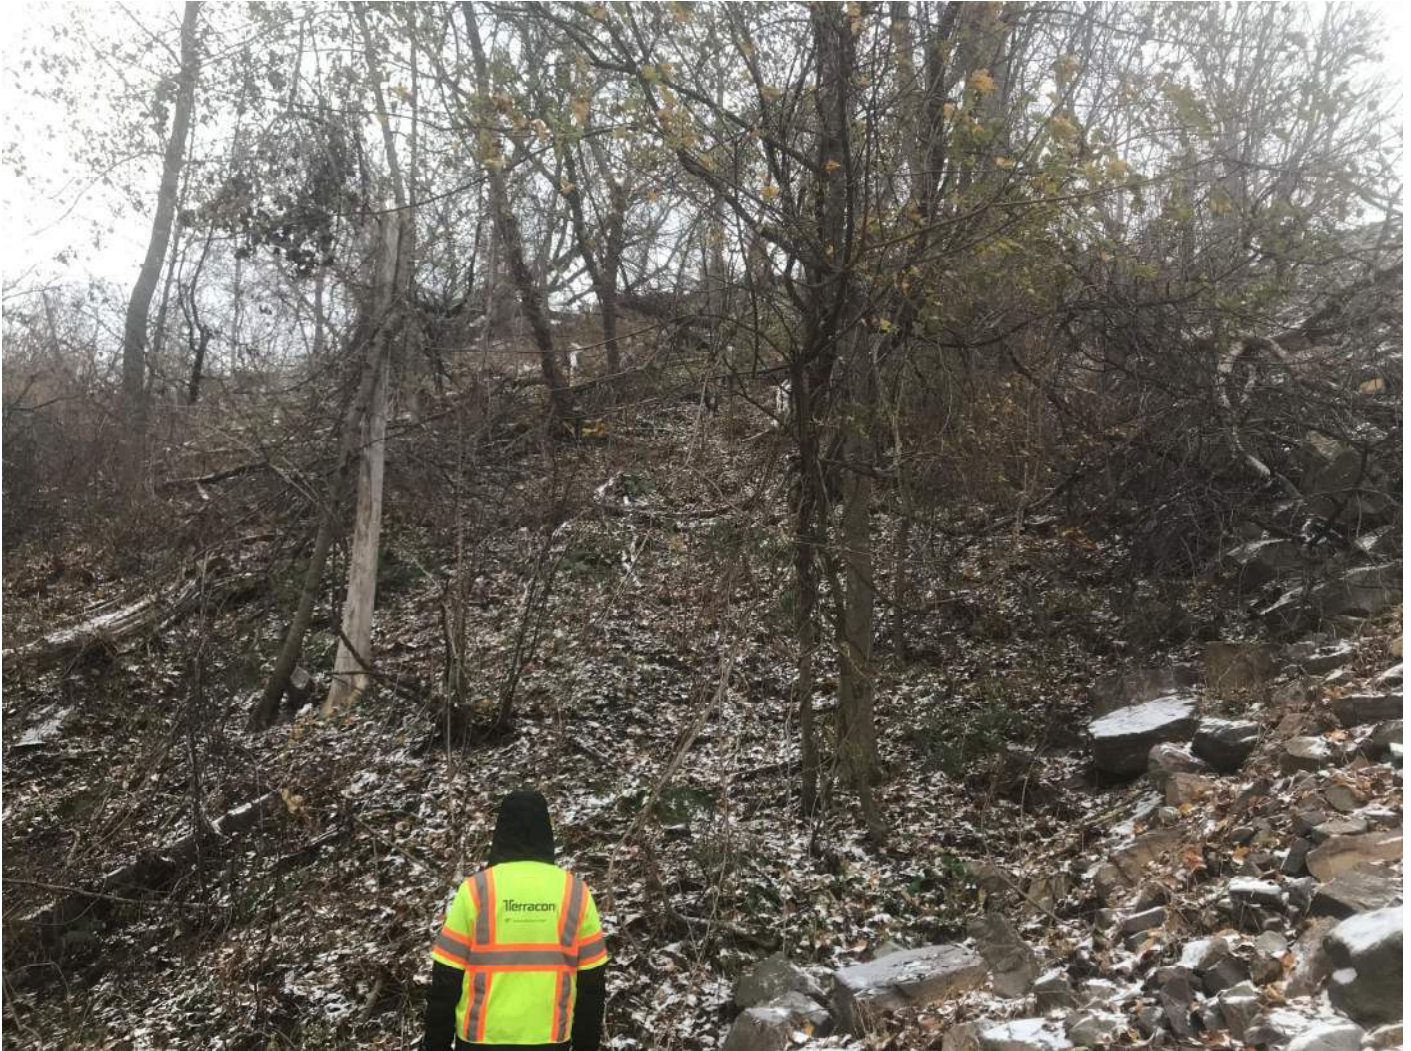
Slope Location: Manhattan Drive at North Champlain Street Date: 11/11/2019  
City: Burlington State: Vermont  
Description : Photograph 4 – Eastern Flank of Remediated Slope

**Photograph 4:** View to south-southeast of natural vegetated slope on eastern flank of remediated slope

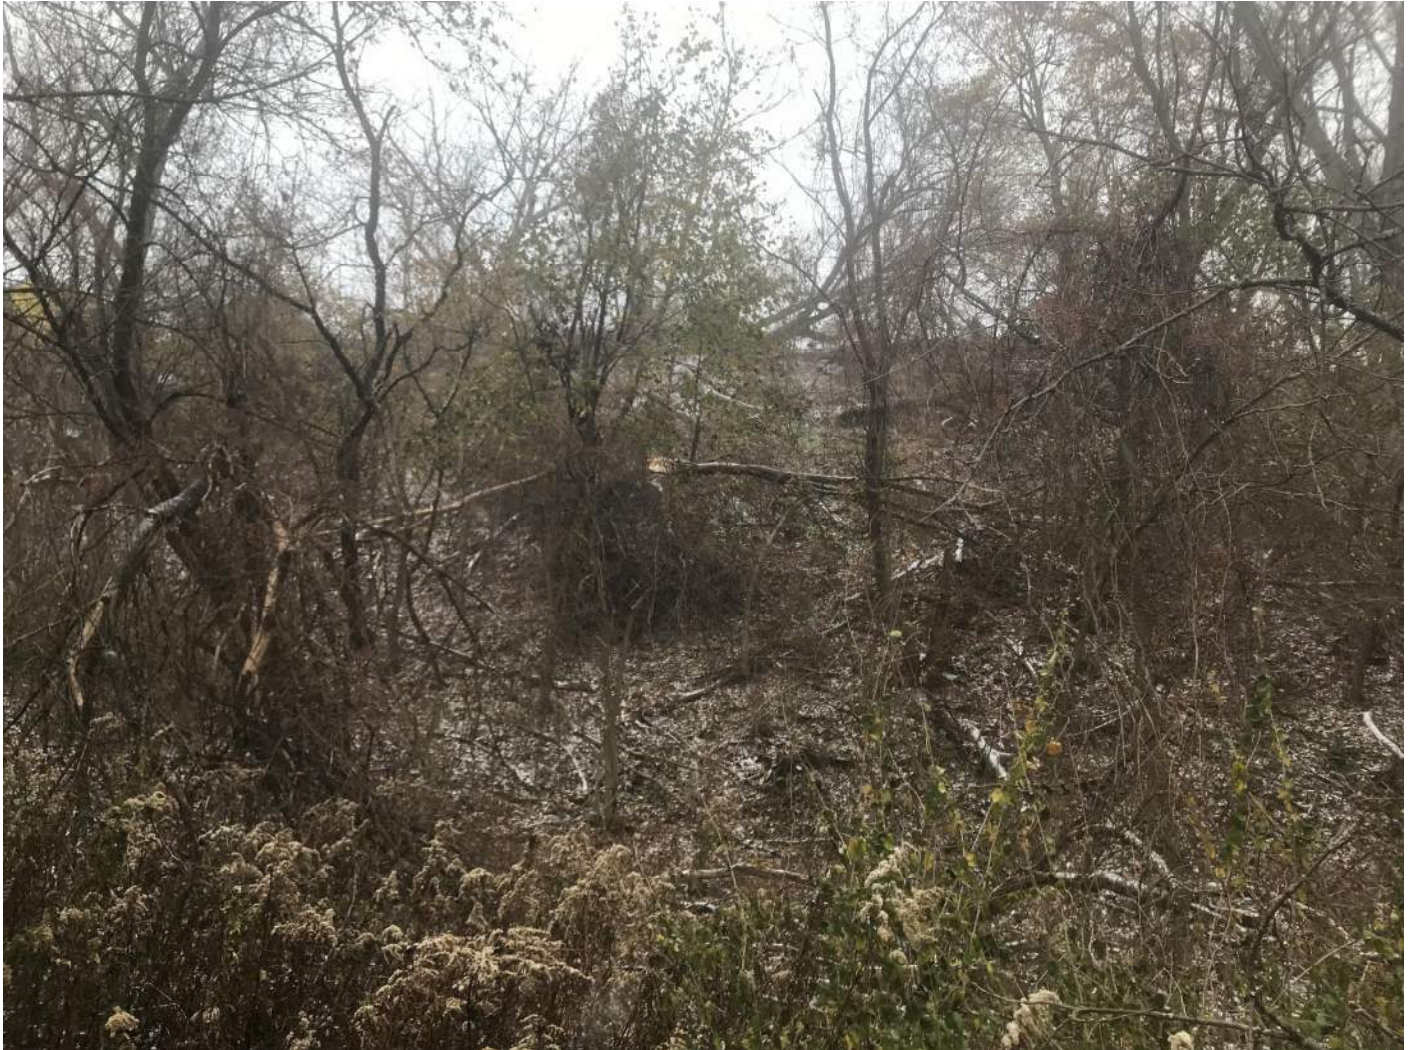
Slope Location: Manhattan Drive at North Champlain Street Date: 11/11/2019  
City: Burlington State: Vermont  
Description : Photograph 5 – Vegetated Natural Slope on Eastern Flank of Remediated Slope

**Photograph 5:** View to south of densely vegetated natural slope on eastern flank of remediated slope

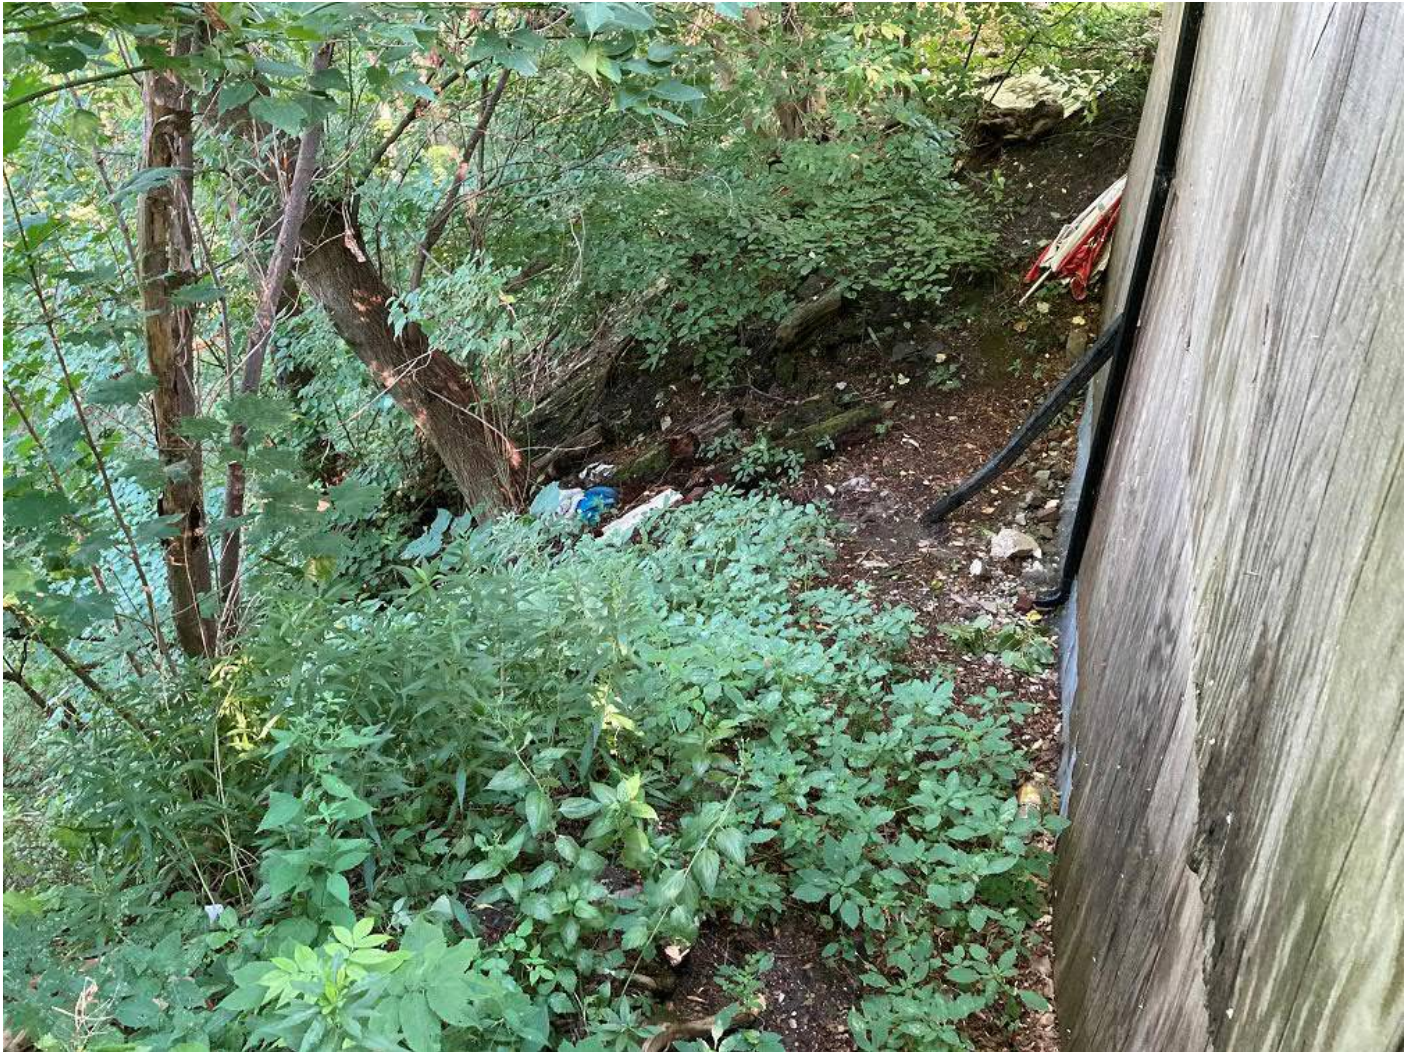
Slope Location: 505 Riverside Avenue – Kismayo Kitchen Date: 8/5/2020  
City: Burlington State: Vermont  
Description : Photograph 3: View Behind Kismayo Kitchen Building

**Photograph 3:** View behind Kismayo Kitchen building showing erosion gully from surface runoff; soil will continue to erode during precipitation events; note location of downspout; note lean of tree left center of photograph; soil scarp at left obscured by vegetation.

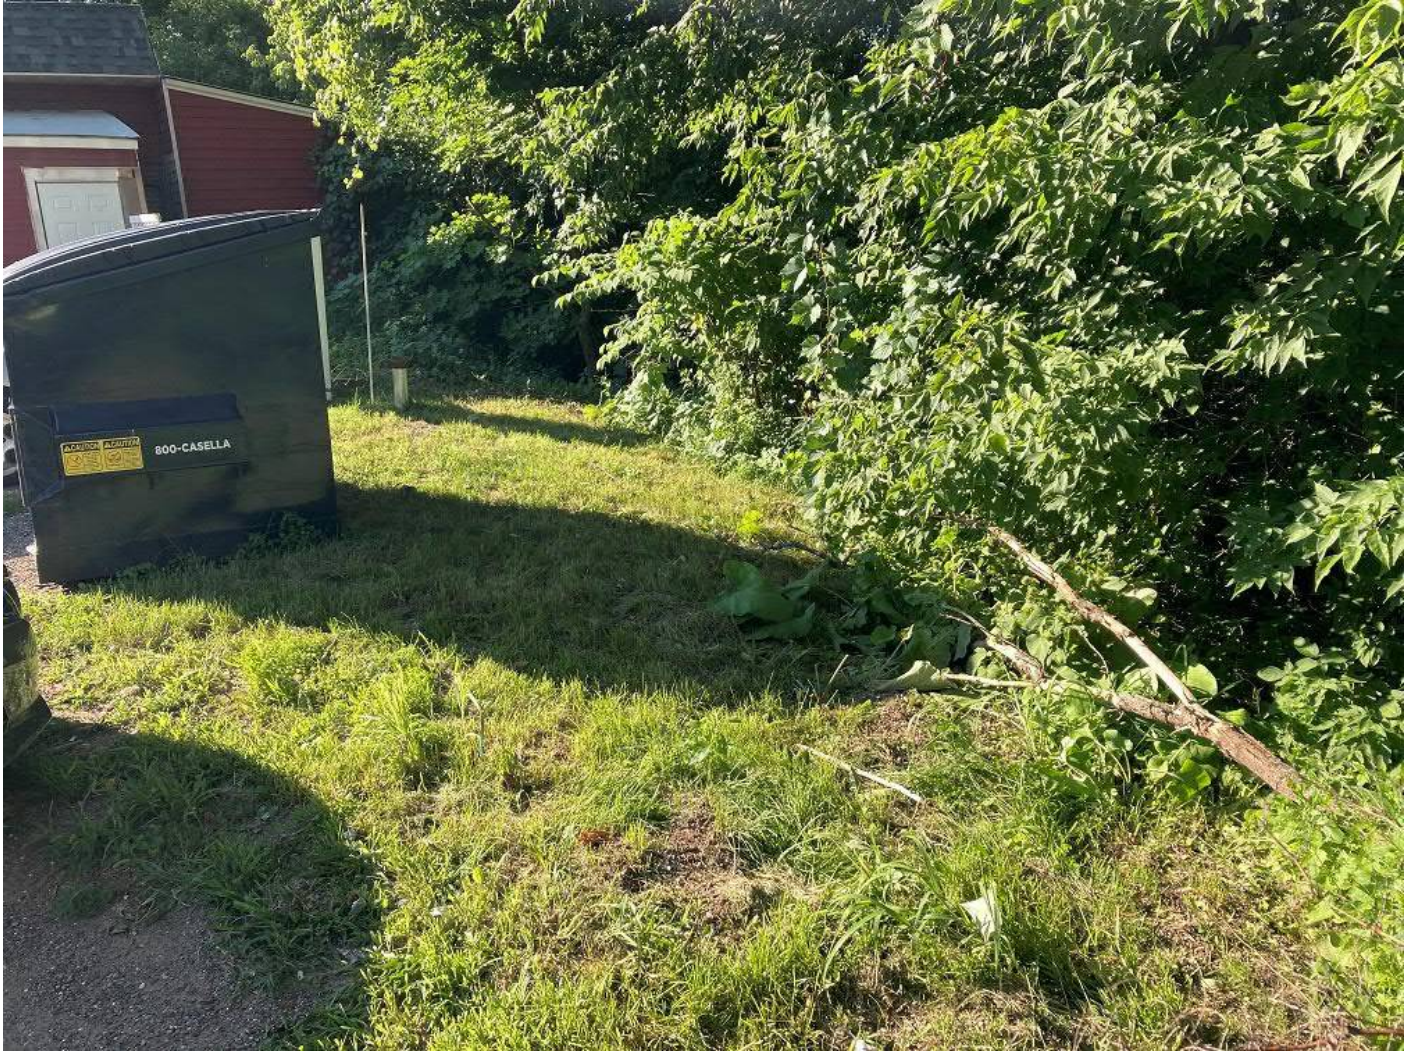
Slope Location: 505 Riverside Avenue – Kismayo Kitchen Date: 8/5/2020  
City: Burlington State: Vermont  
Description : Photograph 4: East Side Kismayo Kitchen Building

**Photograph 4:** View to west-northwest of east side of Kismayo Kitchen building, showing slightly irregular ground surface that appears stable; note monitoring well top left; soil scarp at center and center right obscured by vegetation.

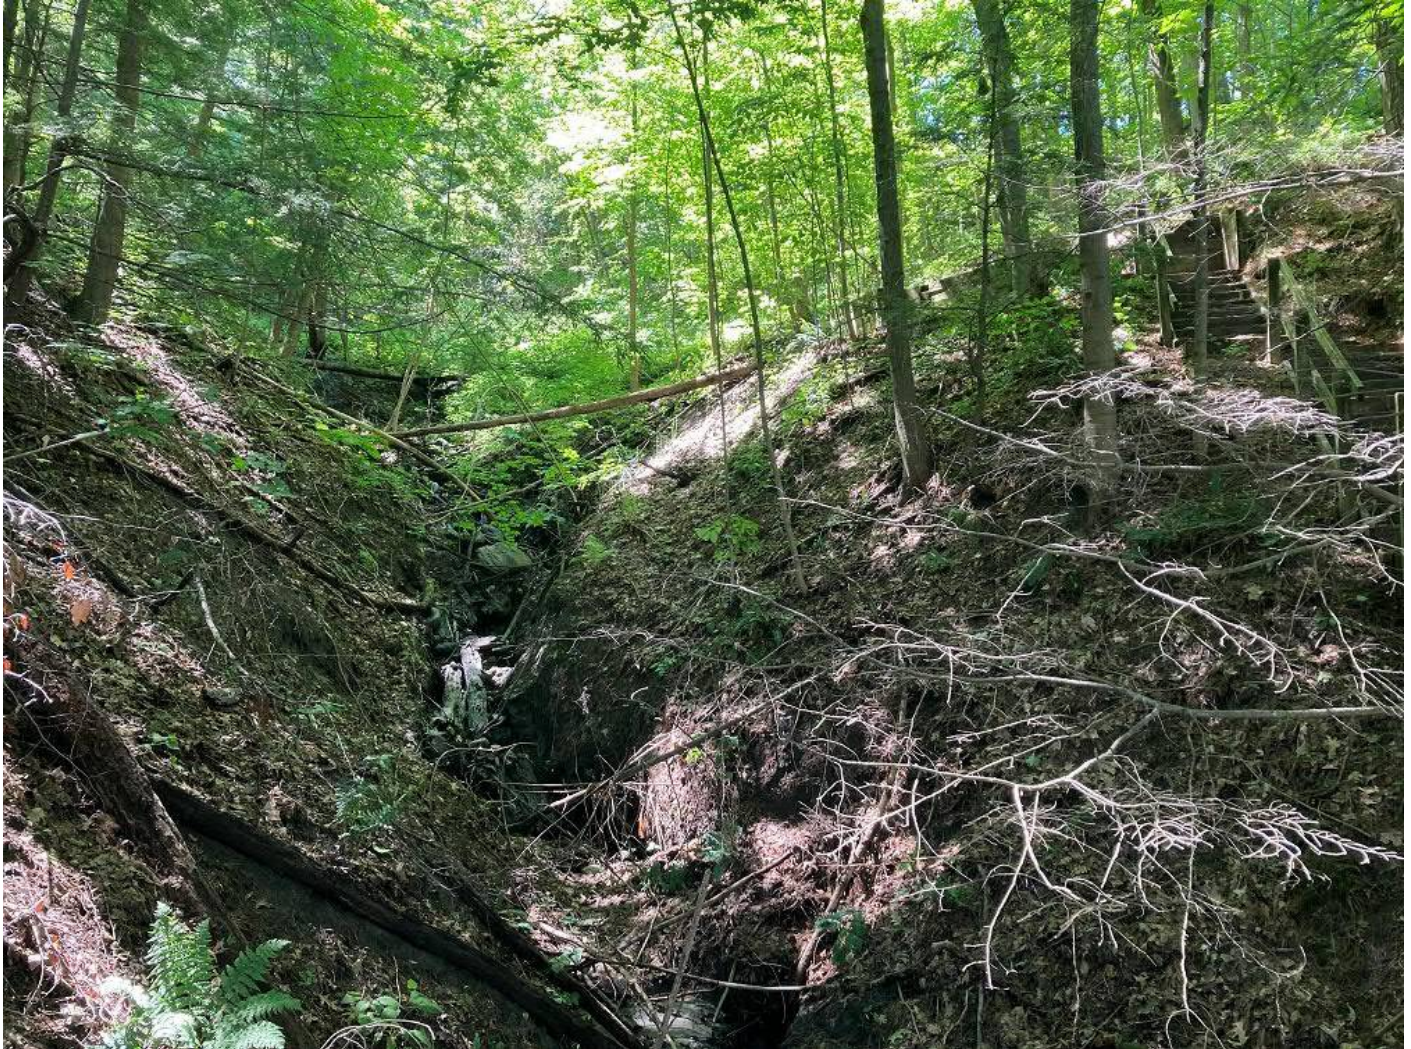
Slope Location: 505 Riverside Avenue – Kismayo Kitchen Date: 8/5/2020  
City: Burlington State: Vermont  
Description : Photograph 5: Erosional Gully Downslope (i.e. North) from 505 Riverside Ave.

**Photograph 5:** View to south southwest, downslope from and north of 505 Riverside Avenue, showing erosional gully formed by runoff and/or discharge from top of slope; unvegetated slopes subject to continued erosion during precipitation events; note stairs to right leading from Intervale Road to River Walk trail

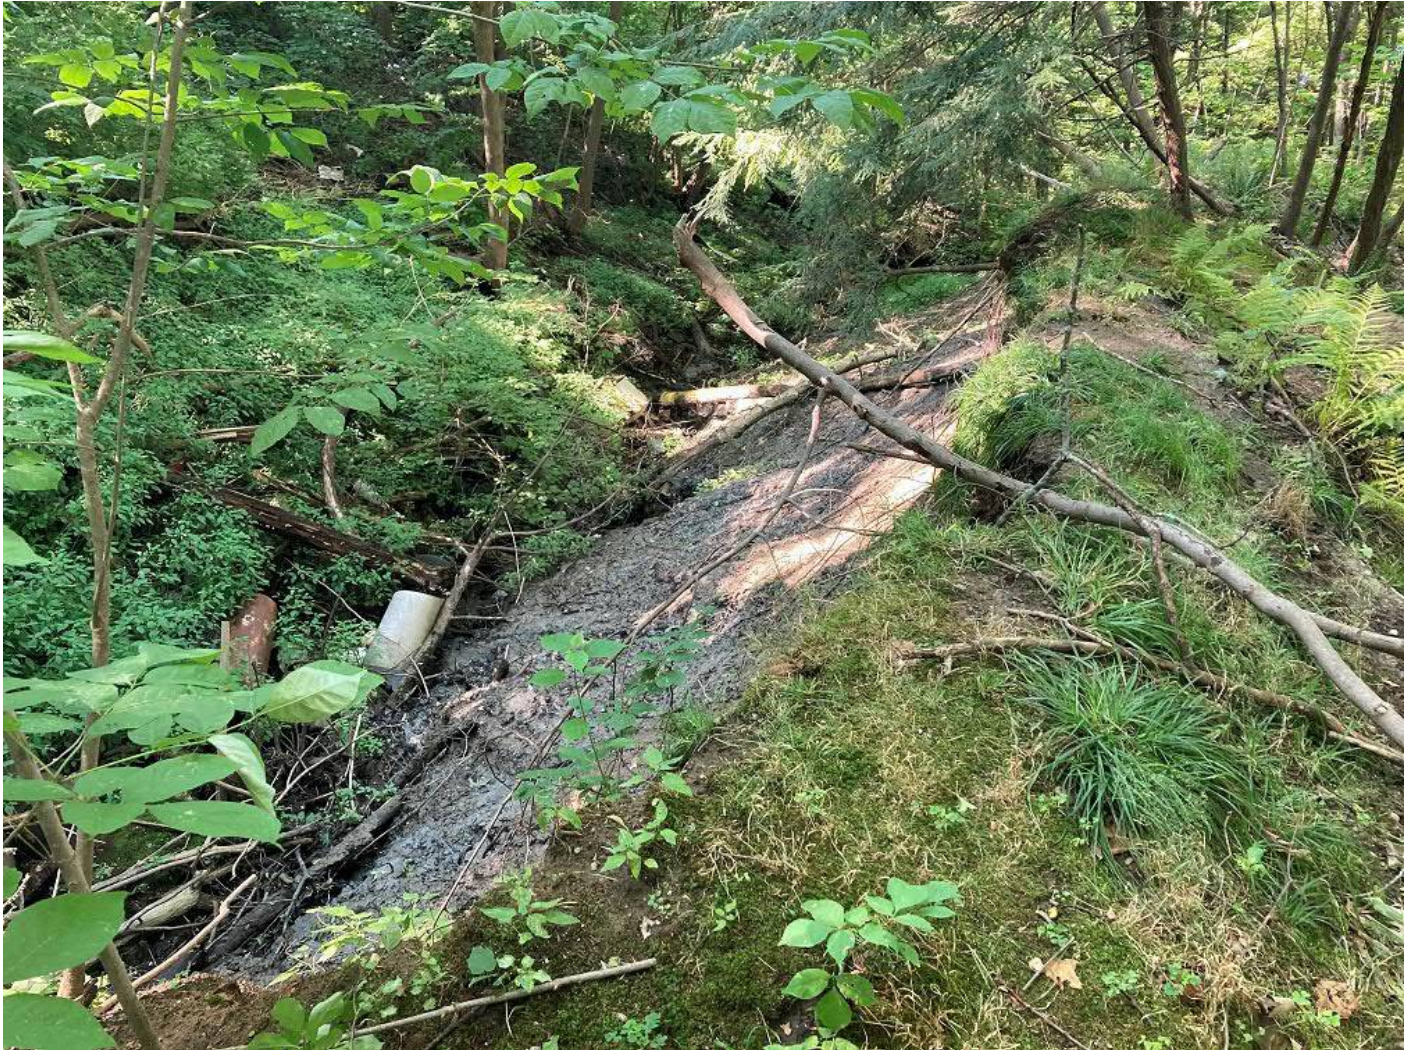
Slope Location: 505 Riverside Avenue – Kismayo Kitchen Date: 8/13/2020  
City: Burlington State: Vermont  
Description : Photograph 8: View Downslope of Gully Formation from Stormwater Discharge

**Photograph 8:** View to north northwest of large gully formed in historic downslope slump mass by stormwater discharge; sides of gully will continue to collapse and expand with ongoing stormwater discharge; note density of summer vegetation.

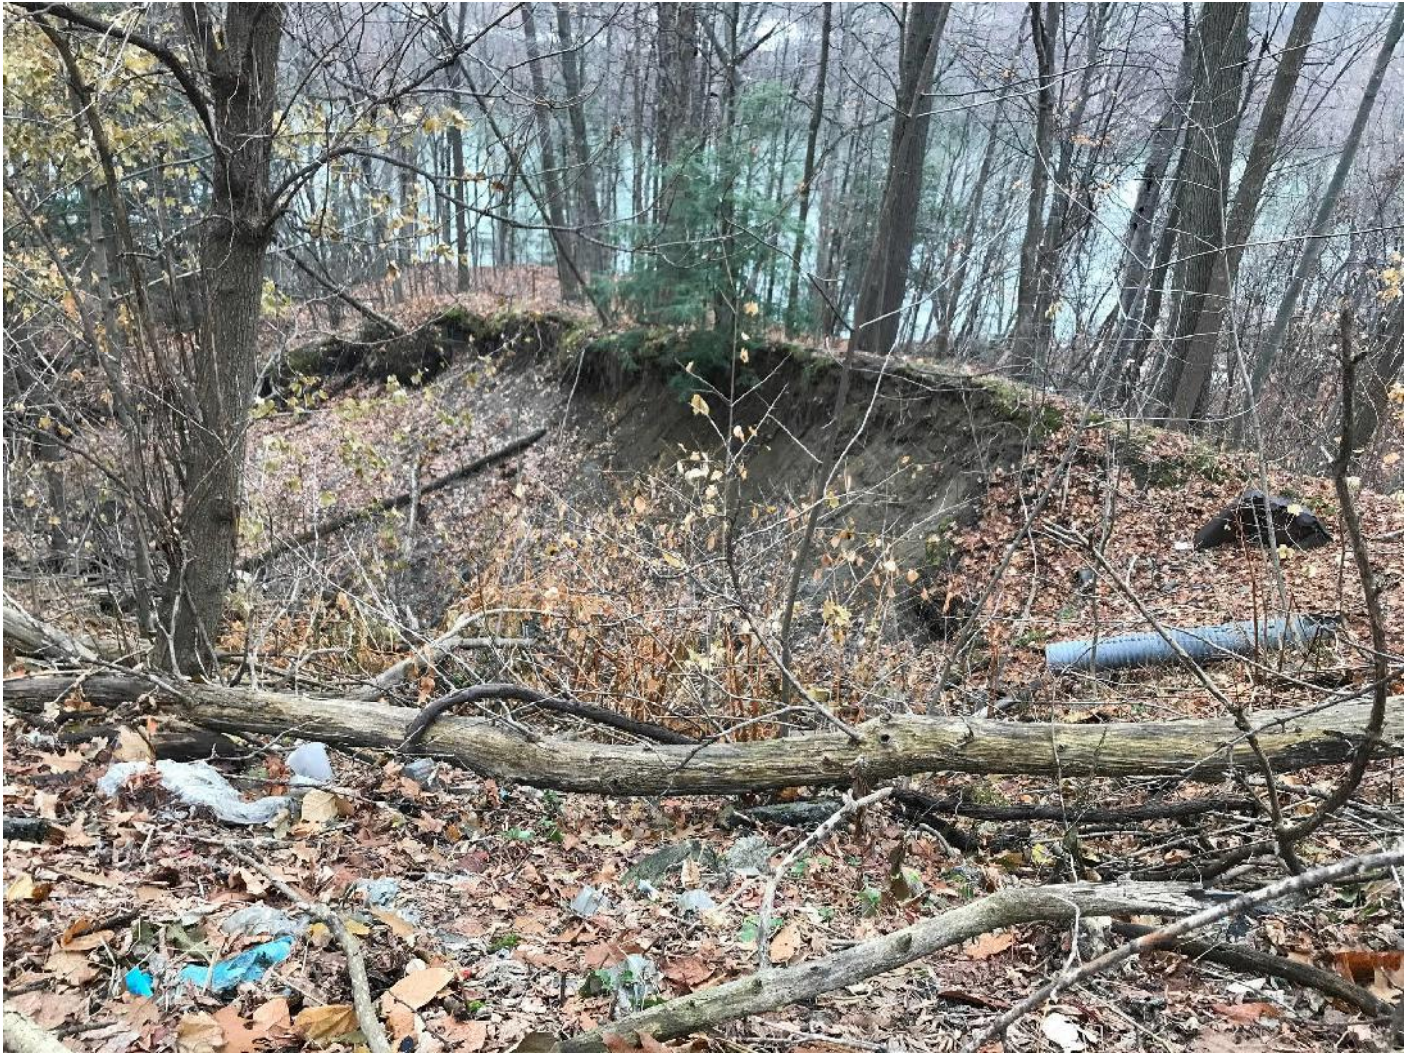
Slope Location: 505 Riverside Avenue – Kismayo Kitchen Date: 12/2019  
City: Burlington State: Vermont  
Description : Photograph 9: Discharge Pipe and Downslope Gully Formation, December 2019 Inspection by Hoyle Tanner Associates

**Photograph 9:** View to north of gully shown in Photographs 7 and 8, taken in December 2019 during slope inspection conducted by Hoyle Tanner Associates; note significant difference in density of winter vs. summer vegetation; exposed side slopes will continue to erode during discharge events as base of slope erodes and collapses.
