## **Burlington Conservation Board**

## Conservation Board Meeting Minutes

## FY20 Burlington Slope Inspections

**CITY OF BURLINGTON, VERMONT  
SLOPE STABILITY INSPECTION**

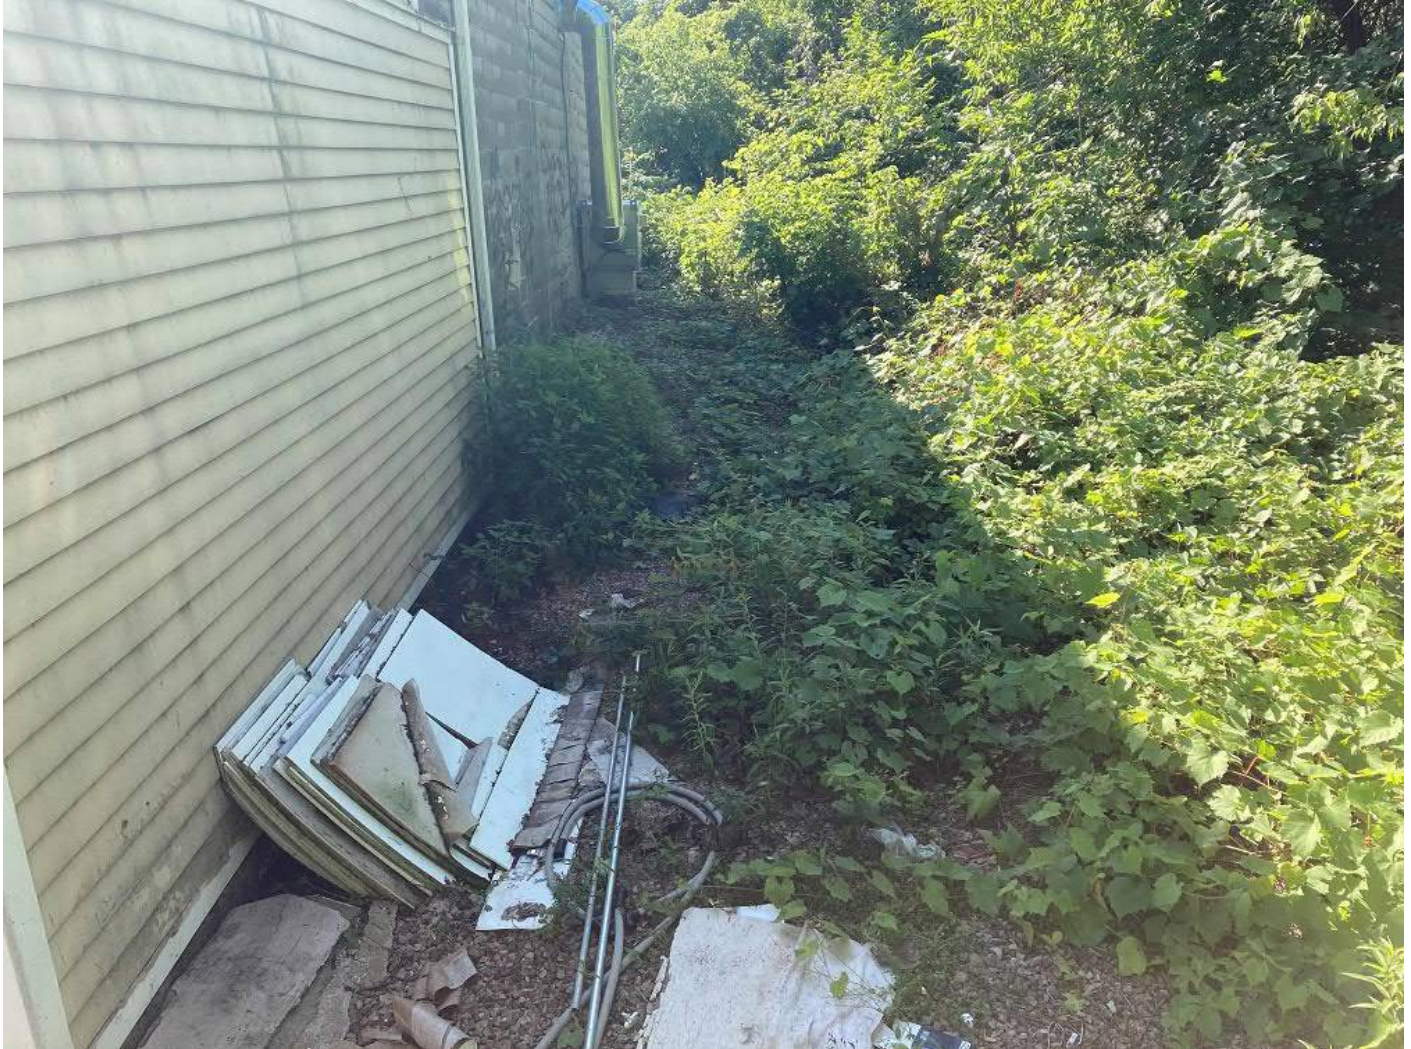
Slope Location: 471 Riverside Avenue – GBG Indian Kitchen Date: 8/5/2020  
City: Burlington State: Vermont  
Description : Photograph 12: View Behind GBG Indian Kitchen

**Photograph 12:** View to west behind GBG Indian Kitchen showing slight irregular surface and incipient slumping at center of photograph obscured by vegetation; exposed soil scarp to right of photograph is also obscured by dense vegetation (see Photograph 15).

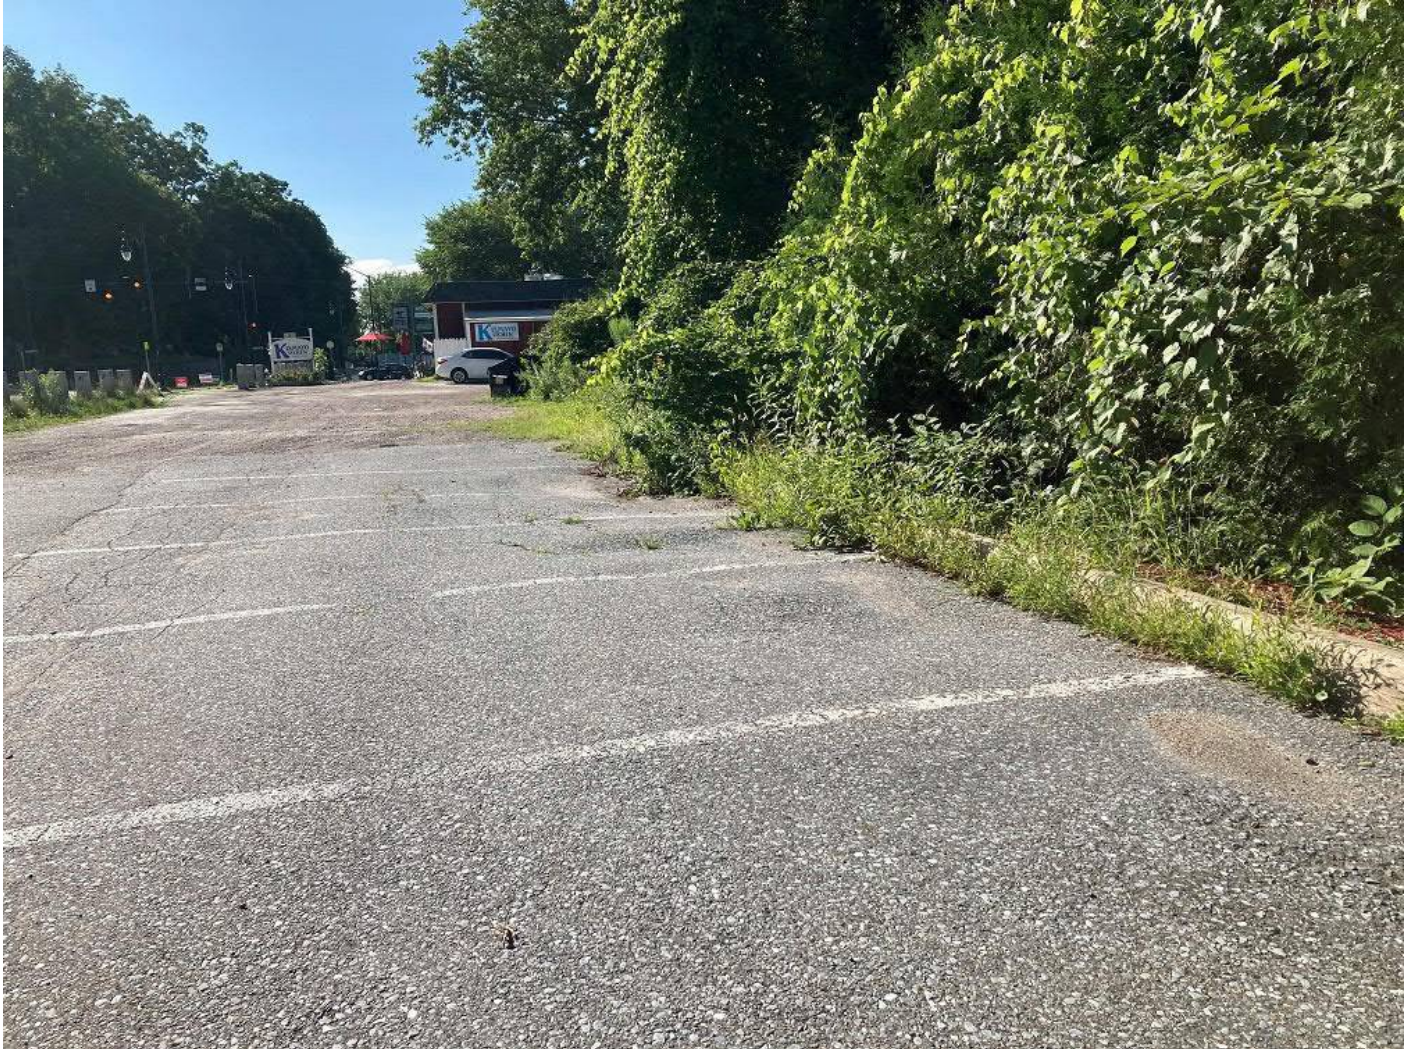
Slope Location: 471 Riverside Avenue – GBG Indian Kitchen Date: 8/5/2020  
City: Burlington State: Vermont  
Description : Photograph 13: Surface Expression of Incipient Soil Slumping

**Photograph 13:** View to west toward Kismayo Kitchen (505 Riverside Avenue) from GBG Indian Kitchen showing stressed pavement and surface depressions as an indicator of incipient soil slumping; exposed soil scarp is present beyond trees to right-center.

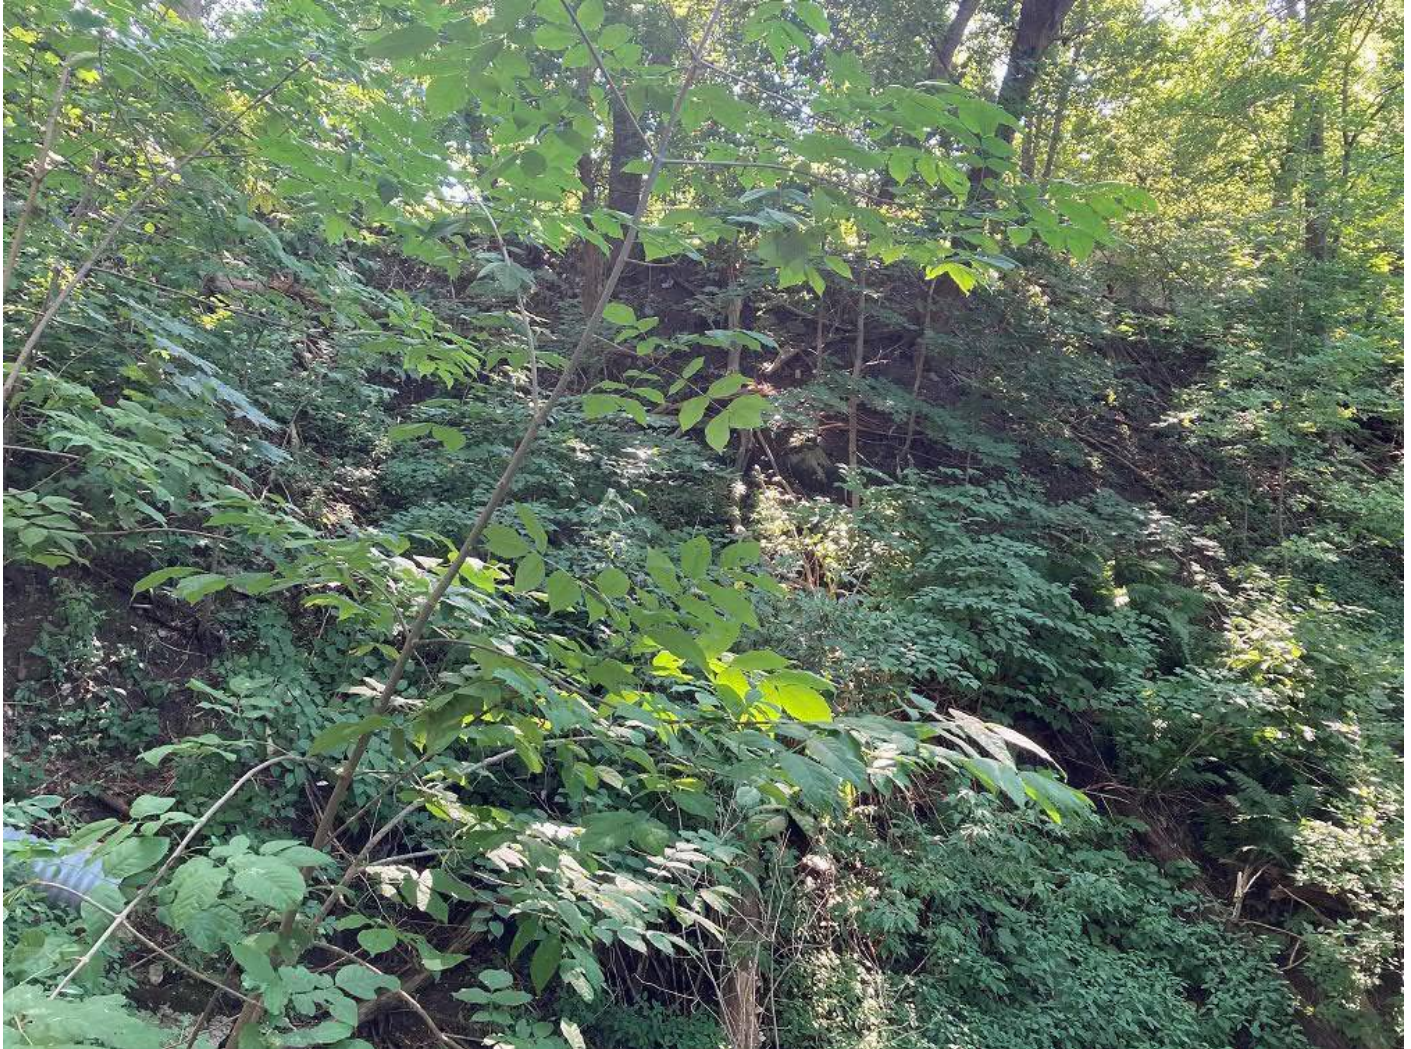
Slope Location: 471 Riverside Avenue – GBG Indian Kitchen Date: 8/13/2020  
City: Burlington State: Vermont  
Description : Photograph 16: Soil Scarp in Slope North of GBG Indian Kitchen Parking Lot

**Photograph 16:** View to southwest showing exposed soil scarp in slope north of GBG Indian Kitchen parking lot; Kismayo Kitchen (505 Riverside Avenue) at top right; note density of vegetation and mature trees at top of scarp leaning downslope.

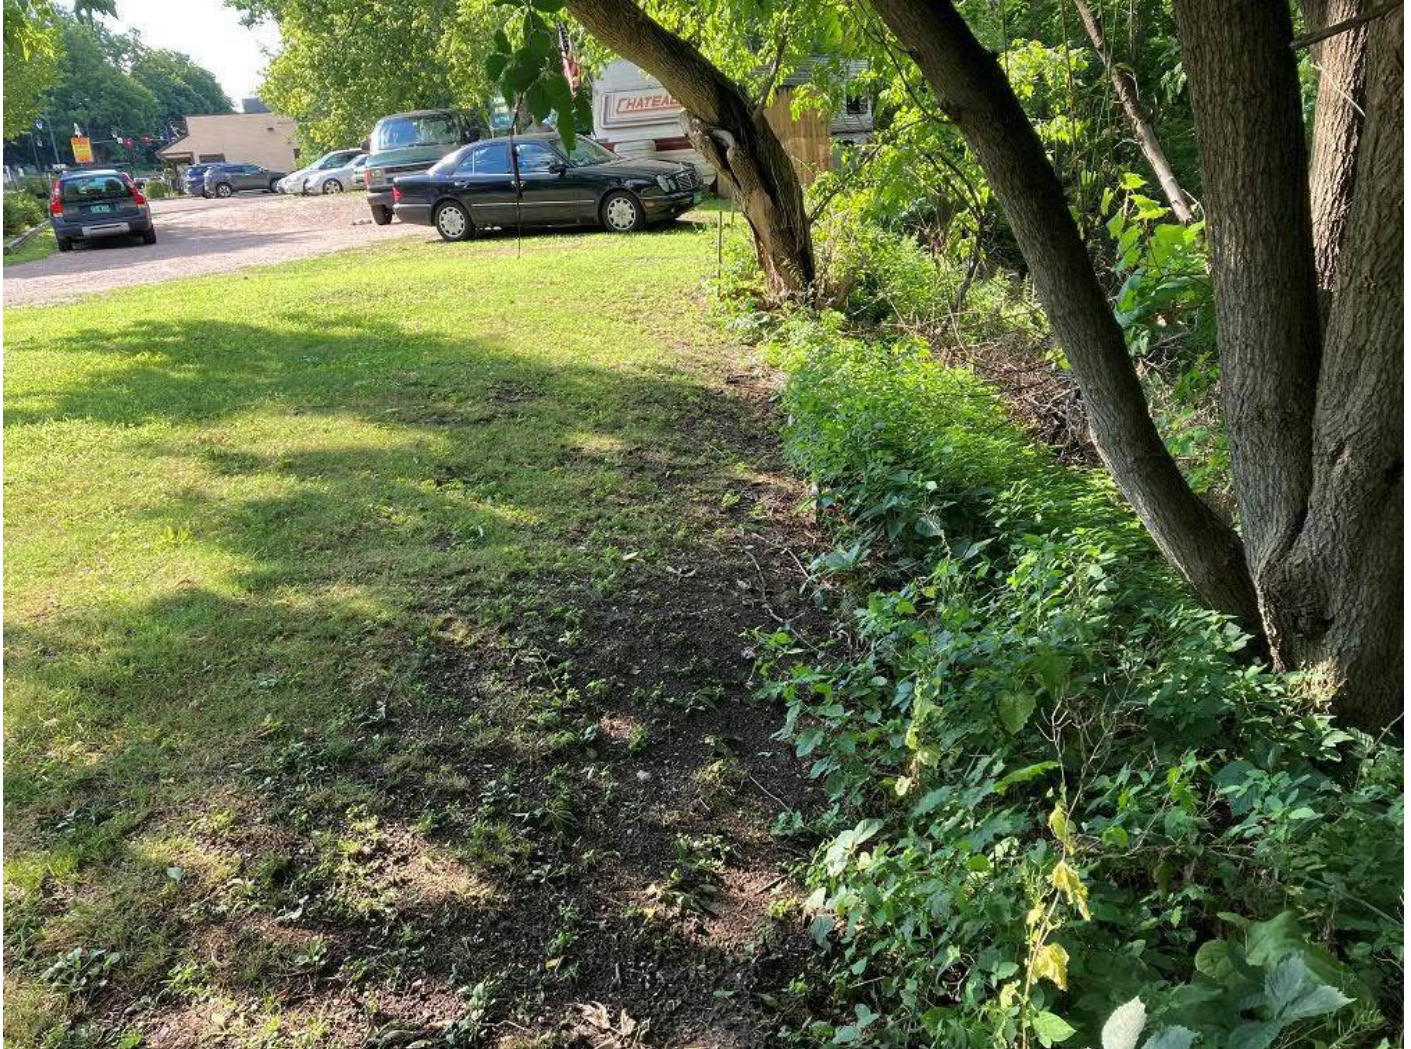
Slope Location: Riverside Avenue – Michael's Auto Sales Date: 8/5/2020  
City: Burlington State: Vermont  
Description : Photograph 19: Eastern Portion of Michael's Auto Sales Property

**Photograph 19:** View to west from eastern portion of Michael's Auto Sales property to GBG Indian Kitchen, showing beginning of scarp formation in center foreground; note trees leaning upslope

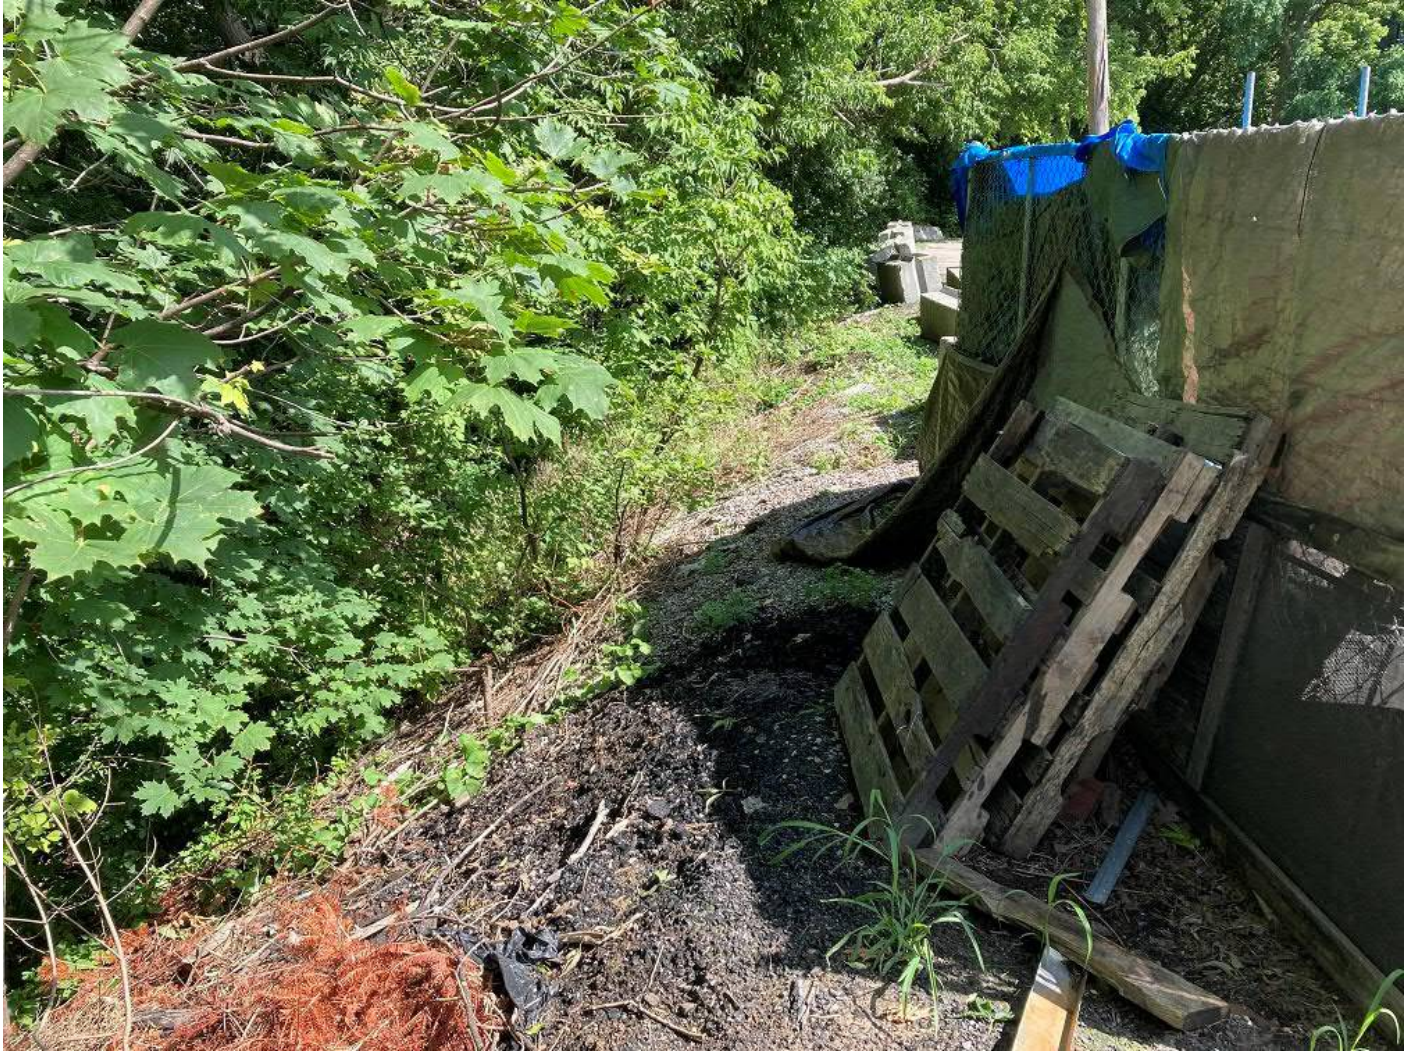
Slope Location: 317 Riverside Avenue – Bluebird BBQ Date: 8/5/2020  
City: Burlington State: Vermont  
Description : Photograph 9: Top of Slope at East Parking Area Bluebird BBQ

**Photograph 9:** View to east of top of slope adjacent to the eastern parking lot of Bluebird BBQ showing rounded surface expression of slope resulting from sheet flow during precipitation events; no surface expression of slumping or cracking apparent, but ongoing surface erosion will continue to cut back slope (see Photo 10 for view in opposite direction)

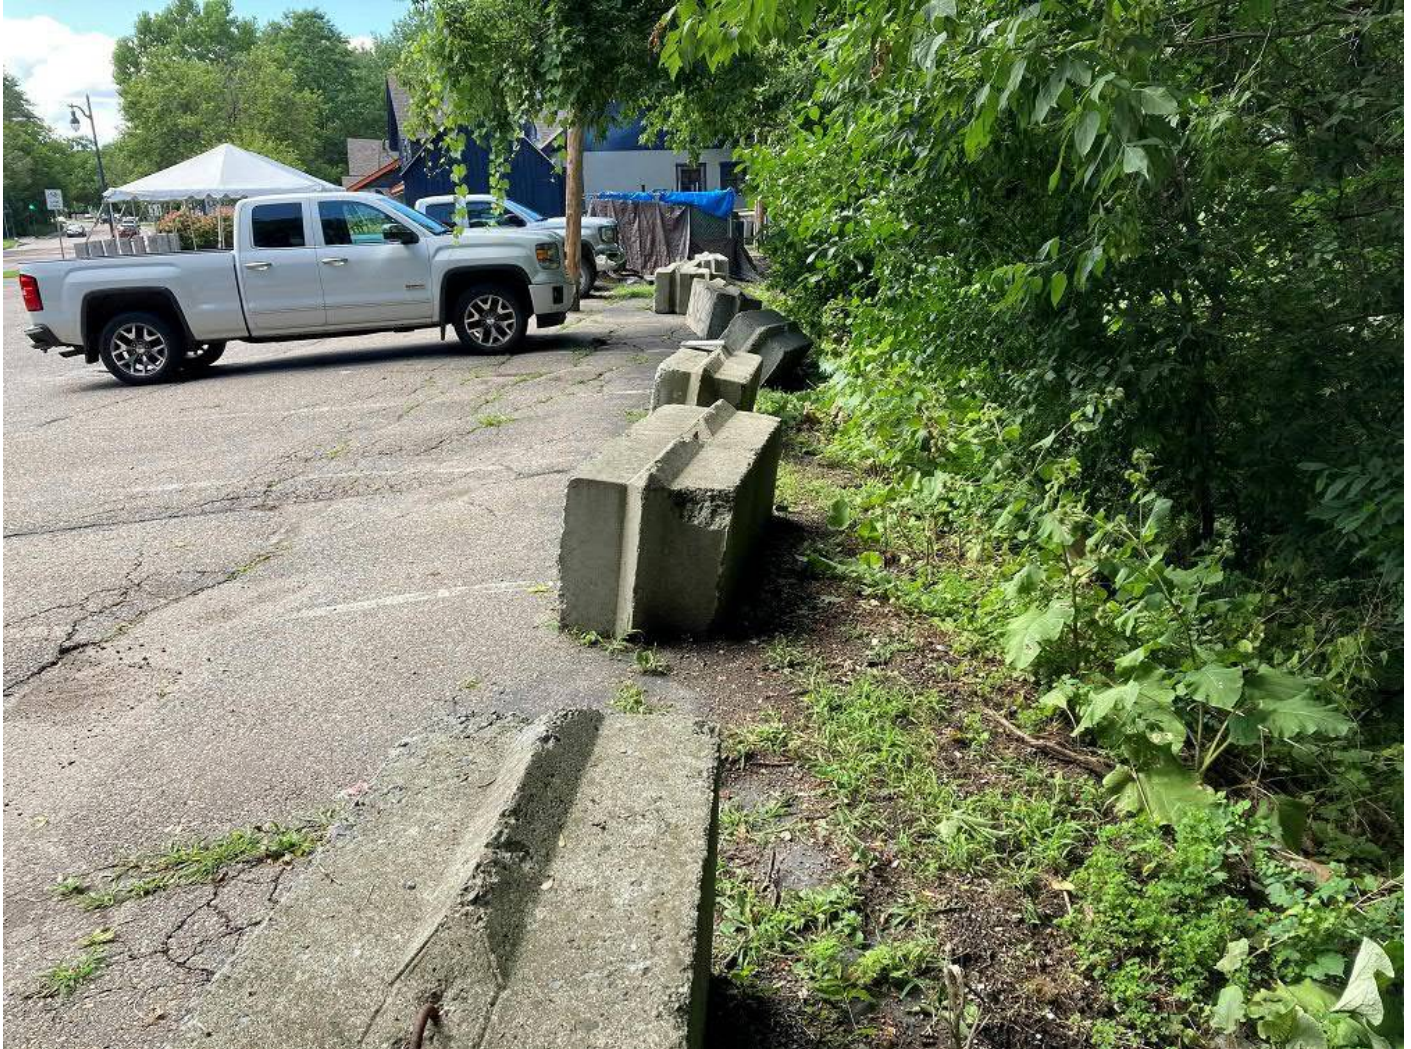
Slope Location: 317 Riverside Avenue – Bluebird BBQ Date: 8/5/2020  
City: Burlington State: Vermont  
Description : Photograph 10: Top of Slope at Eastern Parking Area Bluebird BBQ

**Photograph 10:** View to west toward Bluebird BBQ building showing top of slope at eastern parking lot; asphalt parking most likely sloped to induce surface flow away from slope; note lean of blocks at top center, a possible expression of incipient surface slumping and slope cutback

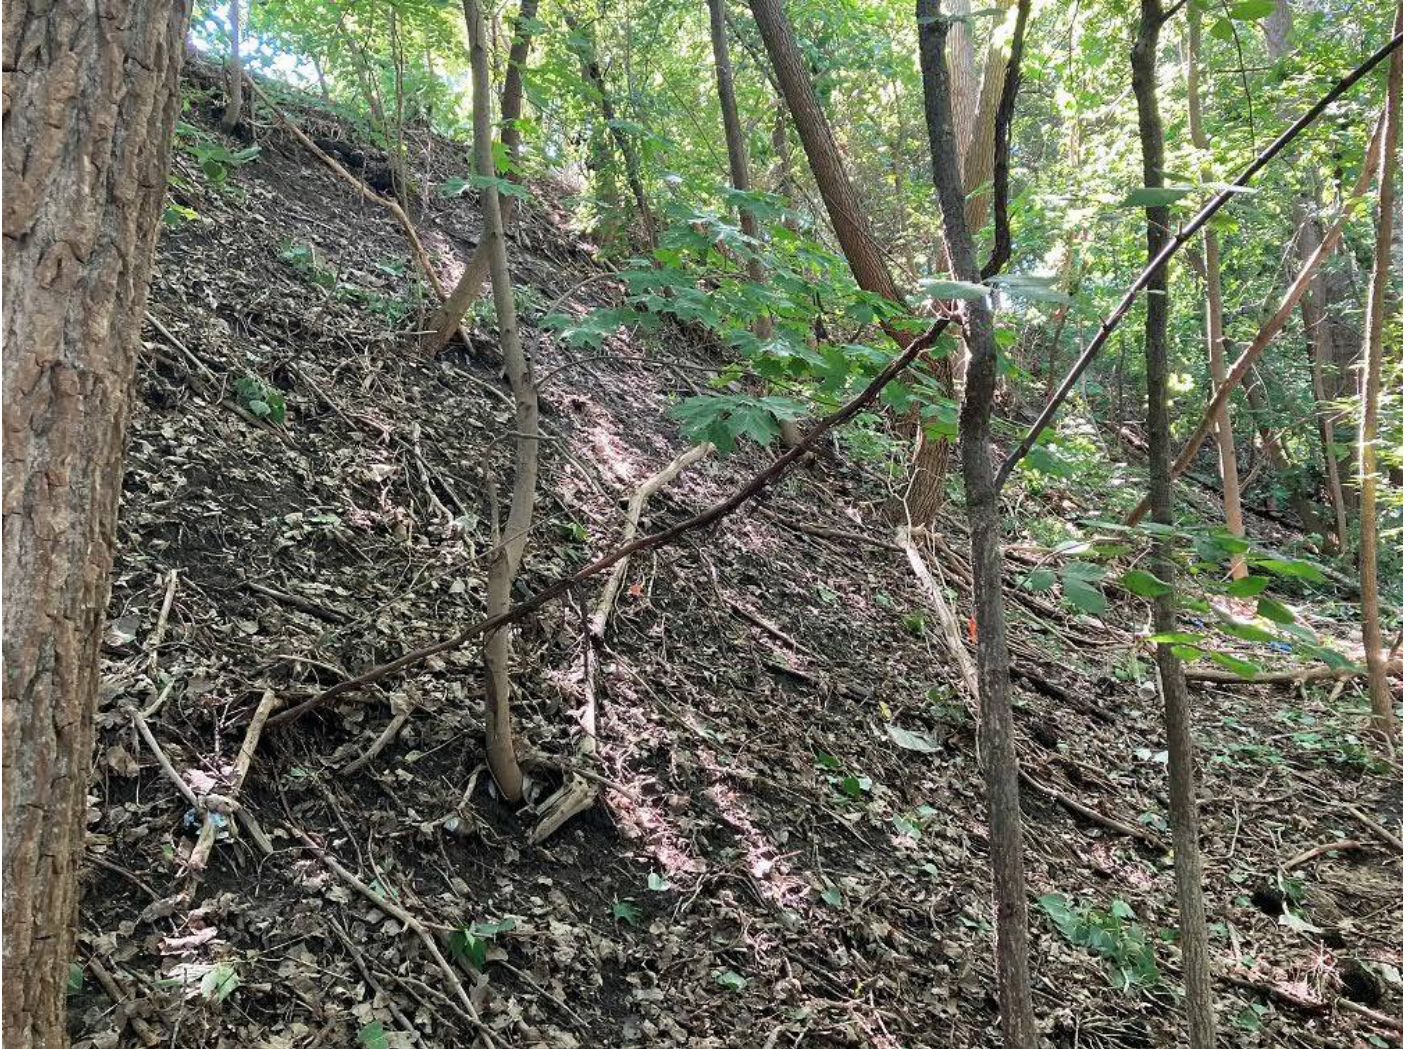
Slope Location: 317 Riverside Avenue – Bluebird BBQ Date: 8/13/2020  
City: Burlington State: Vermont  
Description : Photograph 11: Downslope from Just West of Bluebird BBQ Building

**Photograph 11:** View to southwest of top of slope just to the west of the Bluebird BBQ building showing soil surface exposed to continual erosion during precipitation events; soil scarp present at top left of photograph

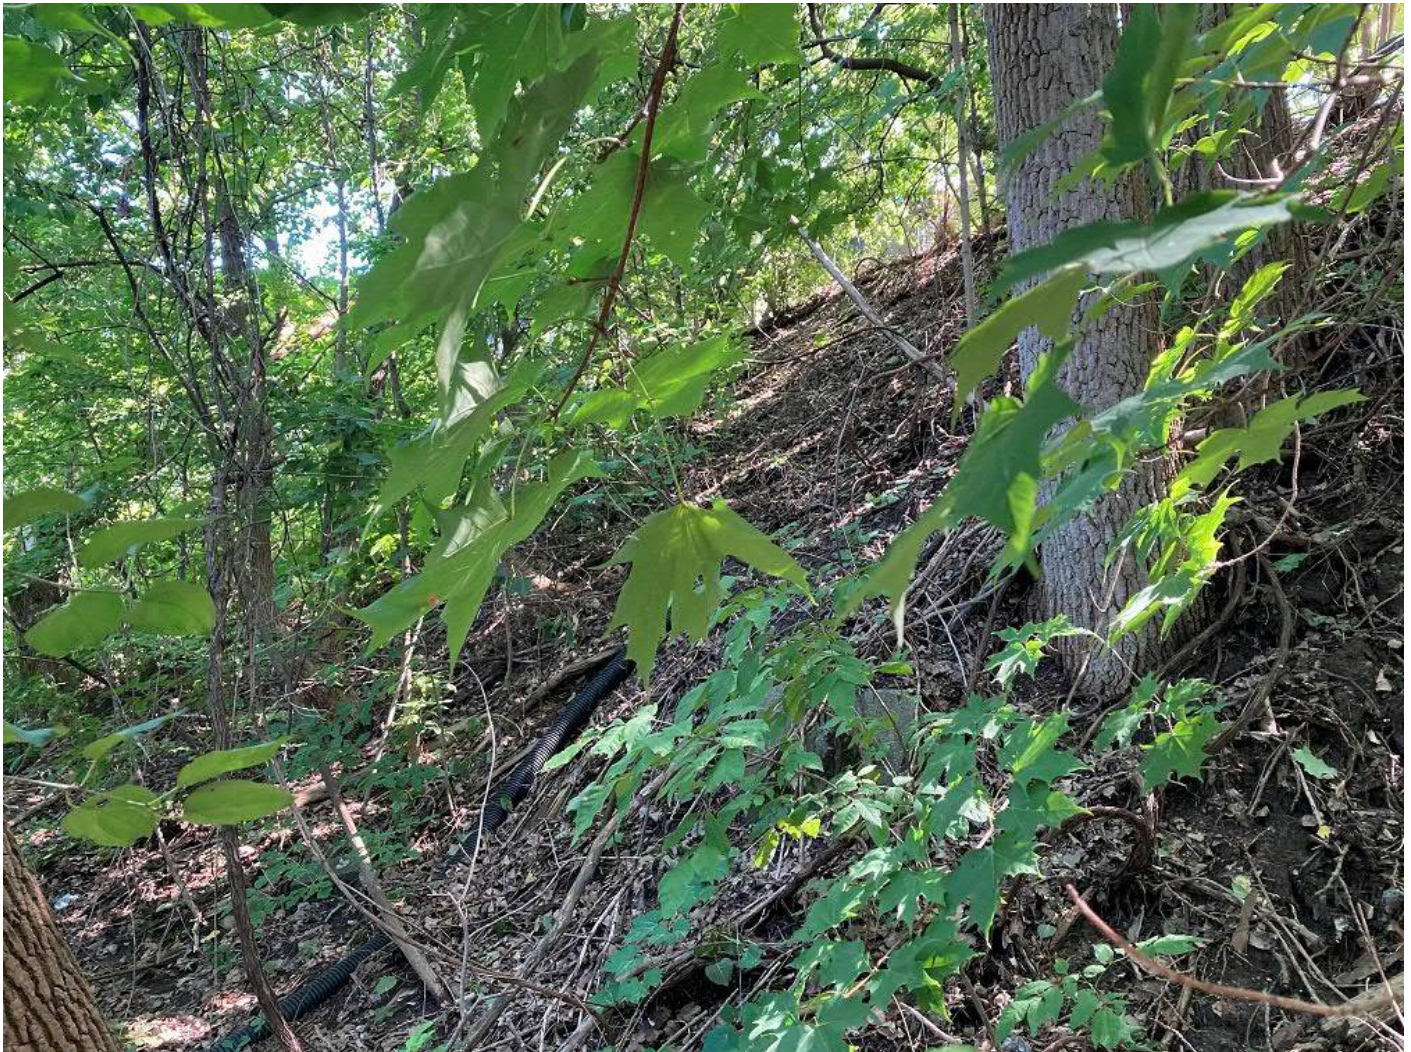
Slope Location: 317 Riverside Avenue – Bluebird BBQ Date: 8/13/2020  
City: Burlington State: Vermont  
Description : Photograph 12: Exposed Slope Behind Bluebird BBQ Building

**Photograph 12:** View to southeast of exposed slope behind Bluebird BBQ building; exposed surface soil subject to continual erosion during precipitation events; note discharge hose left foreground; ongoing discharge downslope facilitates continual erosion of exposed surface soil

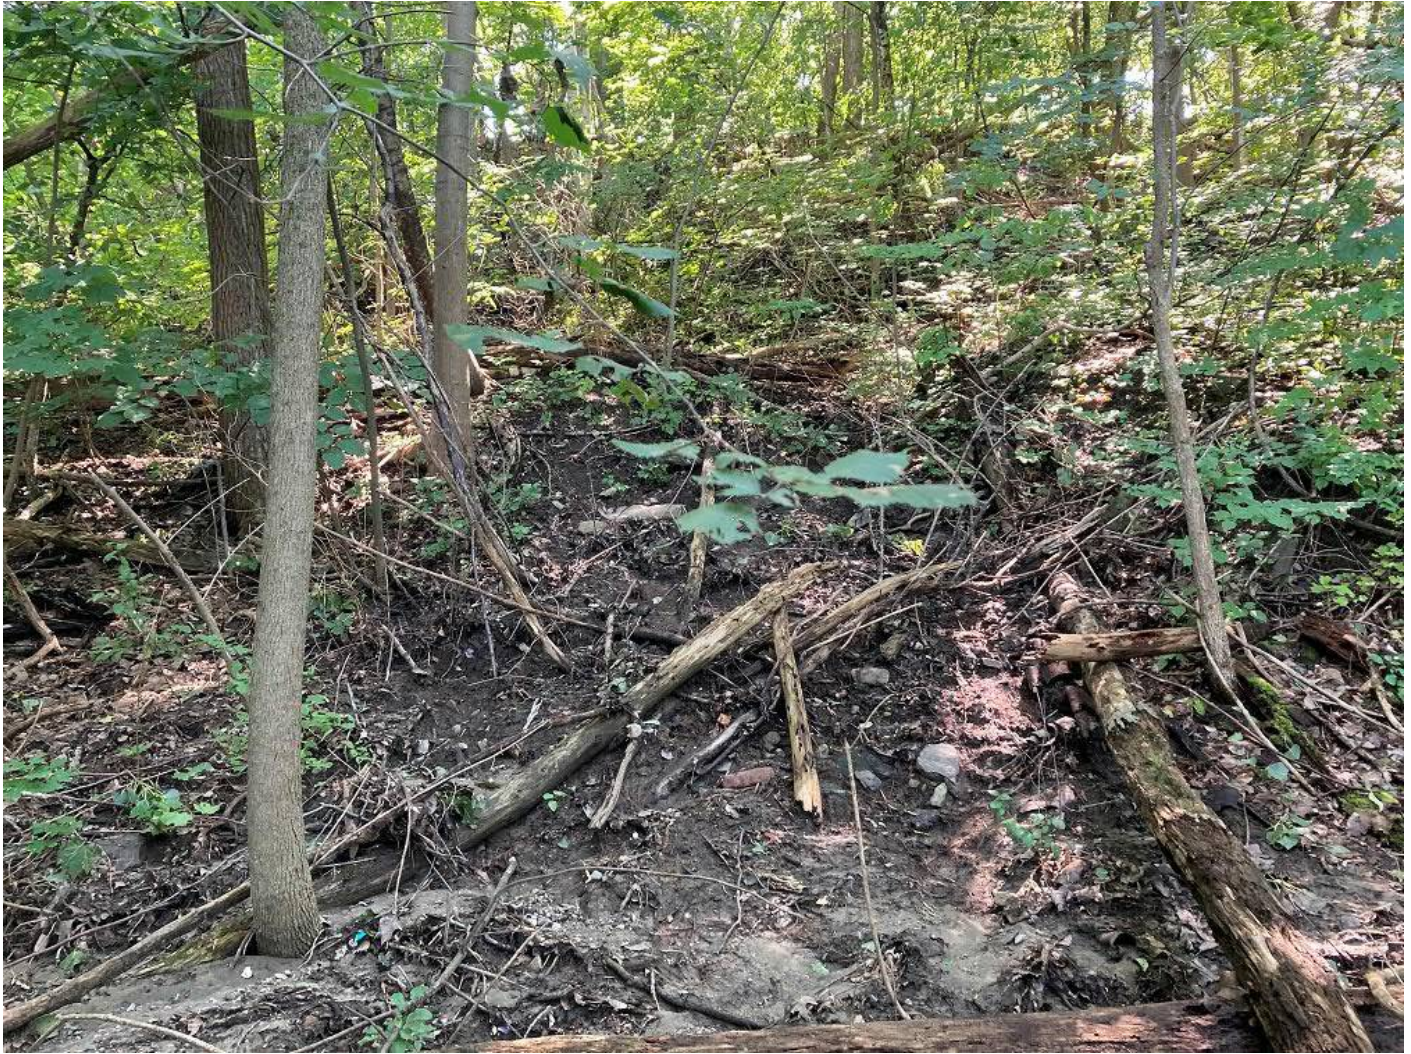
Slope Location: 317 Riverside Avenue – Bluebird BBQ Date: 8/13/2020  
City: Burlington State: Vermont  
Description : Photograph 13: View Upslope Behind Bluebird BBQ

**Photograph 13:** View to south upslope to Bluebird BBQ showing historic slump/slide mass and effects of surface erosion;

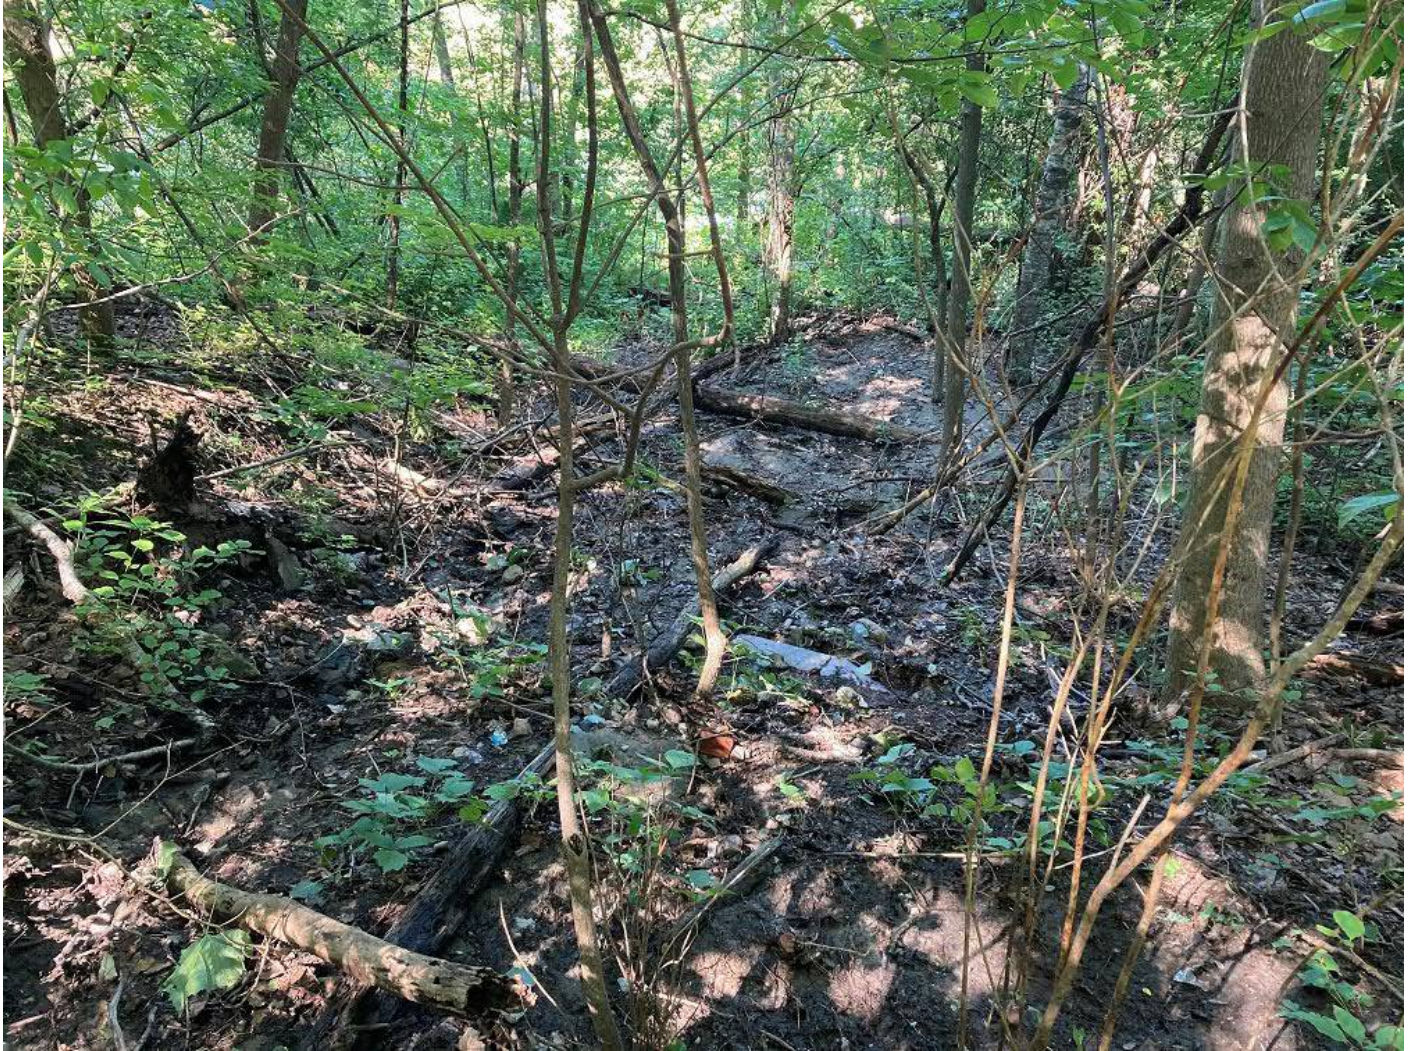
Slope Location: 317 Riverside Avenue – Bluebird BBQ Date: 8/13/2020  
City: Burlington State: Vermont  
Description : Photograph 14: View Downslope of Surface Water Discharge Hose

**Photograph 14:** View to north downslope from near position of Photograph 13 showing surface erosion effects from upslope surface water discharge

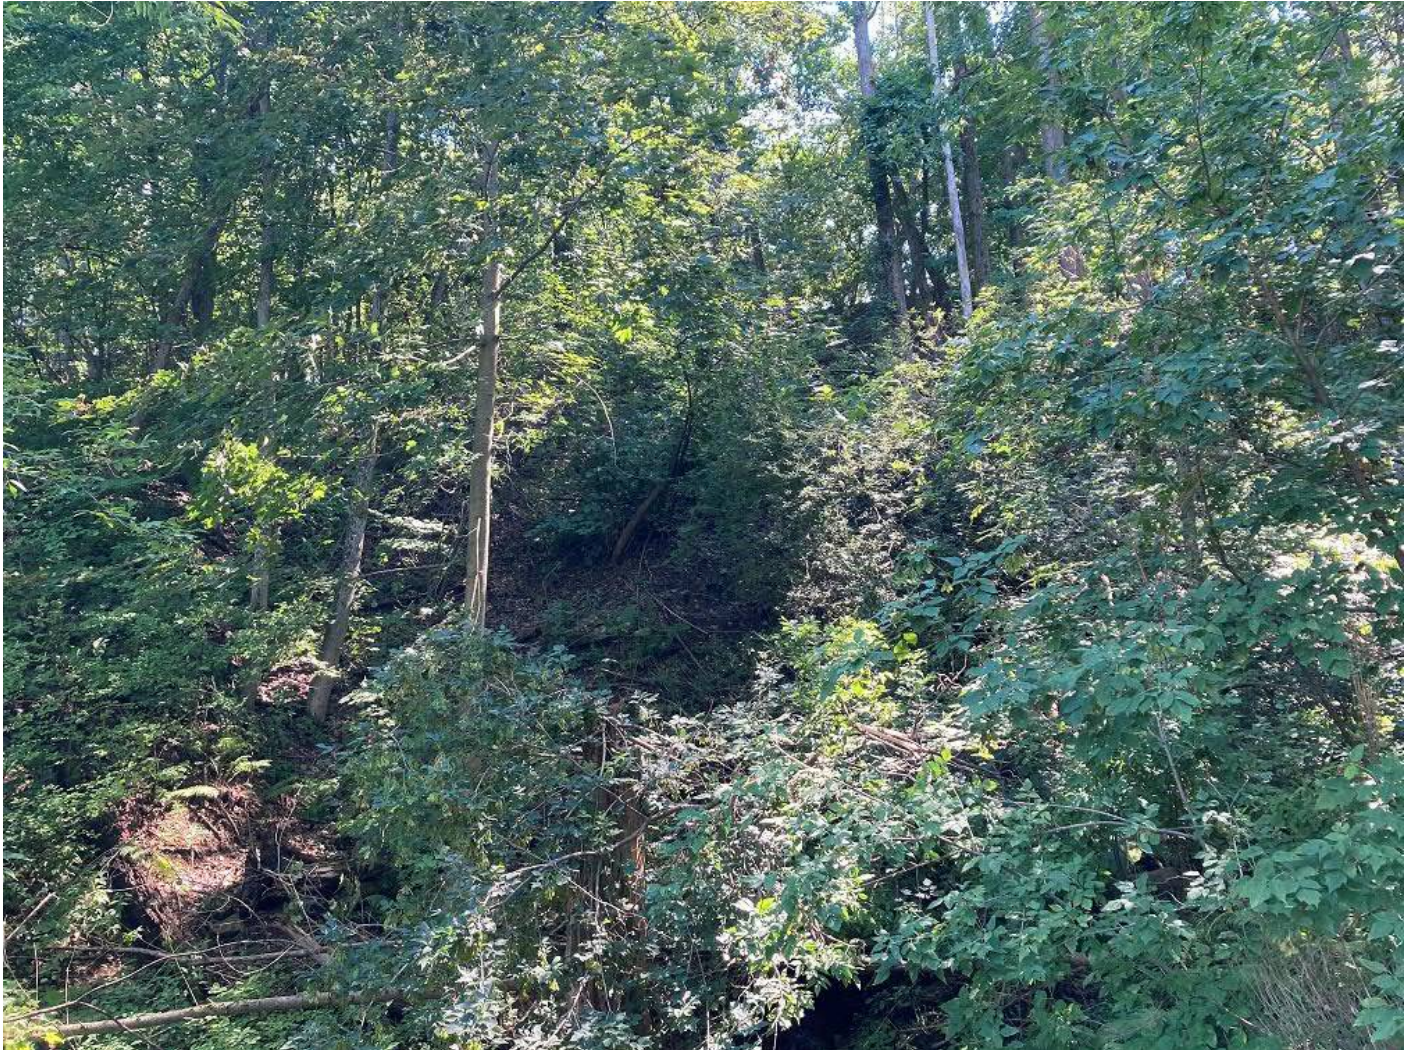
Slope Location: 317 Riverside Avenue – Bluebird BBQ Date: 8/13/2020  
City: Burlington State: Vermont  
Description : Photograph 15: Base of Slope Behind Bluebird BBQ from River Walk Trail

**Photograph 15:** View to south-southeast from River Walk Trail, looking up to eastern side of Bluebird BBQ property, showing dense vegetative growth on historic slide/slump mass

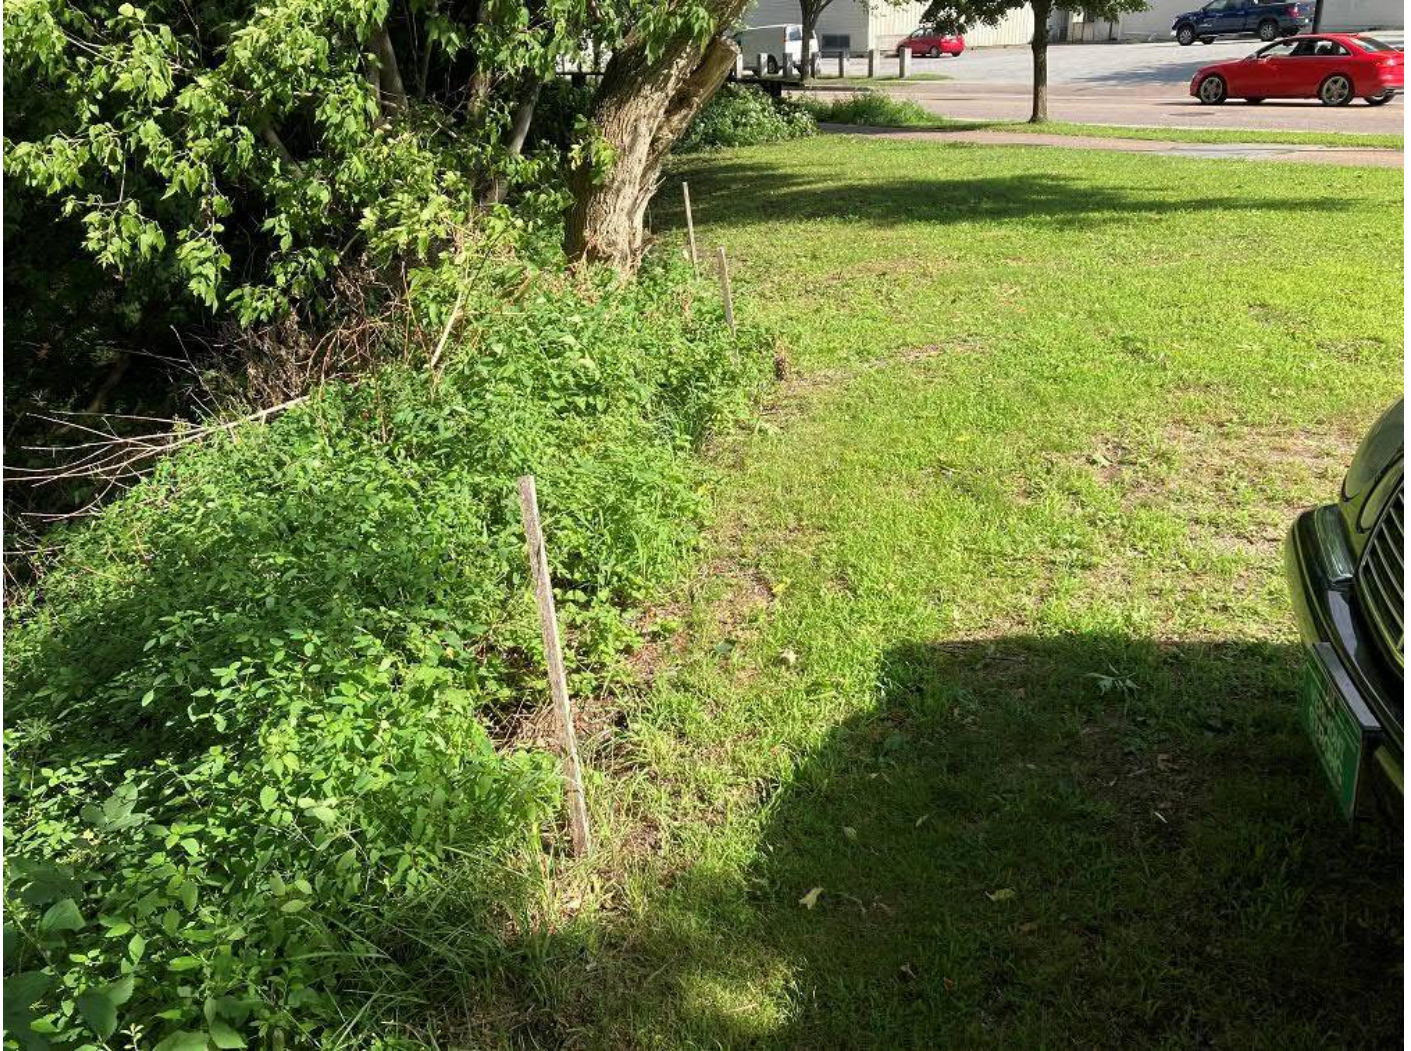
Slope Location: Riverside Avenue – Michael's Auto Sales Date: 8/5/2020  
City: Burlington State: Vermont  
Description : Photograph 20: Eastern Portion of Michael's Auto Sales Property

**Photograph 20:** View to southeast from eastern portion of Michael's Auto Sales property showing beginning of scarp formation at stakes; historic failure scarp obscured by vegetation at left of photograph.

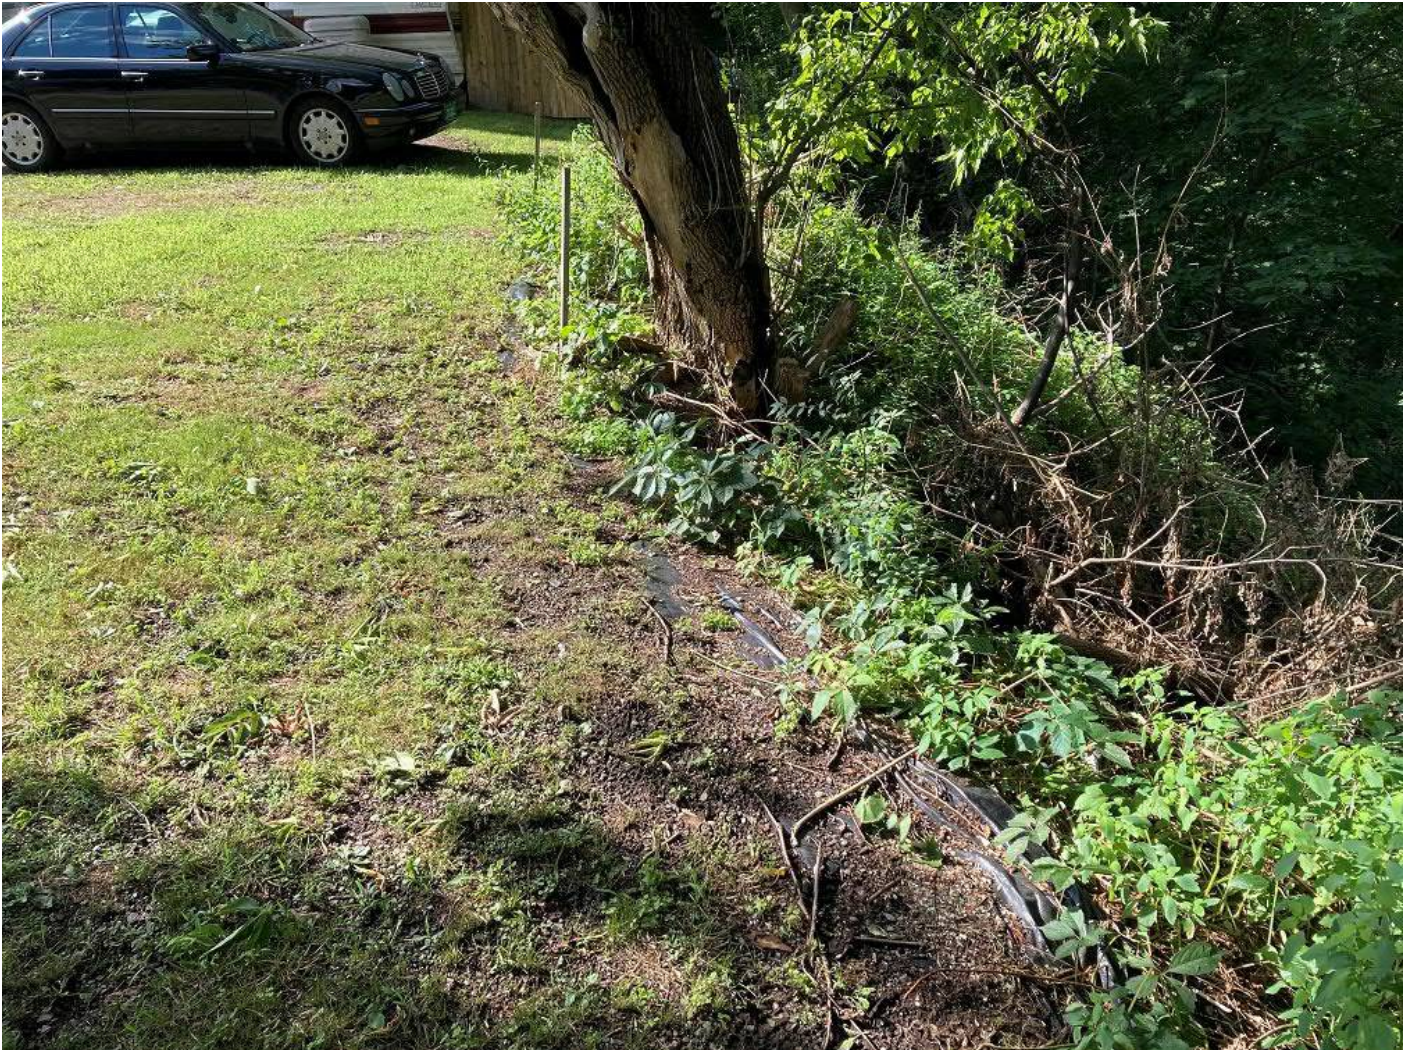
Slope Location: Riverside Avenue – Michael's Auto Sales Date: 8/5/2020  
City: Burlington State: Vermont  
Description : Photograph 21: Slope Remediation by Owner of Michael's Auto Sales

**Photograph 21:** View to northwest from eastern portion of Michael's Auto Sales property showing remediation implemented by landowner, including placing of geotextile fabric and pea-stone ballast; soil scarp occurs beyond and obscured by vegetation to right.

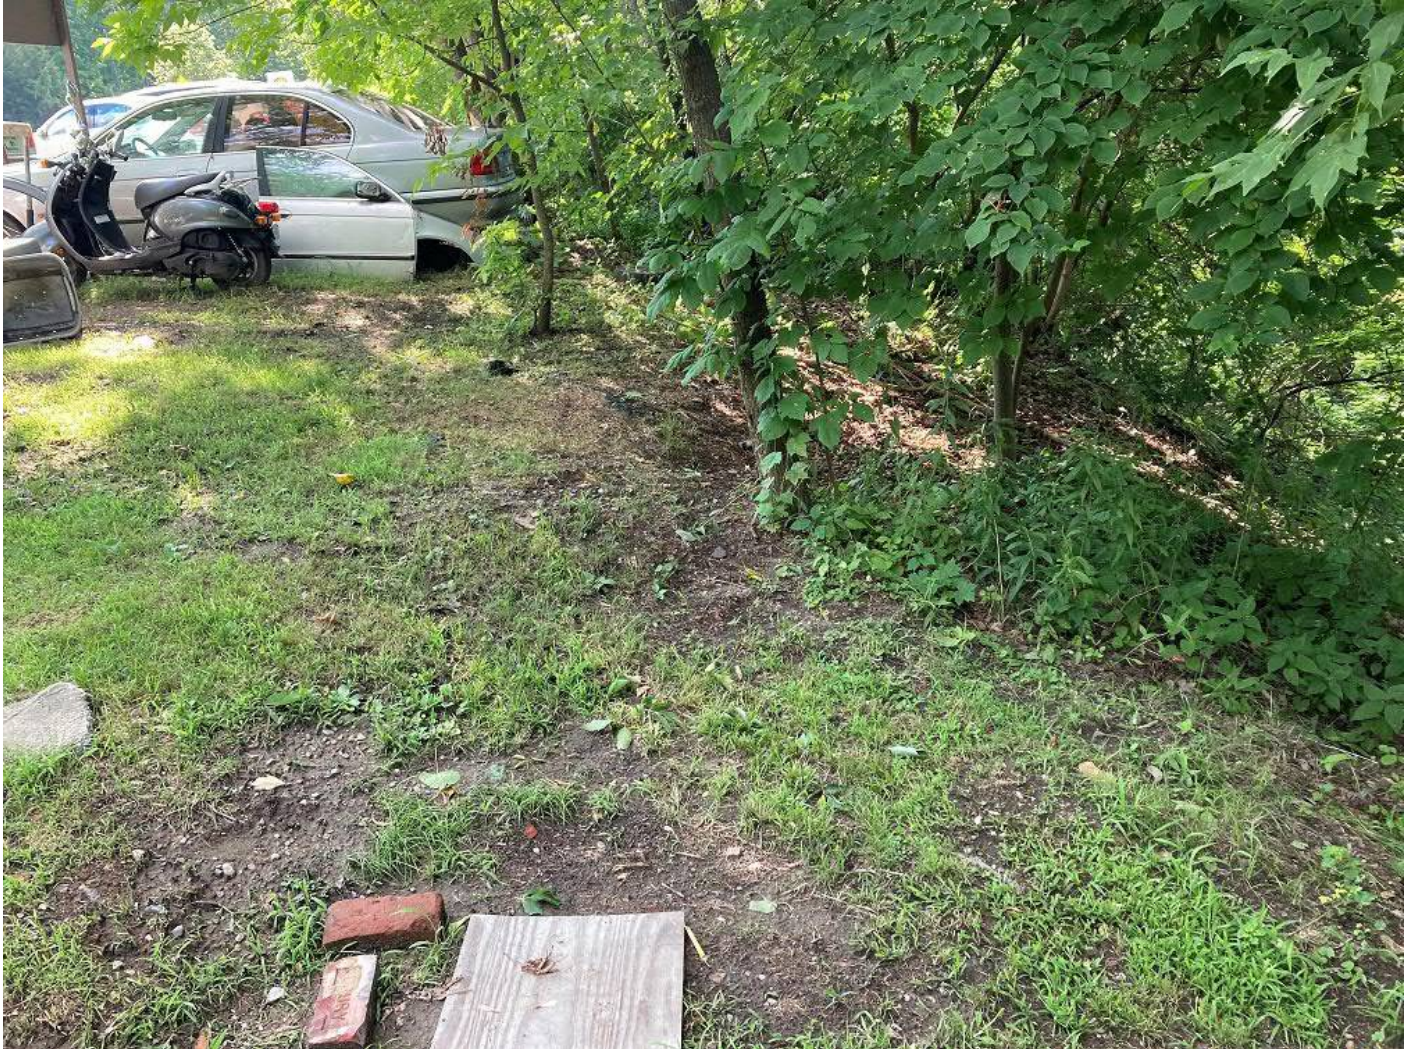
Slope Location: Riverside Avenue – Michael's Auto Sales Date: 8/13/2020  
City: Burlington State: Vermont  
Description : Photograph 22: Central Portion of Michael's Auto Sales Property

**Photograph 22:** View to west from central portion of Michael's Auto Sales showing beginning traces of scarp development at center of photograph (may be initial formation of gully from surface flow)
