## **Burlington Conservation Board**

## Conservation Board Meeting Minutes

## FY20 Burlington Slope Inspections

**CITY OF BURLINGTON, VERMONT  
SLOPE STABILITY INSPECTION**

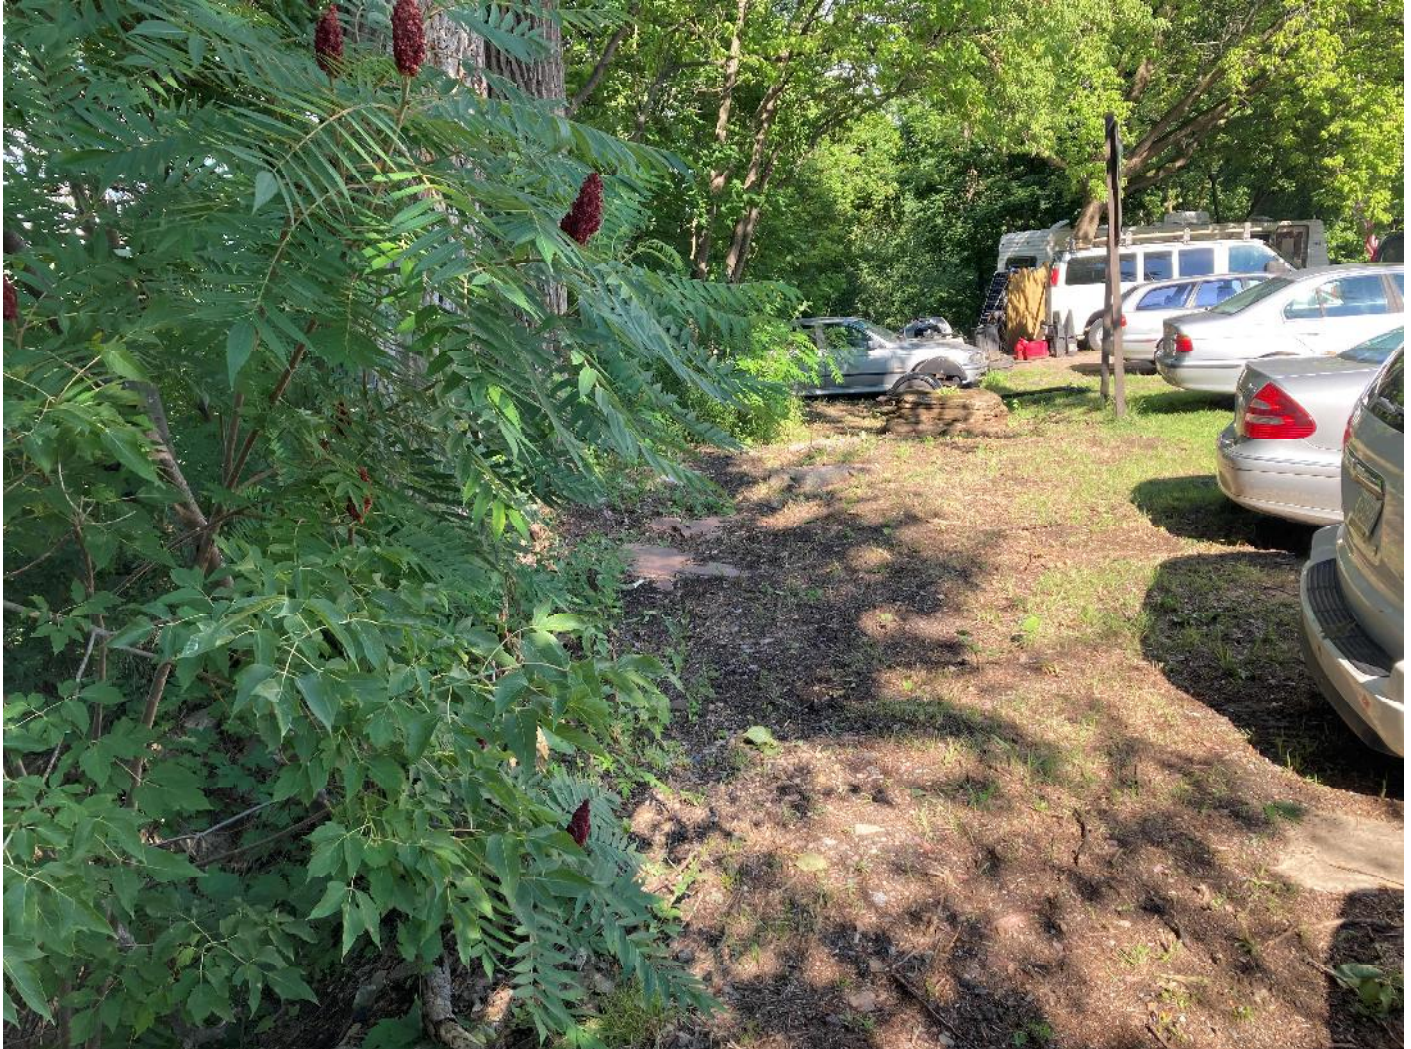
Slope Location: Riverside Avenue – Michael's Auto Sales Date: 8/5/2020  
City: Burlington State: Vermont  
Description : Photograph 23: Area at Top of Slope Exposed to Surface Erosion

**Photograph 23:** View to east showing eastern portion of Michael's Auto Sales property; poorly vegetated area subject to continual surface erosion at the top of the slope and downslope; soil scarp from historic failures obscured by vegetation at left of photograph.

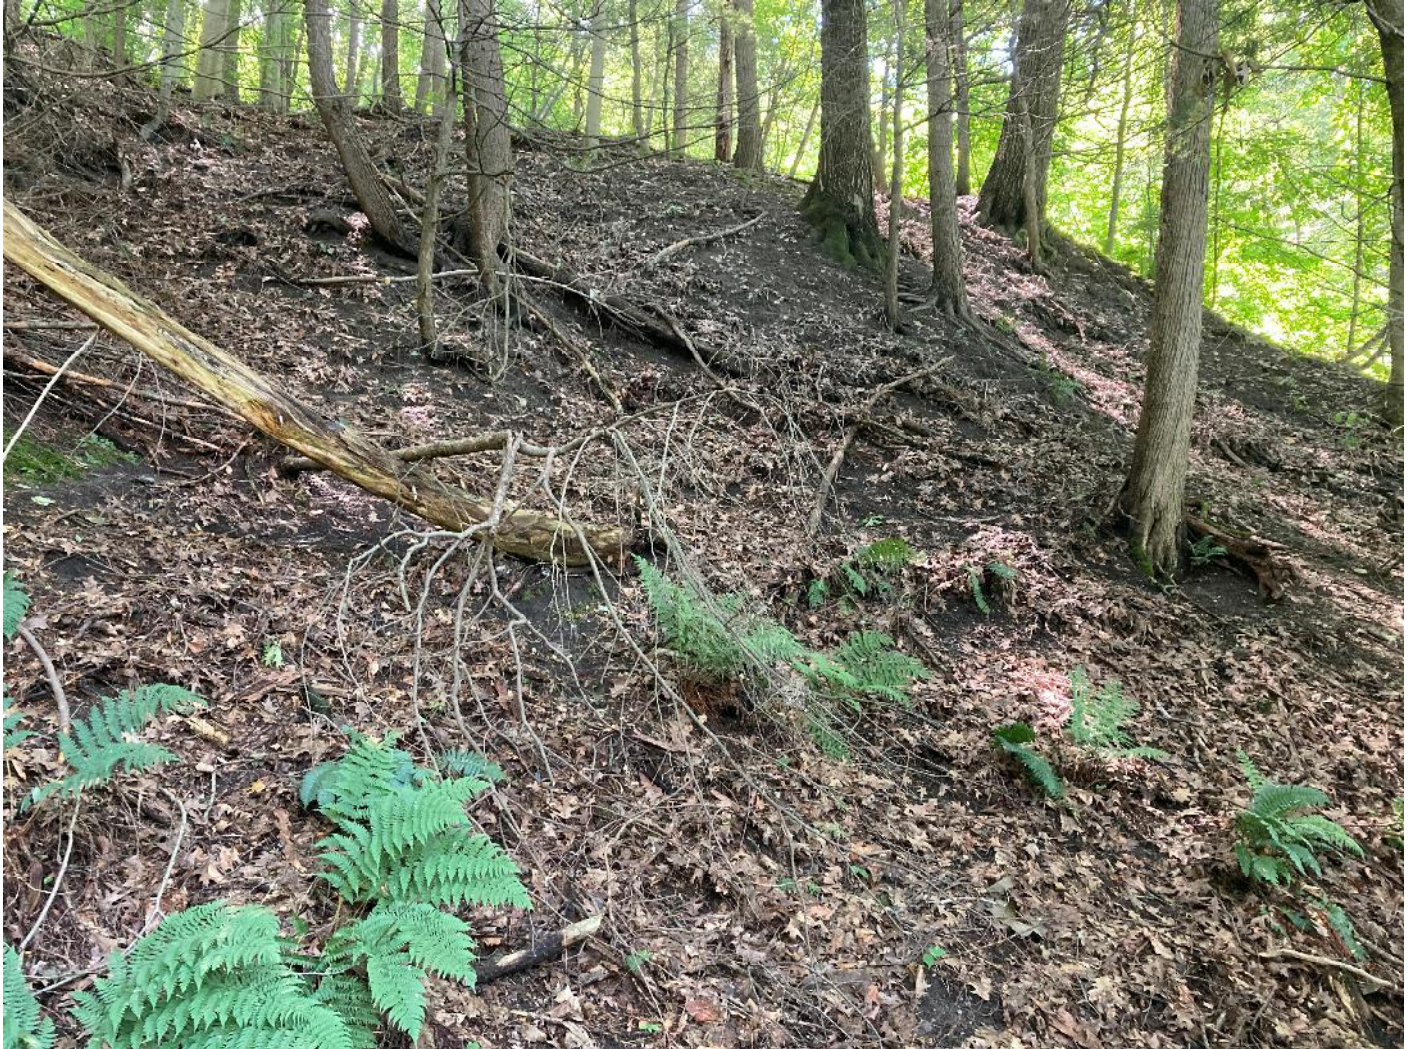
Slope Location: Riverside Avenue – Michael's Auto Sales Date: 8/13/2020  
City: Burlington State: Vermont  
Description : Photograph 25 – Downslope from Michael's Auto Sales, Near River Walk Trail

**Photograph 25:** View to west downslope from Michael's Auto Sales, (near River Walk Trail) showing poorly vegetated, exposed, former slump/slide debris; poorly vegetated soil surfaces subject to continual surface erosion from precipitation events;

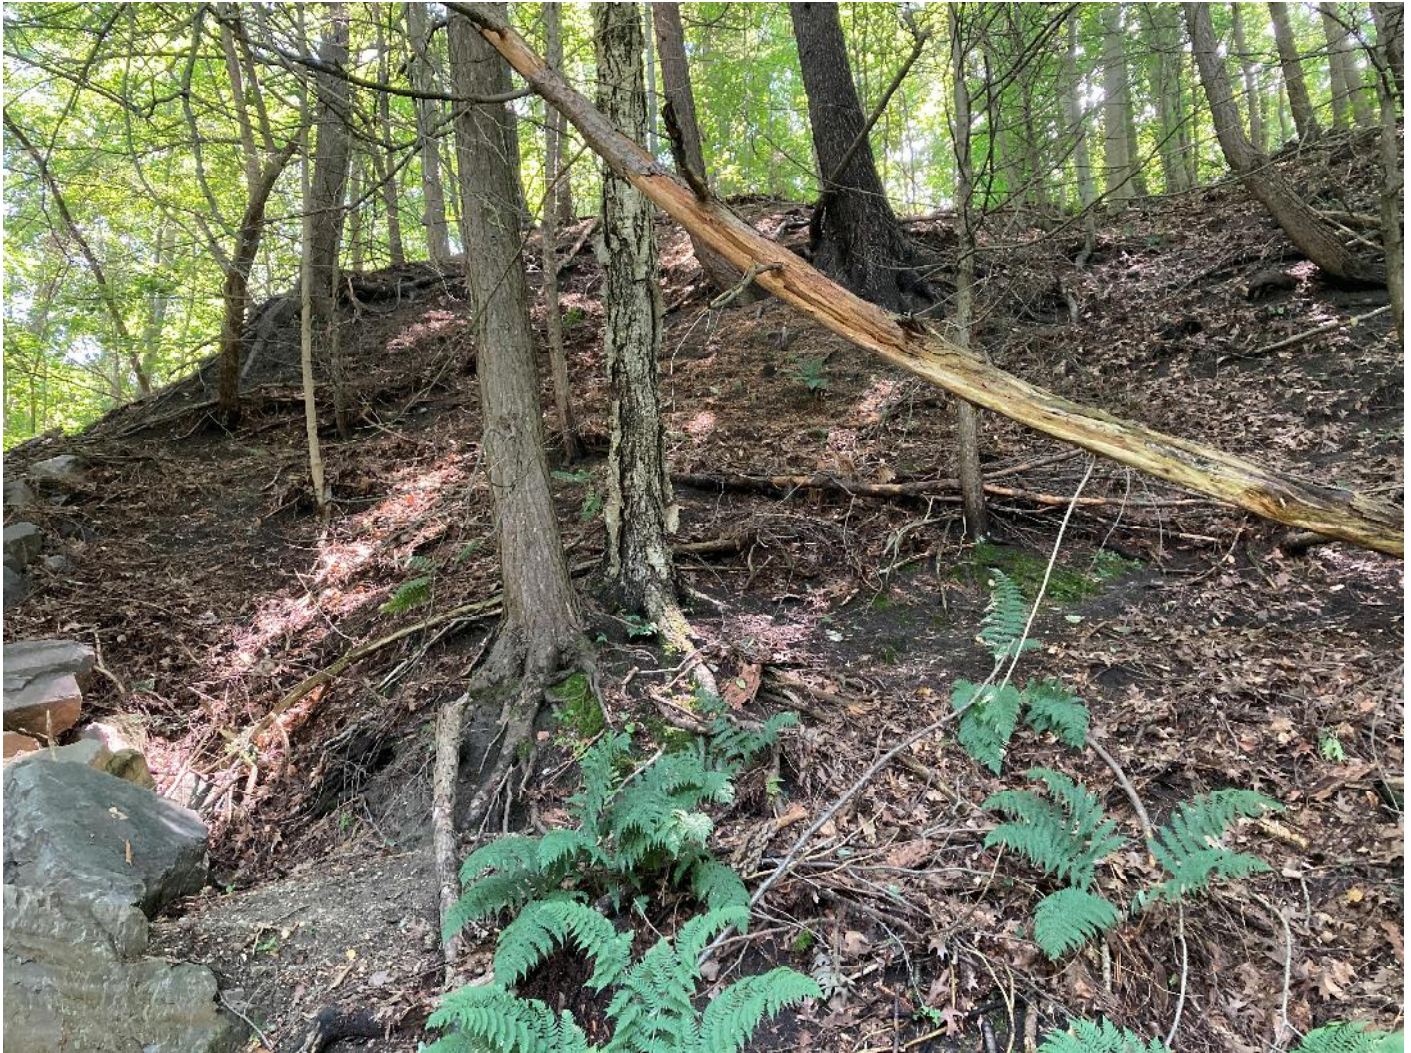
Slope Location: Riverside Avenue – Michael's Auto Sales Date: 8/13/2020  
City: Burlington State: Vermont  
Description : Photograph 26: Former Debris Slide/Slump Downslope from Michael's Auto

**Photograph 26:** View to southeast downslope from Michael's Auto Sales; gullies evident top right and top left provide conduit for surface flow; poorly vegetated slope continues to erode during precipitation events
