# **Design Advisory Board**

**Tuesday, November 12, 2024, 3:00 PM**

**ZPW-24-156; 573 South Willard Street (RC, Ward 6) Asa Levi / Natalie Komarov / Elwin Herringshaw**

**ZP-24-394; 46 North Willard Street (RL, Ward 1) Loomis Willard, LLC / Rebecca Tourville**

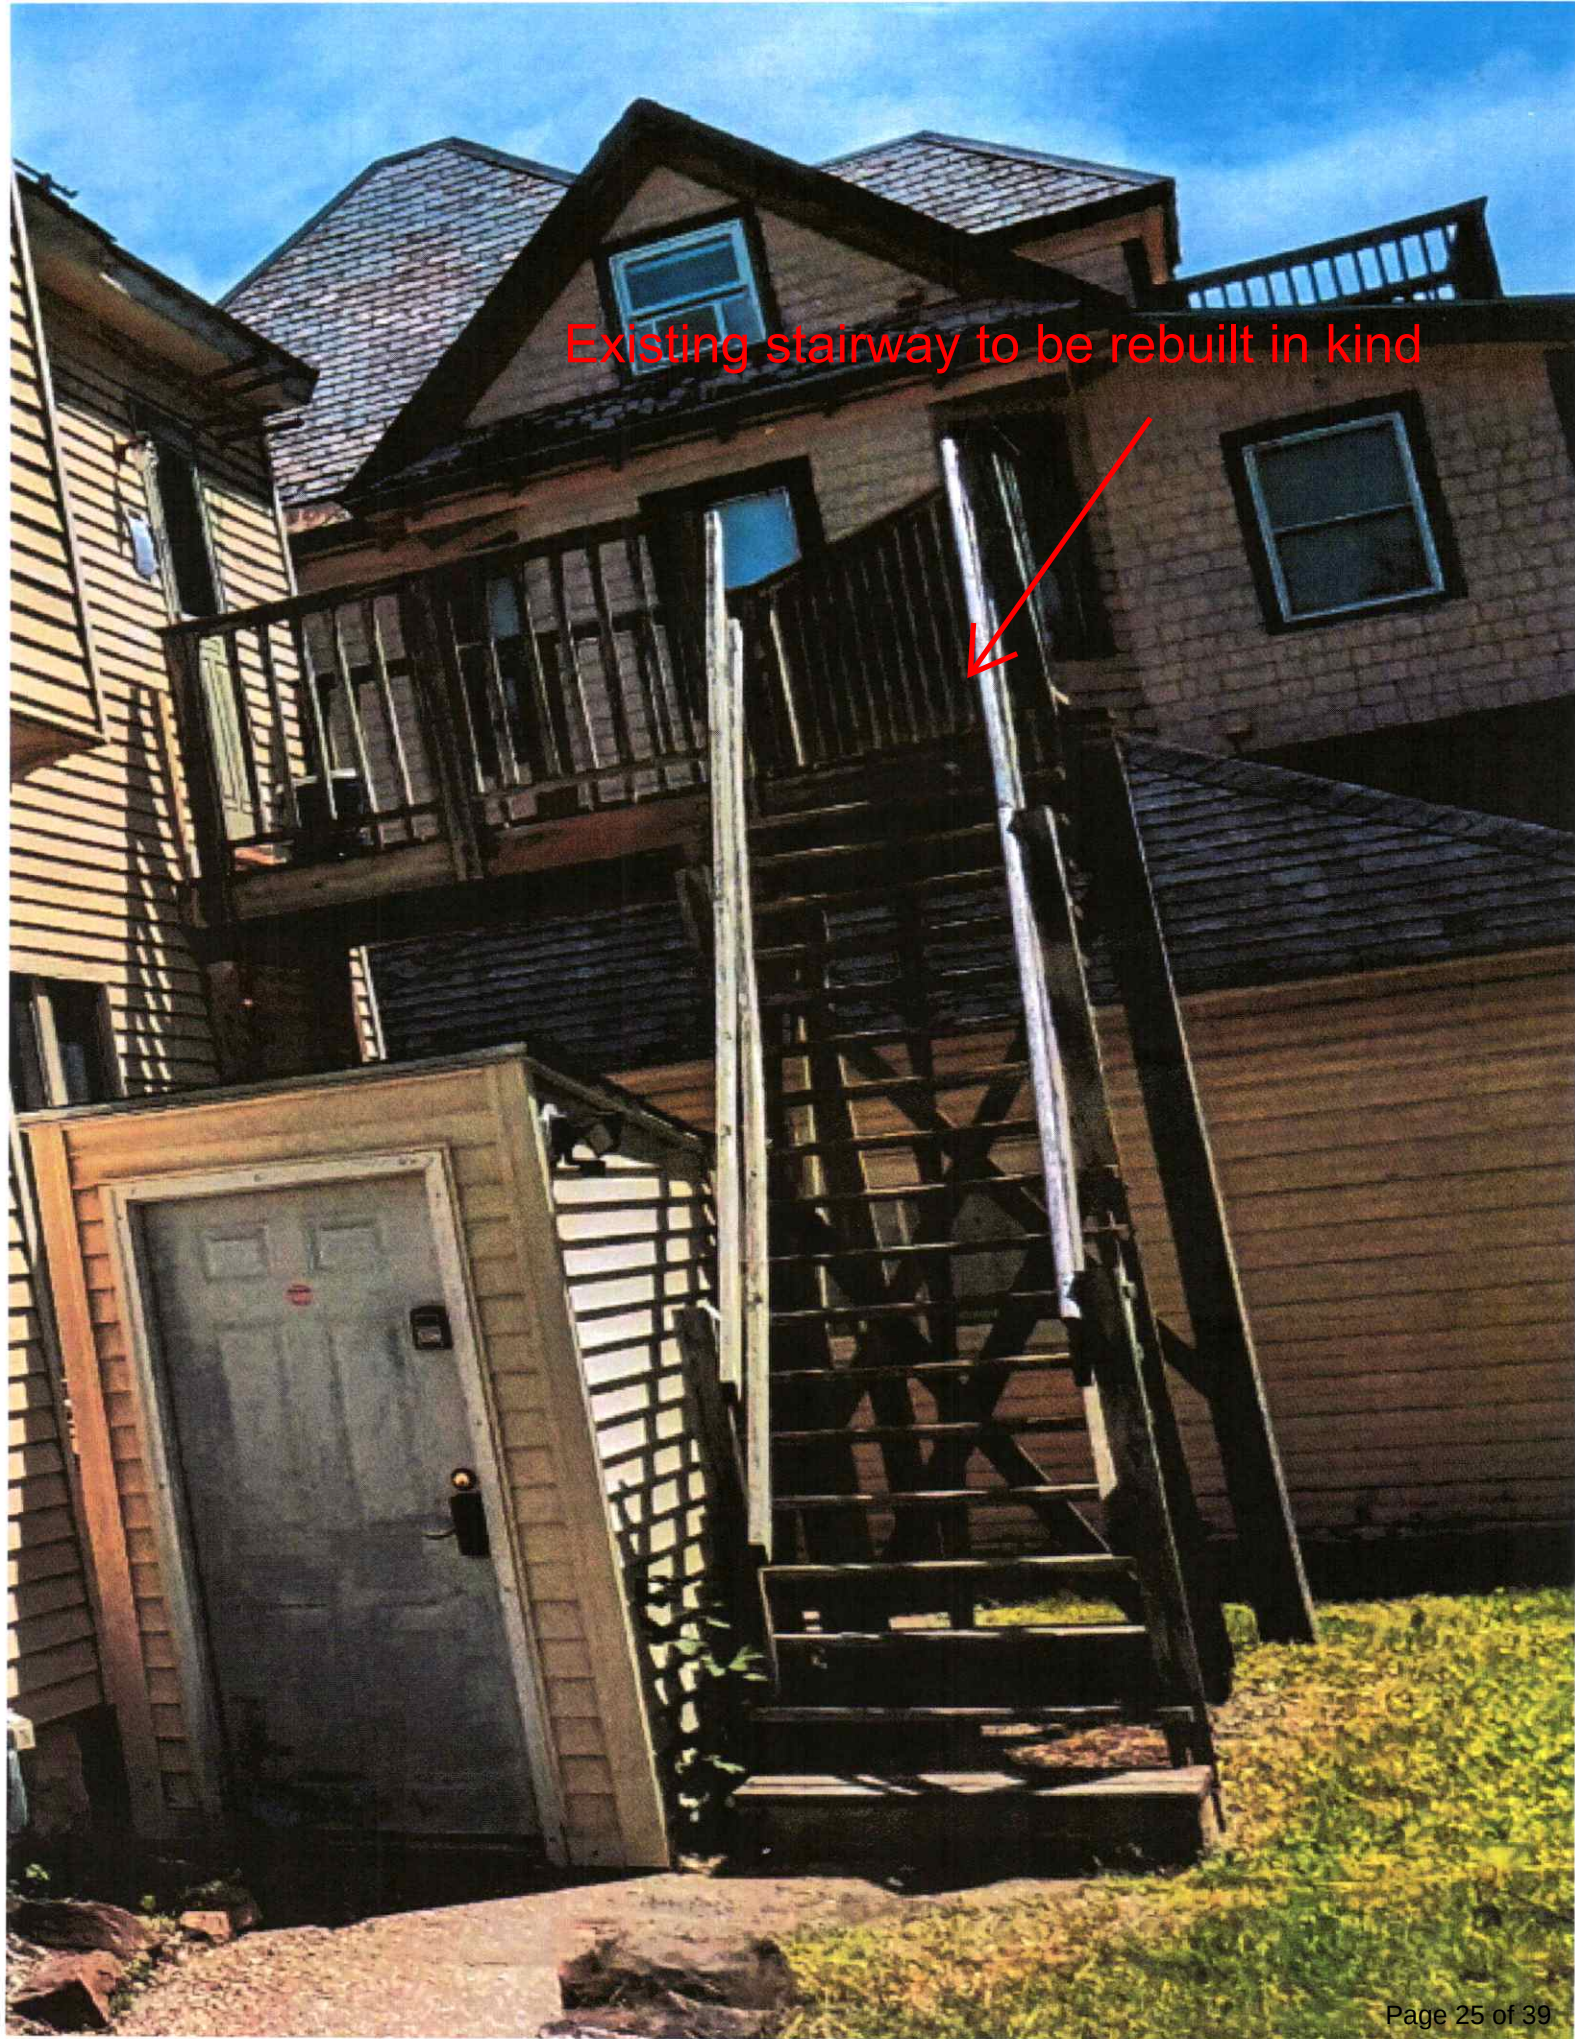
46 NORTH WILLARD

Existing stairway to be rebuilt in kind

~~REMOVE UNPERMITTED  
ENTRANCE~~

After the Fact entrance to remain

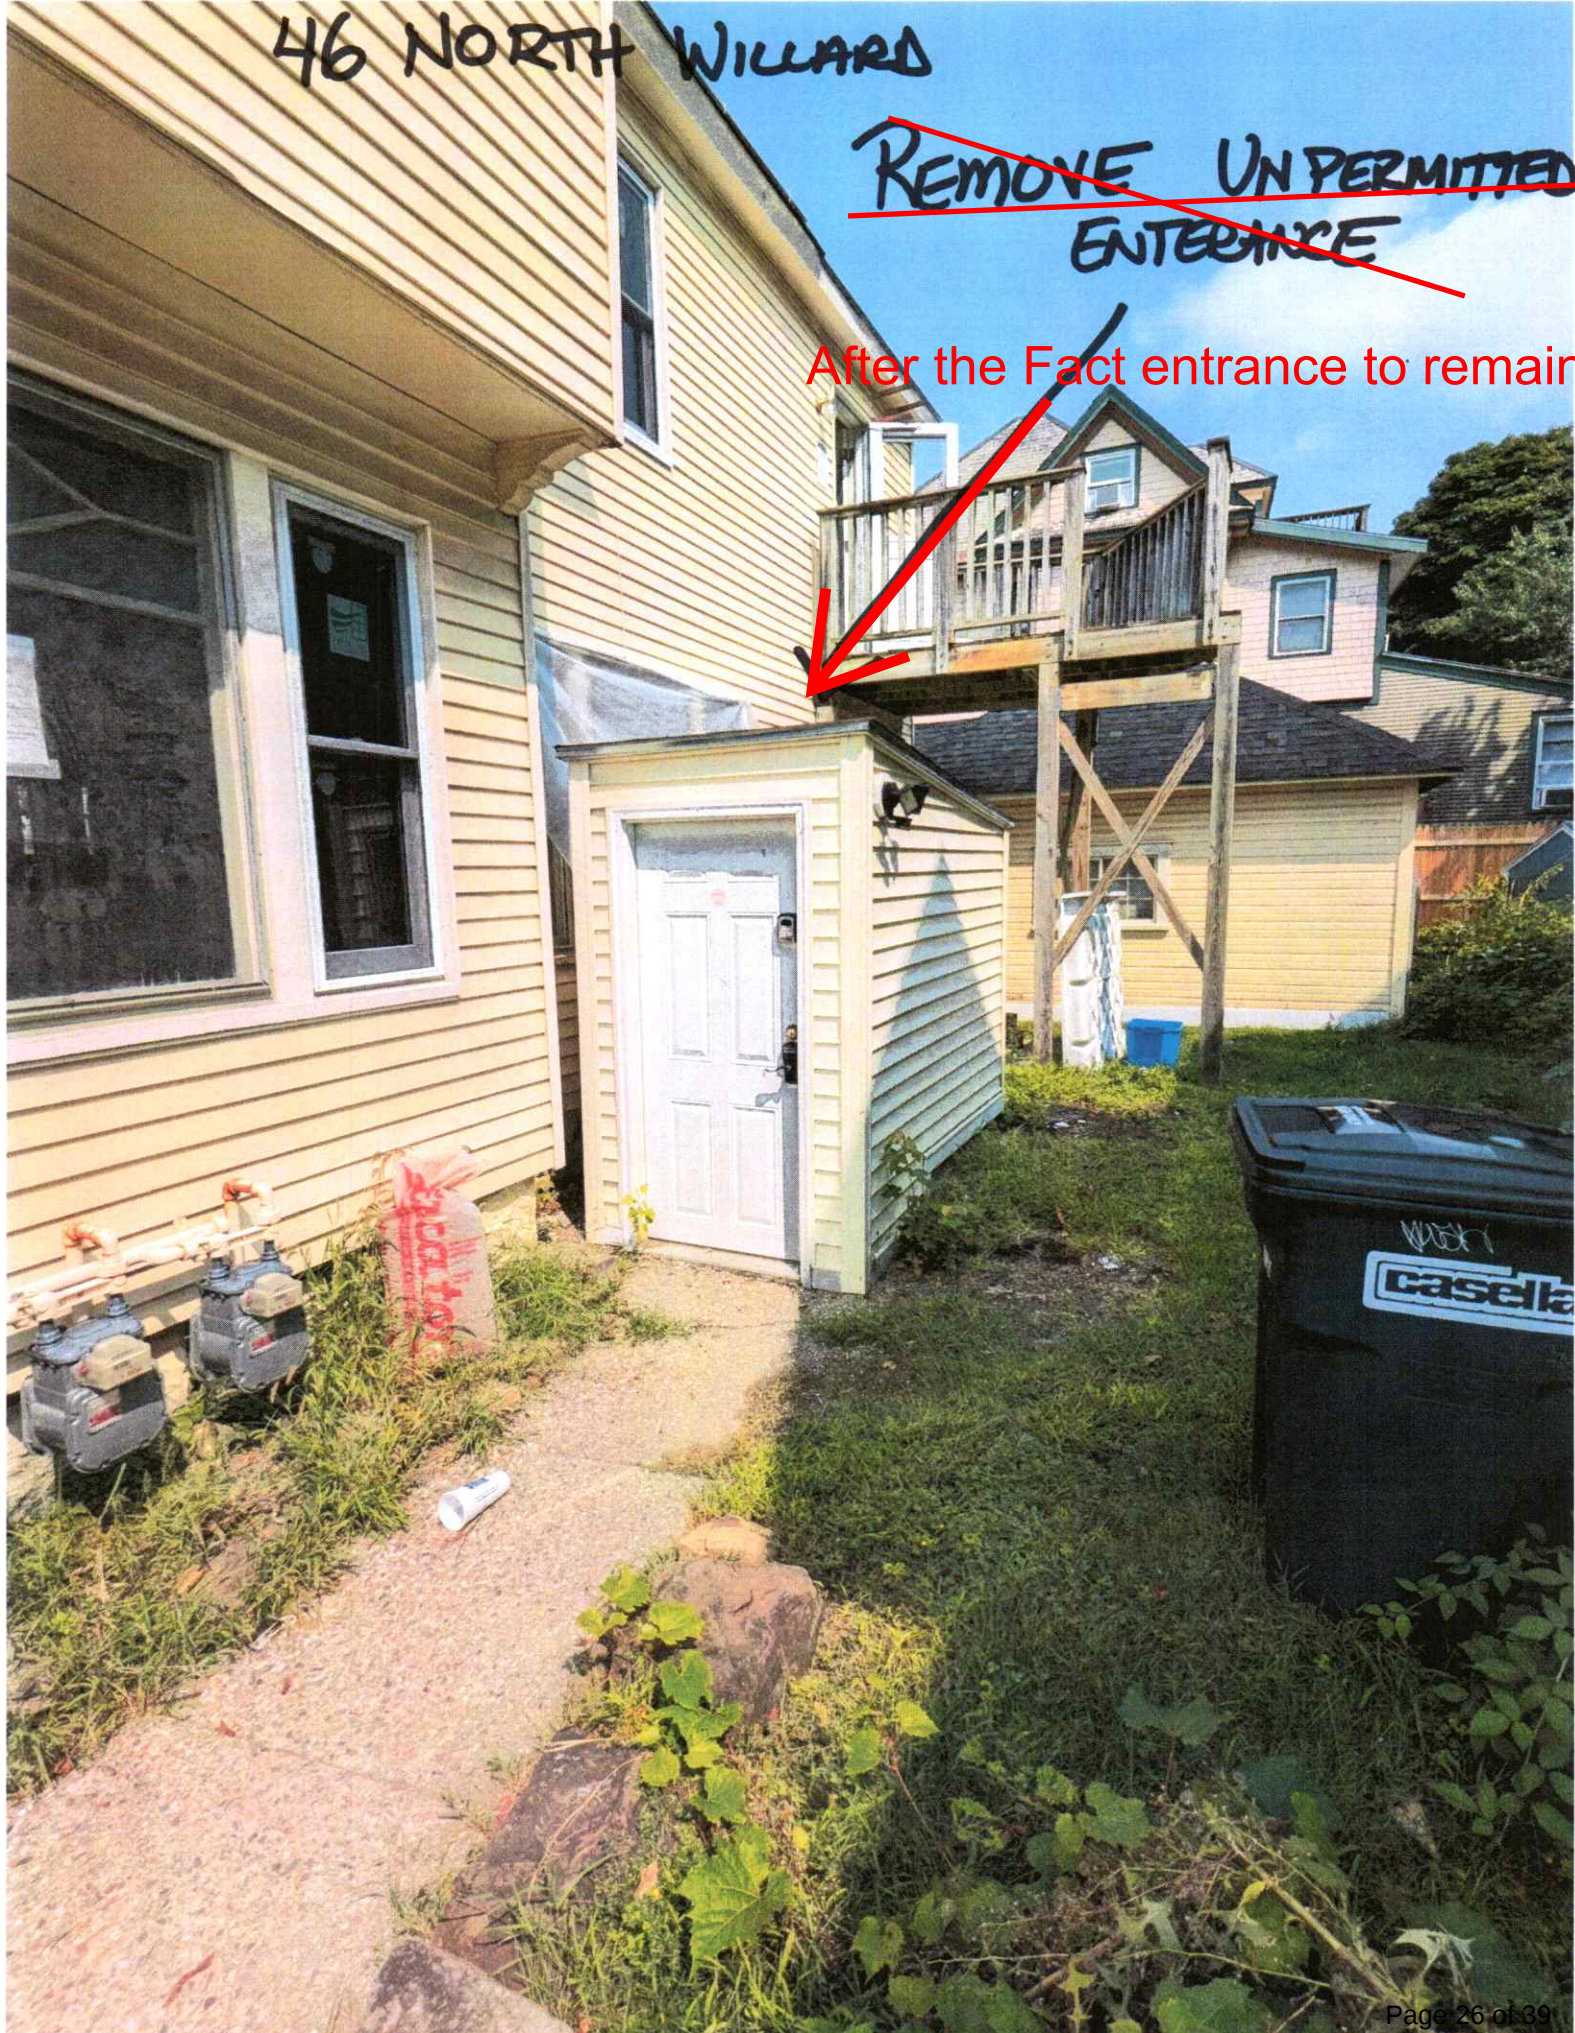
46 NORTH WILLARD

~~REMOVE~~

46 NO WILLARD

REMOVE  
DOOR

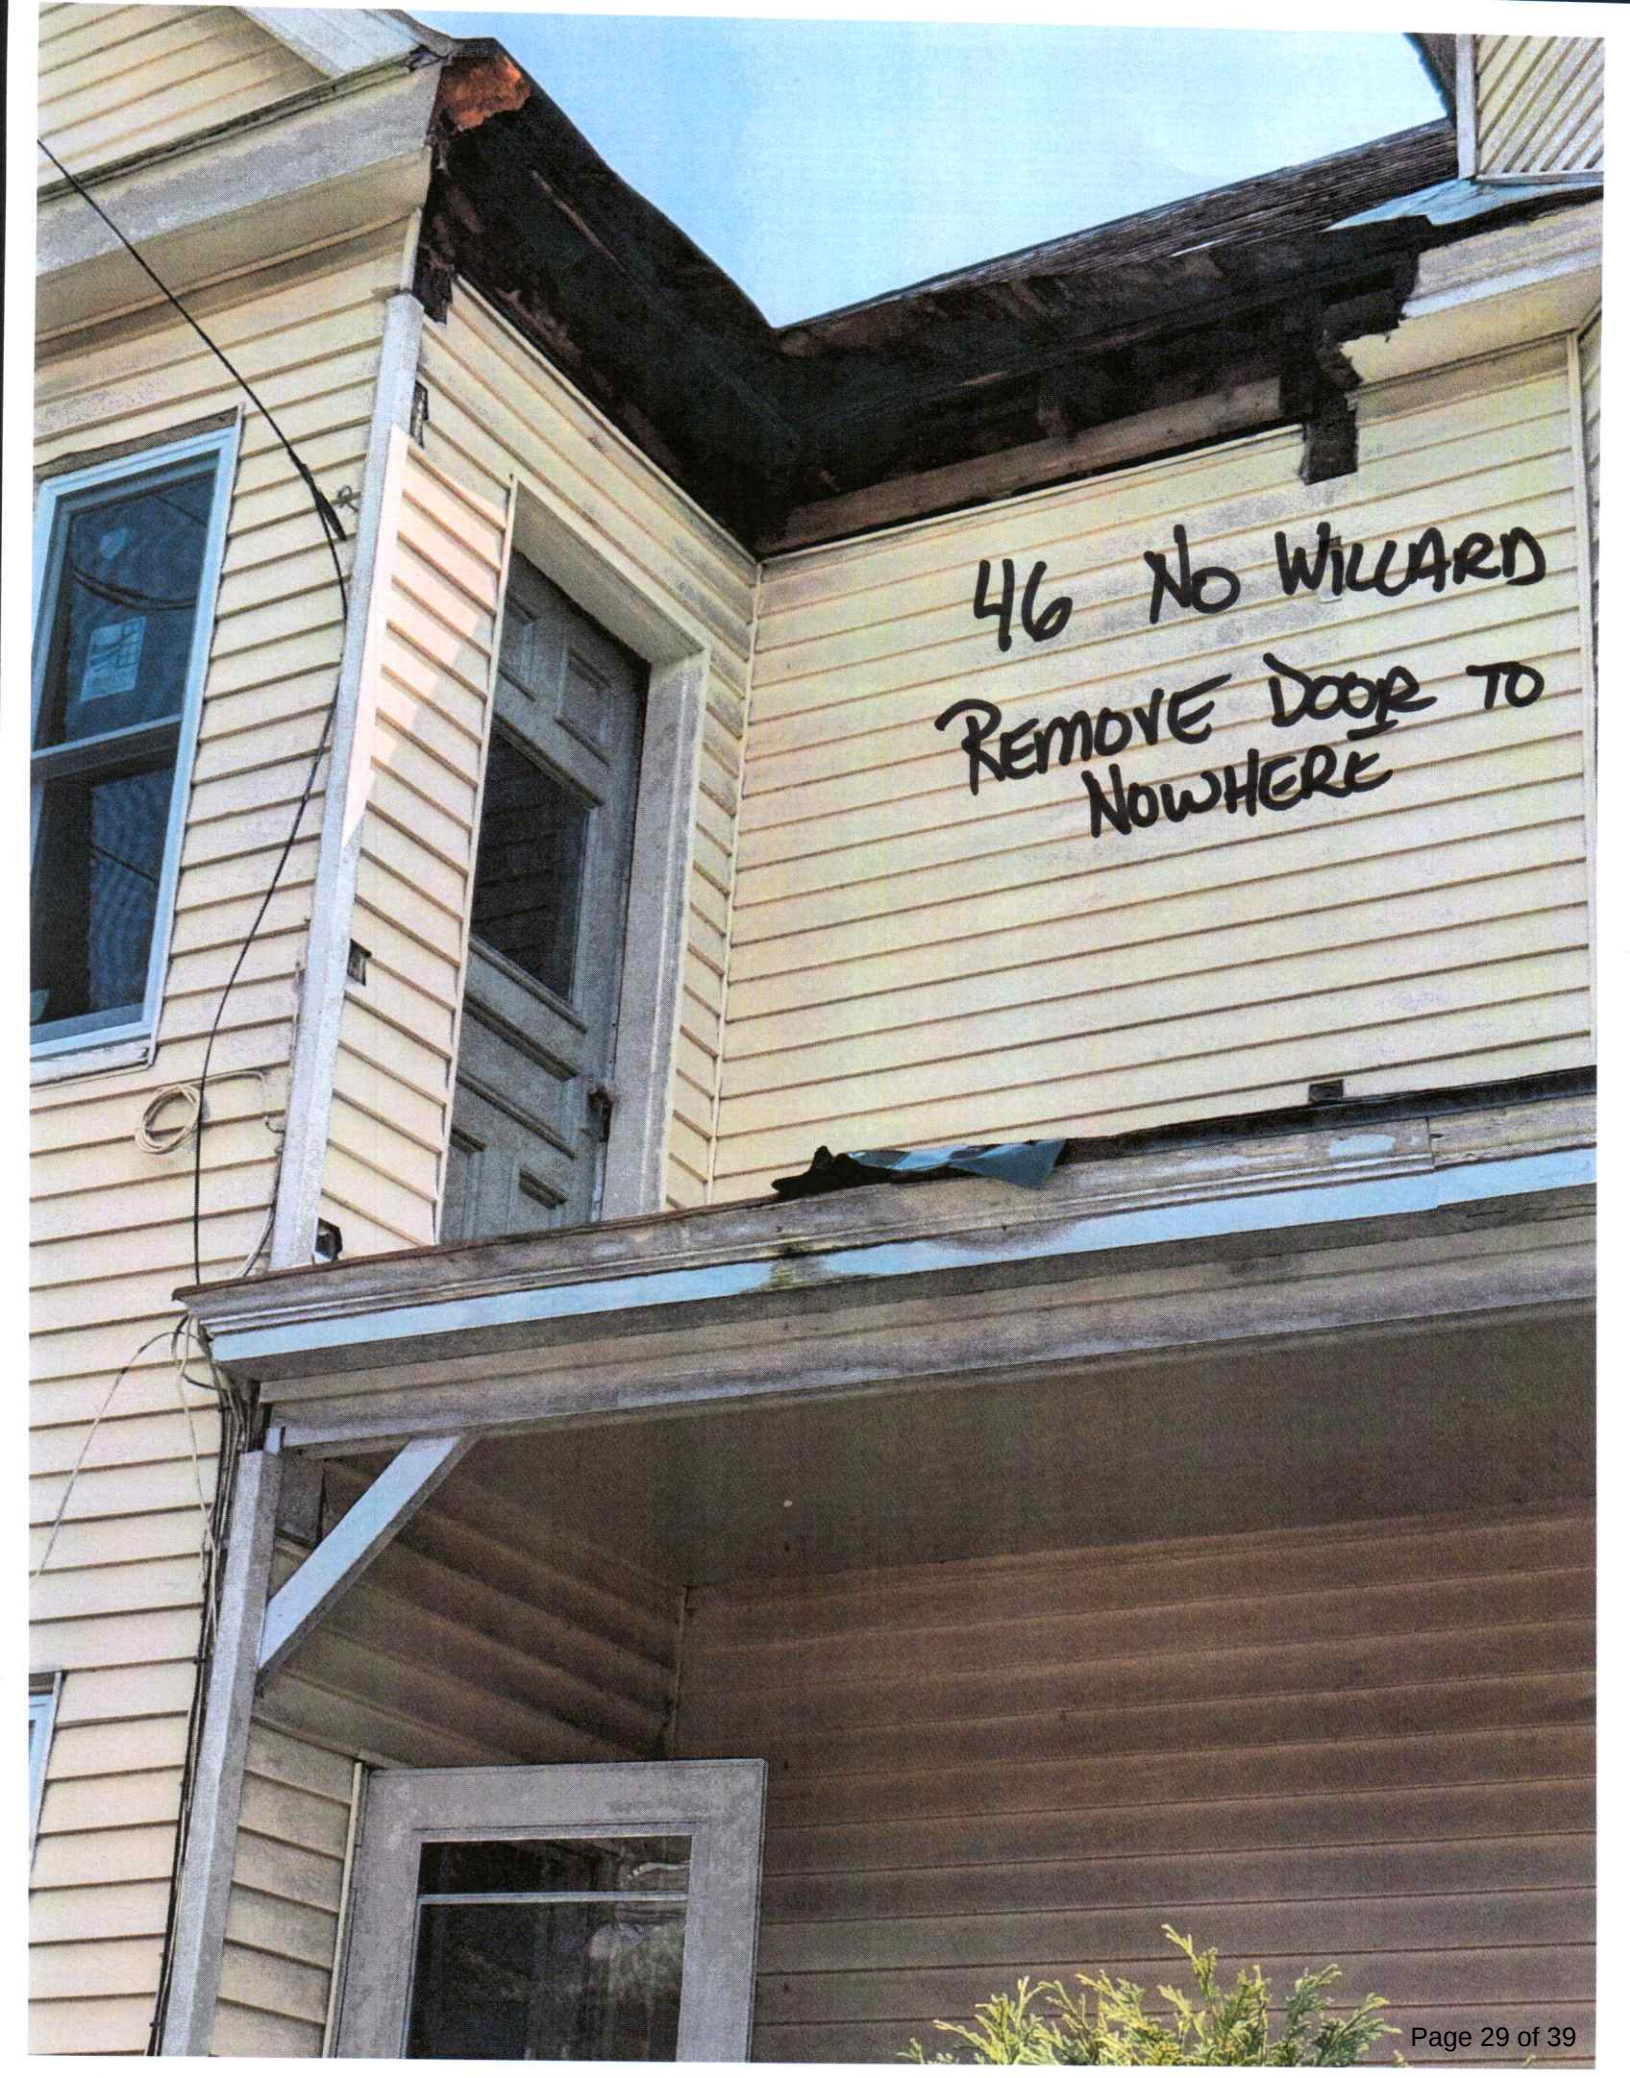
46 NO WILLARD  
REMOVE DOOR TO  
NOWHERE

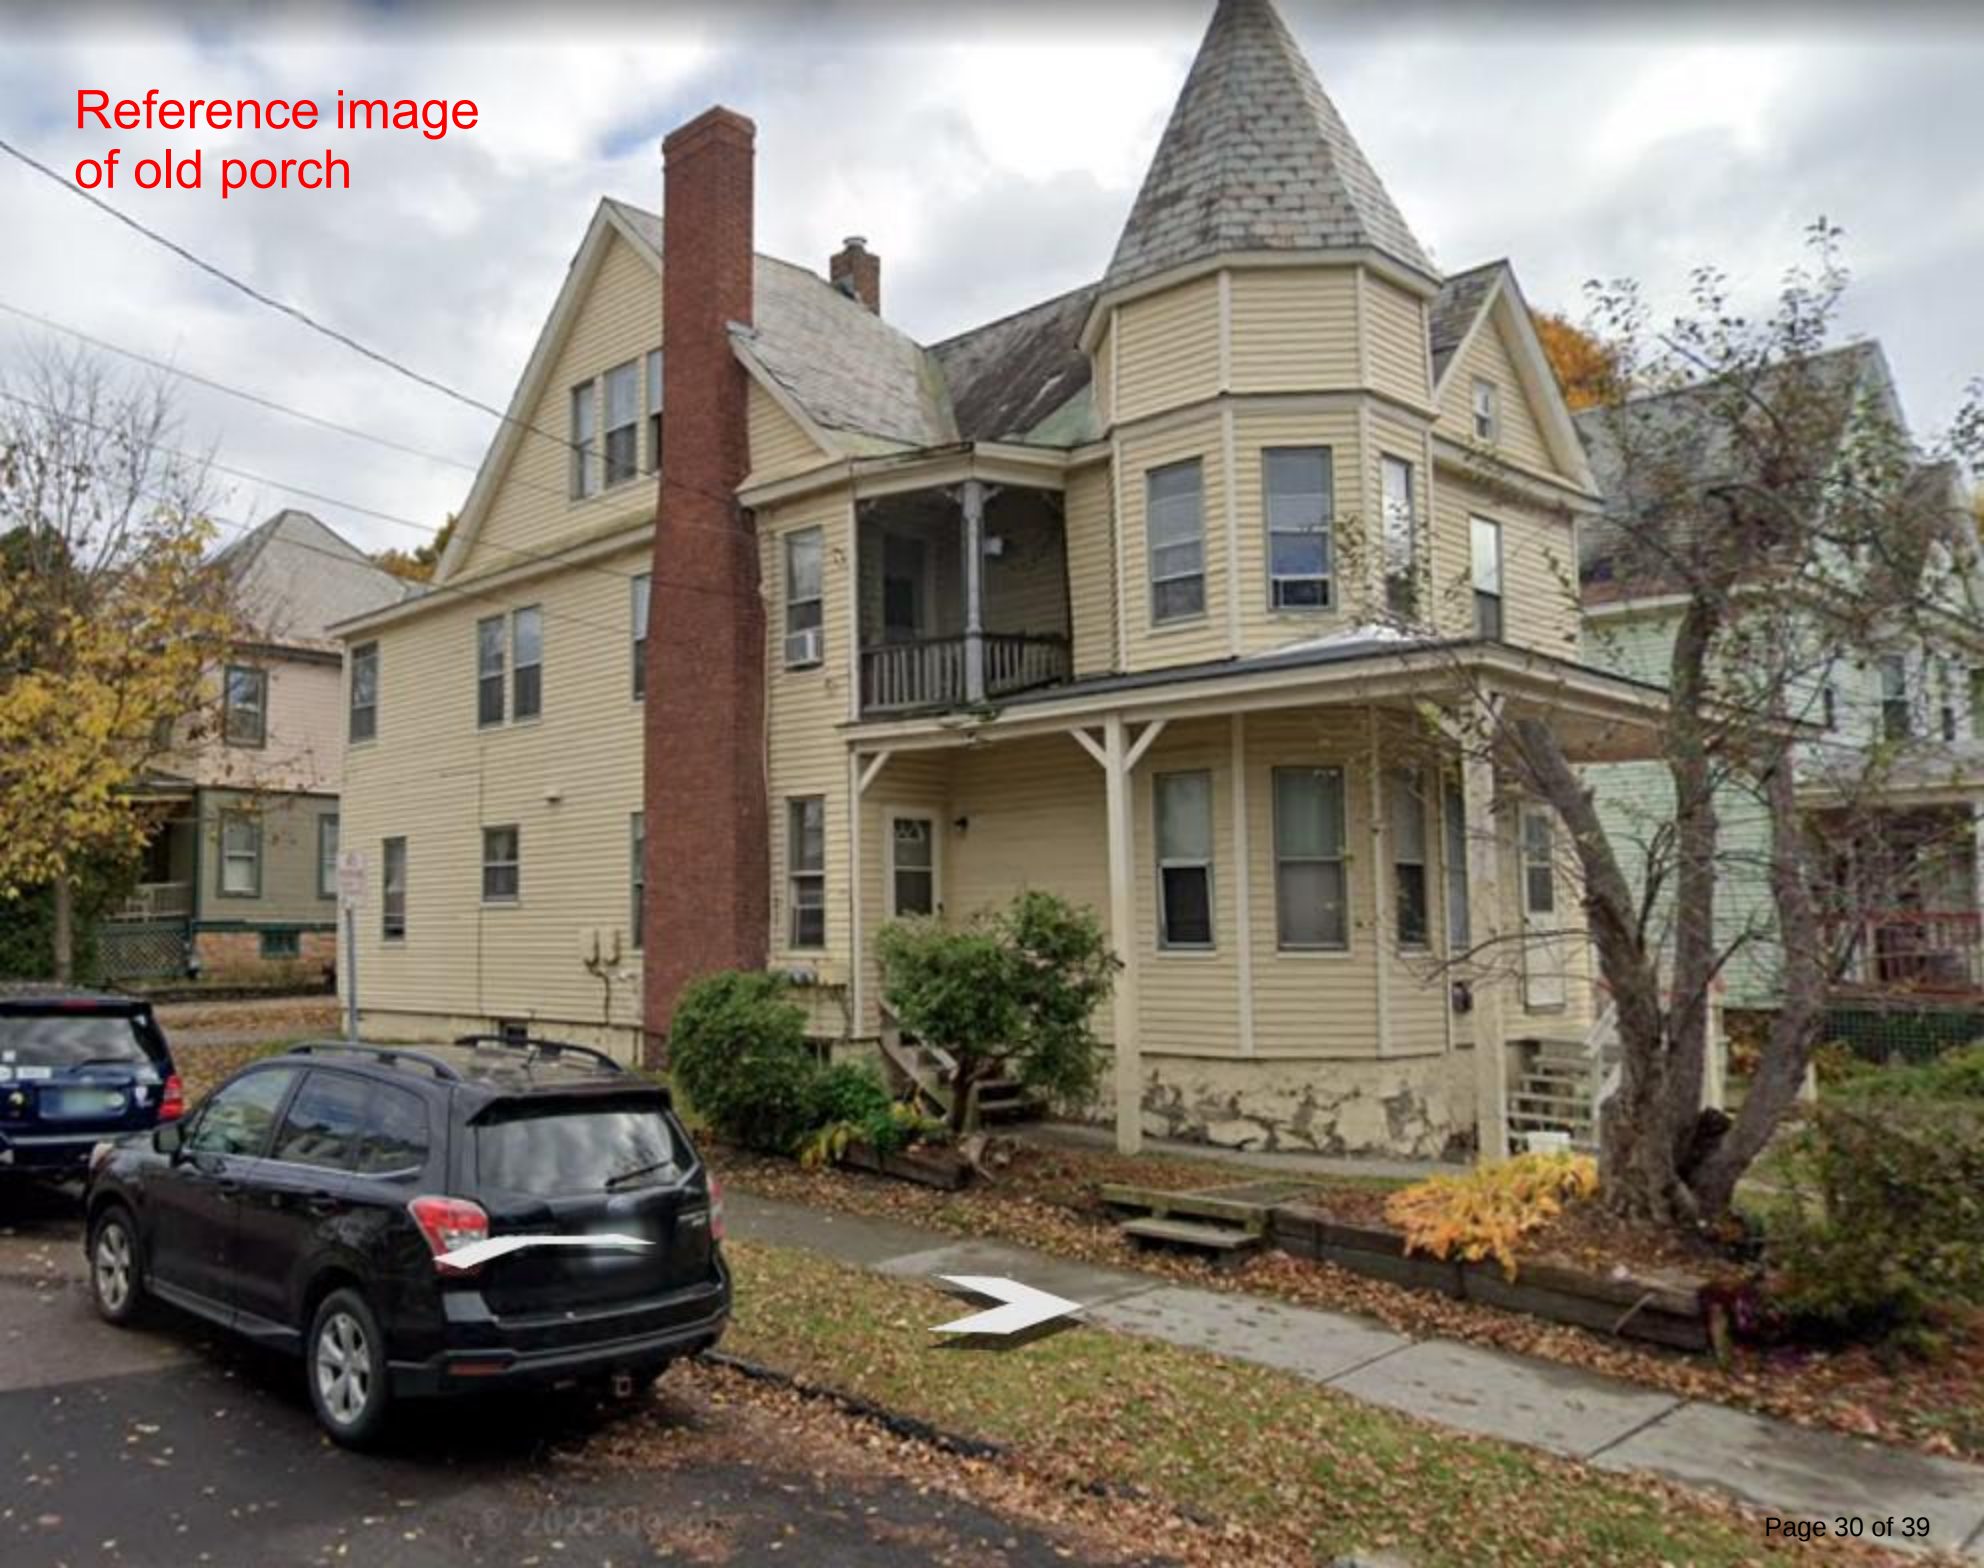
Reference image  
of old porch

Require the reconstruction of the second story porch as it is a distinctive feature explicitly noted in the historic listing of the property.

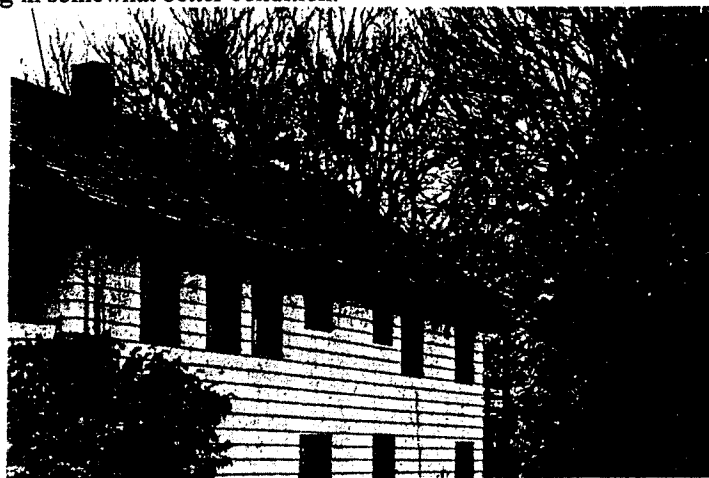
North side of roof

As noted above, the north side of the roof appears to be in somewhat better condition than the south side. It is possible to replace the two sides of the roof separately. For example the south side could be replaced next year and the north side left to be replaced one or two years down the road.

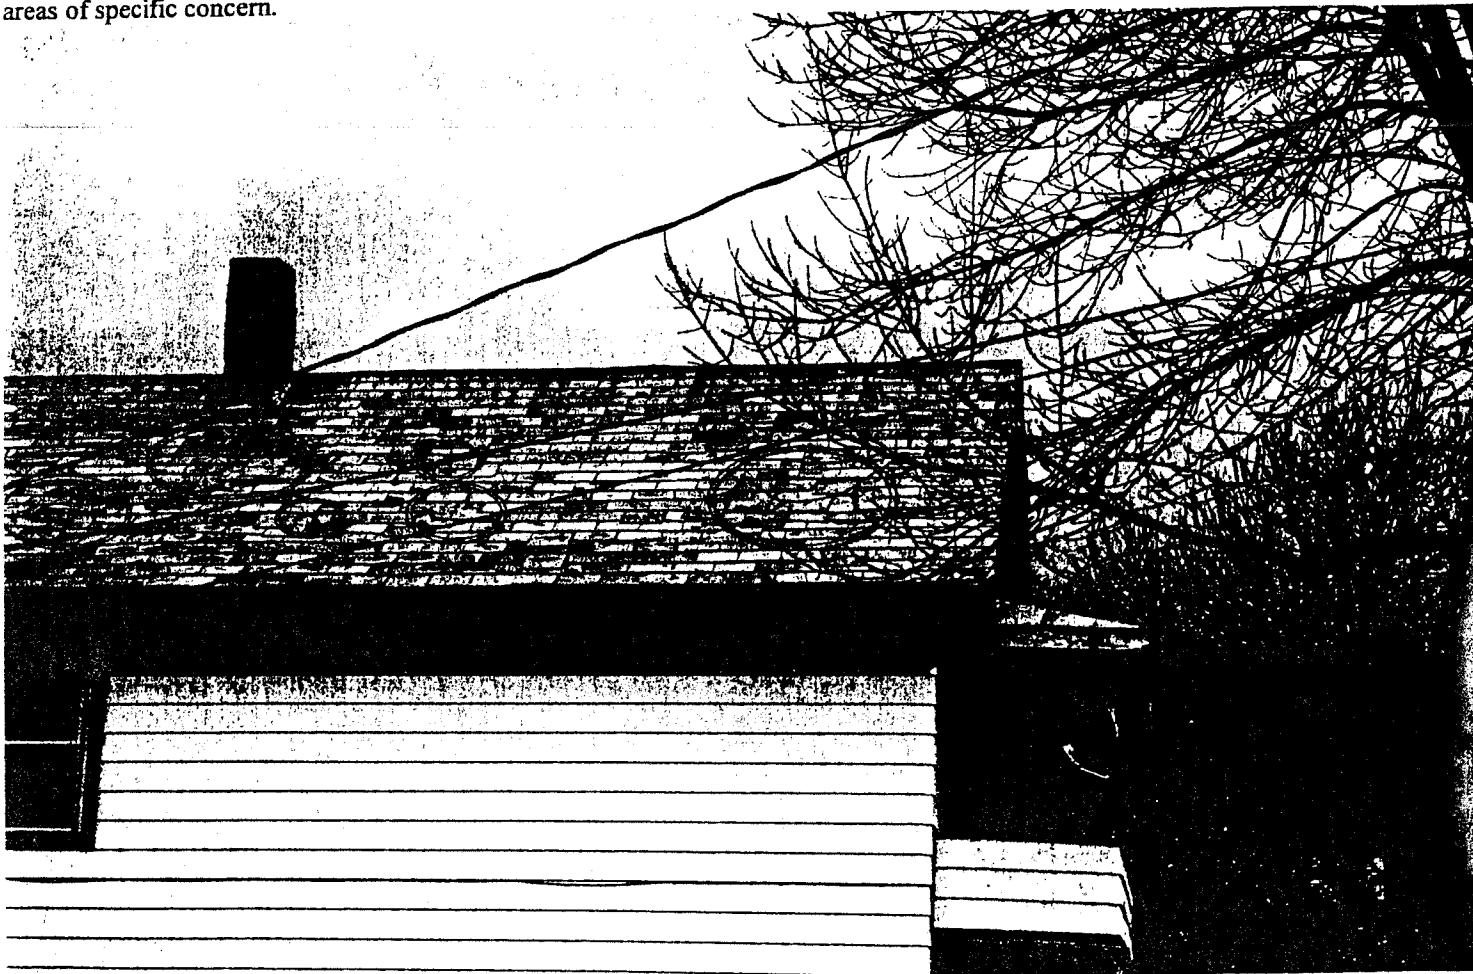
Immediate problems with the roof seem to be located on the south side of the roof. A visual inspection of the roof shows several areas of specific concern.

Areas of specific concern are highlighted in the photograph above, and details of selected areas are shown enlarged in the selections below.

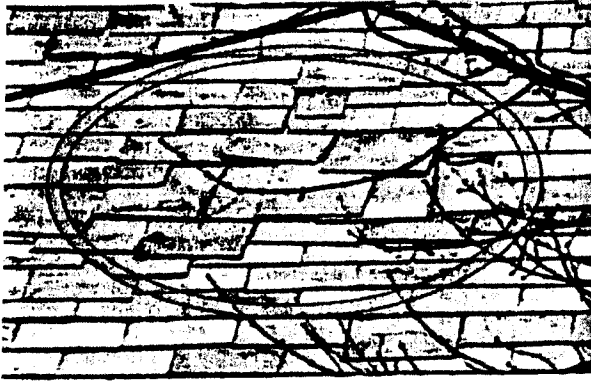
All photographs above show an advanced condition of deterioration in both the condition of the slate, and the integrity of the roof in general.

It is important to realize that there may be and likely are multiple other areas, which appear on the surface to be in tact, which in fact conceal damage as significant as the damage that is visible.

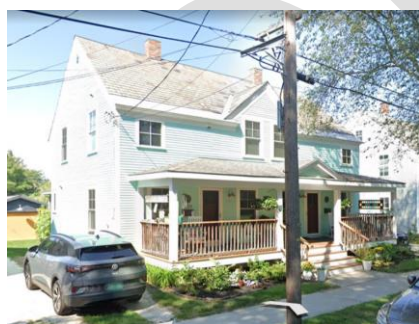
59-61 Central Avenue  
Reconstructed chimneys

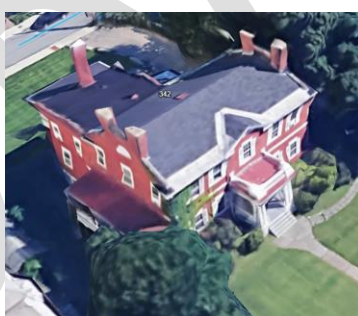
342 Pearl Street  
Repair/repointing 5 chimneys

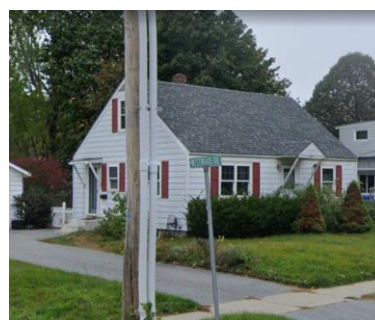
1999 North Avenue  
Chimney removal possible
