### DESIGN ADVISORY BOARD Tuesday, June 23, 2015 at 3:00 PM Conference Room 12, City Hall, Burlington, VT

- 2. 15-1314CA; 495 Colchester Ave., (Neighborhood Mixed Use, Ward 1), Brisson Properties**  
Raise buildings repair and restore exterior, remove porch. Add one floor of living space. Associated site improvements.

PROJECT: 495 COLCHESTER AVE. RESTORATION  
BRISSON PROPERTIES  
JOB No. 14-03

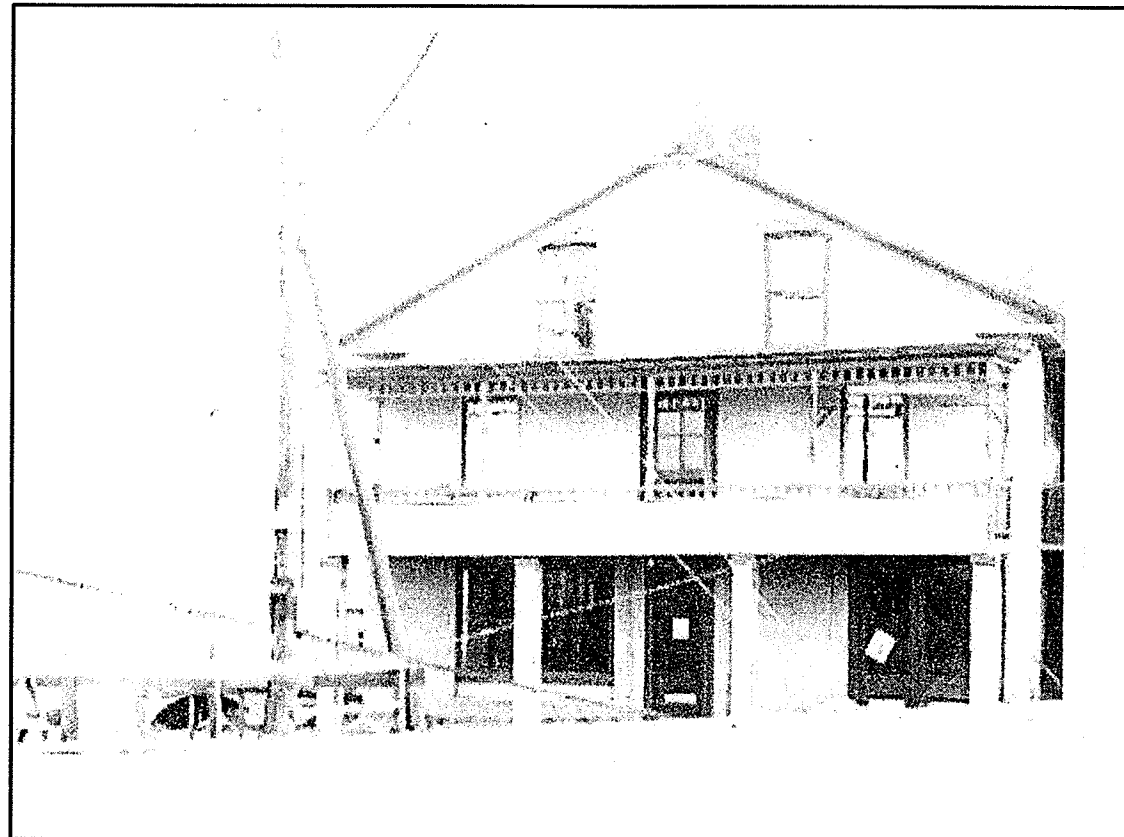
HISTORIC VIEW BEFORE BRIDGE TO WINOOSKI WAS RECONSTRUCTED TALLER AFTER FLOOD OF 1927

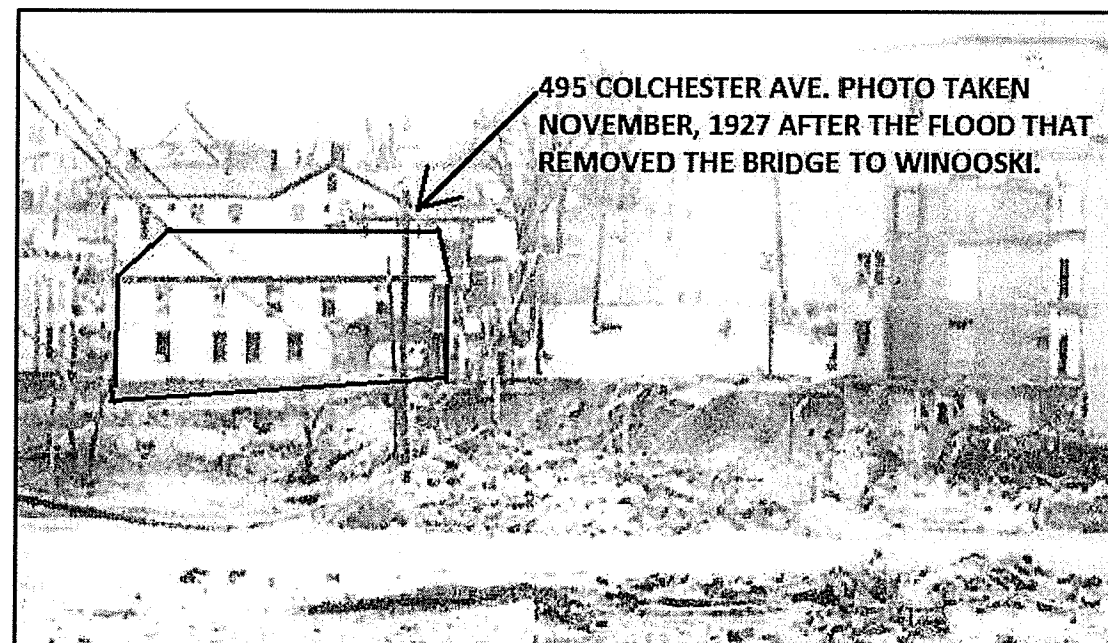
HISTORIC CONDITIONS PRIOR TO BUILDING BEING BURIED DURING BRIDGE TO WINOOSKI RECONSTRUCTION.

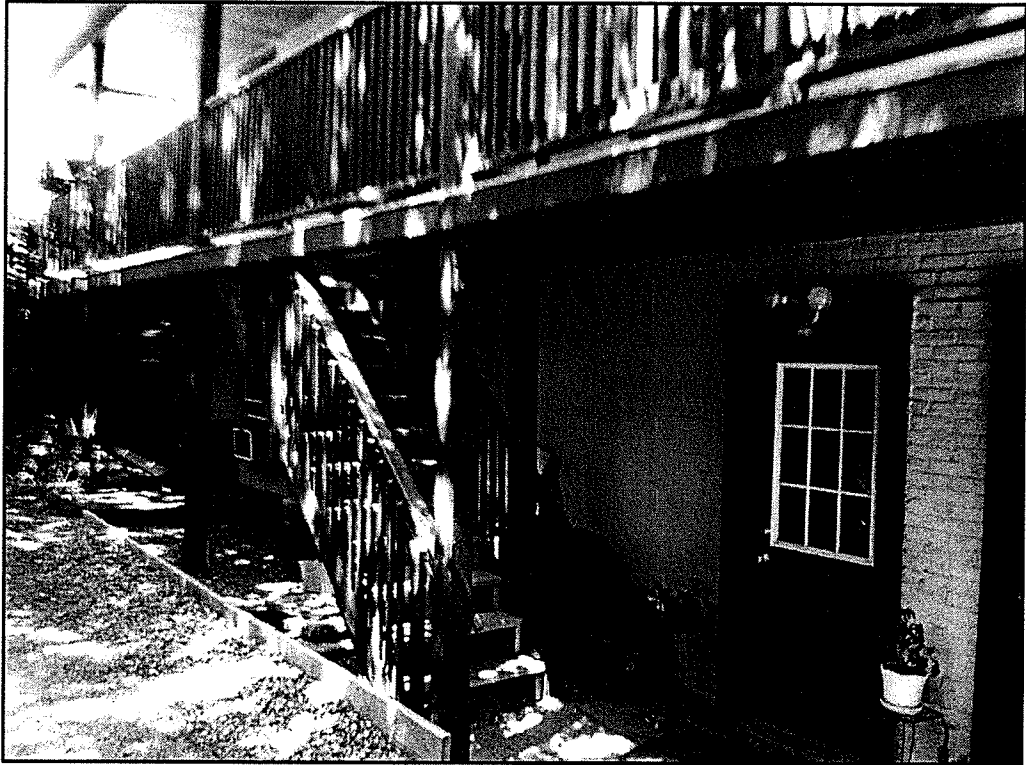
EXISTING CONDITIONS, SOUTH SIDE COURTYARD

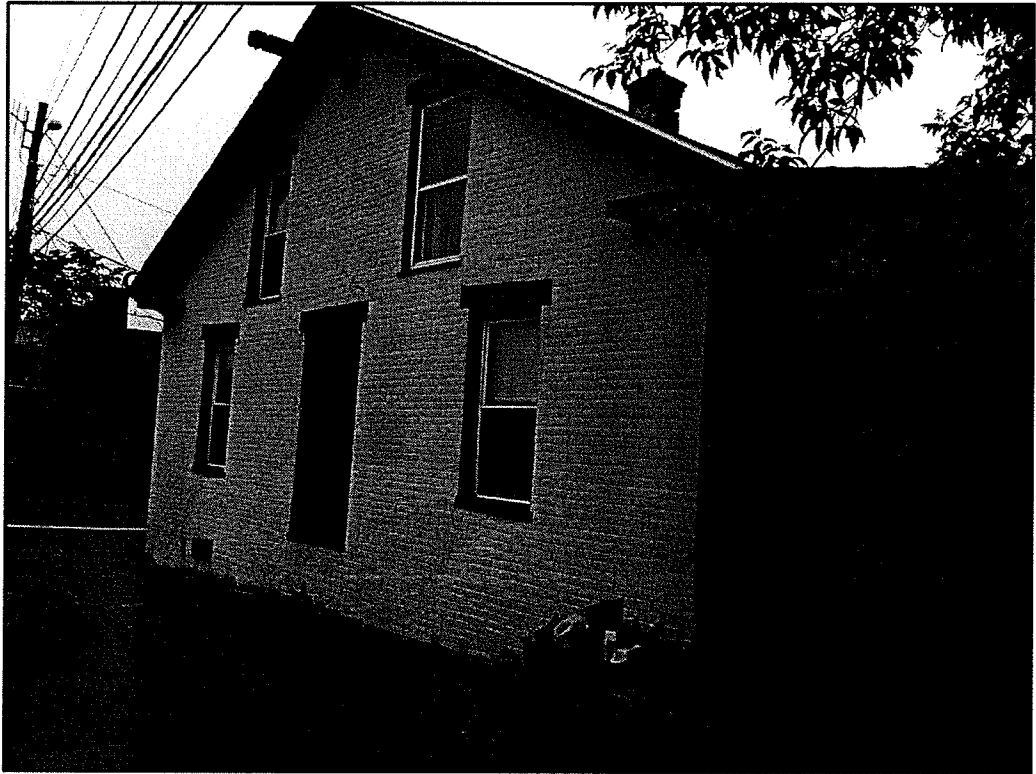
EXISTING CONDITIONS, WEST ELEVATION

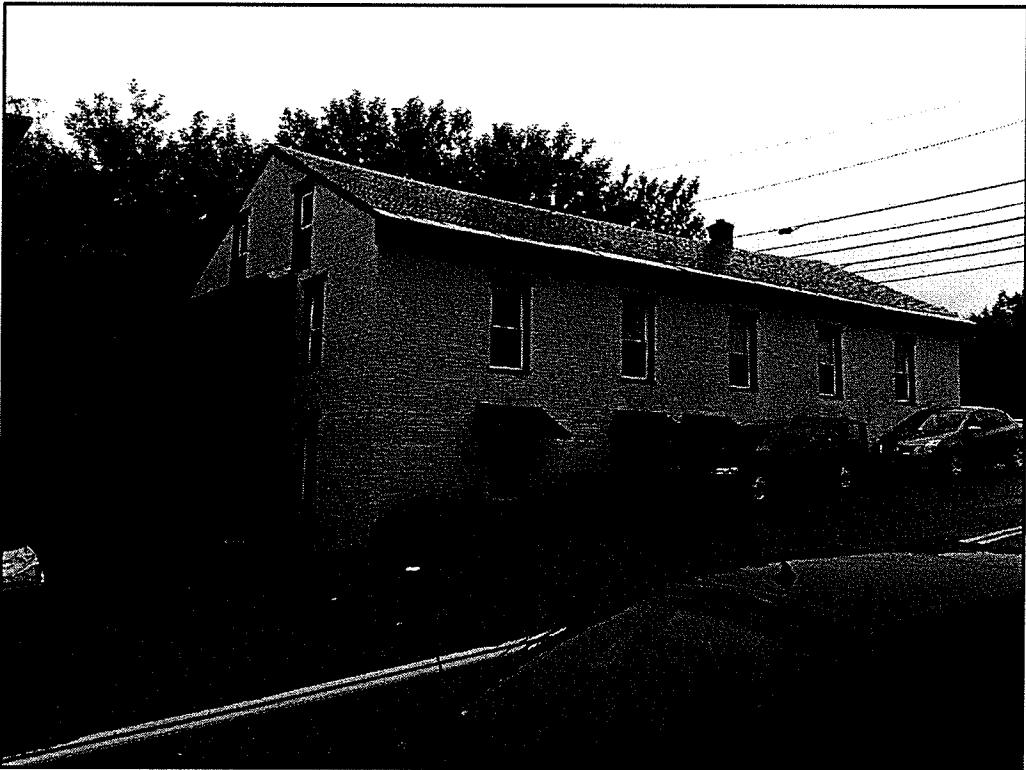
EXISTING CONDITIONS EAST AND NORTH ELEVATIONS

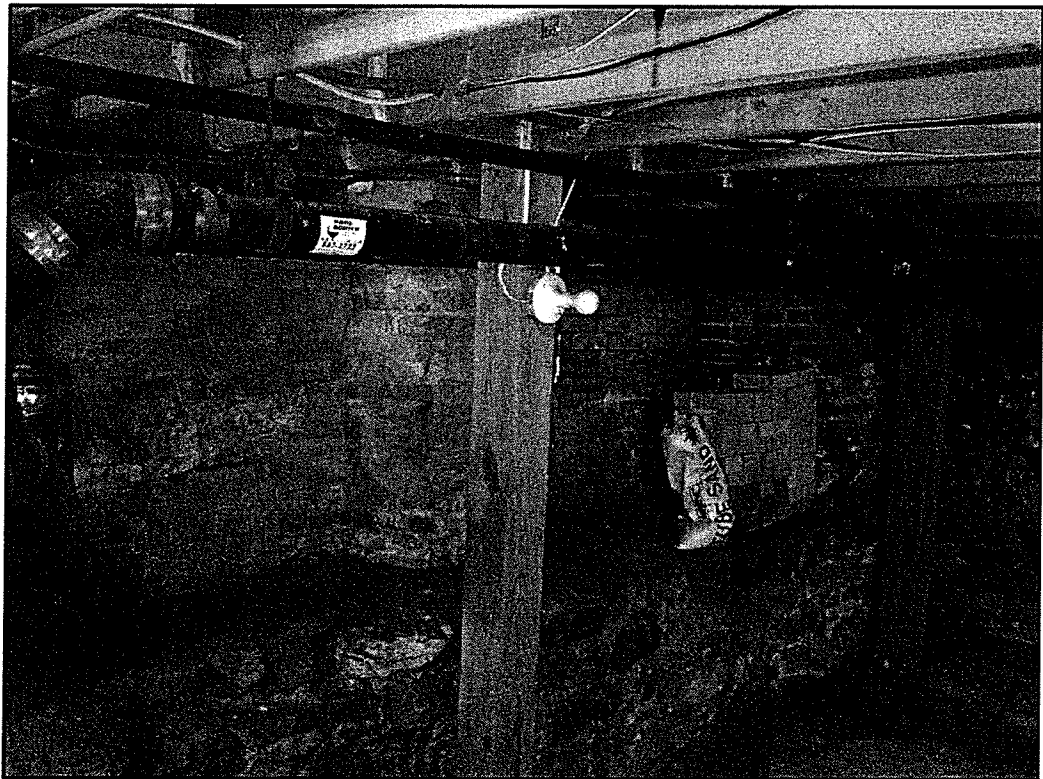
EXISTING CONDITIONS VIEW OF EXISTING CELLAR

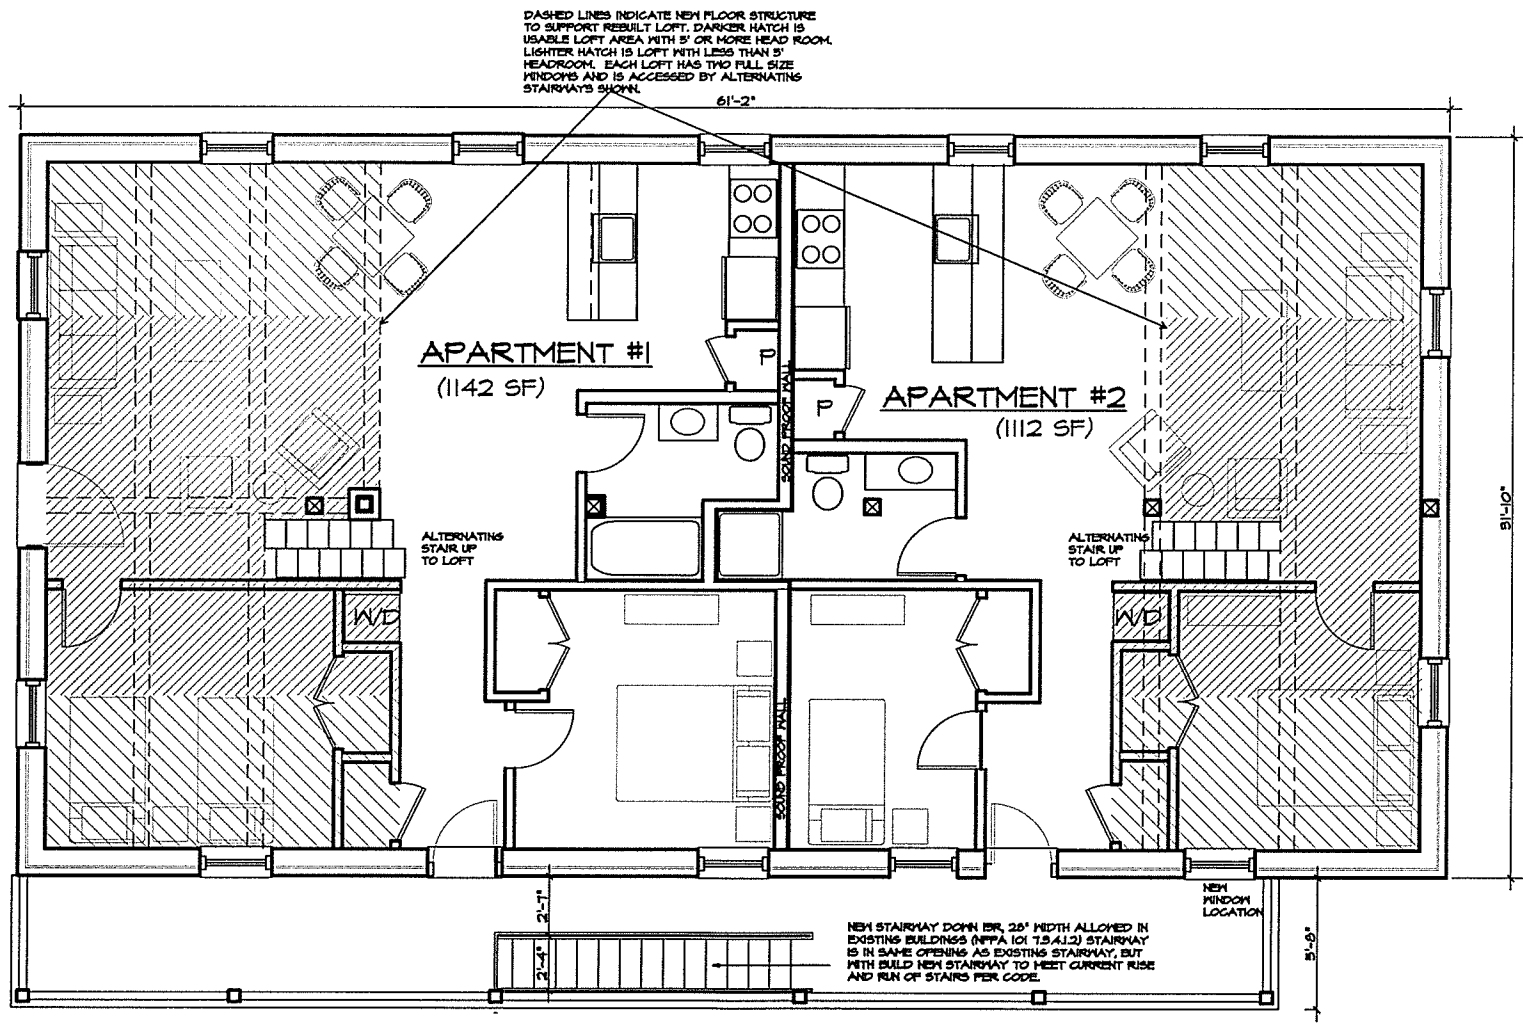
SHEET No.  
A201

↑  
**PROPOSED SECOND FLOOR PLAN**  
**2254 NET SF IN APARTMENTS 3 AND 4 (SECOND FLOOR)**  
DARKER HATCHED AREA INDICATES LOFTS WITH MORE THAN 5' HEAD ROOM.  
1/8" = 1'-0"

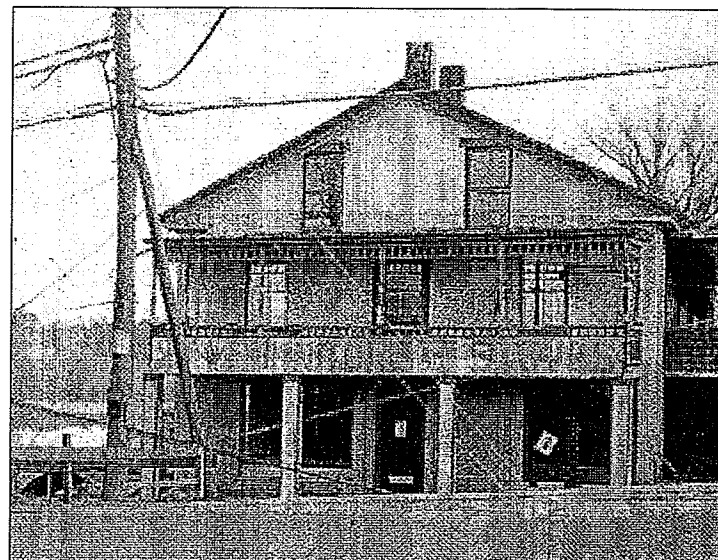
HISTORIC PHOTO c. 1928

NOTE: RECONSTRUCTION OF HISTORIC PORCH  
DEPENDS ON GETTING OWNERSHIP OR AN EASEMENT  
OF PROPERTY NOW IN THE VTRANS R.O.M.

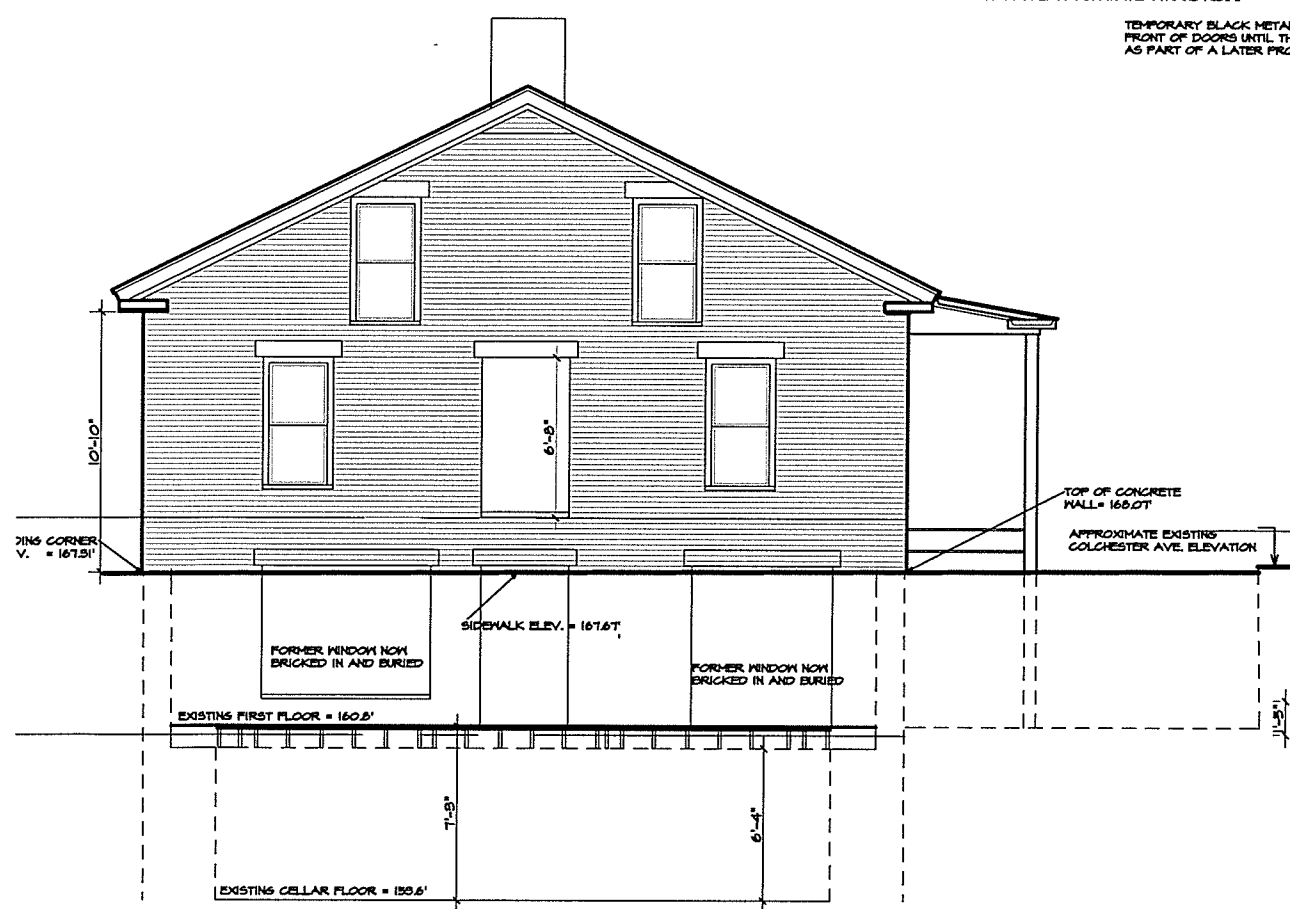
EXISTING WEST ELEVATION  
1/8" = 1'-0"

1. Correct the labeling error on the west elevation plans (bricked-in doors vs. windows).
2. Note window and lintel materials.
3. Clarify whether a step or steps will accompany the re-installed doors on the west elevation.
4. Indicate the net new number of rooms constructed and associated off-street parking.

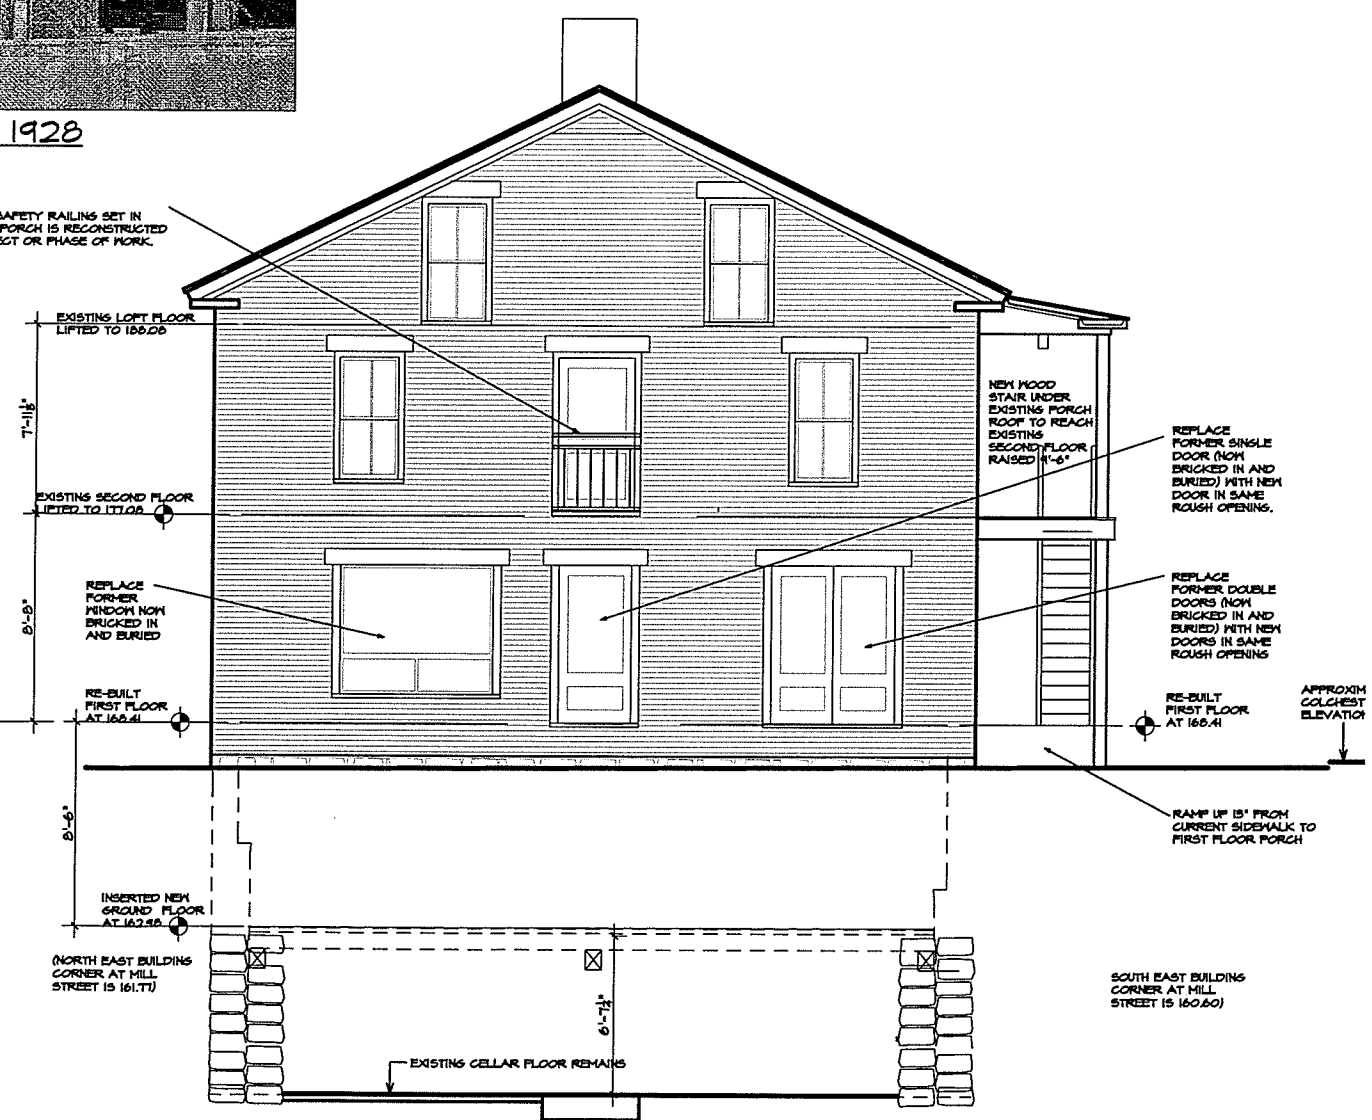
TEMPORARY BLACK METAL SAFETY RAILINGS SET IN  
FRONT OF DOORS UNTIL THE PORCH IS RECONSTRUCTED  
AS PART OF A LATER PROJECT OR PHASE OF WORK.

PROPOSED WEST ELEVATION  
1/8" = 1'-0"

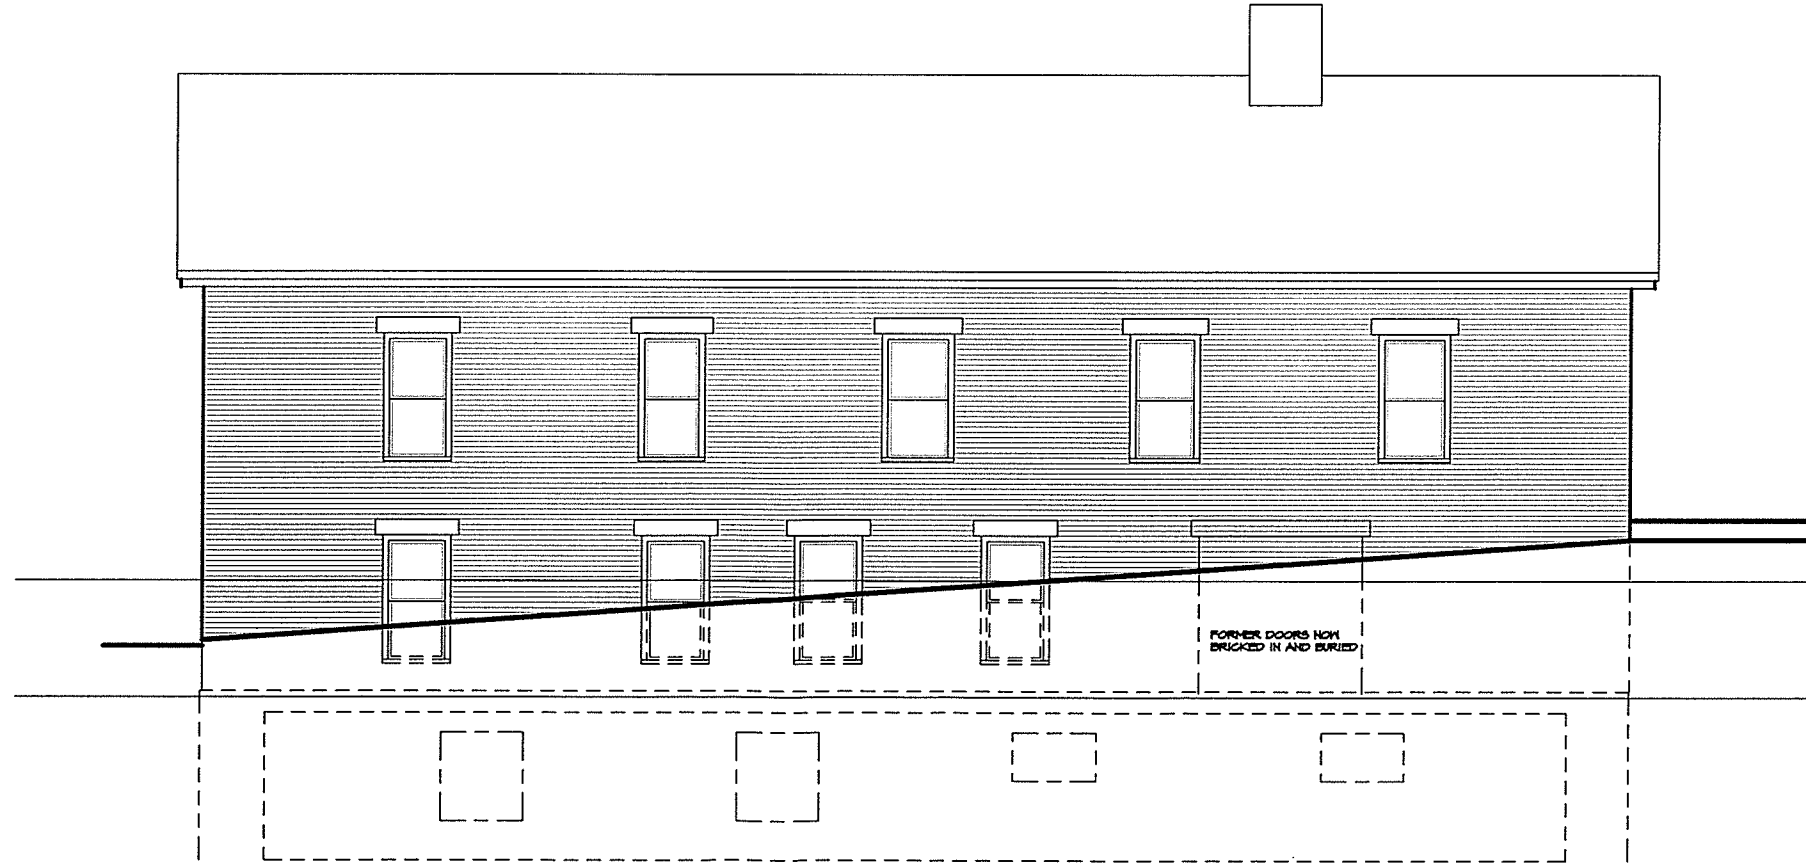
SHEET No.  
A203a

EXISTING NORTH ELEVATION  
1/8" = 1'-0"  
(WITH WINDOW HOODS REMOVED)

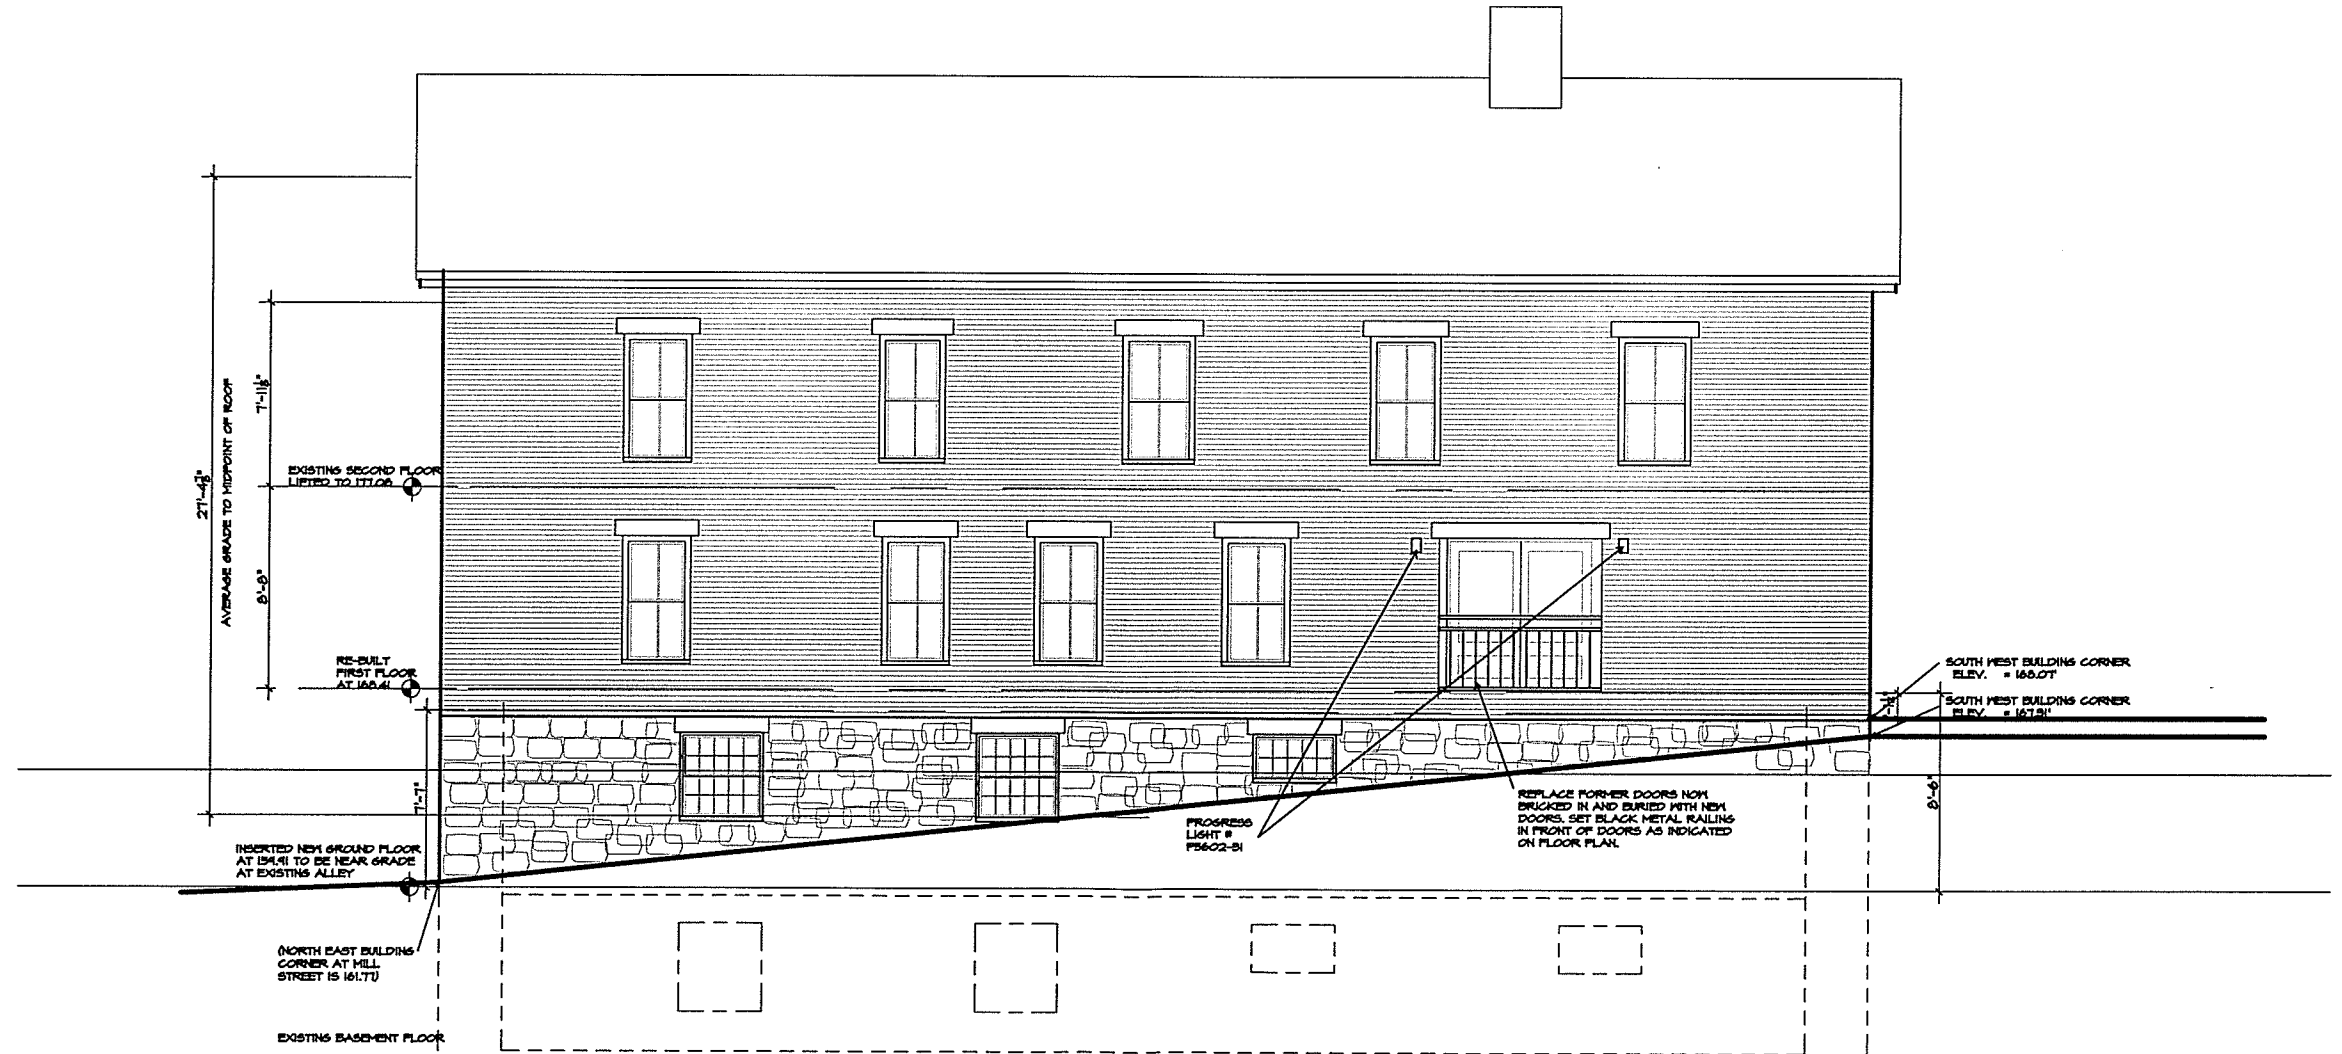
PROPOSED NORTH ELEVATION  
1/8" = 1'-0"  
(AFTER LIFTING 8' 0")

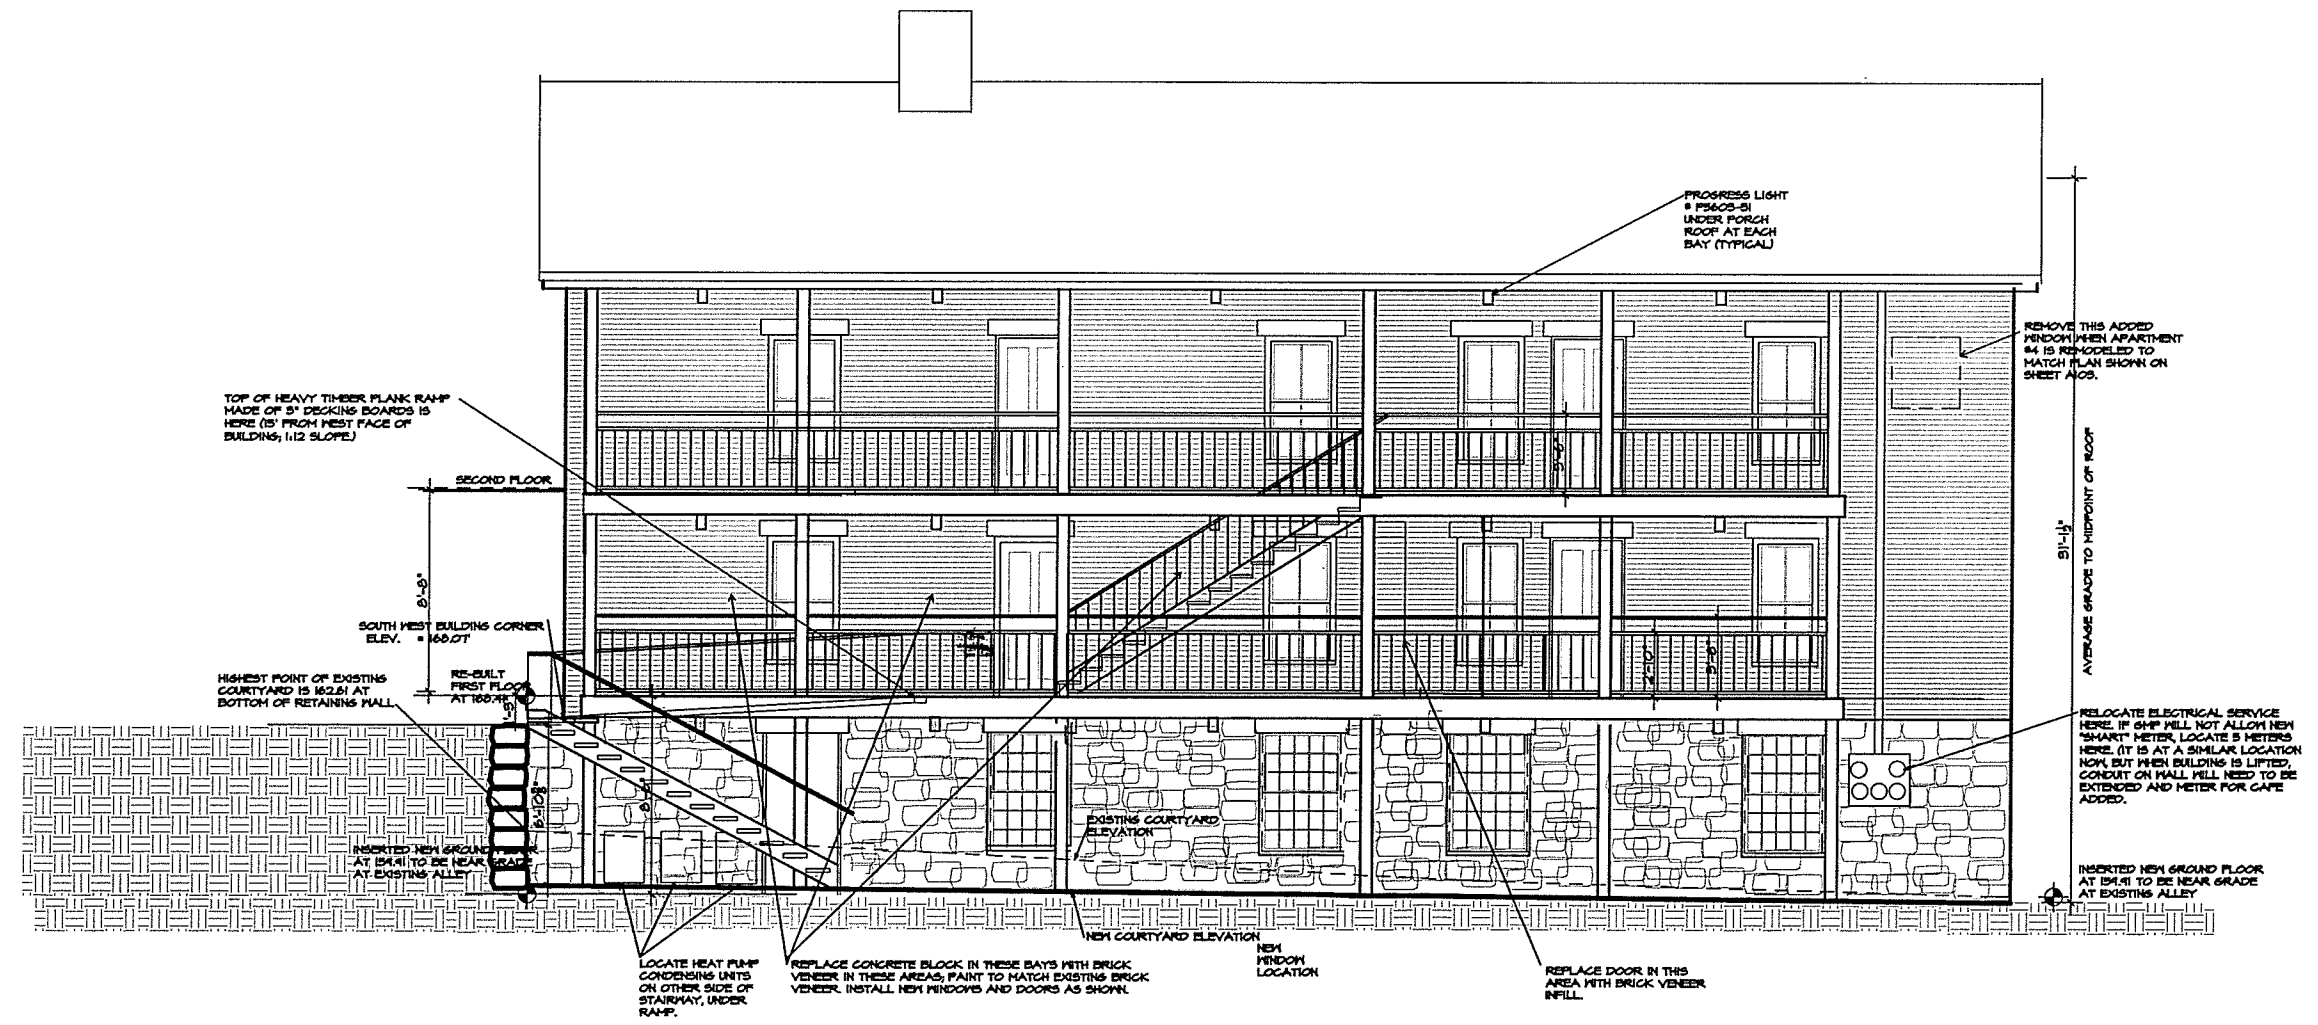
SHEET No. A301

PROPOSED SOUTH ELEVATION  
1/8" = 1'-0"

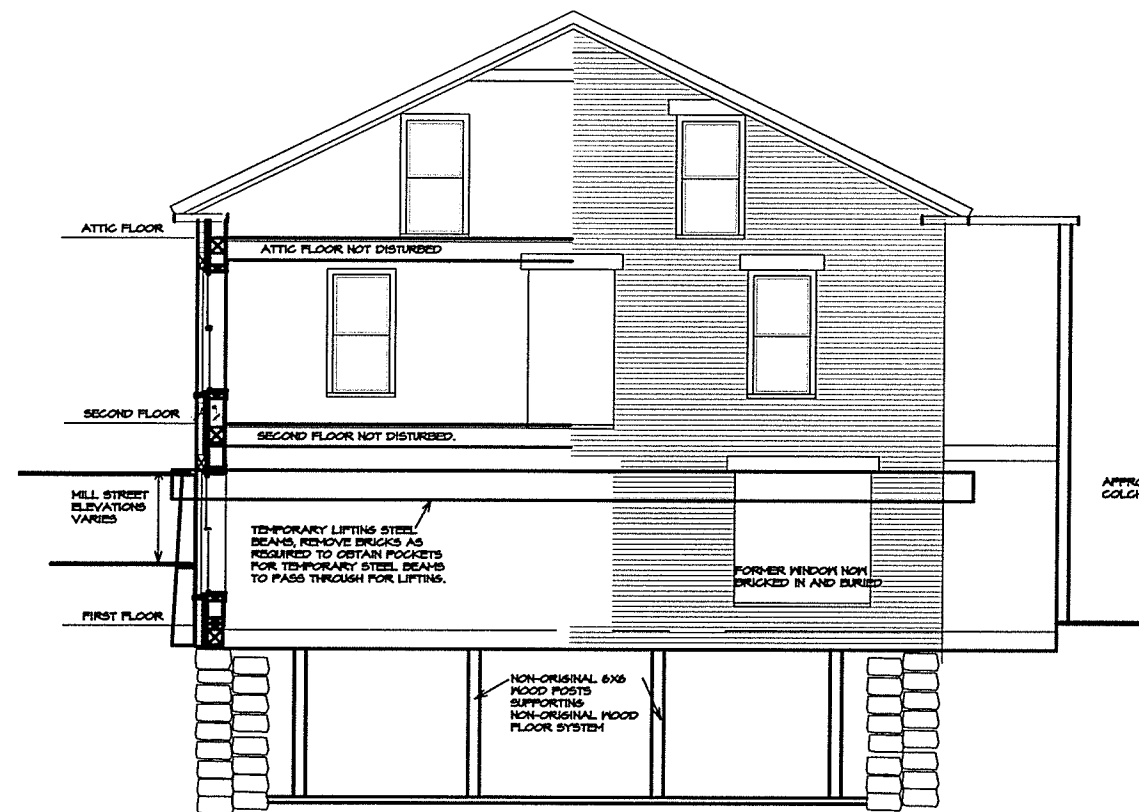
EXISTING SECTION LOOKING EAST  
1/8" = 1'-0"  
(BEFORE LIFTING)

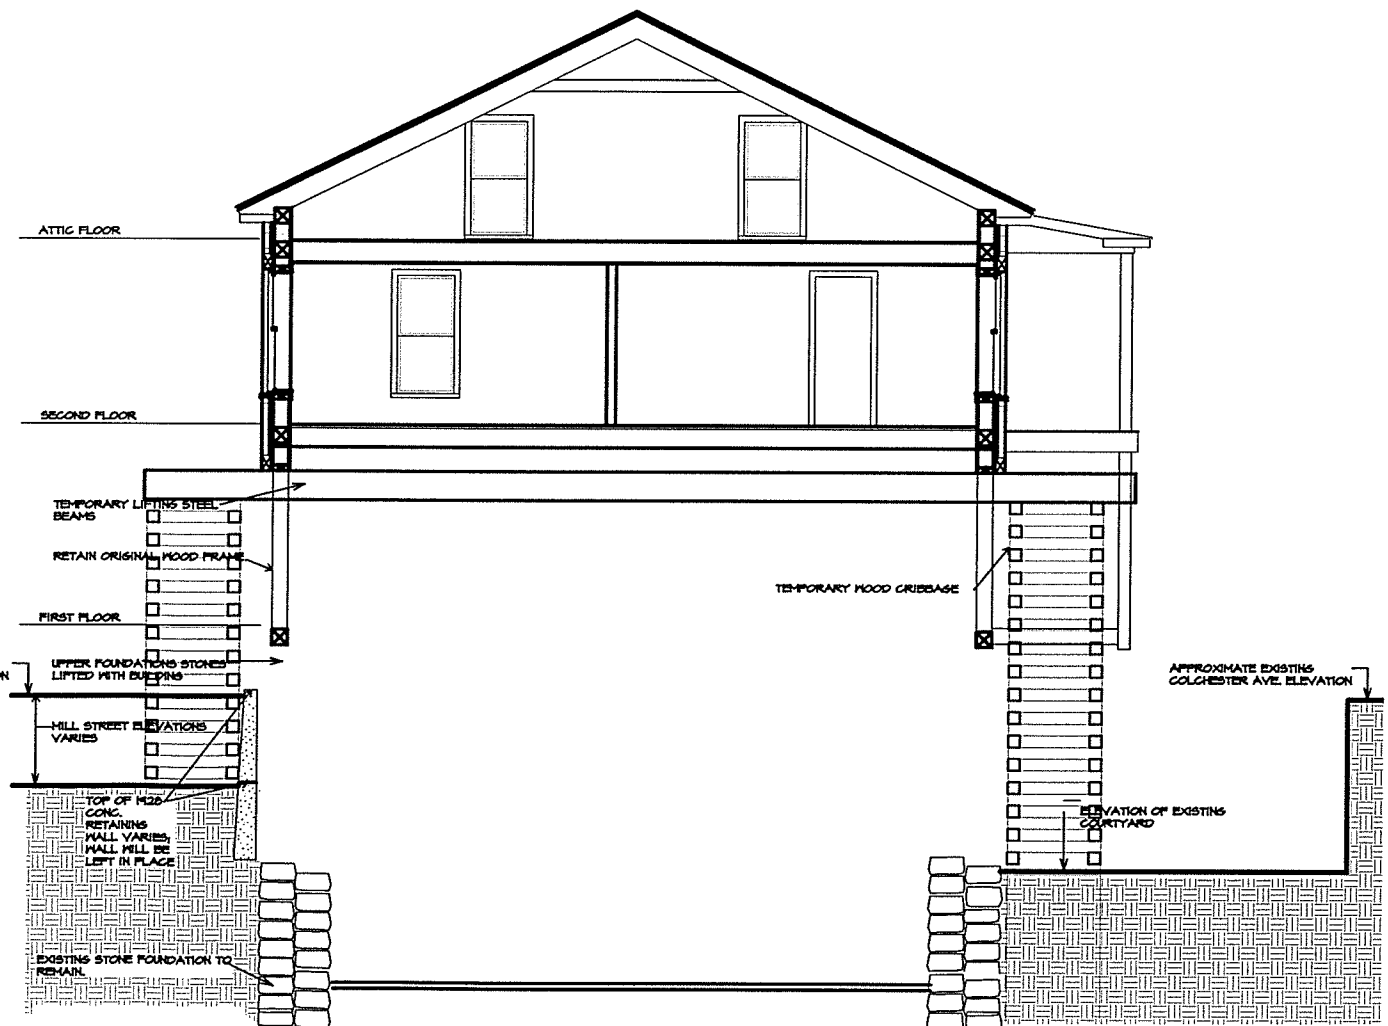
PROPOSED SECTION LOOKING EAST  
1/8" = 1'-0"  
(AFTER LIFTING)

The existing concrete Cellar Floor (not original to the building) will be lowered 12" to accommodate adequate headroom and be replaced with a new concrete slab on top of a new vapor barrier. This option will also allow uses of efficient and comfortable radiant heating coils in the new slab if the owner decides to explore that option.

New concrete walls exterior walls made of insulated concrete forms will be built between the lifted building and the original stone foundation. The exterior of these wall will be faced with 6" -7" thick granite stones similar in size and texture to the existing foundation stones. These new stones will be placed under and support the existing brick veneer to match the original orientation of brick above stone. The interior of the concrete walls will be plastered, so they are not confused with the original foundation stones the will remain visible in the Café's lower floor. As envisioned now, the café would be on parts of both of the interconnected two lowest floors: the inserted, rebuilt ground floor and the rebuilt cellar floor set about 1' lower than it is now in order to gain sufficient head room.

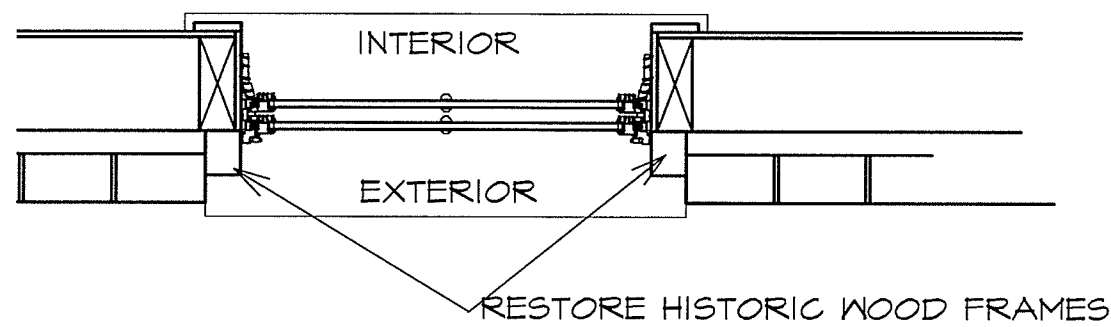
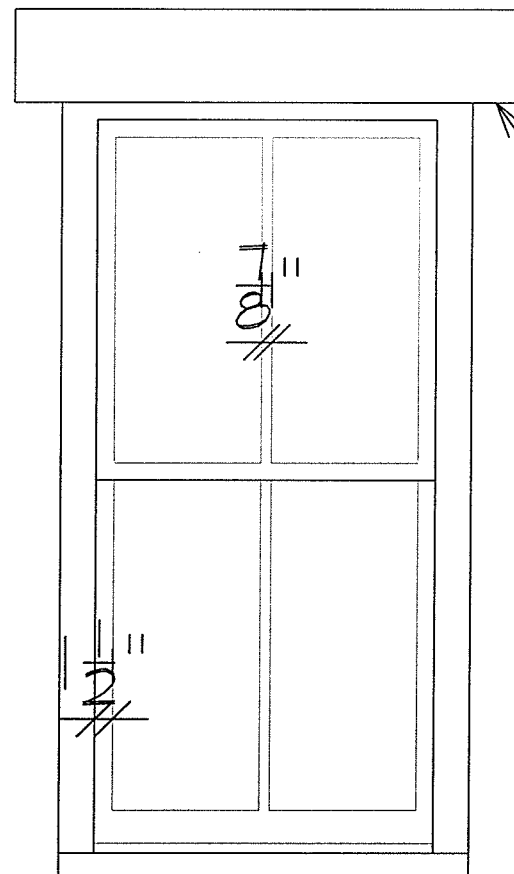
## WINDOW JAMB DETAIL

RESTORE HISTORIC WOOD HEADERS.

NEW MARVIN WOOD ULTREX INTEGRITY WINDOWS WITH  $\frac{7}{8}$ " WIDE VERTICAL SIMULATED DIVIDER TO MAKE 2-OVER-2 TO MATCH HISTORIC PHOTOS.

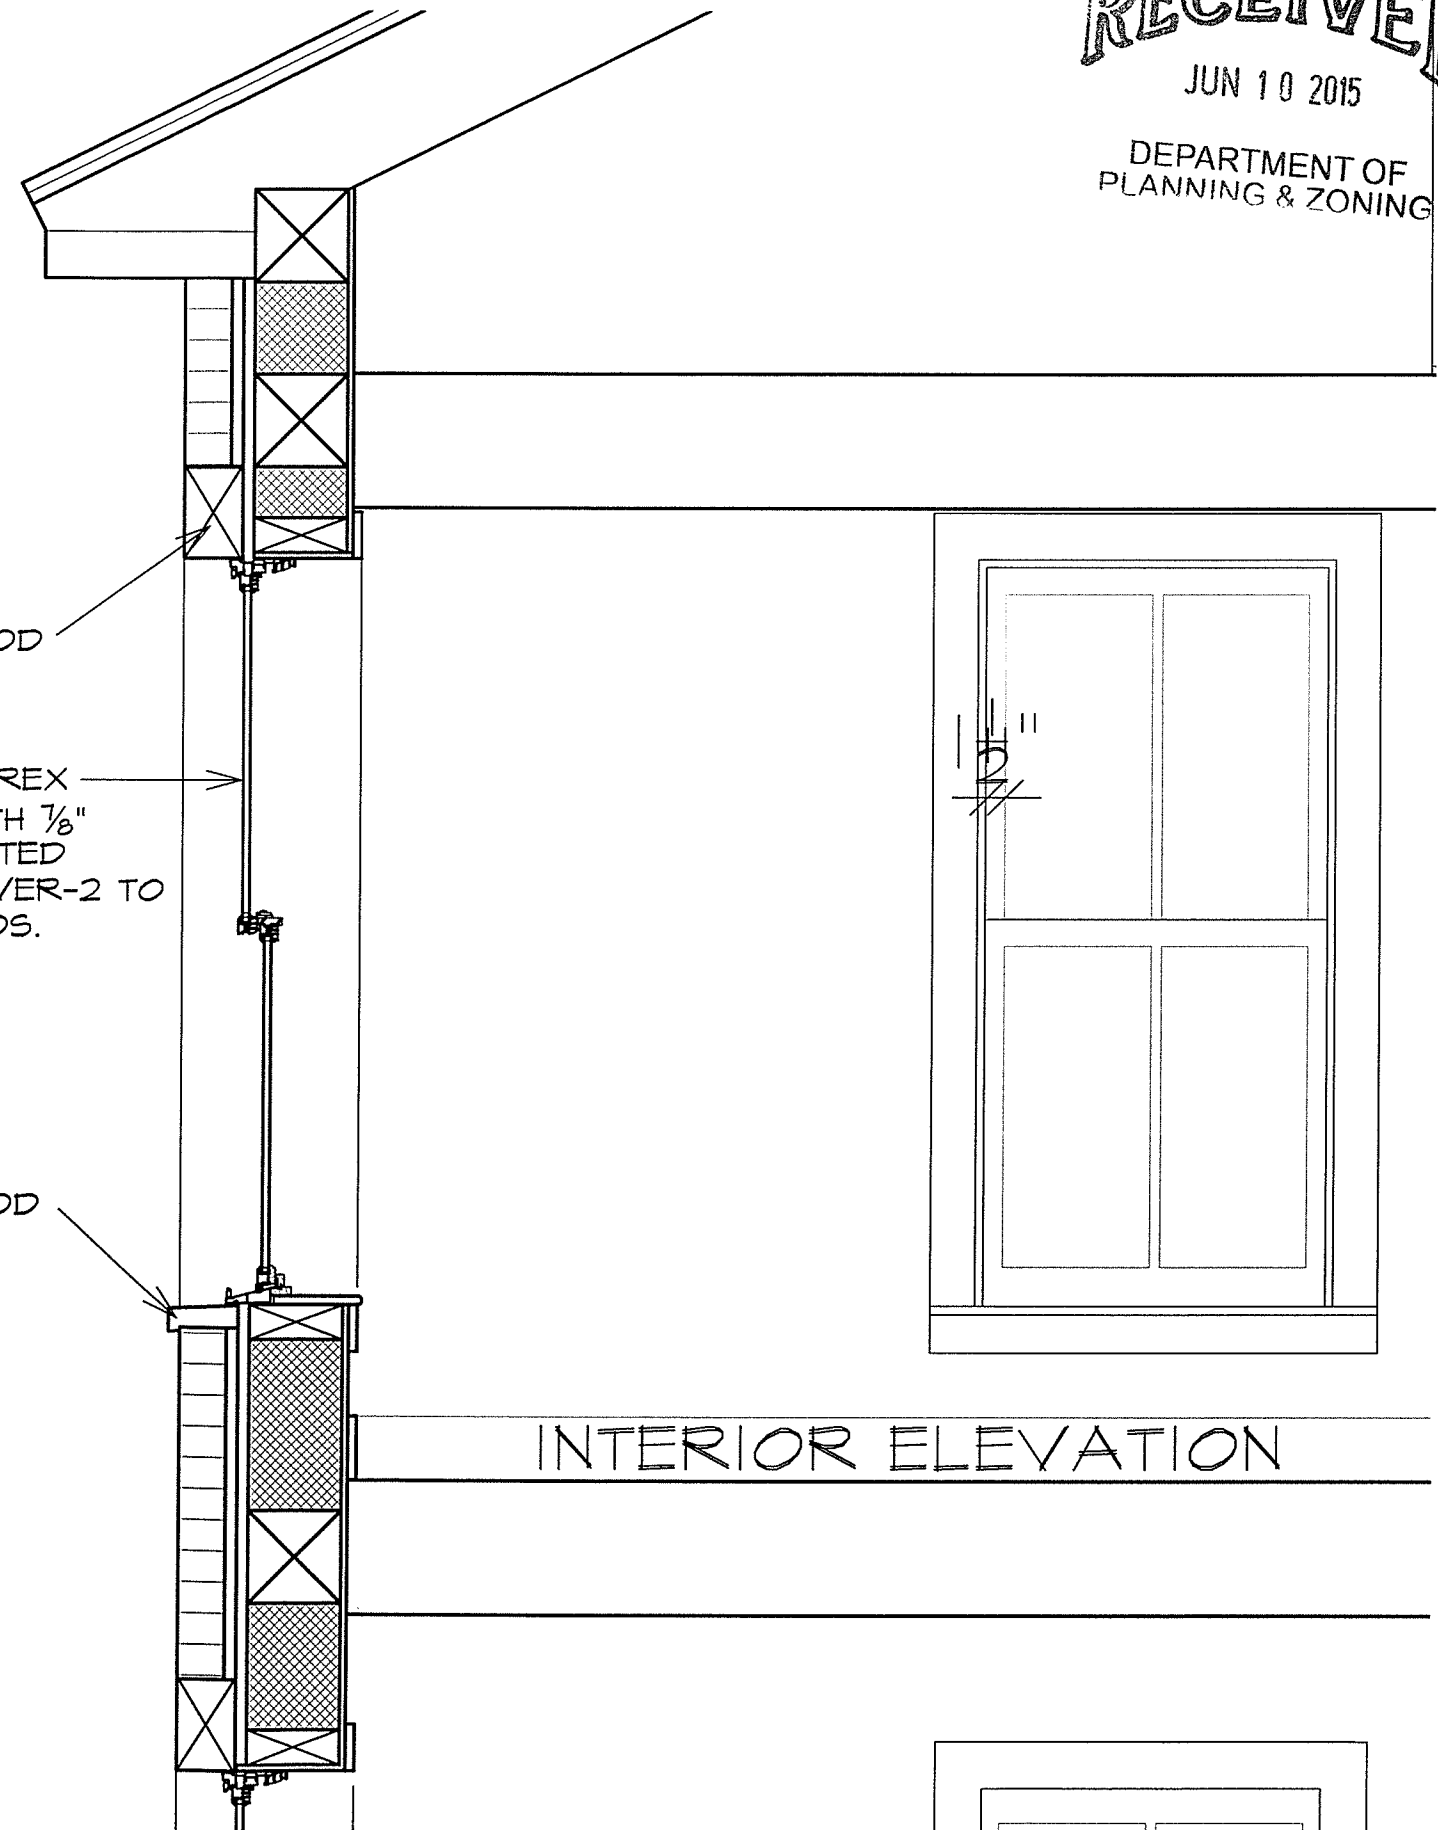
## EXTERIOR ELEVATION AT UPPER TWO LEVELS

NOTE: REFER TO EXTERIOR ELEVATIONS FOR WINDOW PATTERNS AT GROUND FLOOR LEVEL. DETAIL OF JAMBS, HEADS AND MUNTINS MATCH THESE SHOWN AT UPPER TWO FLOORS. EXTERIOR FINISHES ARE 6" THICK GRANITE STONE AT GROUND FLOOR LEVEL INSTEAD OF BRICK SHOWN HERE.

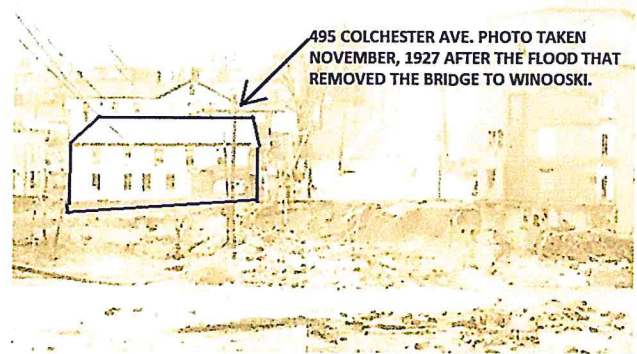
*Historic Photo (1927) showing building before it was buried*
