### DESIGN ADVISORY BOARD Tuesday, June 23, 2015 at 3:00 PM Conference Room 12, City Hall, Burlington, VT

- 2. 15-1314CA; 495 Colchester Ave., (Neighborhood Mixed Use, Ward 1), Brisson Properties**  
Raise buildings repair and restore exterior, remove porch. Add one floor of living space. Associated site improvements.

PROJECT: 495 COLCHESTER AVE. RESTORATION  
BRISSON PROPERTIES  
JOB No. 14-03

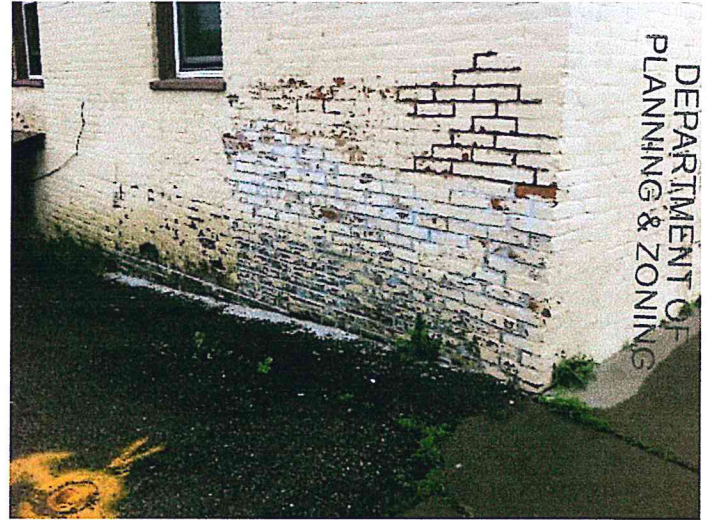
The upper two floors are constructed of brick veneer just one wythe thick, supported on a heavy-timber frame similar to the other mill buildings in the area. When the building was buried, a concrete retaining wall was poured against the brick veneer walls on the north and west sides. This supports the current raised street elevation, but has caused significant damage to the buried brick and wood frame behind it, as seen below in the photo of rising-damp on the west end of the north facade.

*Rising damp damage to bricks at west end of north façade.*

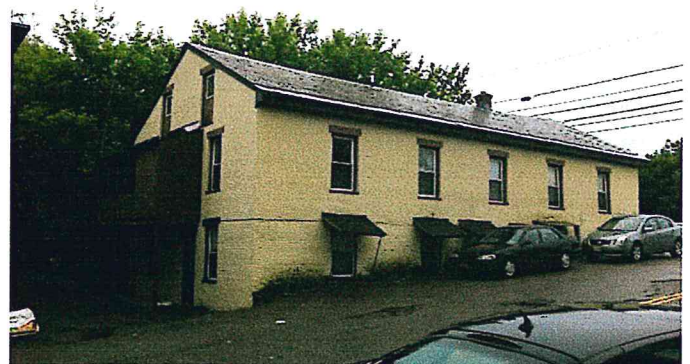
NO SITE WORK is proposed in the R.O.W. except connection to existing utilities lined under Mill Street, and the removal of the four window-wells and the shed roofs over them when the building is lifted. These will not be necessary, nor will they be replaced.

*View of window wells and shed roofs over them we want to remove.*

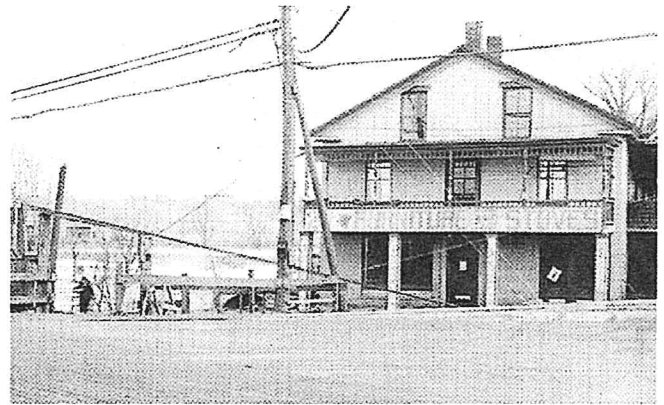
1. Although we originally proposed rebuilding the historic west porch, we will not be able to do that unless we were to be given use of seven feet of ROW space against our west façade and the curb was moved out to align with that on the bridge. Vtrans will not allow use of non-transportation functions within the Route 7 ROW. After discussion with Laura Wheelock at the Burlington Public Works Department and Scott Gurley an historic preservation specialist at Vtrans, it may be possible, but seems unlikely within a year and won't happen without Burlington's support. If the option becomes available, we may file to do this work under a separate permit, but it is no longer part of this proposed project. The restoration of the building, however, including restoration of windows and doors that are now buried, is part of this project.

*Historic photo (1927) showing original porch we are not allowed to rebuild without Vtrans permission. We will restore the façade behind the porch as you see it here.*

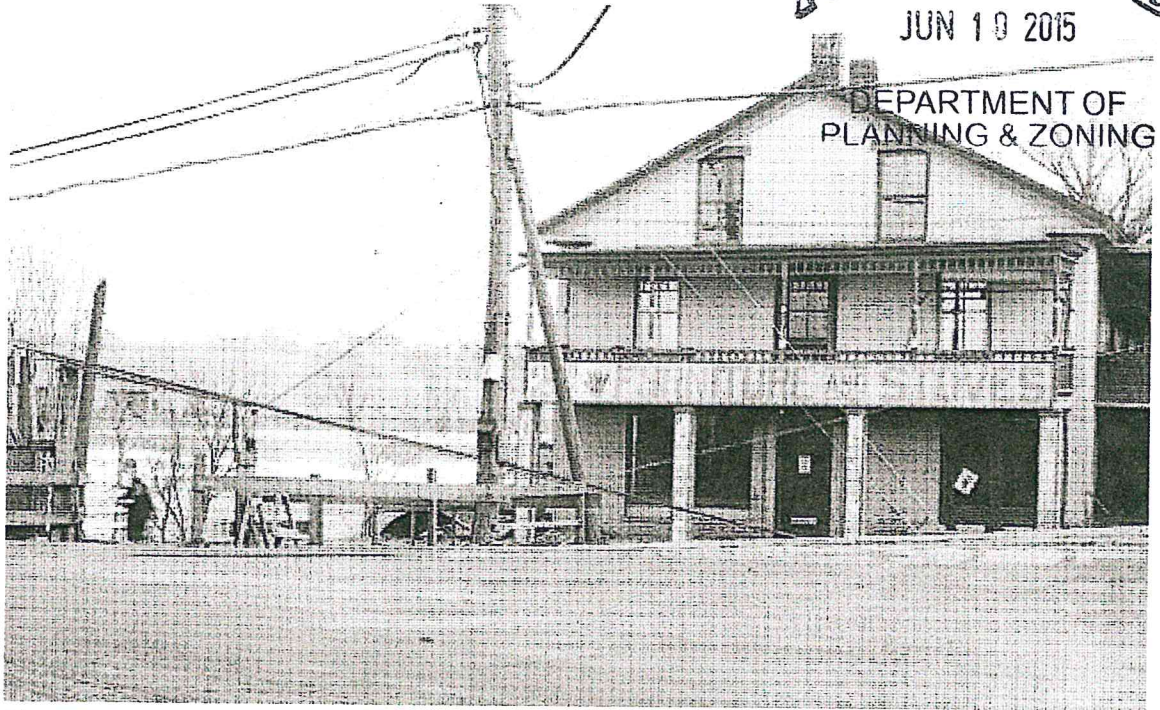
Photo 1. West elevation photo taken 1927, after the flood, but before bridge was rebuilt 9 feet higher.

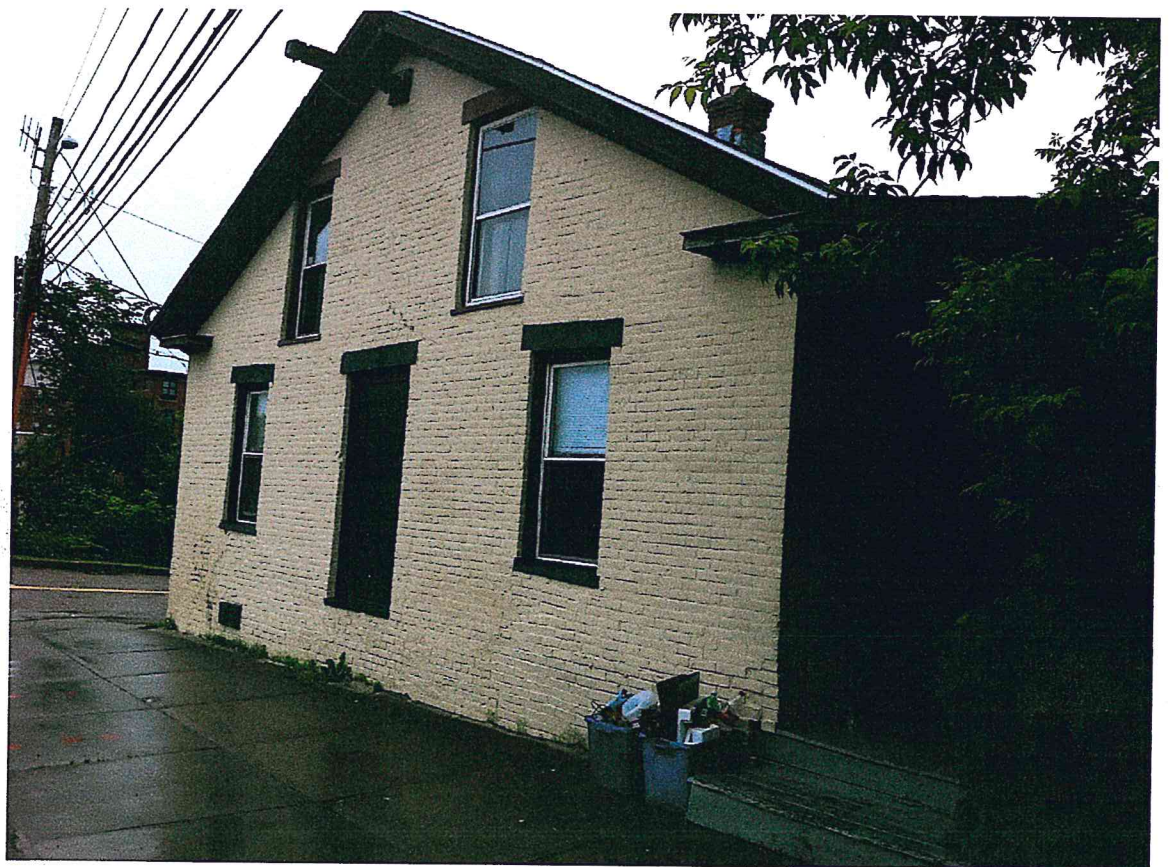
Photo 2. West elevation taken 2014. What is now a blocked in doorway just above the sidewalk used to be a door to the second floor porch seen in Photo 1. The porch was removed when the building was buried. Windows have been replaced with 1-over-1 windows, instead of the original 2-over-2 windows seen in the historic photograph.

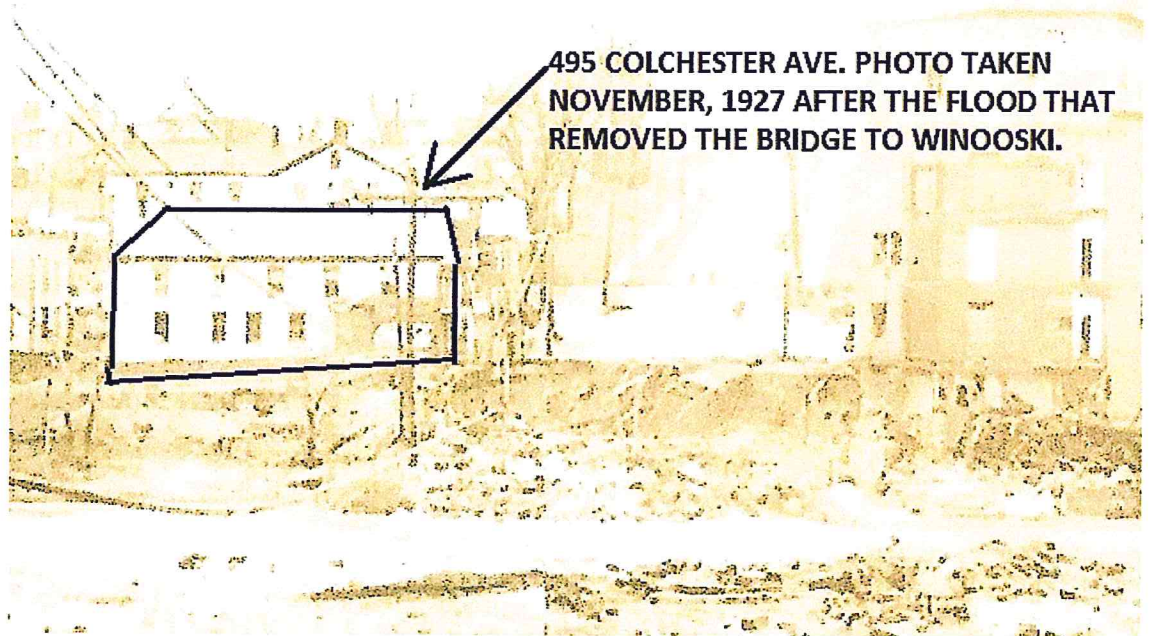
Photo 3. North elevation photo taken 1927, after the flood, but before bridge was rebuilt 9 feet higher. Dark outline is the building of this application. Note the stone foundation wall and windows visible at the Cellar level, and four windows to the left side of the loading doors.

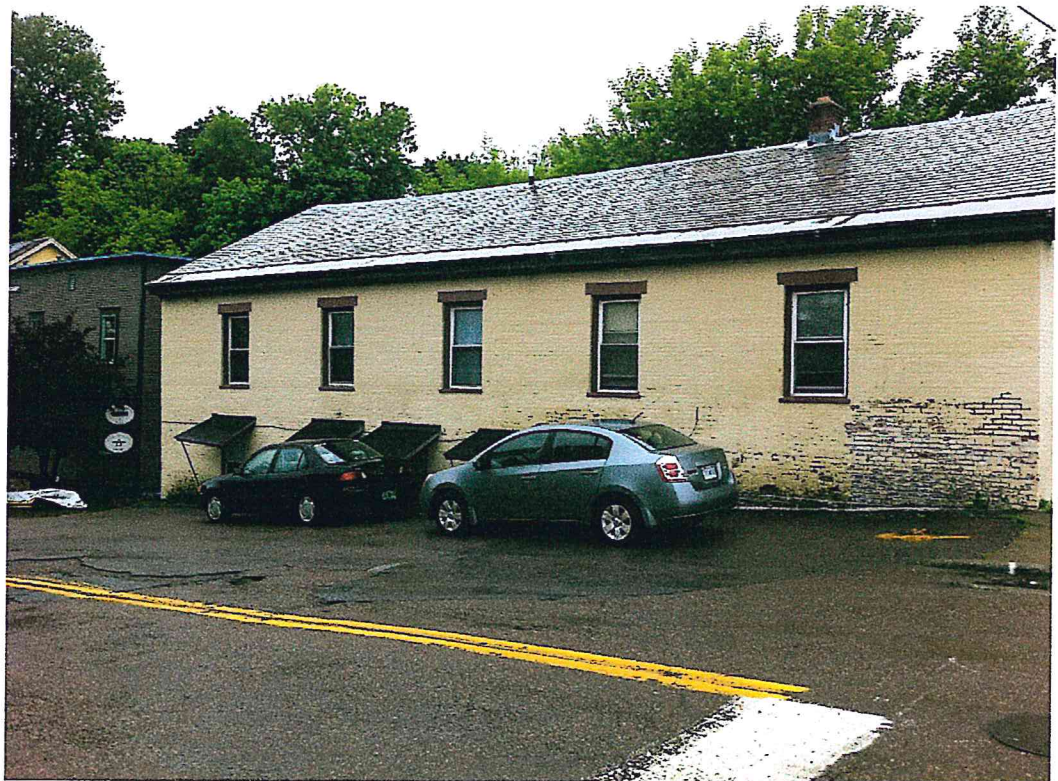
Photo 4. North elevation photo taken 2014.

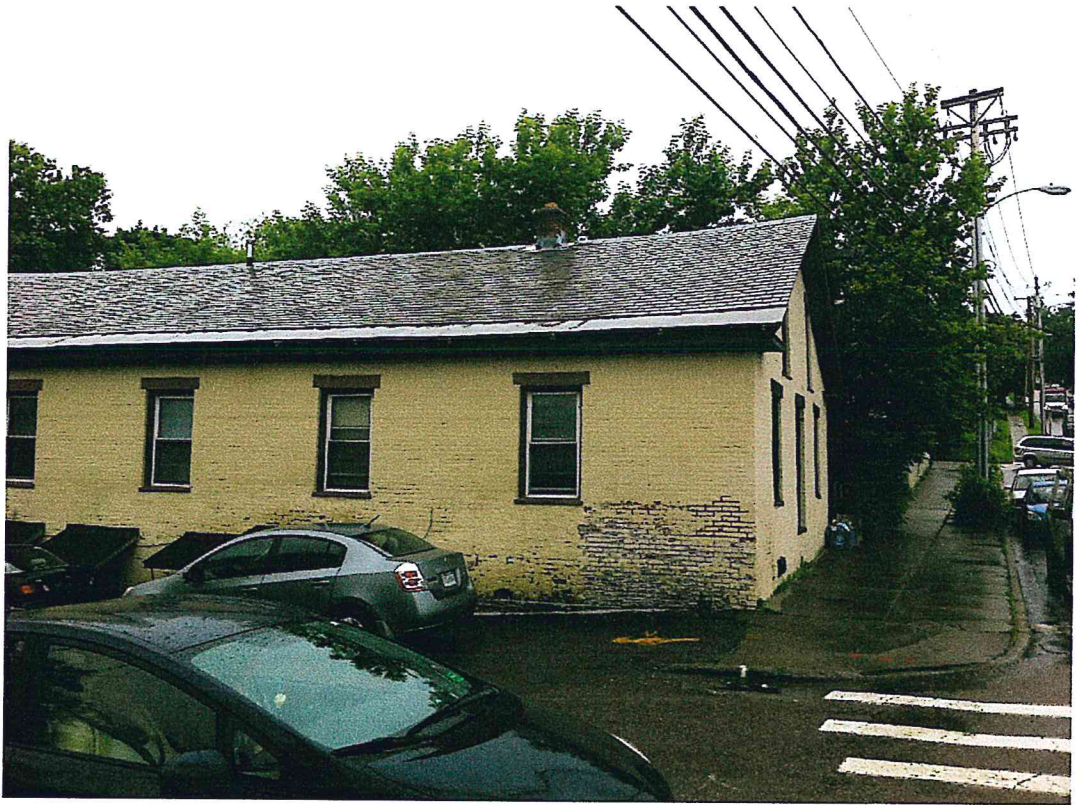
Photo 5. North elevation photo taken 2014. Note evidence of rising damp on the bricks at the west end of the north elevation, caused by the building being buried.

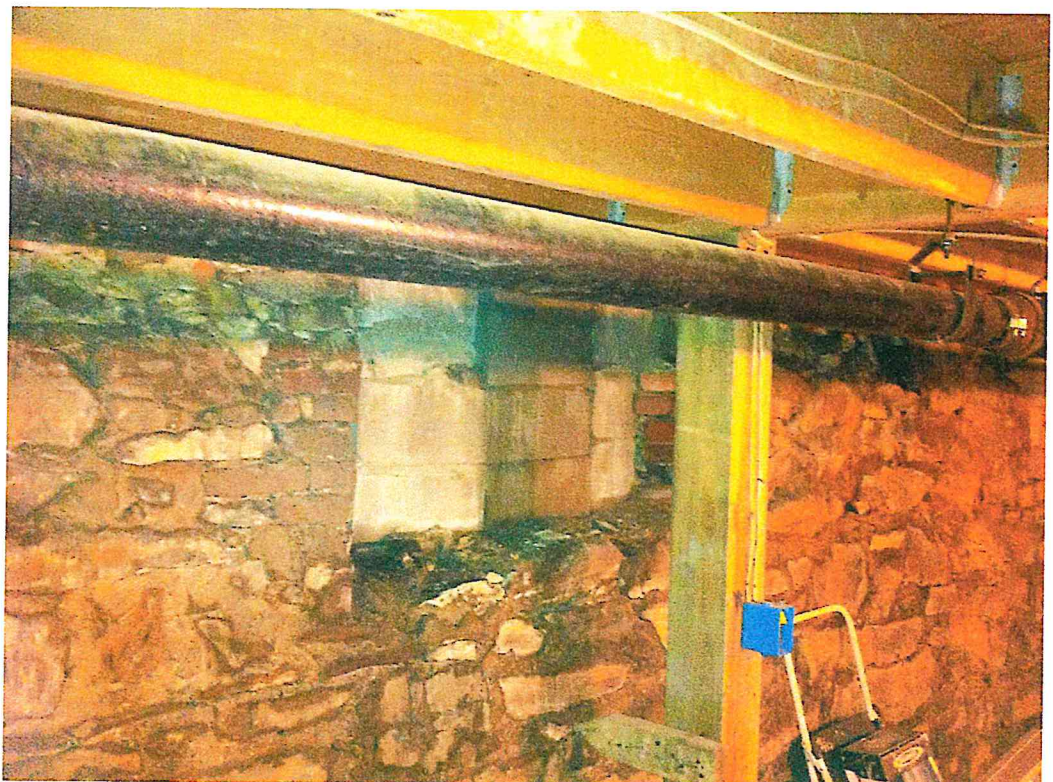
Photo 6. Interior of north wall of cellar showing original stone foundation. Former above ground windows have been filled in. The floor structure supporting the first floor is not original and will be replaced with mill construction techniques matching extant framing of the floors above. Stone walls will remain exposed in the adaptation of this level into a Café.

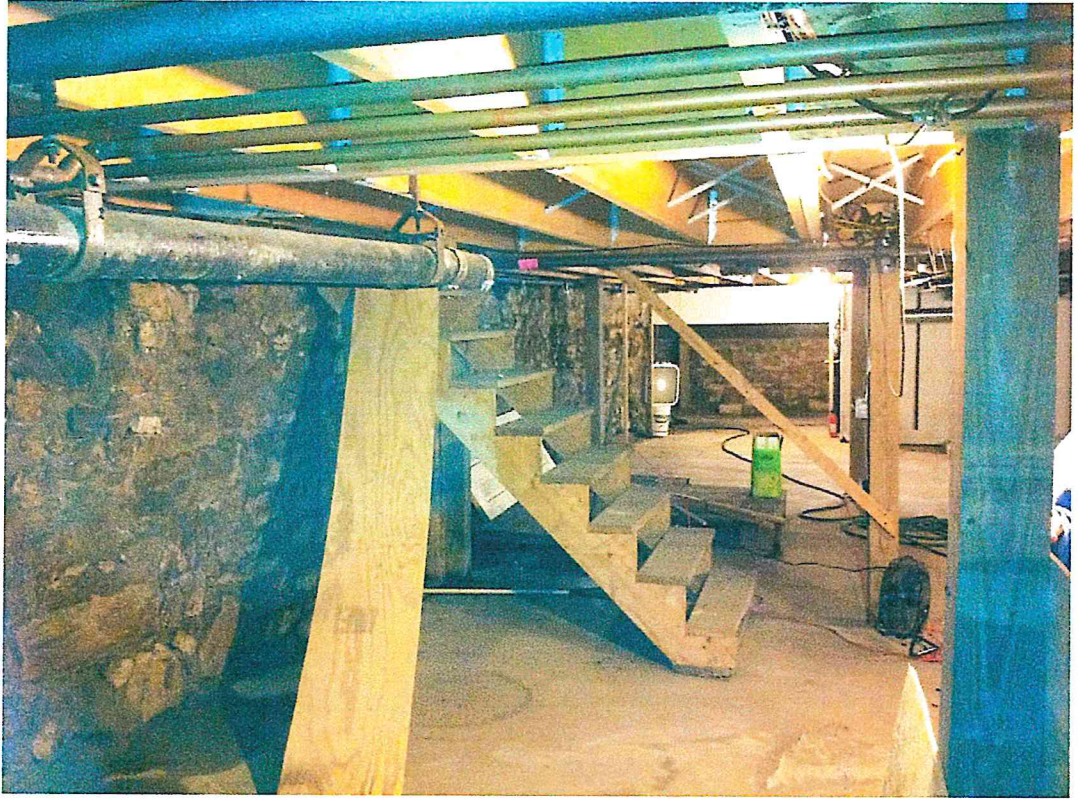
Photo 7. Existing south wall of cellar. Structure of First Floor above is modern, made of 2x10 joists and 6x6 posts spaced 12' apart.

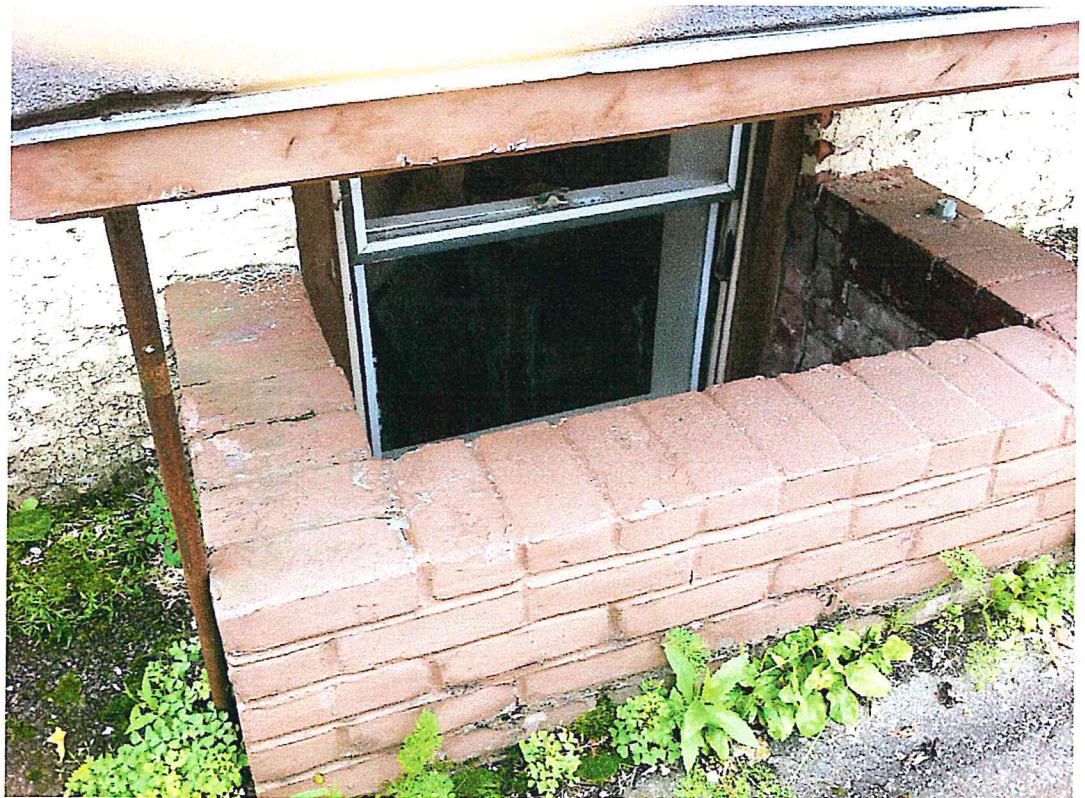
Photo 8. The first floor windows are now mostly buried. The north windows have these little window wells put in to offer some protection from snow and rain. Rooms inside are dark and gloomy. The Cellar is a full floor below the floor these windows are on.

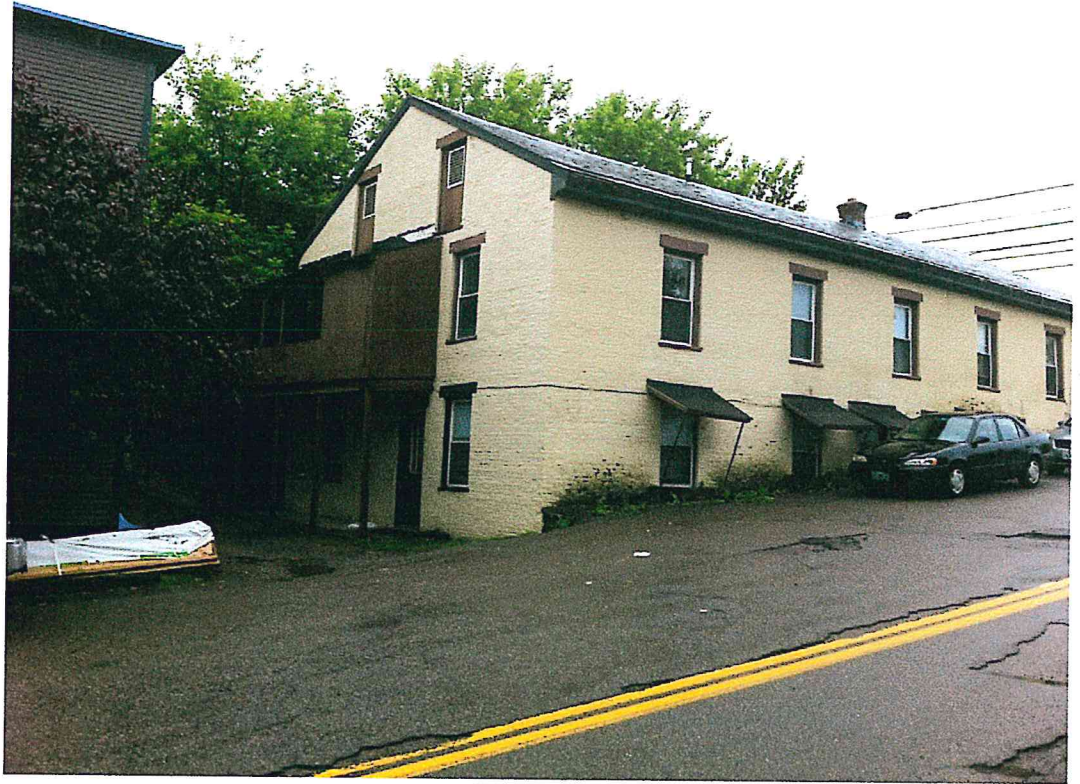
Photo 9. The first floor apartments are currently at grade level on the east end of the building shown here. The apartment door is not original and was cut into the brick façade. Originally this floor was about 9 feet above grade with the cellar having an on-grade access at this end of the building.

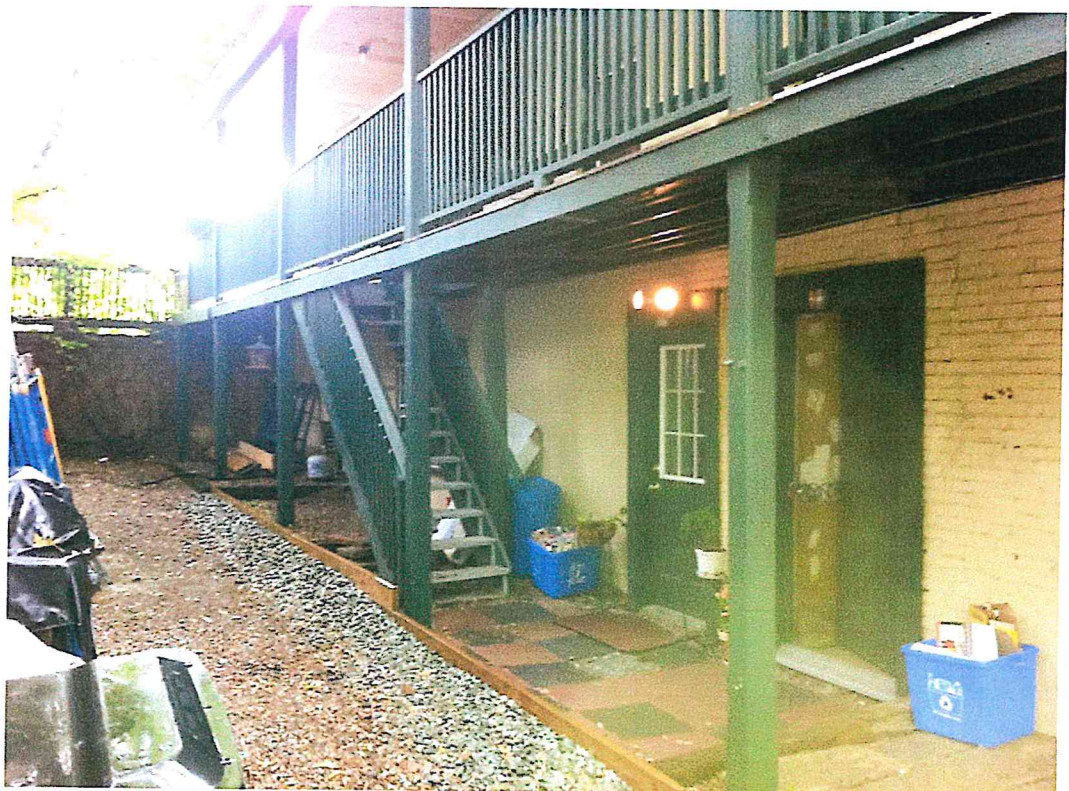
Photo 10. On the south side, a courtyard was cut in to allow access to the first floor apartments. The door on the left leads to one of the apartments. The door on the right leads to the cellar. The side porch was not part of the building prior to the flood.

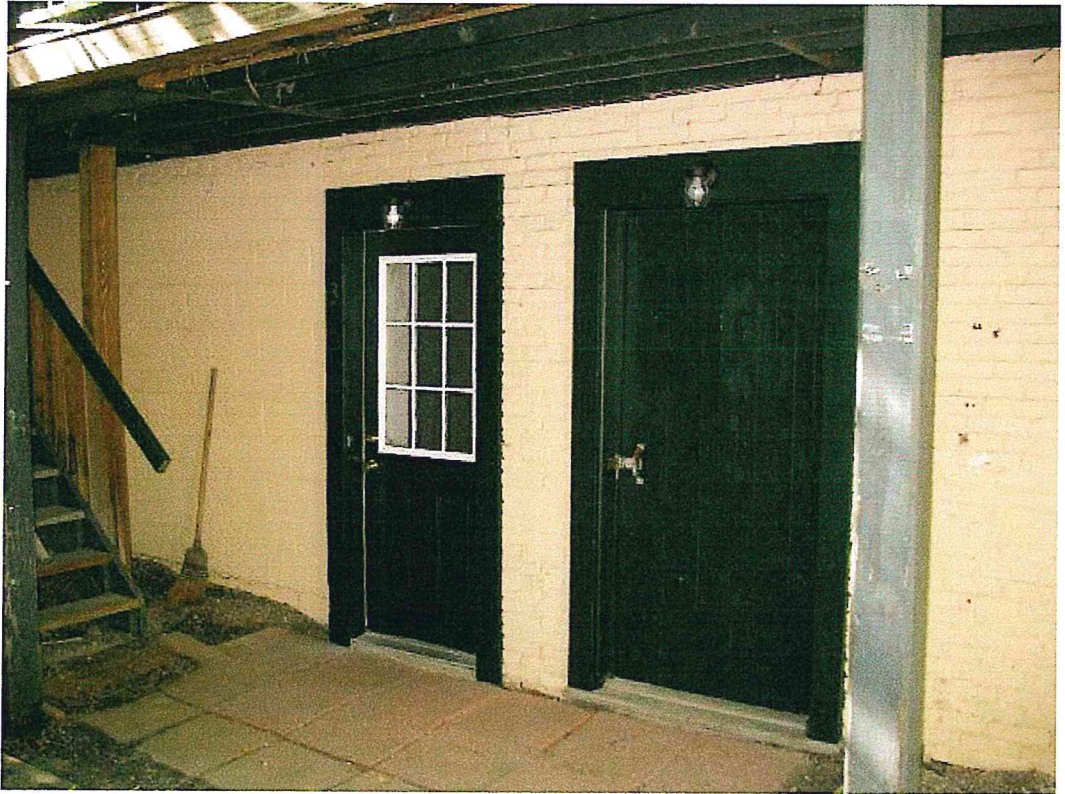
Photo 11. On the south side, the wall east of the first floor apartment past the door with the light in it, was rebuilt in concrete block. We assume that the brick veneer failed at some point and was replaced with concrete block. The renovations will replace this concrete block with brick veneer to match the original brick veneer conditions.

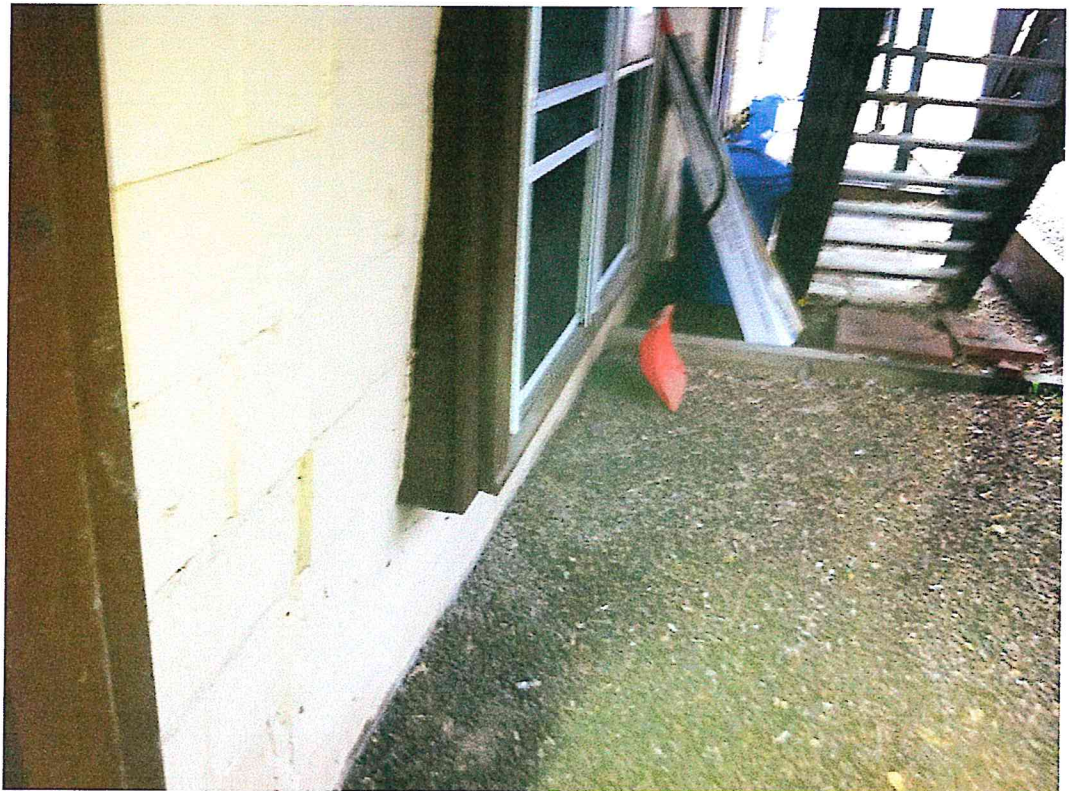
Photo 12. Part of the original south wall was replaced with concrete block. The wall has begun to lean out at the top; the boxed out windows are vertical.

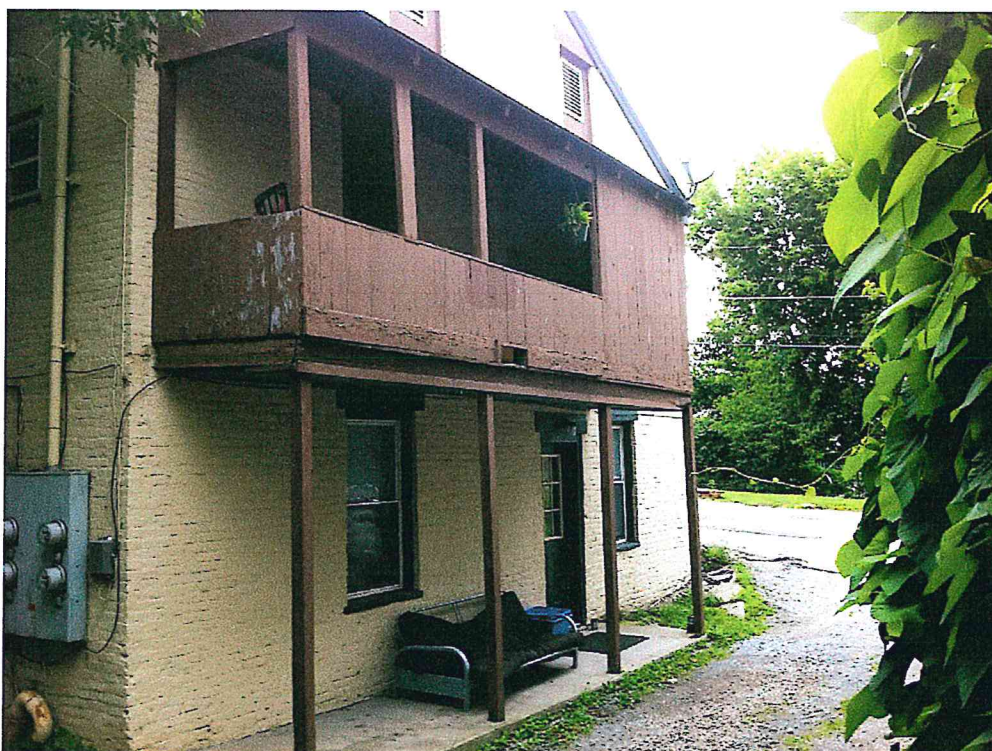
Photo 13. Exterior porch, east side was first built in 1916 and remodeled later to its present condition shown here. The door at the upper level replaced a former window from the 1820 design. The lower door was put in after 1929, as the first floor was well above the ground floor on the east side.

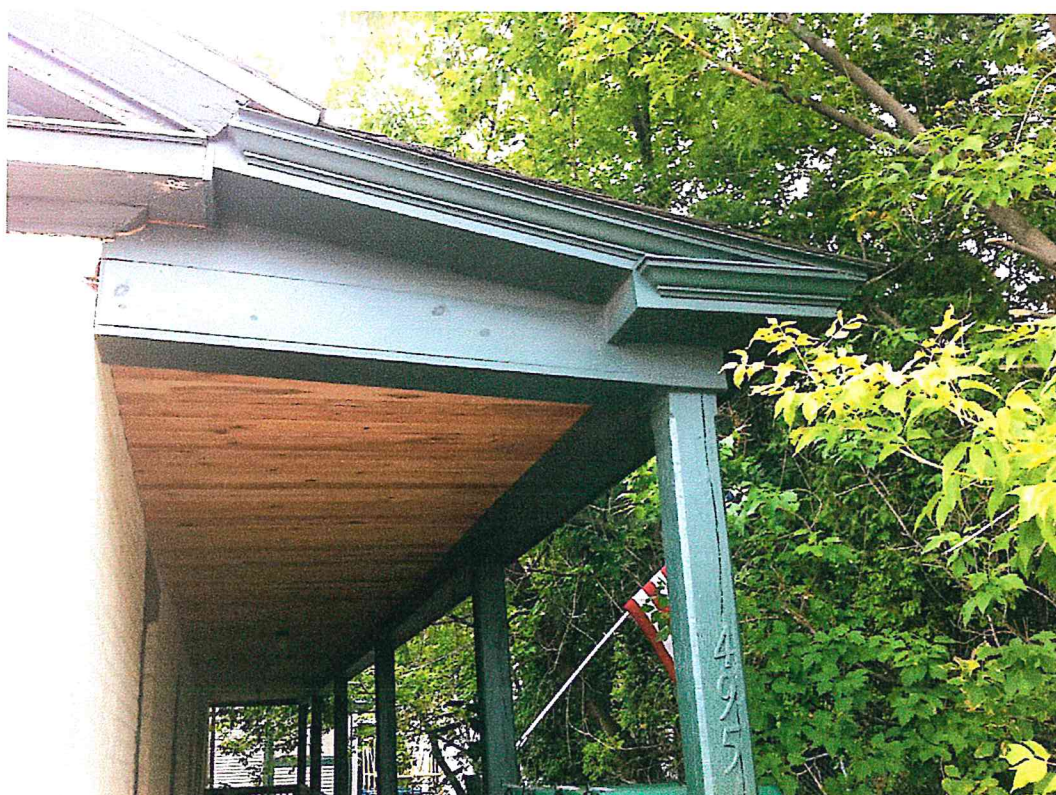
Photo 14. Replaced south side porch. Original south side porch seen in PHOTO 1, does not come all the way to the west façade as this one does. The ceiling of the porch seen here is fairly new.

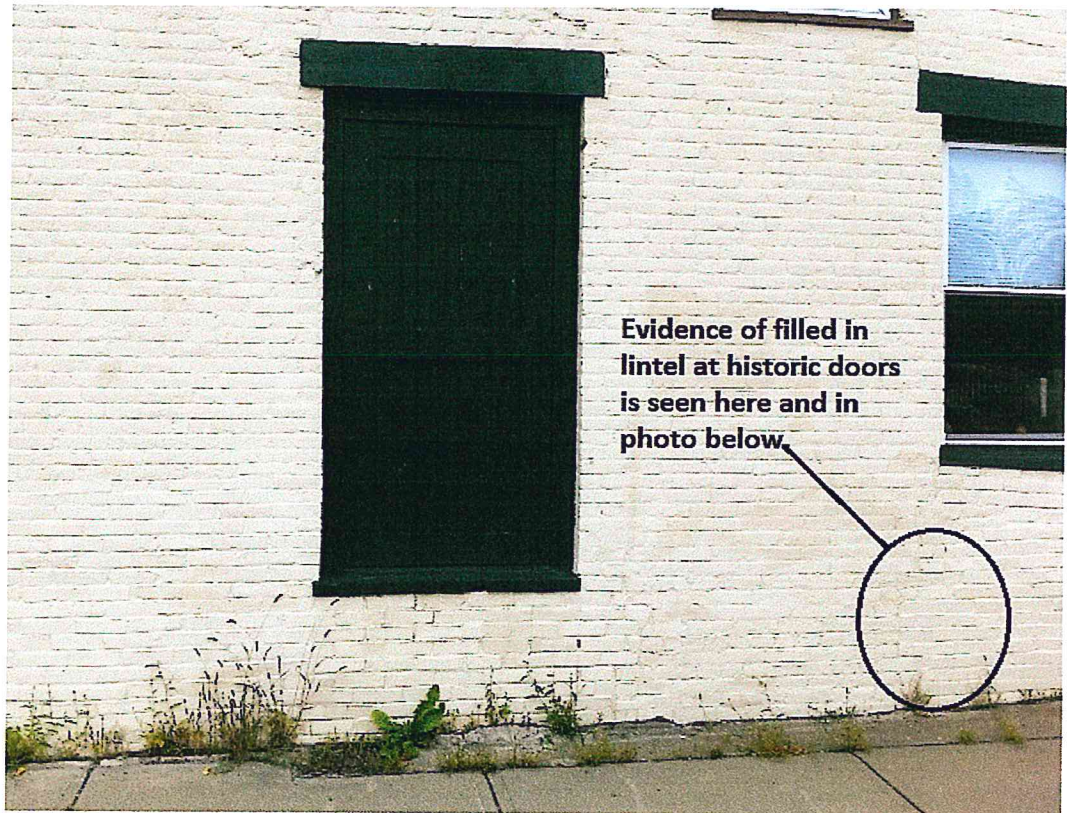
Photo 15. Evidence of where shop doors were filled in with brick. This is the lintel location.

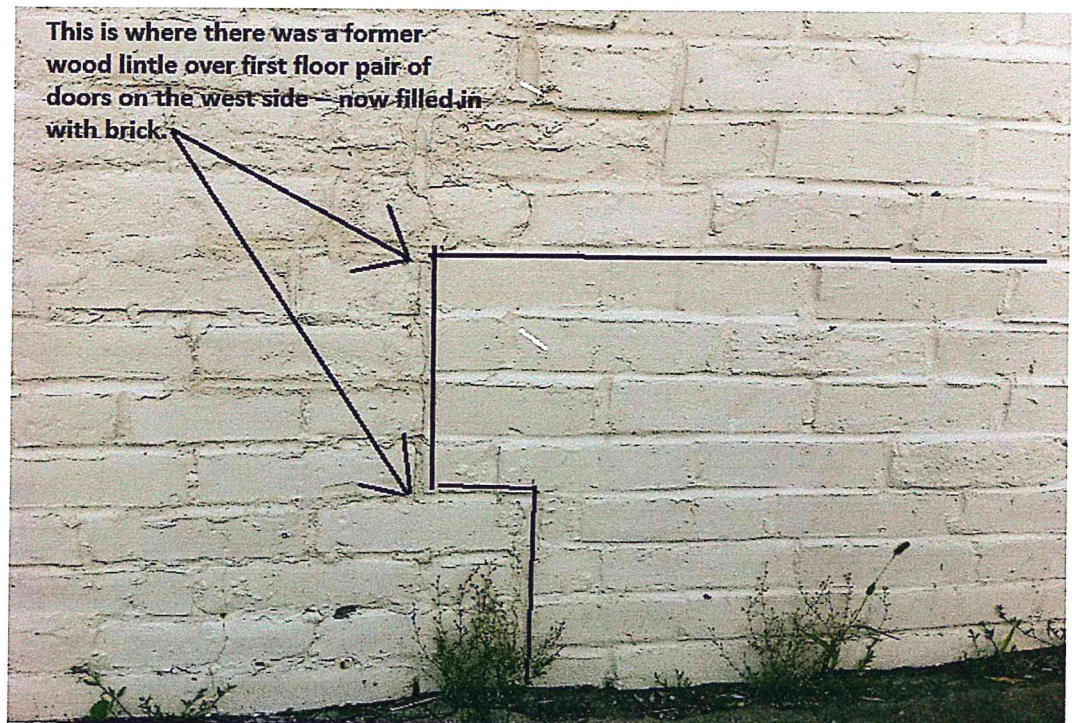
Photo 16. Evidence of where shop doors were filled in with brick. This is the lintel location. Note the difference in joint detail and brick face texture.

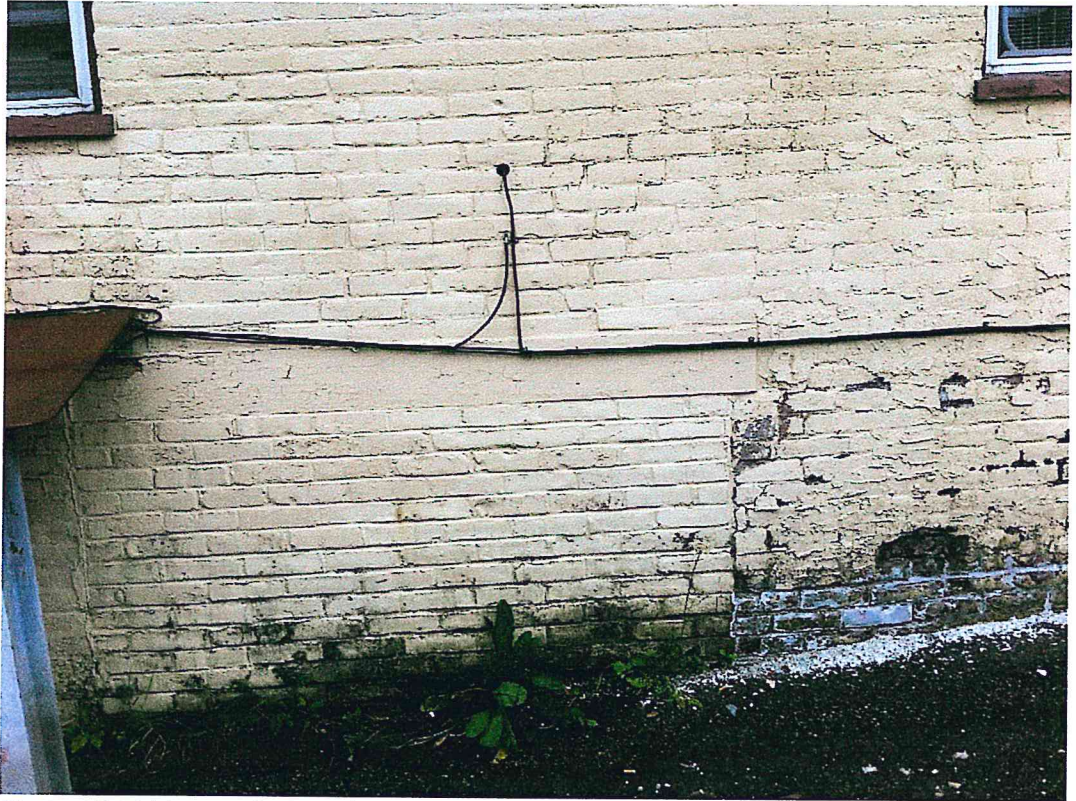
Photo 17. Evidence of where loading dock doors were filled in with brick on the north elevation. The painted wood lintel remains. Note damage from rising damp to the right of the blocked opening. The black lines are cable TV cables.

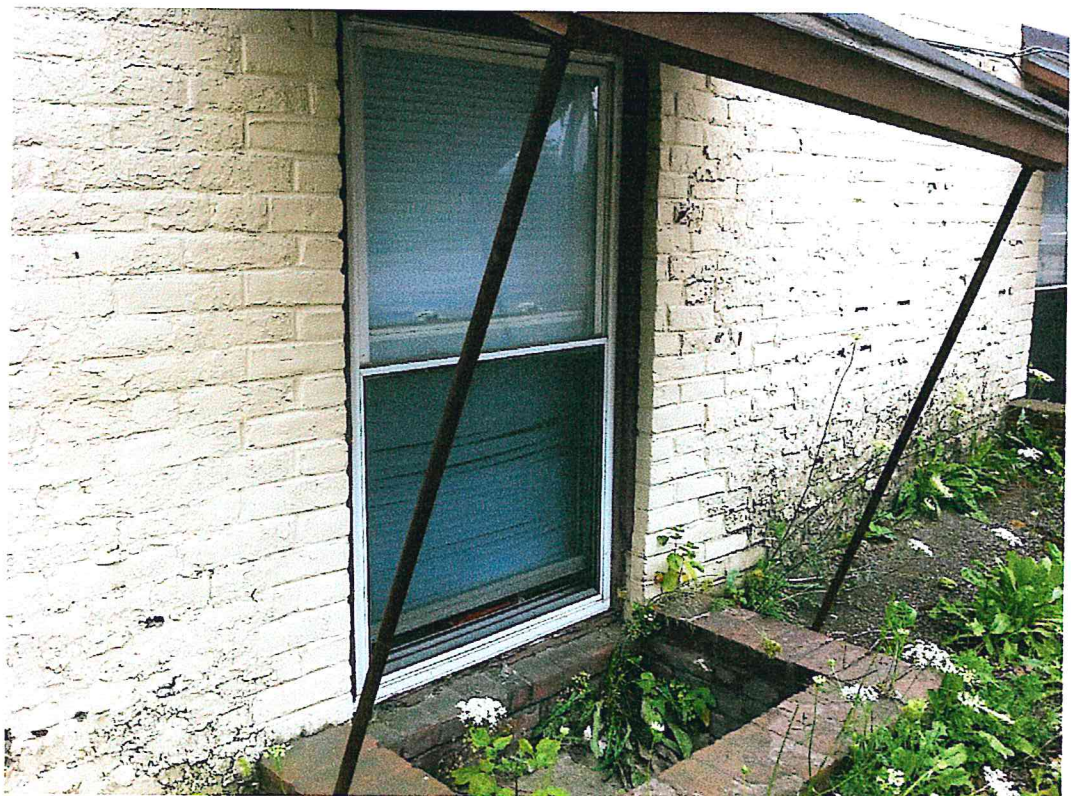
Photo 18. North side windows are buried to various depths. They have more exposure the closer they are to the east side of the building. None of the windows are the original 2-over-2 pattern seen in historic PHOTO 3.

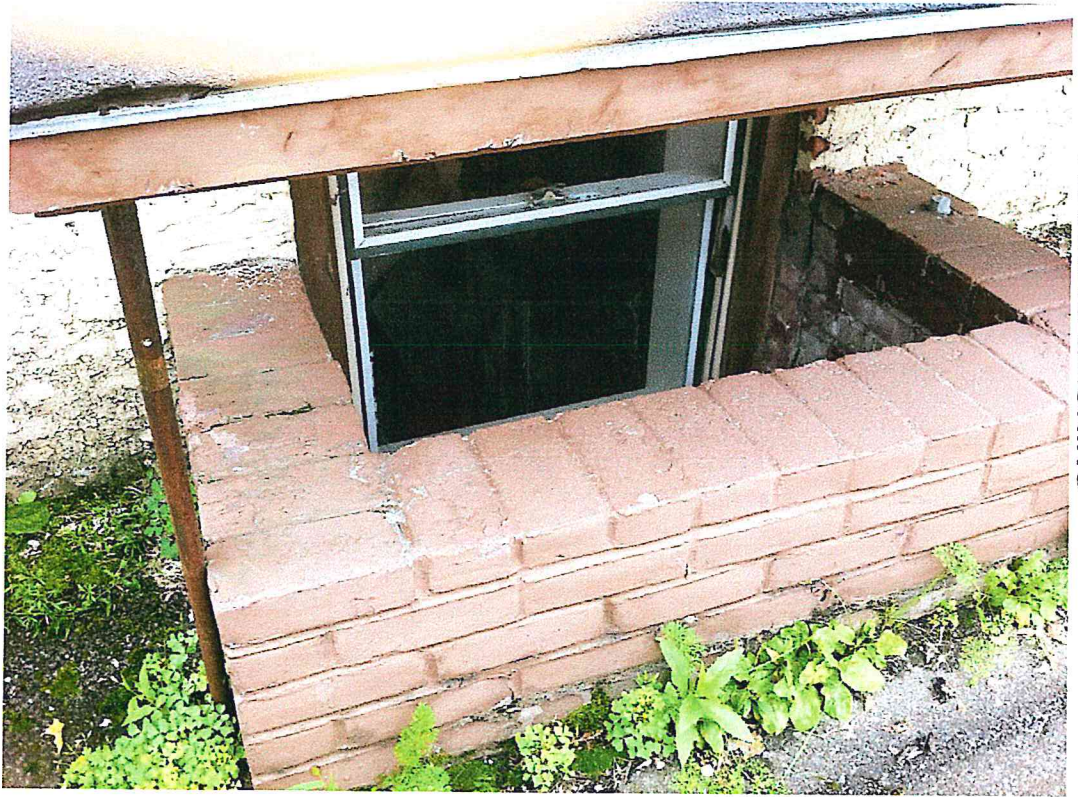
Photo 19. North side first floor windows on the west are buried more than those toward the east due to the slope of the street in front of the windows. The brick window wells were built when the building was buried in 1928.

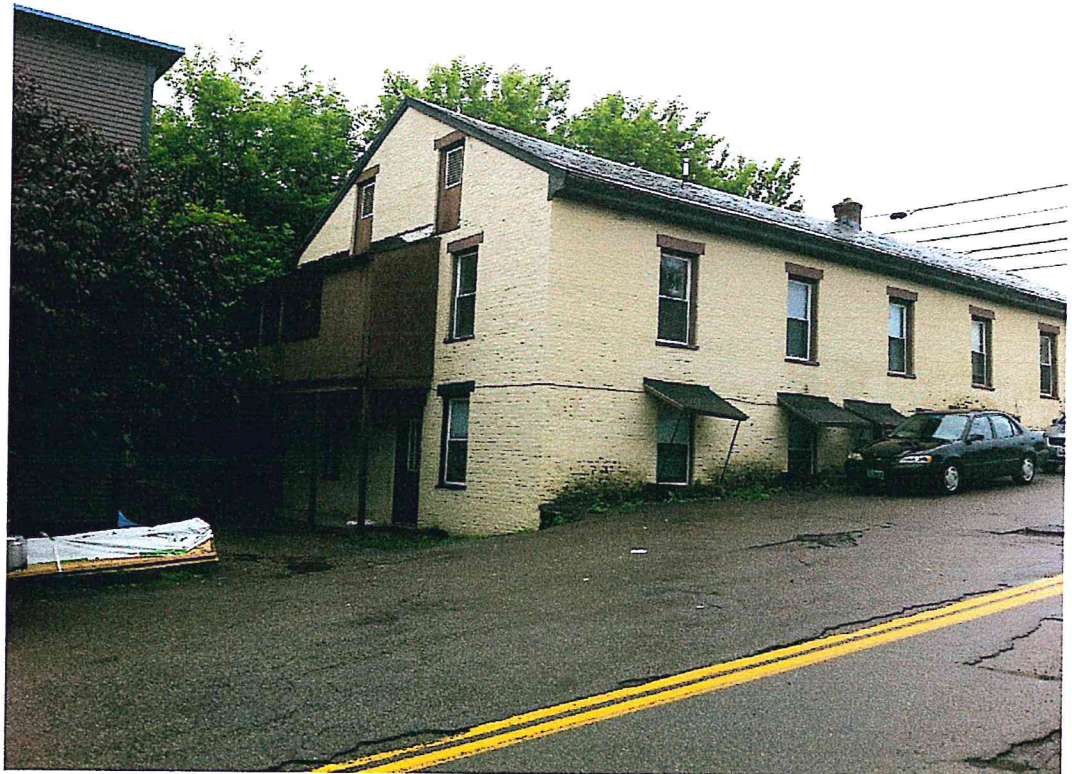
Photo 20. East and North elevation showing location of first and second floor doors and windows. The door just to the left of the window on the east elevation is not original and was cut in to access the apartment at the east end of the first floor in 1928.

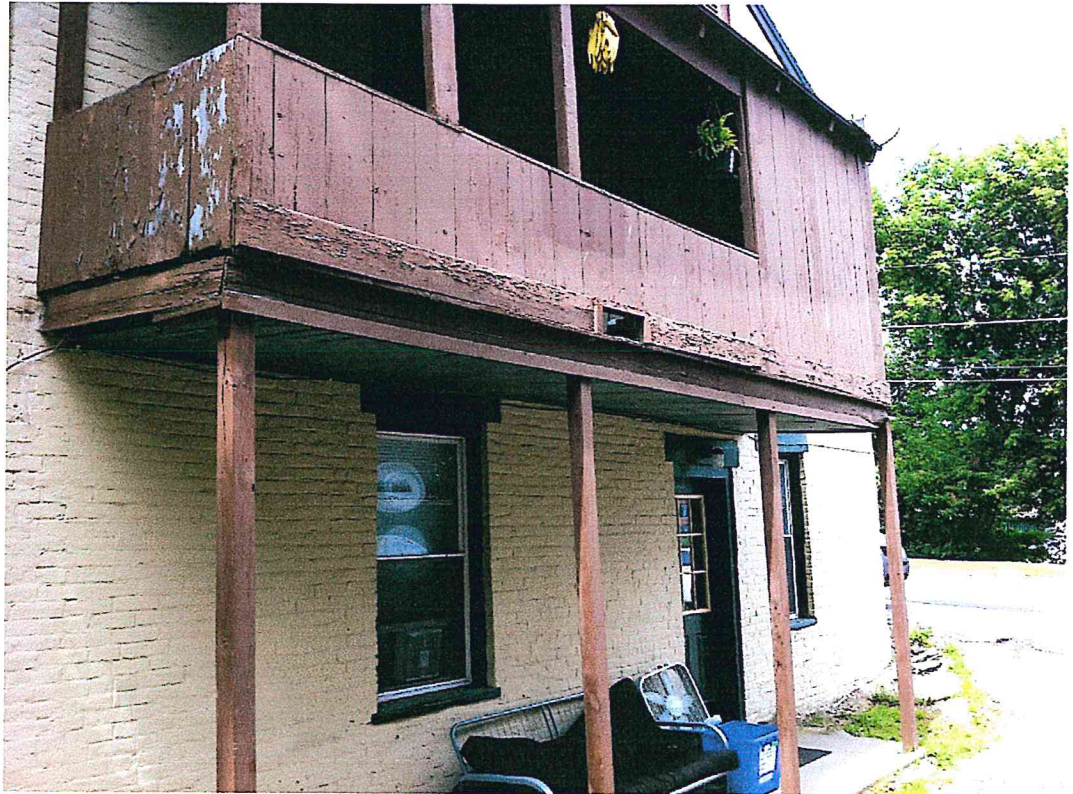
Photo 21. East side showing added porch and door cut in to access the apartment at the east end of the first floor in 1928. The porch was built after 1928.

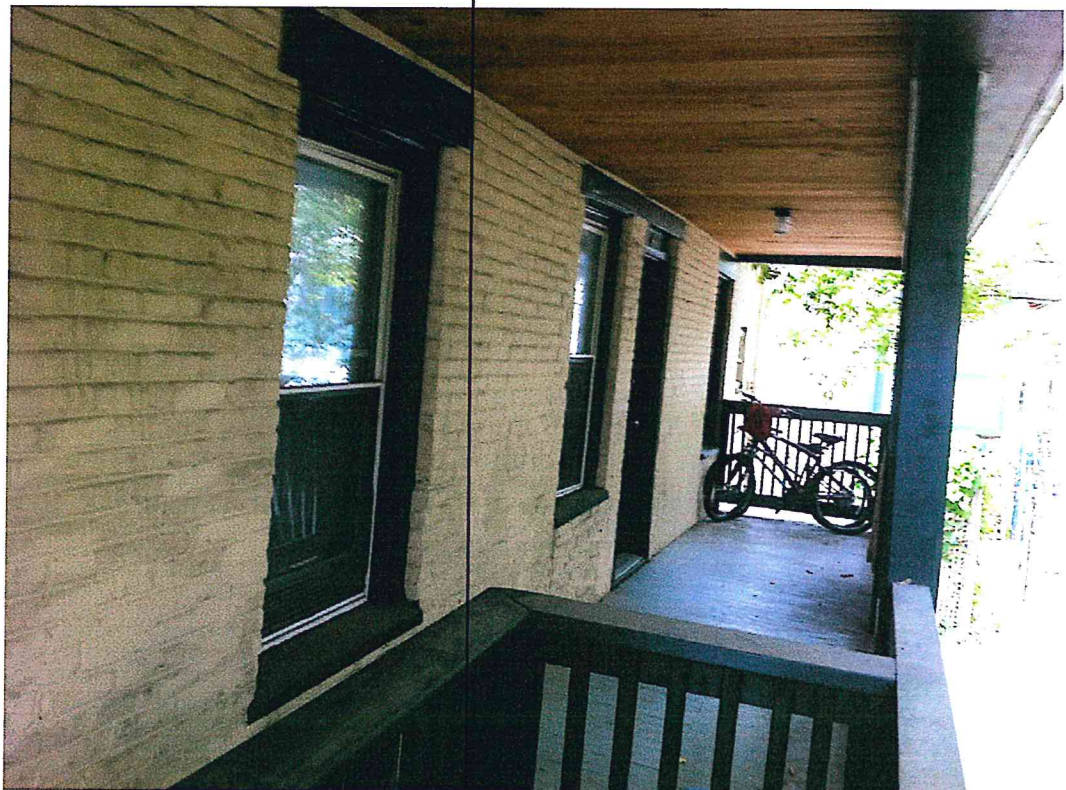
Photo 22. South side at Second Floor of south porch. Windows and doors are at original location with original solid wood headers and sills. Sash and doors are not original.

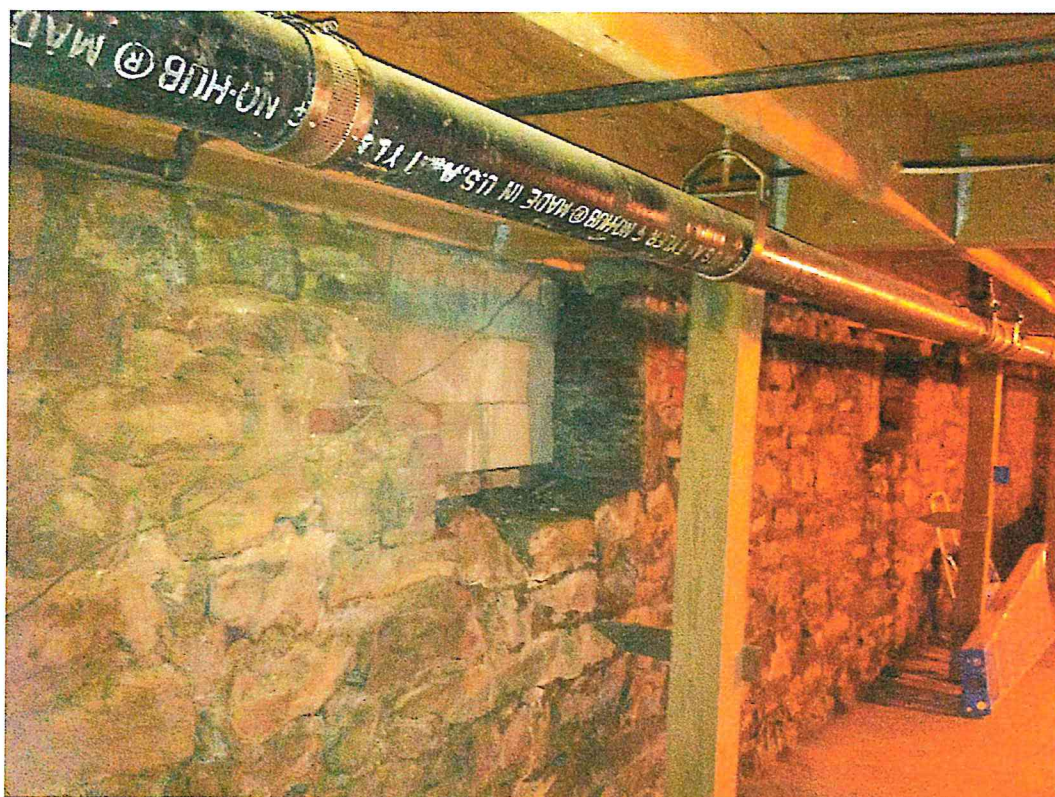
Photo 23. North wall of cellar, showing infill of windows buried in 1928. Locations of these windows will be duplicated in the new Ground Floor walls that will be inserted between these existing walls that will remain and the raised walls of the first and second floors.

New concrete walls exterior walls made of insulated concrete forms will be built between the lifted building and the original stone foundation. The exterior of these wall will be faced with 6" -7" thick granite stones similar in size and texture to the existing foundation stones. These new stones will be placed under and support the existing brick veneer to match the original orientation of brick above stone. The interior of the concrete walls will be plastered, so they are not confused with the original foundation stones the will remain visible in the Café's lower floor. As envisioned now, the café would be on parts of both of the interconnected two lowest floors: the inserted, rebuilt ground floor and the rebuilt cellar floor set about 1' lower than it is now in order to gain sufficient head room.
