### DESIGN ADVISORY BOARD Tuesday, June 23, 2015 at 3:00 PM Conference Room 12, City Hall, Burlington, VT

- 2. 15-1314CA; 495 Colchester Ave., (Neighborhood Mixed Use, Ward 1), Brisson Properties**  
Raise buildings repair and restore exterior, remove porch. Add one floor of living space. Associated site improvements.

PROJECT: 495 COLCHESTER AVE. RESTORATION  
BRISSON PROPERTIES  
JOB No. 14-03

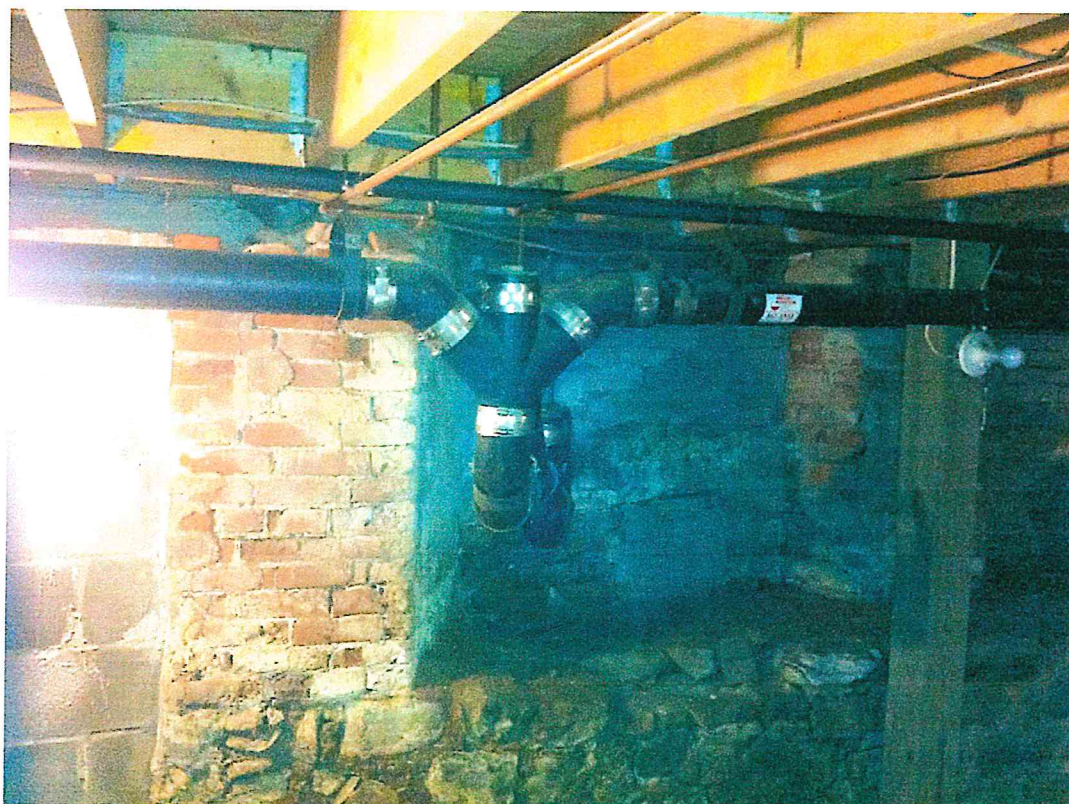
Photo 24. East wall of cellar, showing original on-grade entrance on the left, now blocked with concrete blocks. The pair of windows on the right, provided natural light and display features from the east end, which was fully above grade at this level before 1928. Now sewer lines from the apartments above gather and exit here.

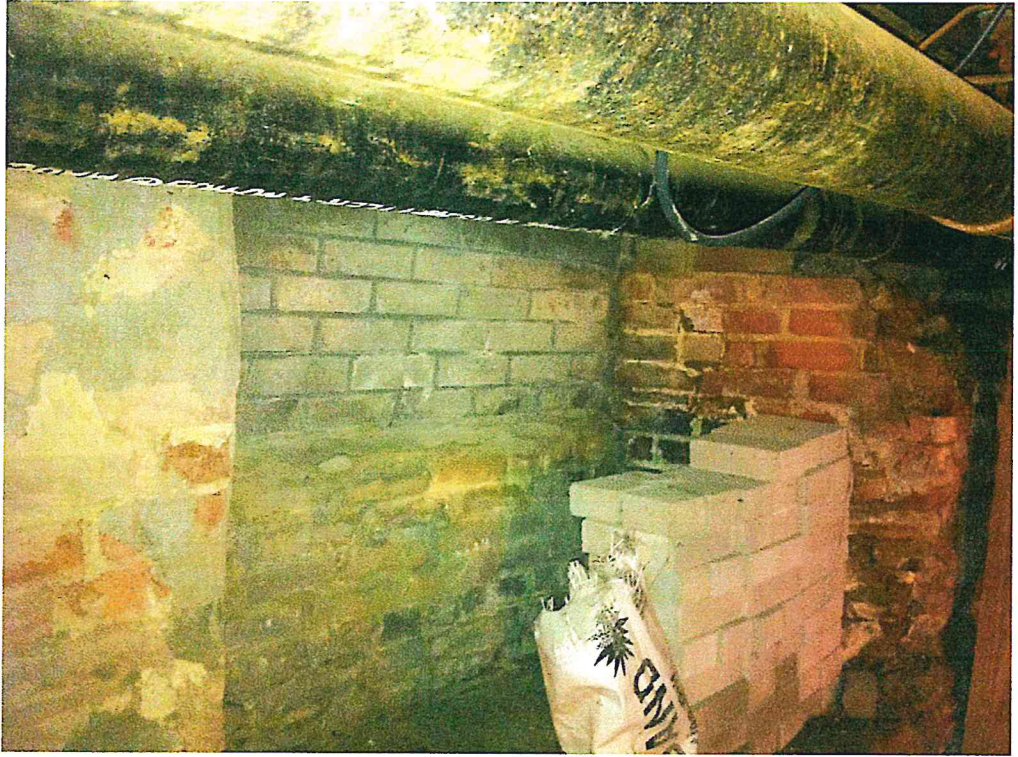
Photo 25. Eastern-most window at the north wall in the Cellar. Original sill was at the top of the remaining stone, which is recessed toward the exterior of the foundation wall. Sewer lines above will be relocated in the renovation to not be parallel to the exterior walls, so as not to block the tops of these windows. Concrete blocks will be plastered over.

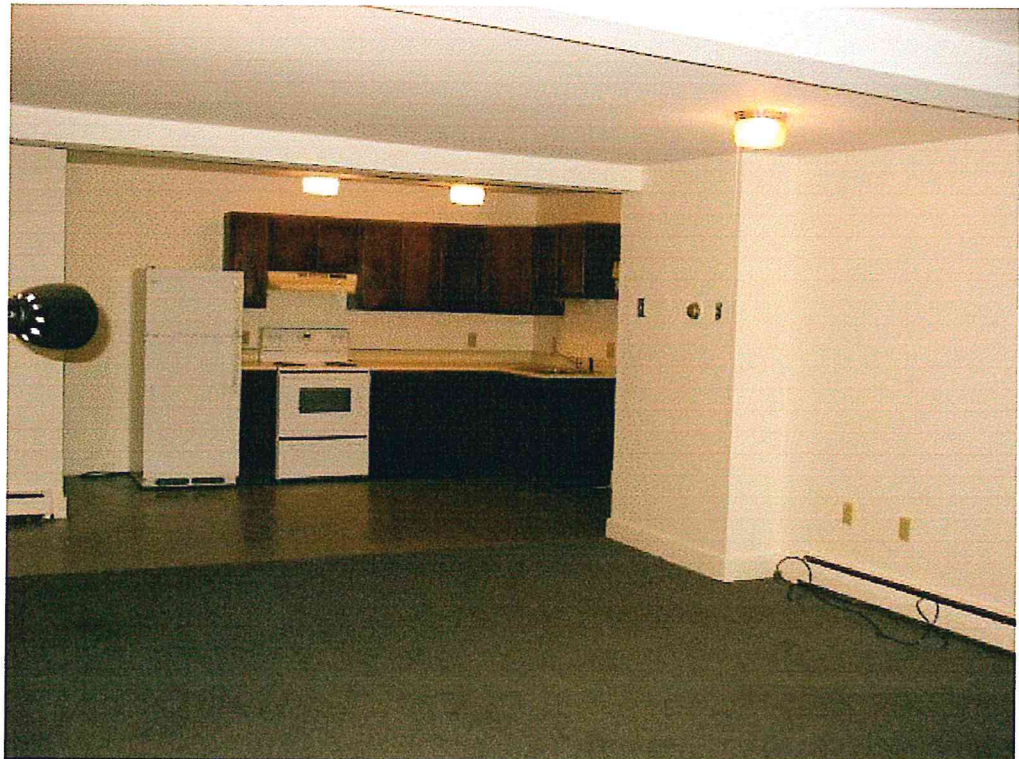
Photo 26. First Floor, west end apartment (#3). The rooms in this mostly buried apartment get almost no natural light. The original beams supporting the second floor are 8x8 wood beams that have been covered in sheetrock. No historic fabric remains at the interior of this level, except for the heavy timber frame made of 8x8 beams that support the second floor and attic floor.

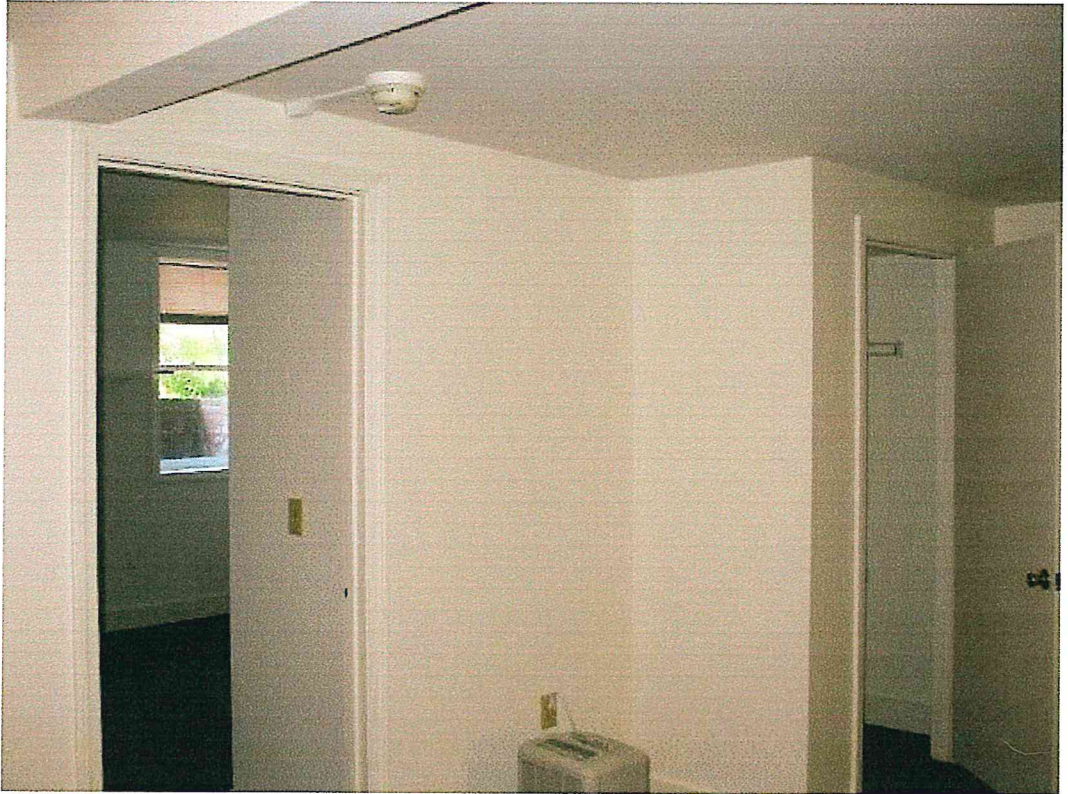
Photo 27. First Floor, west end apartment (#3). Note the mostly buried window visible through one of the two bedrooms in the apartment. One of the historic 8x8 beams (now covered in Sheetrock) is visible in the upper right hand corner.

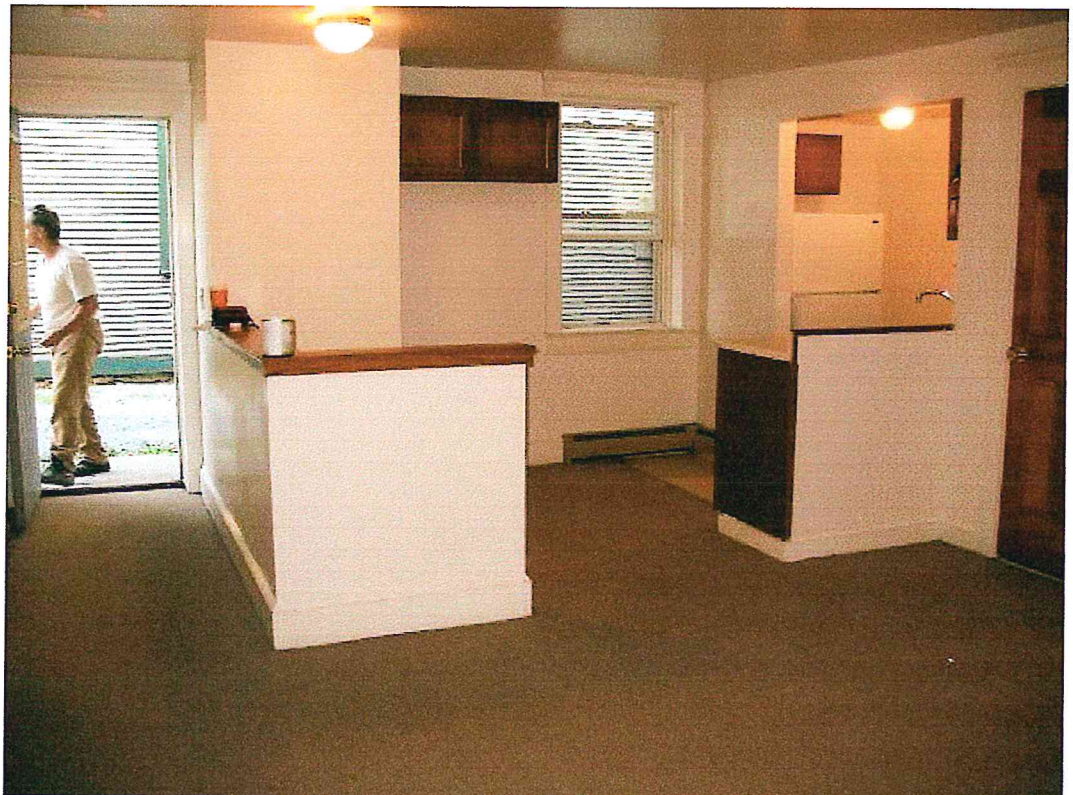
Photo 28. First Floor, east end apartment (#4). This is the brightest part of the apartment.

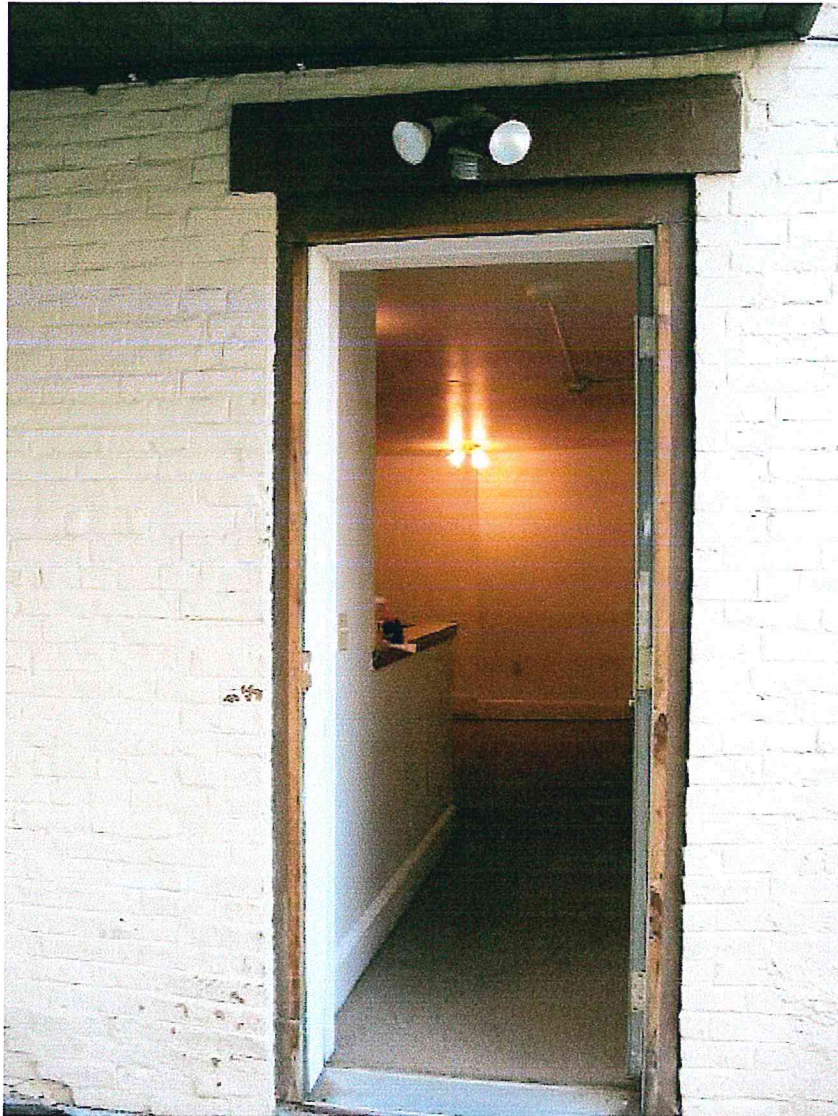
Photo 29. Door to apartment (#4) on east end of first floor. Door frame is modern and bricks have been cut to create this opening.

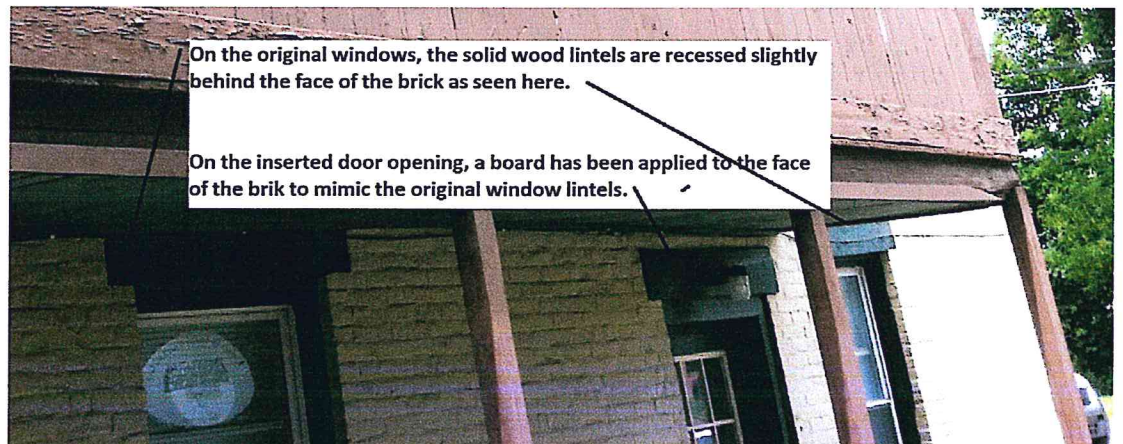
Photo 30. Note that on the historic windows, the solid wood lintels are recessed just behind the face of the brick. Where the door has been inserted under the porch, the historic lintels are mimicked with a faux lintel that is really just a board applied over the brick cut opening with the door frame acting as support for the brick veneer wall surface.

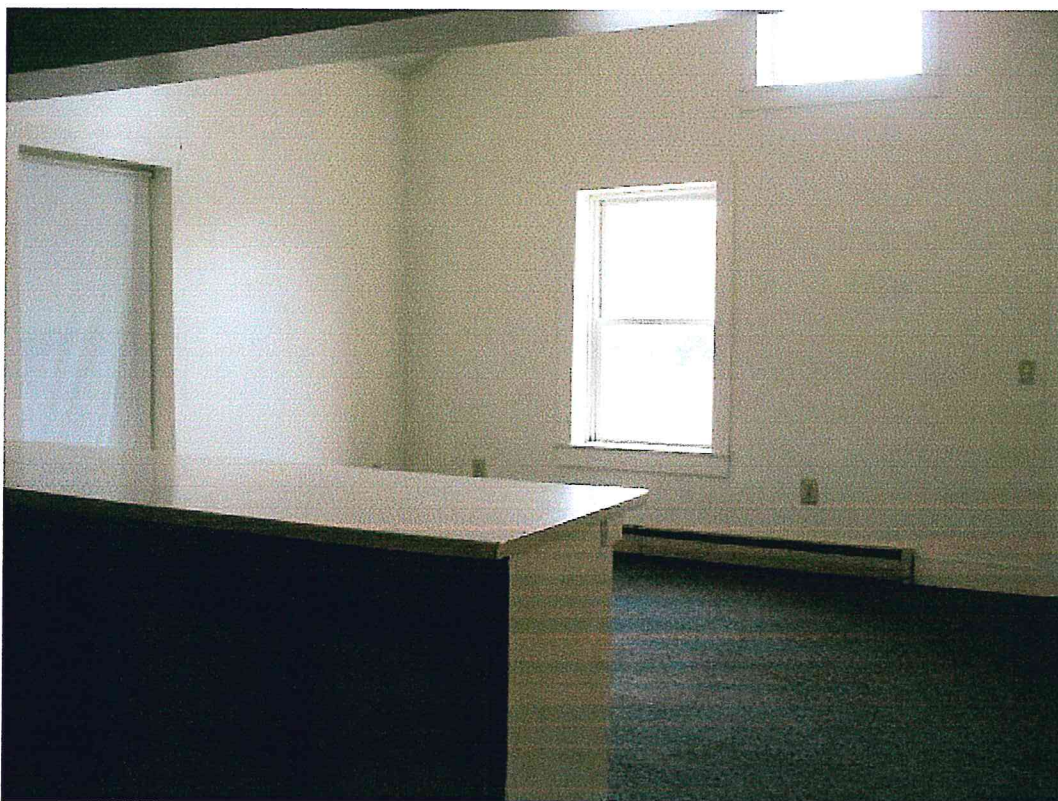
Photo 31. Living Room of apartment (#1) west side, second floor. Note that the tall space also shows the window at the attic level.

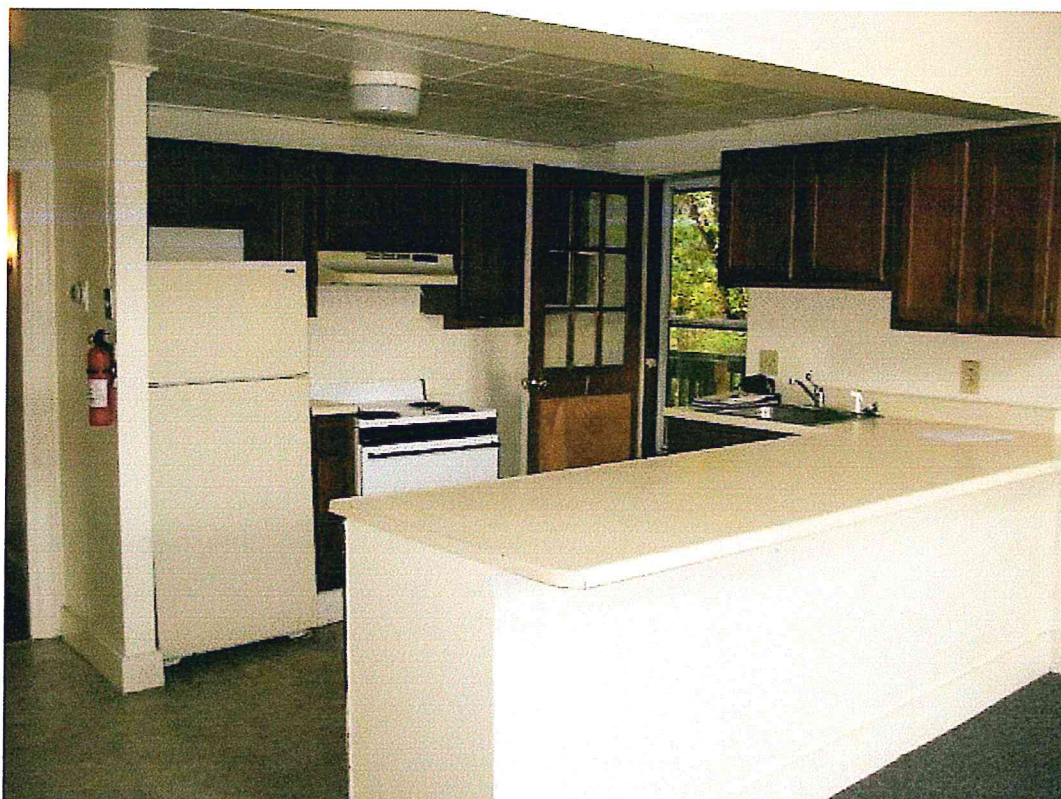
Photo 32. Kitchen of apartment (#1) at west end of Second Floor. Beam in foreground is one of the original 8x8 framing timbers, now wrapped in Sheetrock. No historic fabric exists at the interior of the first or second floors.

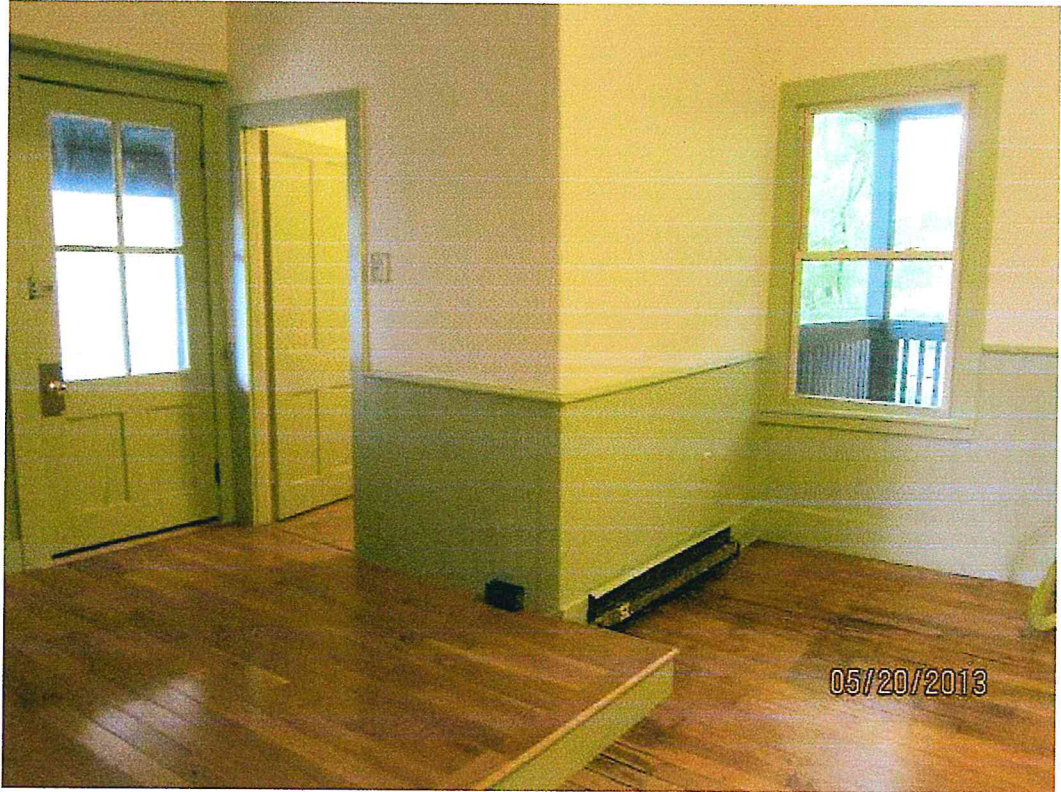
Photo 33. Kitchen (on raised platform) and living space of apartment (#2) at east end of Second Floor. Door with glass leading to the mostly-enclosed east porch replaces an historic window.

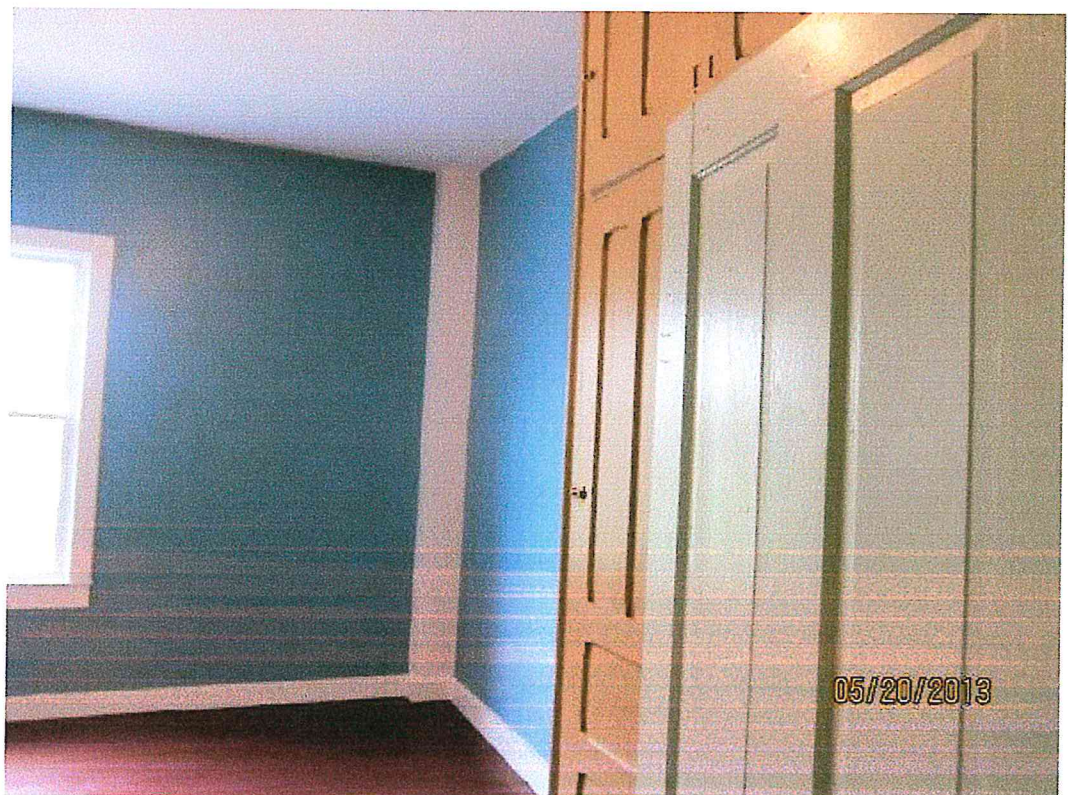
Photo 34. One of the three bedrooms of the east end apartment (#2) on the Second Floor. Note the corner post that is part of the 8x8 heavy timber frame of the building.

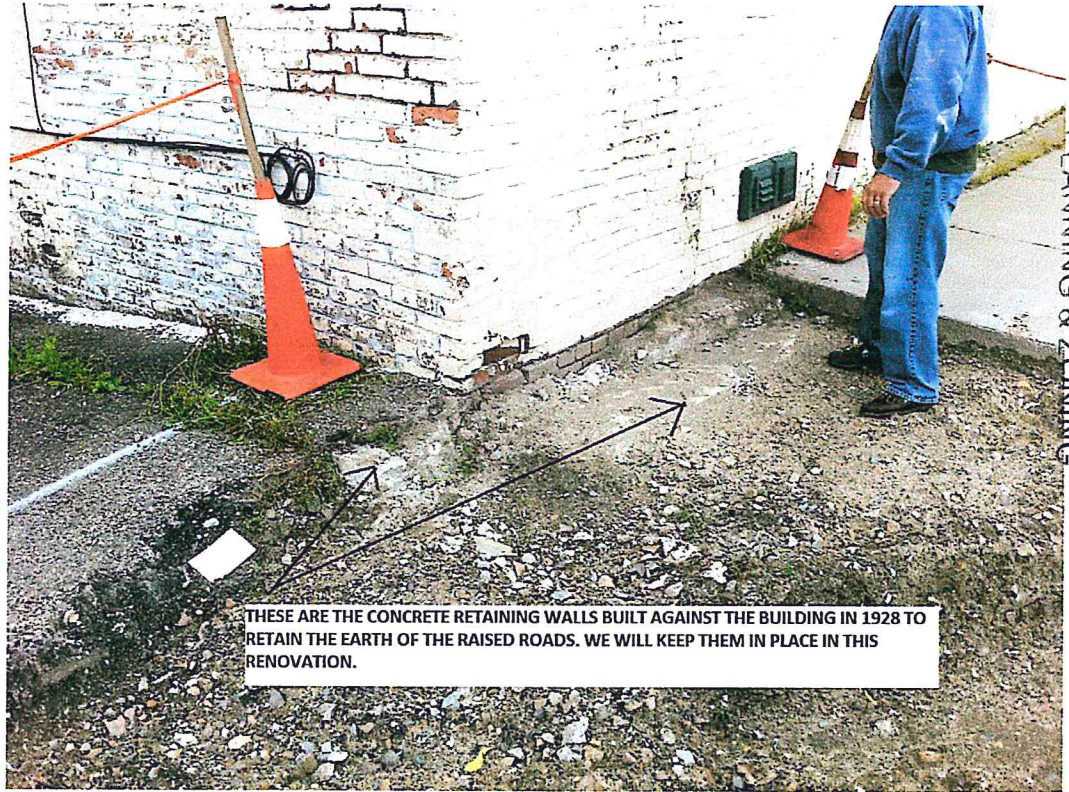
Photo 35. Retaining walls built in 1928 to retain the earth of the raised roads. Wall is poured directly against the brick veneer of the building, and is causing damaging rising damp to the façade. Note that original color of building was unpainted dark red/maroon colored bricks.

*Rising damp damage to bricks at west end of north façade.*

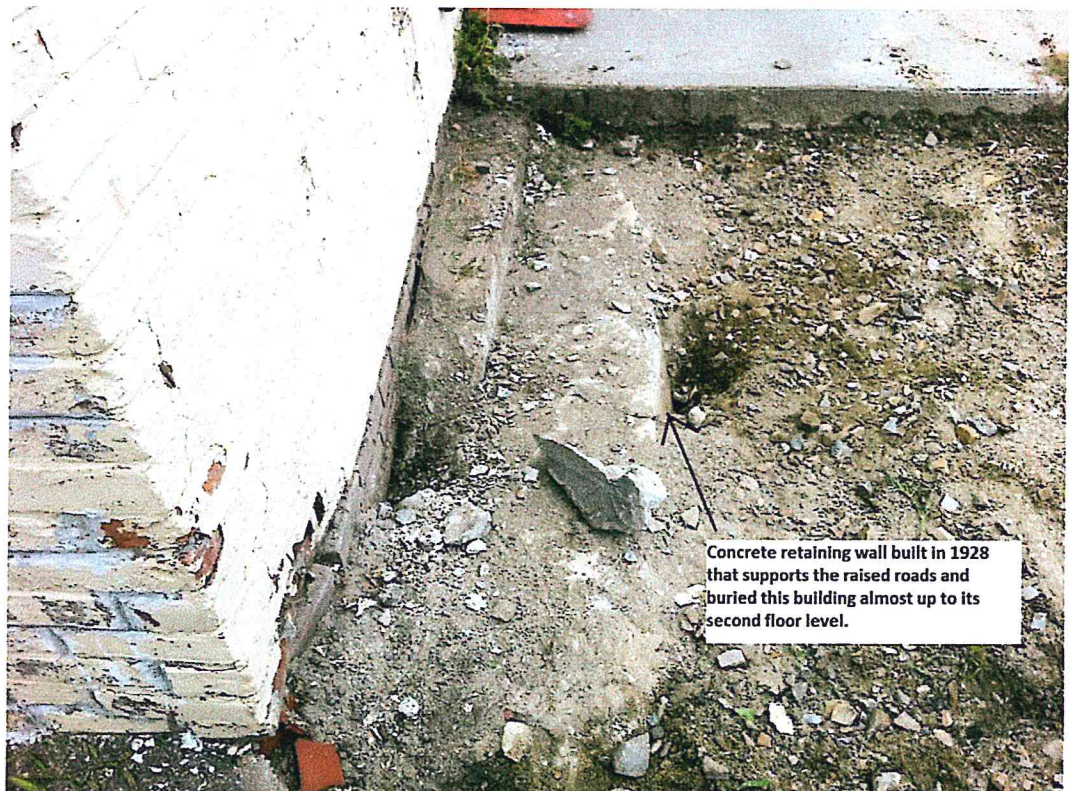
Photo 36. Detail at top of retaining wall at west side of building.

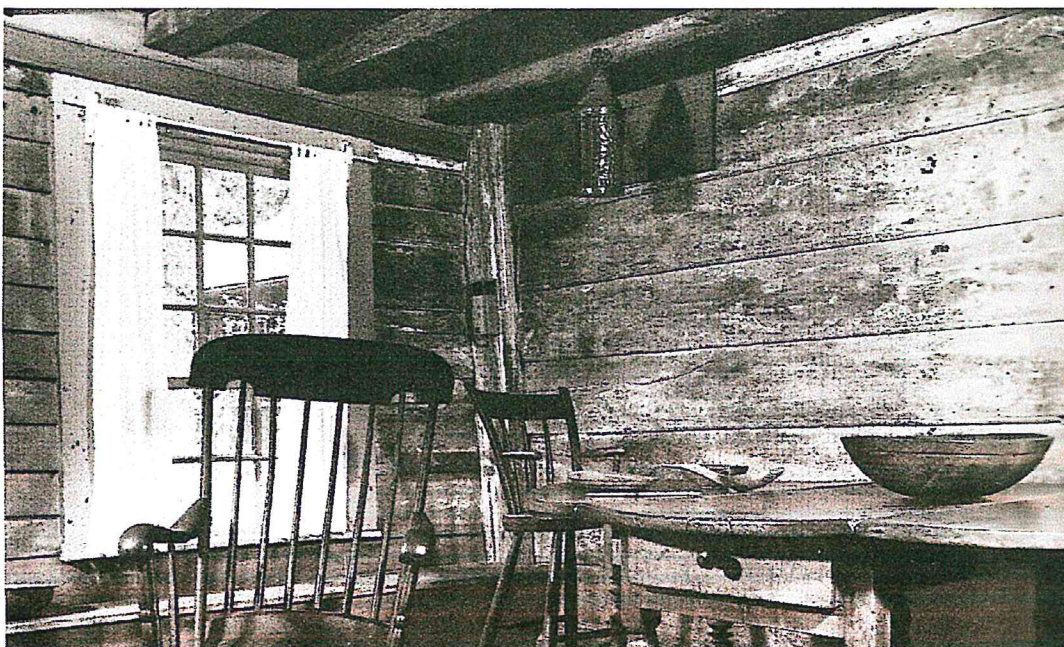
Photo 37. The new floor structure of the inserted floor and the first floor apartments when seen from the cellar floor will be similar to that seen here.

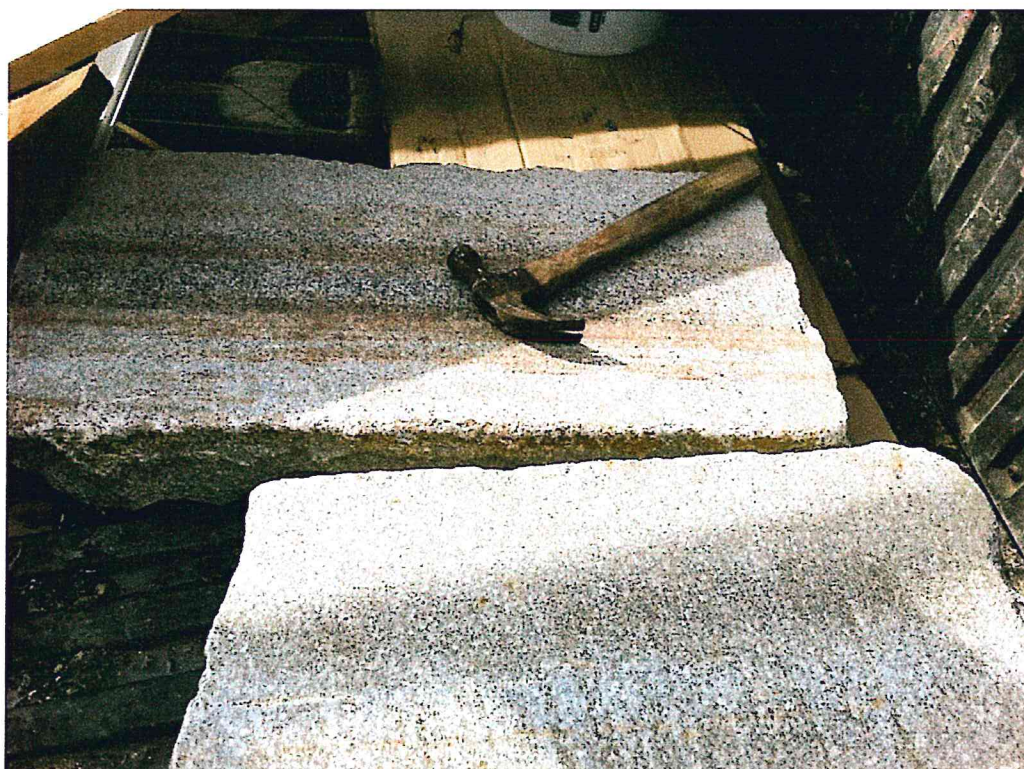
Photo 38. This photo shows two the granite stones that will be used to reconstruct the foundation wall between the top of the existing stone foundation that will remain and the bottom of the brick at the lifted building. Sizes are similar with similar cut to the existing stones, but these are grayer – compatible, but different so they do not fool someone to thinking they are the original stones. These stones will only be visible on the exterior and will be backed up to a new insulated concrete foundation wall on the interior, faced with plaster.

New concrete walls exterior walls made of insulated concrete forms will be built between the lifted building and the original stone foundation. The exterior of these wall will be faced with 6" -7" thick granite stones similar in size and texture to the existing foundation stones. These new stones will be placed under and support the existing brick veneer to match the original orientation of brick above stone. The interior of the concrete walls will be plastered, so they are not confused with the original foundation stones the will remain visible in the Café's lower floor. As envisioned now, the café would be on parts of both of the interconnected two lowest floors: the inserted, rebuilt ground floor and the rebuilt cellar floor set about 1' lower than it is now in order to gain sufficient head room.

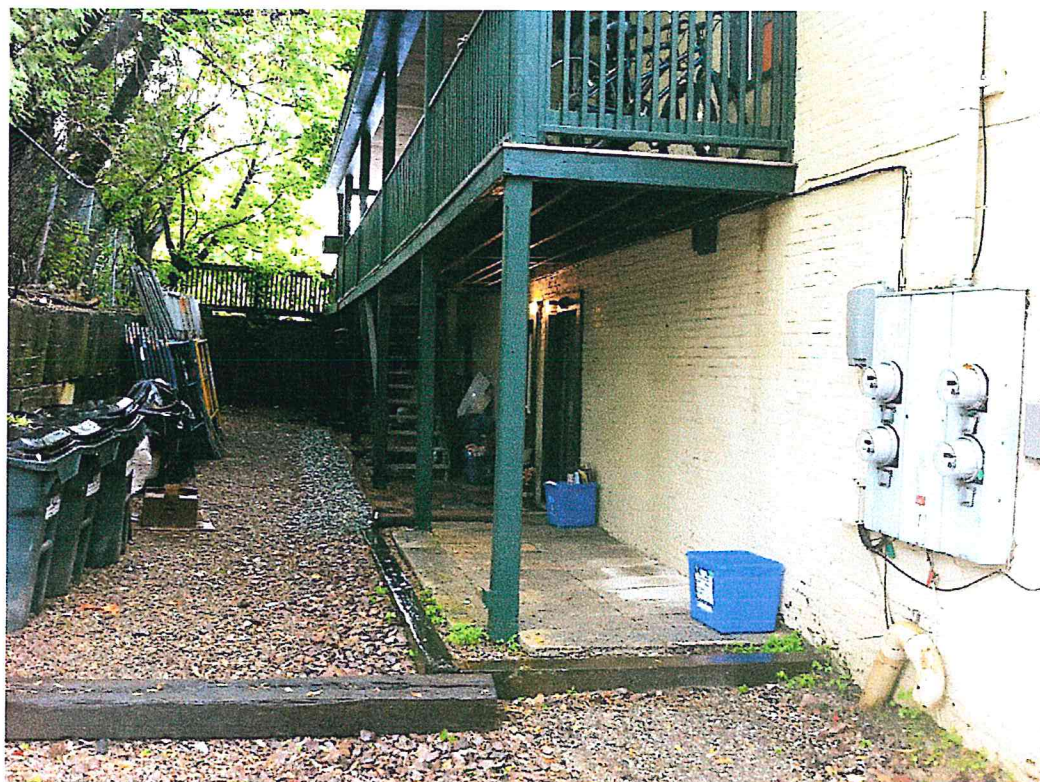
Photo 39. Location of existing meters on east end of south elevation. Intent is to move these to the west end of the south elevation after the building is lifted and service the building with an underground primary feed from the existing power pole near that location. One additional meter will be included for the Café. If possible, all meters may be put inside the building if Green Mountain Power can accept "smart metering" at this location with a remote reading ability for each meter.

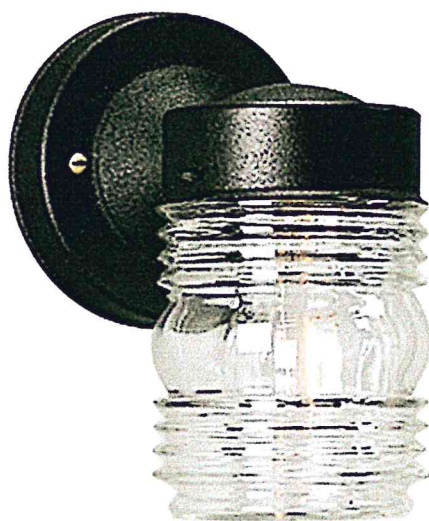
Photo 40. Light at apartment doors. Lamp will be an LED lamp with 2700K color temperature to match that of incandescent lighting. Width is 4.785" Height is 7.25". Housing is black.

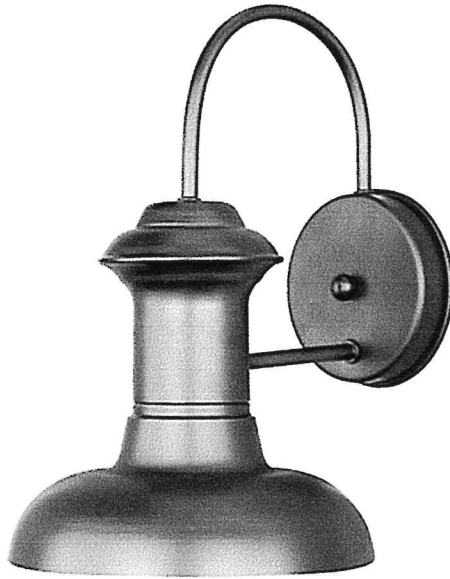
Photo 41. Light at Café entrance. Light is Progress P5721-71. Width is 10". Height is 10.75". Projection is 11.75". Light will be set directly above the Café Entrance main door on the east side of the building. Color is Gilded Iron (black).

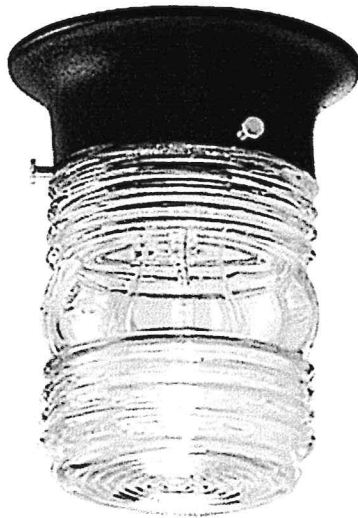
Photo 42. Lights under the porches. Light is Progress P5603-31. Width is 5". Height is 6.25". Housing is black.

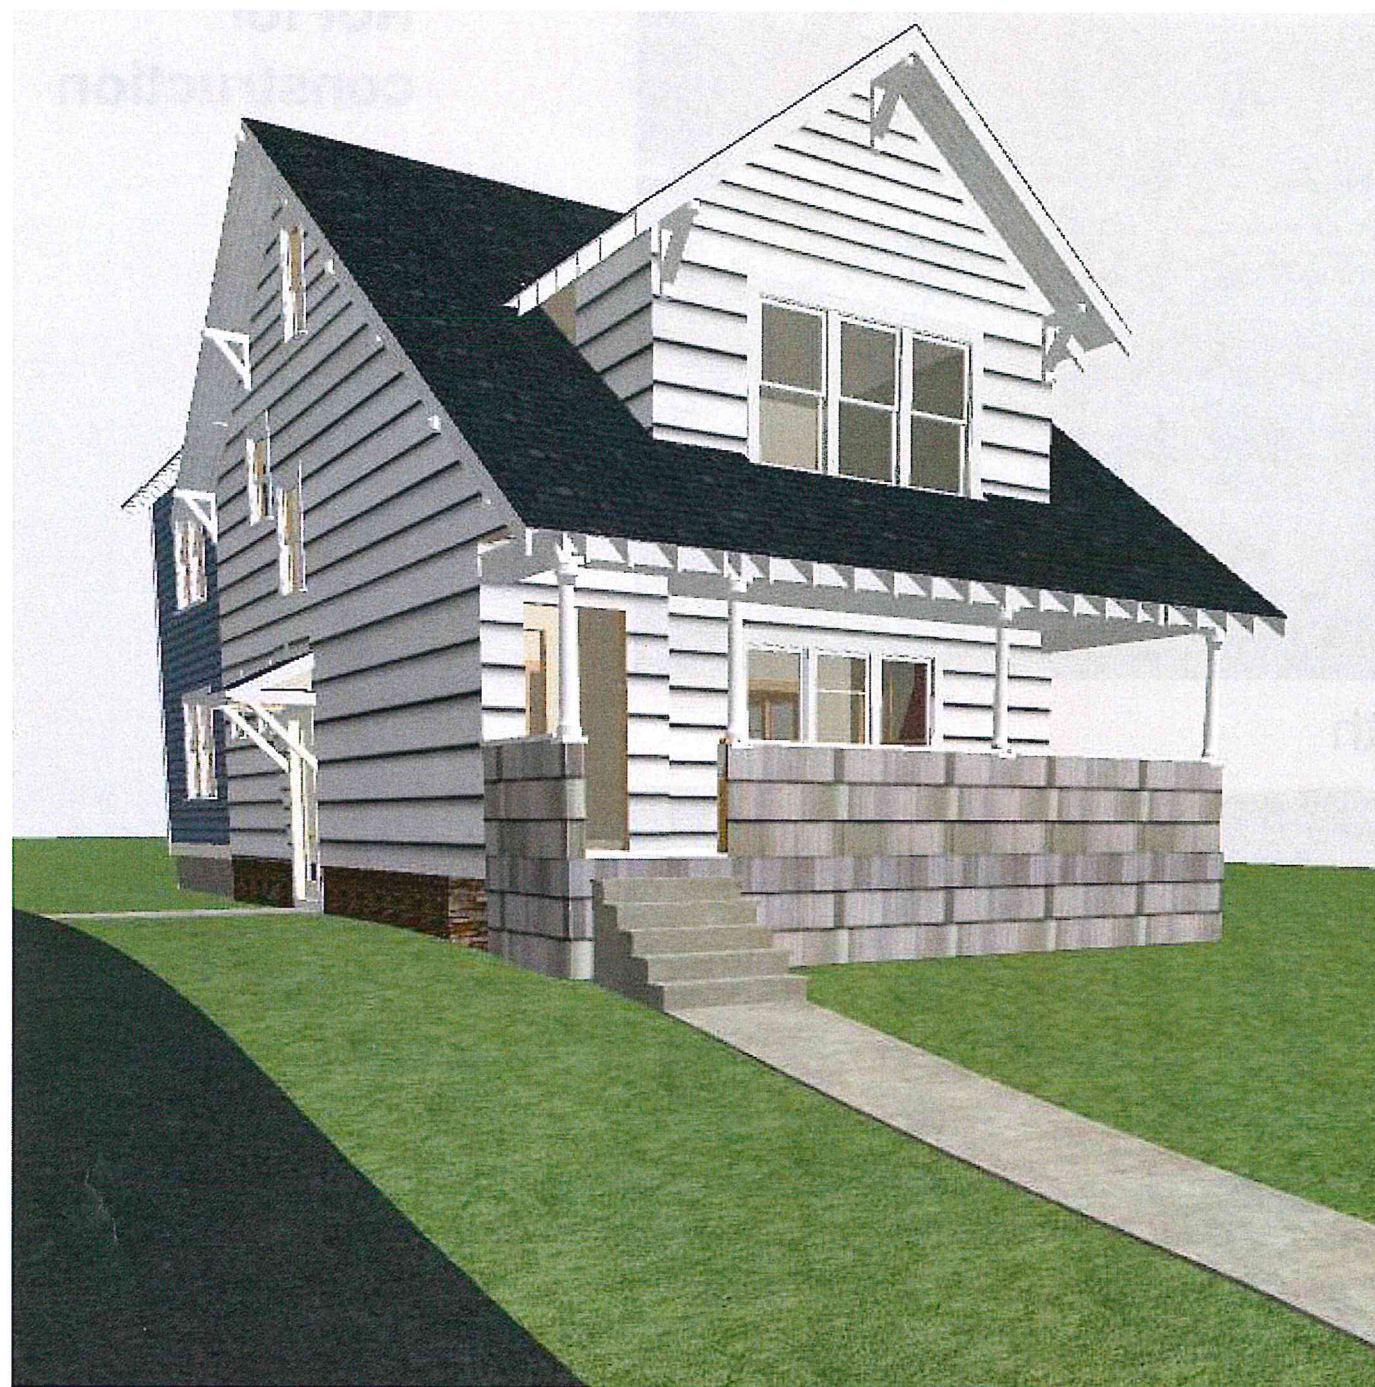
Perspective view  
from street

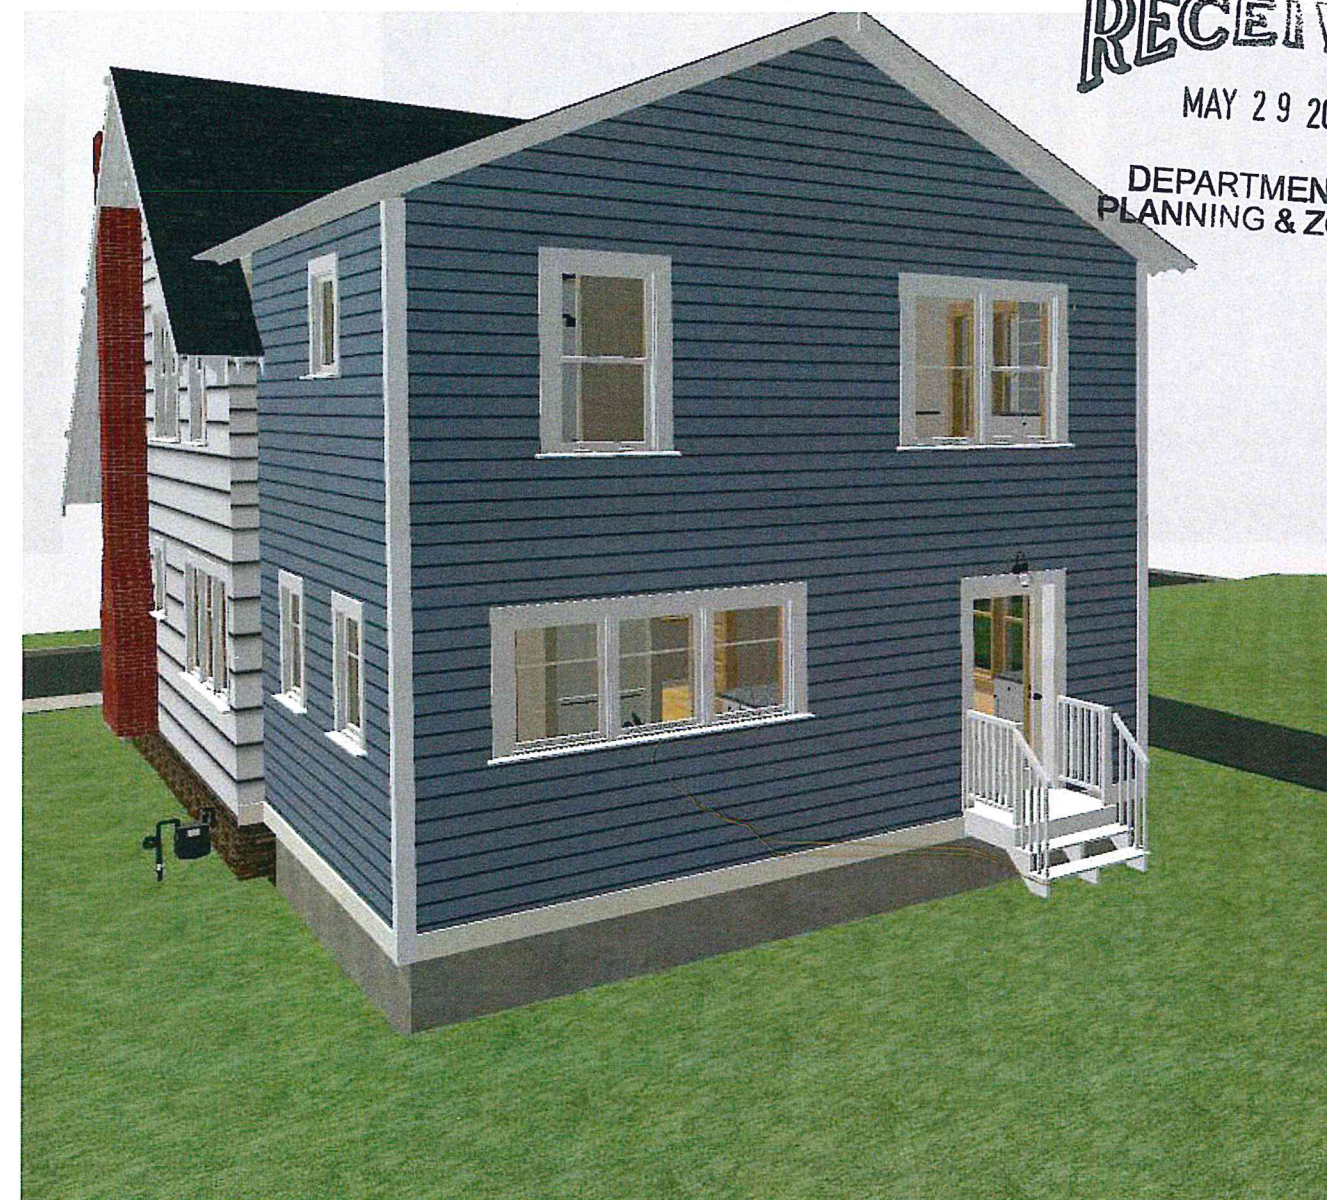
Perspective view  
of addition from  
rear

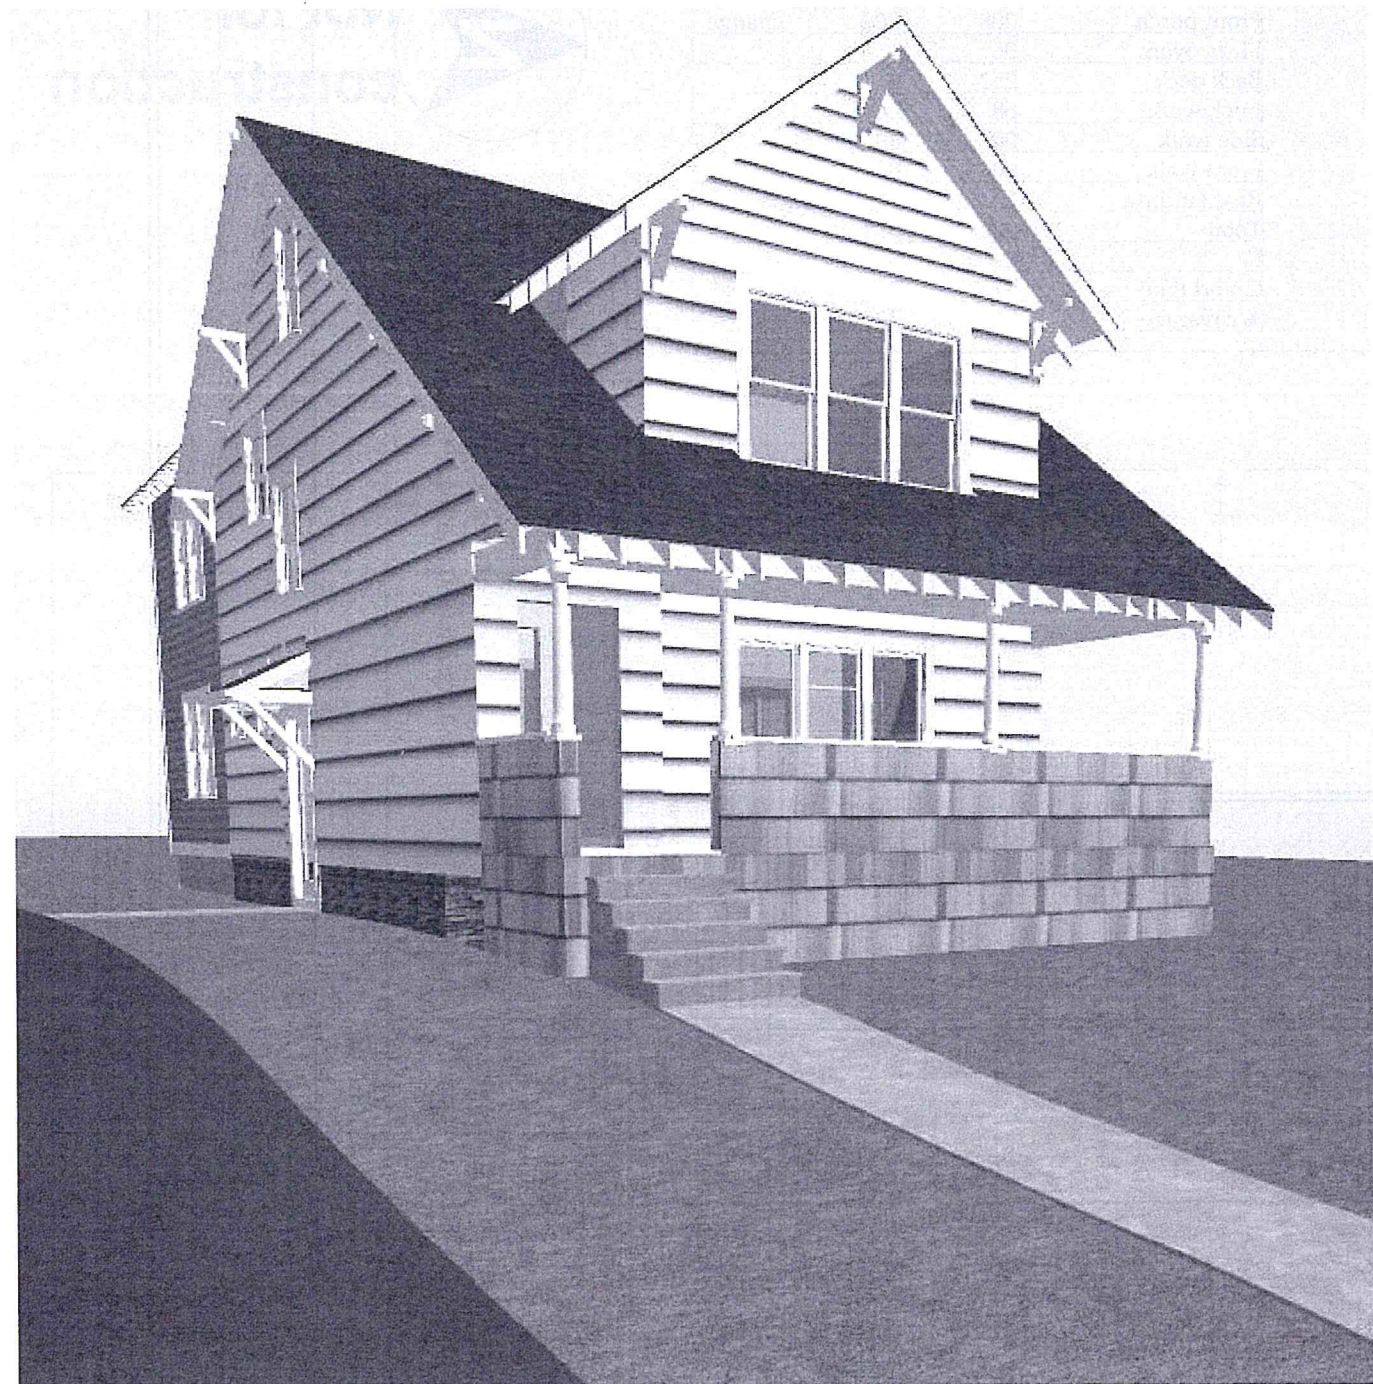
Perspective view  
from street

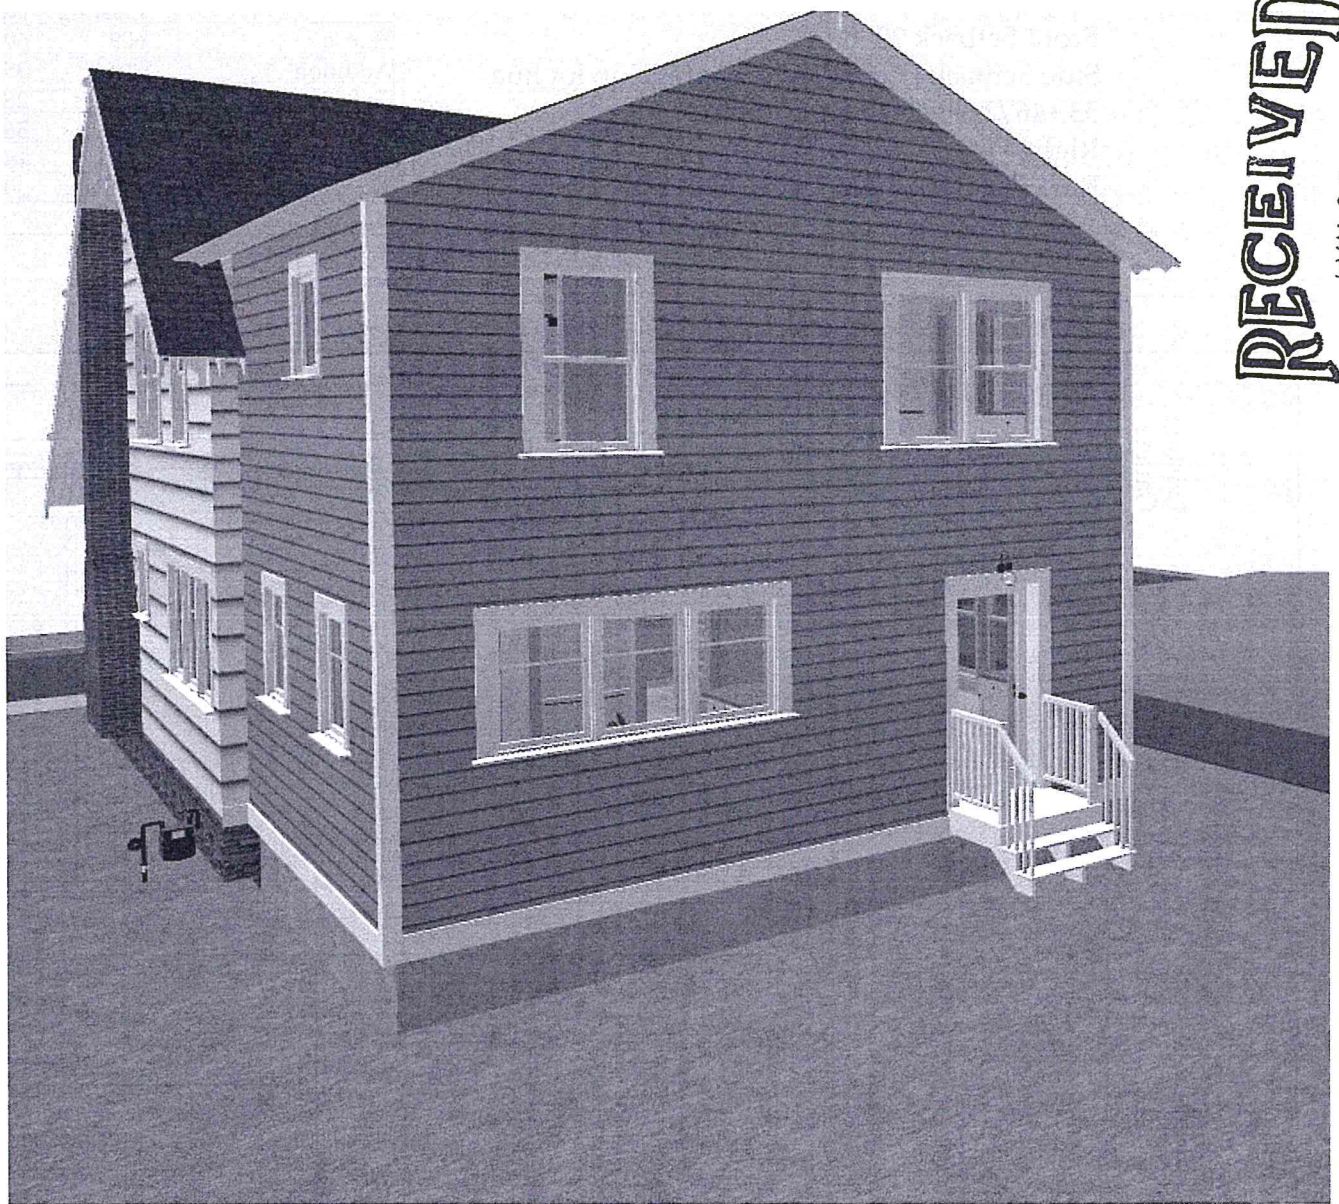
A1

Perspective view  
of addition from  
rear

1. A canopy is recommended over the northerly (rear) entrance door.
2. All meters and exterior mechanical equipment must be illustrated on site plans or elevations as appropriate.
3. Standard Permit Conditions 1-15.
