### DESIGN ADVISORY BOARD Tuesday, June 23, 2015 at 3:00 PM Conference Room 12, City Hall, Burlington, VT

- 2. 15-1314CA; 495 Colchester Ave., (Neighborhood Mixed Use, Ward 1), Brisson Properties**  
Raise buildings repair and restore exterior, remove porch. Add one floor of living space. Associated site improvements.

PROJECT: 495 COLCHESTER AVE. RESTORATION  
BRISSON PROPERTIES  
JOB No. 14-03

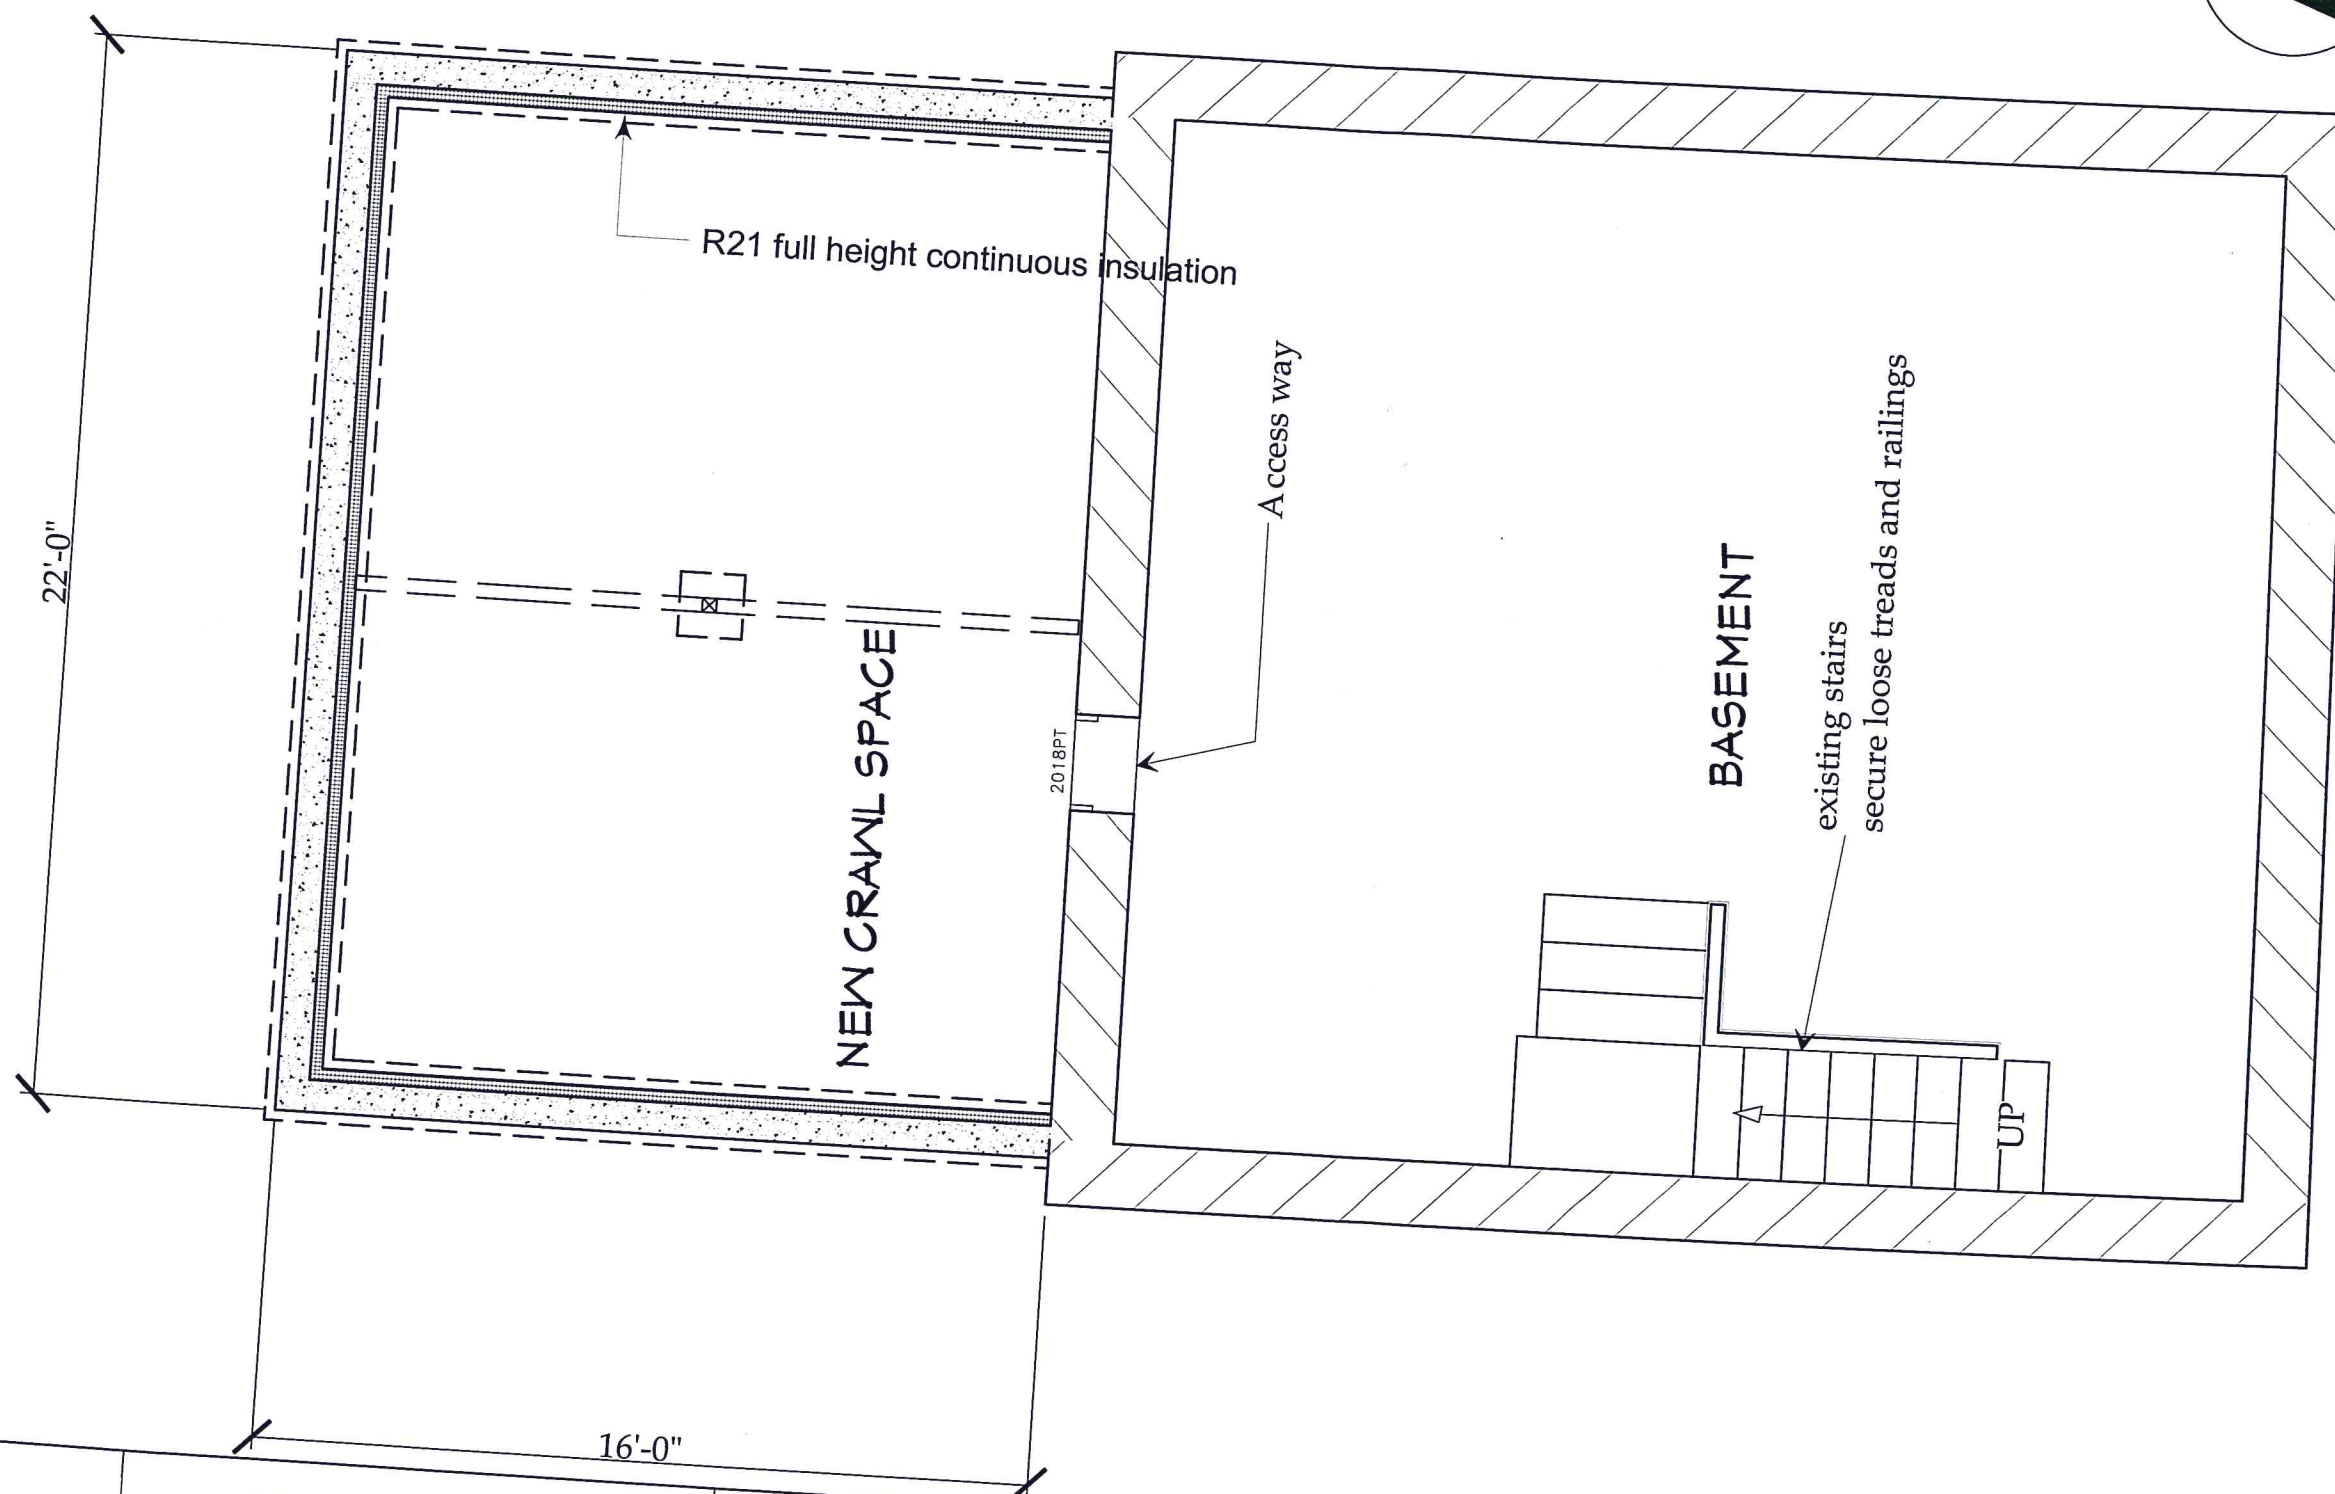
A3

Foundation Plan
