# FACILITY CONDITION ASSESSMENT AND LEVEL I ENERGY AUDIT

## FACILITY CONDITION ASSESSMENT AND LEVEL I ENERGY AUDIT of LAKEVIEW CEMETERY BUILDING

455 North Avenue  
Burlington, Vermont 05401

**EMG Project #:** 110226.14R-014.294  
**Date of Report:** November 11, 2014  
**On site Date:** August 26, 2014 and August 29, 2014

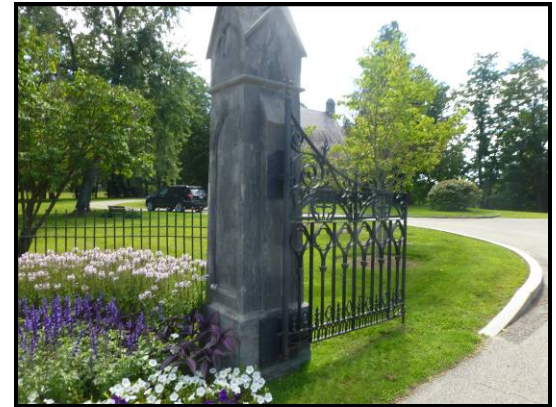
- The property and tenant identification signs are in good condition. Routine maintenance will be required during the assessment period.
- The exterior site and building light fixtures are in fair condition. Routine maintenance will be required during the assessment period.
- The chain link site fencing is in fair condition and will require routine maintenance during the assessment period.
- The iron fencing on the eastern border is in poor condition. The fencing is heavily bent in many areas as well as leaning and heaving along its entire length. Numerous repairs and structural additions have been added to remedy the irregularity of the fencing. The repairs were not effective and has caused the fences to heave an increasing amount more. An inspection was done during the site visit and structural inadequacy was found in the fencing overall.

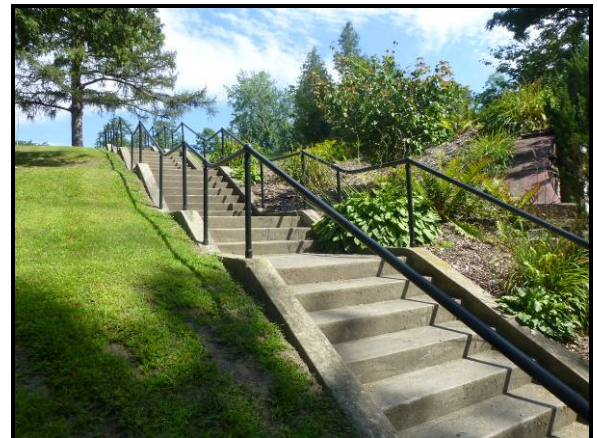
- The cemetery exterior stairs, balusters, and handrails are in good condition and will require routine maintenance during the assessment period.
- The interior stairs at the other buildings are in fair condition and will require routine maintenance during the assessment period. The carpet on the House/Office stairs will require replacement. The costs for replacement are included in the finish replacements in section 8.1.
- The exterior steps at the House/Break Room are in poor condition. The concrete steps are deteriorated and will require replacement during the assessment period. The cost of this work is included in the Replacement Reserves Report.

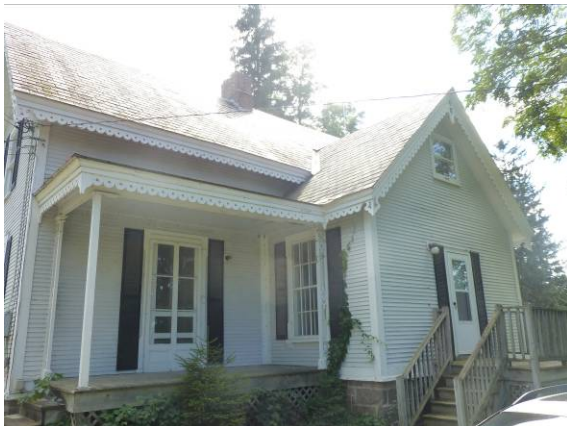
Photo #3: North elevation of cemetery building

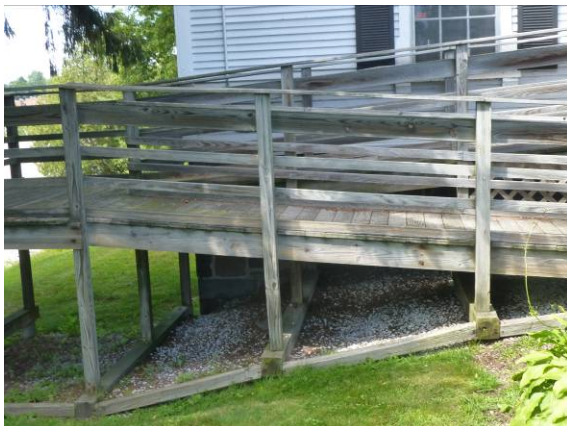
Photo #9: Cemetery building ADA ramp

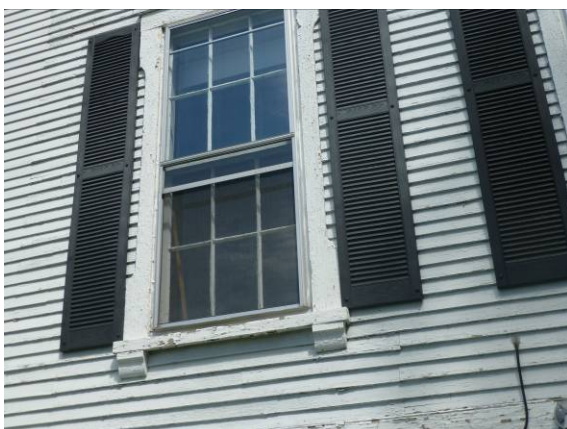
Photo #11: Cemetery building window

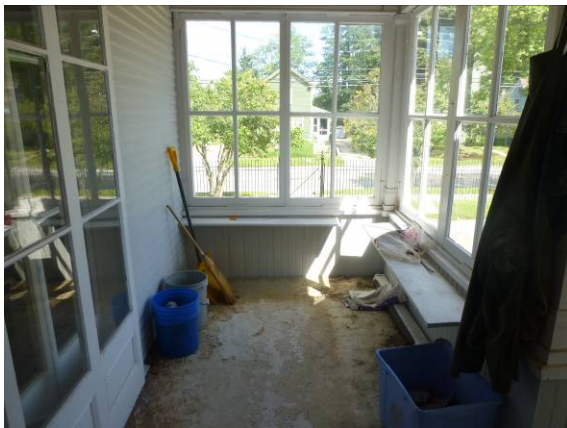
Photo #15: Enclosed porch

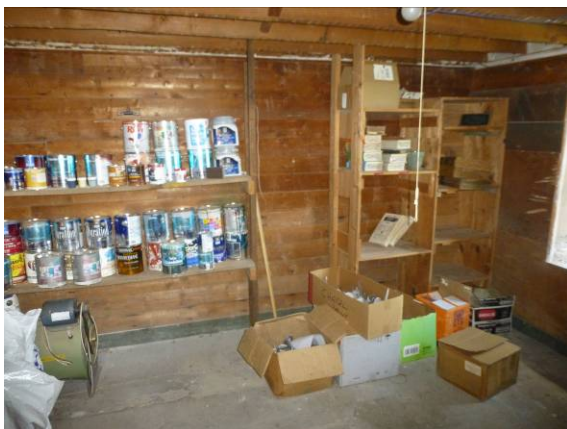
Photo #23: Basement

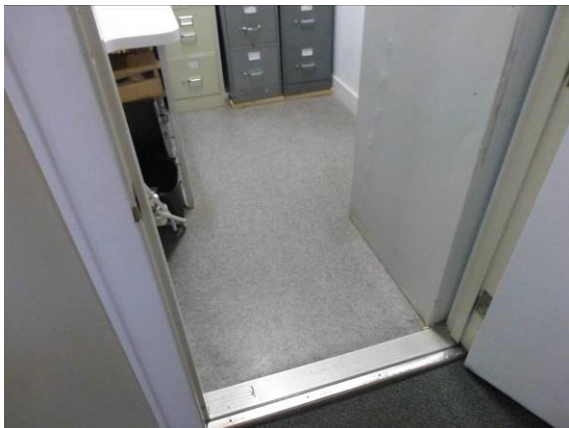
Photo #27: Carpet detail

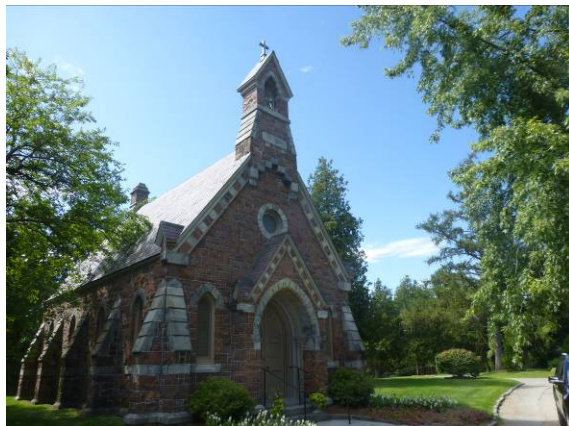
Photo #33: Chapel east elevation
